Volunteer Fire Fighter Sitting in his Parked Vehicle Warning Oncoming Traffic of a Motor Vehicle Incident was Struck and Killed by a Tractor-Trailer– Montana

SUMMARY

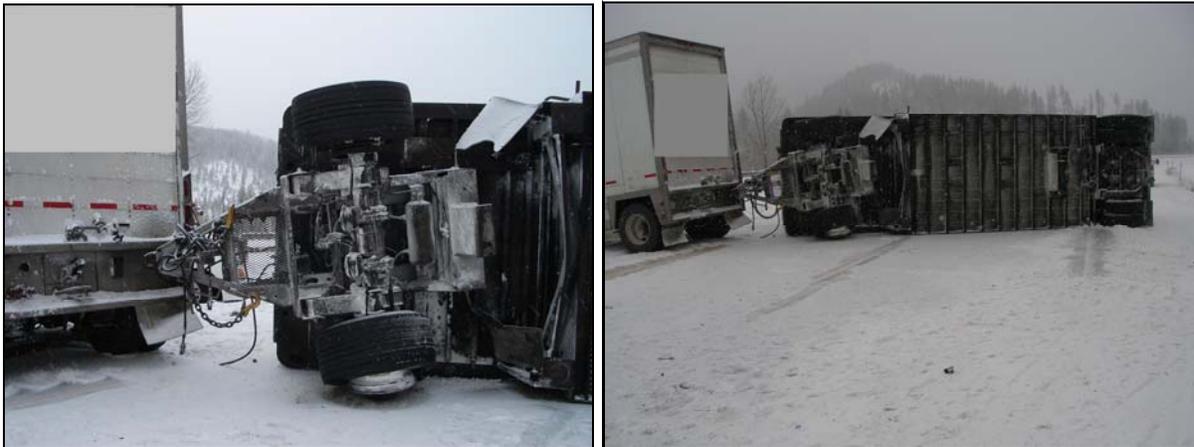
and two tires (see Photo 1). The first trailer was attached to the tractor while the second trailer with dolly was hitched to the rear of the first trailer. The first trailer measured approximately 26 feet in length and the second trailer measured approximately 25 feet. It is not believed that the trailers were over weight at the time of the incident.

Photo 1. Dolly used to pull second trailer in tandem.
(Photo courtesy of State Highway Patrol)

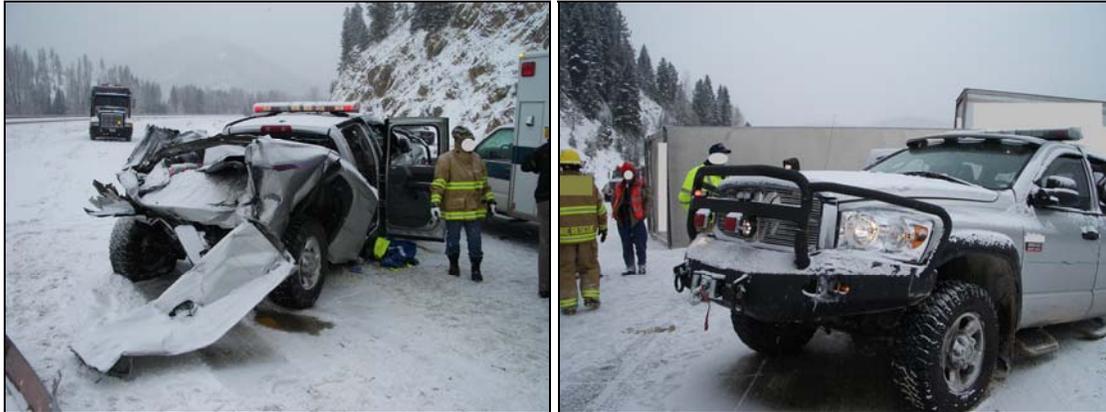
The victim's pick-up truck was positioned at an angle on the north shoulder of the westbound lanes. State Highway Patrol investigators could not determine the exact angle, but it was determined that the vehicle was not in the right travel lane. The vehicle was placed in park with the motor running. It was never determined if the victim had exited the vehicle to flag and warn traffic prior to the incident, but the victim was found not wearing his ANSI/ISEA 107-2004 Class III garment after the fatal incident. The pick-up truck's optical warning lights were all on (see Photo 2).

Photo 2. Placement and use of optical warning devices on the victim's pick-up truck.
(Photos courtesy of State Highway Patrol)

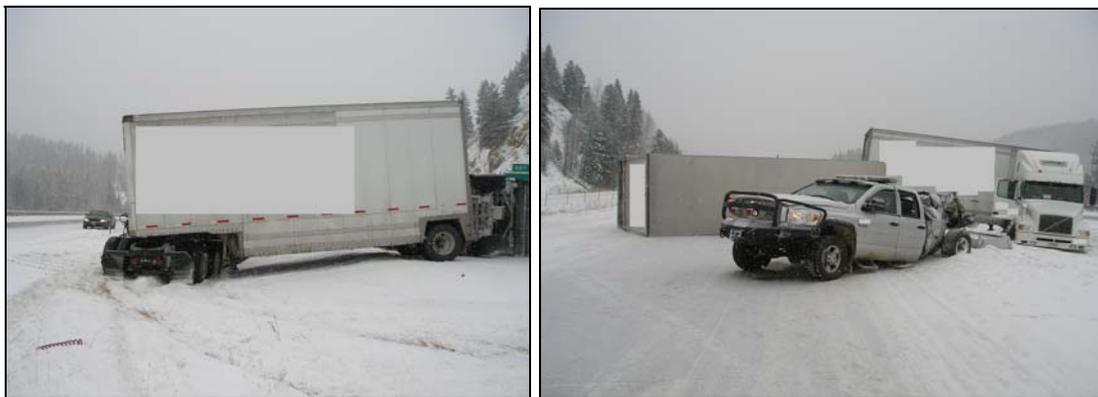
The victim's pick-up truck was pushed approximately 150 feet west of its original position coming to rest in the left travel lane. The tractor-trailer continued in the same direction coming to rest in the median in a snow bank (see Photo 3).

Photo 3. From left to right, downstream and upstream views of incident scene.
(Photo courtesy of State Highway Patrol)

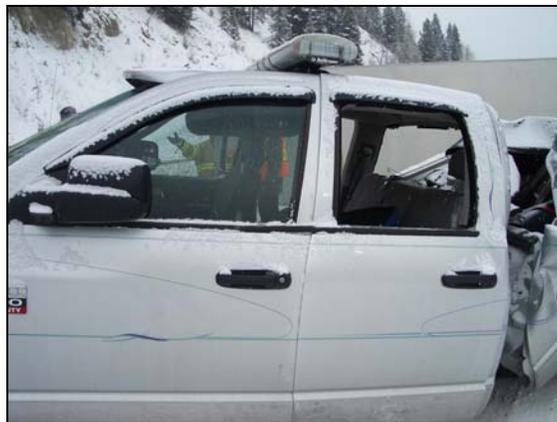
The victim was found unrestrained and not seated in the driver seat. He was found with his legs draped over the driver seat, torso laying on the rear row of seats, body facing supine, and pointed towards the passenger side rear door. The driver seat was positioned beyond a 90° angle. It was not determined whether it was broken or reclined. The State Highway Patrol investigator confirmed that the column shifter was placed in park and observed that the icon to “put your seat belt on” was illuminated on the instrument panel after the incident. The parking brake was also set. It is believed that the victim was ejected from the driver seat and suffered fatal injuries after striking the interior of the vehicle. Crash investigators found transfer of the victim’s hair from impacting the headliner in the area of the driver side C-pillar. There was little damage to the vehicle’s interior passenger compartment between the A- and B-pillars (see Photo 4), and it appears that the space for the front seat occupants was preserved. All four doors on the vehicle were jammed requiring mechanical means to access the victim.

Photo 4. Showing virtually no damage to the passenger compartment.
(Photo courtesy of fire department)

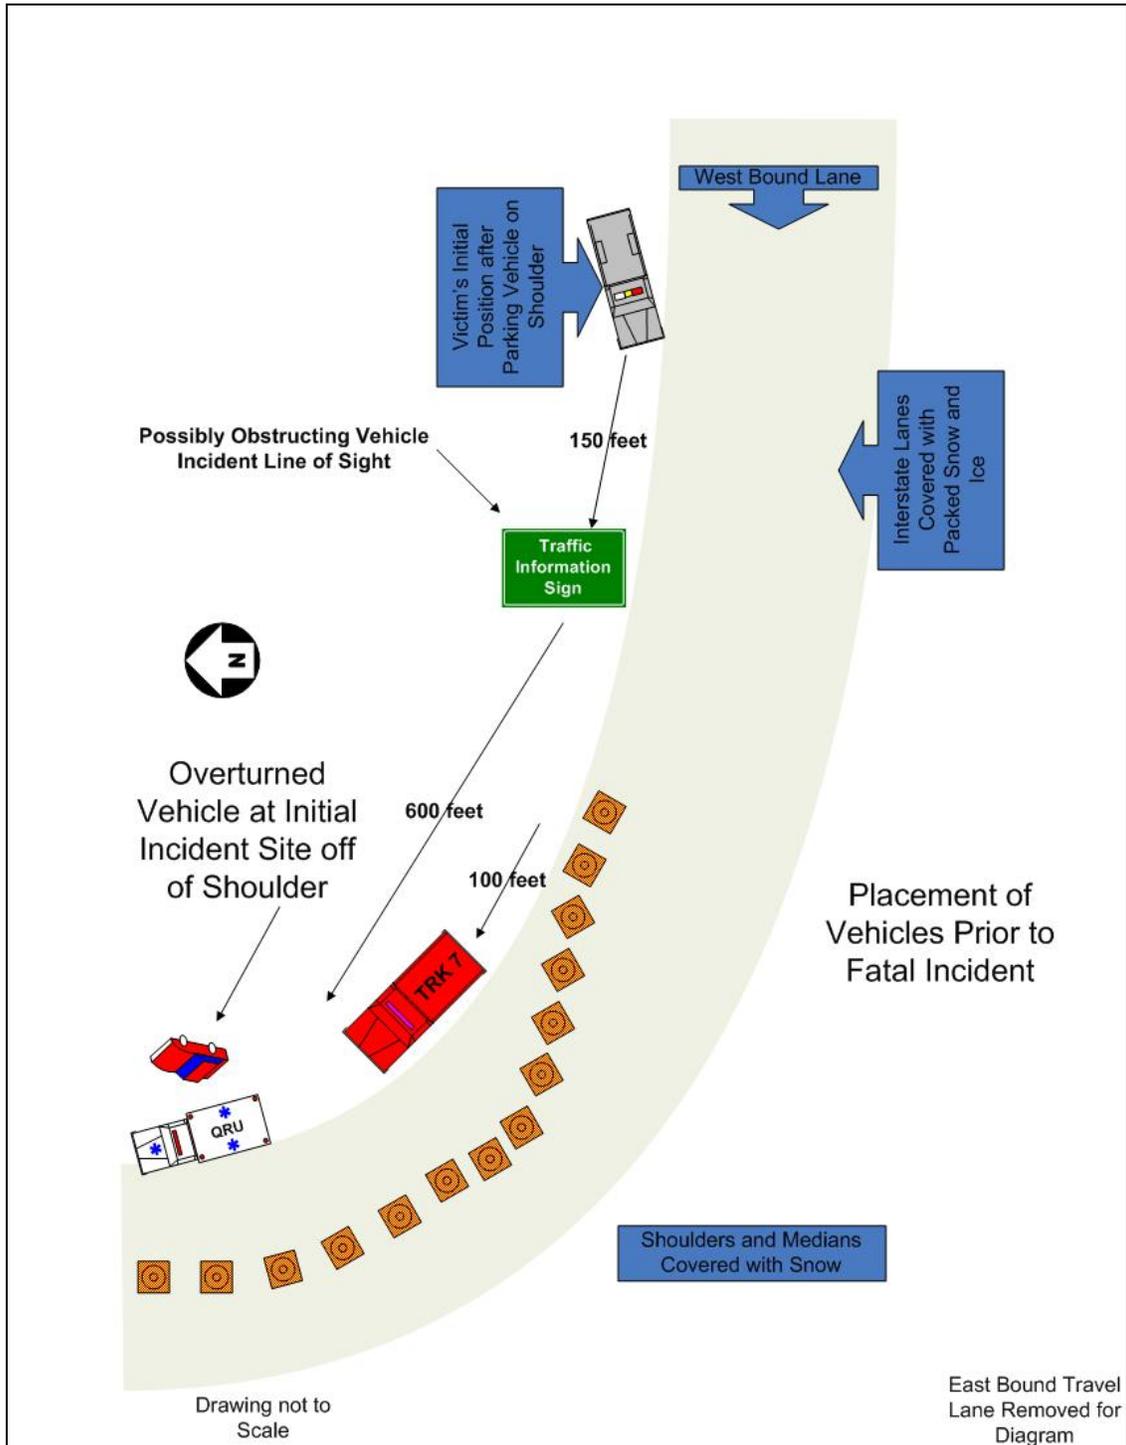
During this incident, cones and an apparatus block had been established for an incident on the right shoulder in a curve. Emergency signs had not been placed. The incident was minor and in the wrap up stages. The victim would usually respond to the scene of highway incidents to assist in the set-up of the temporary traffic control. When not needed at the scene the victim would position his vehicle upstream from the incident to warn oncoming traffic of the downstream traffic control zone. This was very important during this incident because a motorist could not see the incident on the straightaway before the curve. The temporary traffic control zone was established 100 feet before the incident and the victim positioned his vehicle 650 feet upstream from the first cone placed for the temporary traffic control zone. While operating in or around moving traffic one should never trust oncoming traffic or turn their backs to it.¹¹ The victim did not exit the vehicle, leaving his back turned to oncoming traffic. The victim also did not have emergency road signs, cones, or flagging equipment in his vehicle. Even though these temporary traffic control devices were not used by the victim, the operator of the tractor-trailer stated that the victim's vehicle and optical emergency warning lights were visible while parked on the right shoulder. During the process of the tractor-trailer moving over, the chain of events began ultimately taking the life of the victim.

Diagram 1. Temporary traffic control prior to victim's fatal incident.

Recommendation #3: Fire departments should reevaluate current policies and procedures to ensure that temporary traffic control devices are available and deployed upstream of warning vehicles
