A summary of a NIOSH fire fighter fatality investigation

August 10, 2009

## One Career Fire Fighter Dies and Another is Seriously Injured in a Single Vehicle Rollover Crash—Georgia

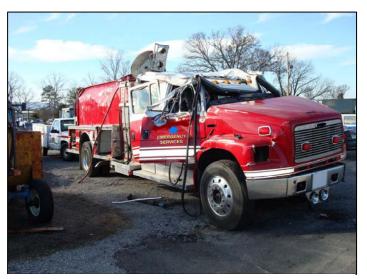
Apparatus involved in incident (Photo by NIOSH.)

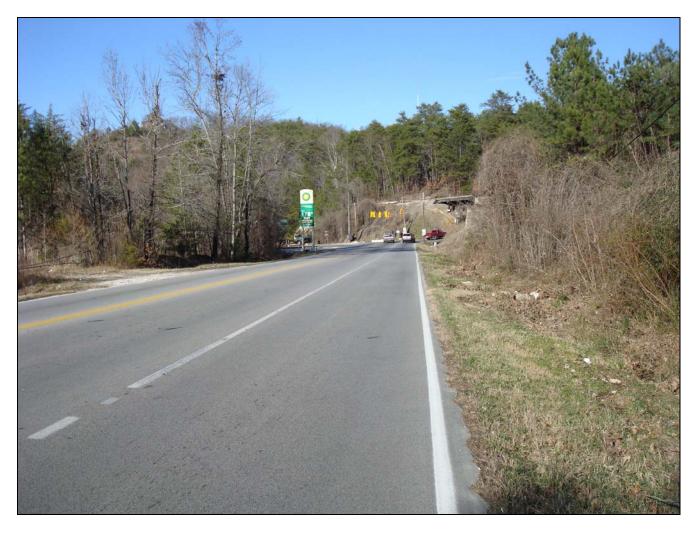
The fire truck was traveling downgrade on a two-lane, blacktop state highway with a posted speed limit of 40 mph (Photo 1). The highway had a downgrade slope approaching the intersection that descended 200 feet over 1.7 miles. The crash occurred at the end of this highway where it intersects in a curve with another two-lane highway. The intersecting highway also had a grade that sloped downward and away from the approach road. The intersection was controlled with a traffic signal and had a railroad trestle on the right creating a blind approach for vehicles approaching from the right (Photos 2 and 3). The intersection had a raised concrete lane divider on the left side of the approach and a significant grade change between the two intersecting highways. The road surface was asphalt, in good condition, and was dry. At the time of the crash it was dark, the skies were clear, and the temperature was  $32^{\circ}$ F. Winds were calm.<sup>2</sup>

Photo 1. Approach to intersection. (Photo by NIOSH.)

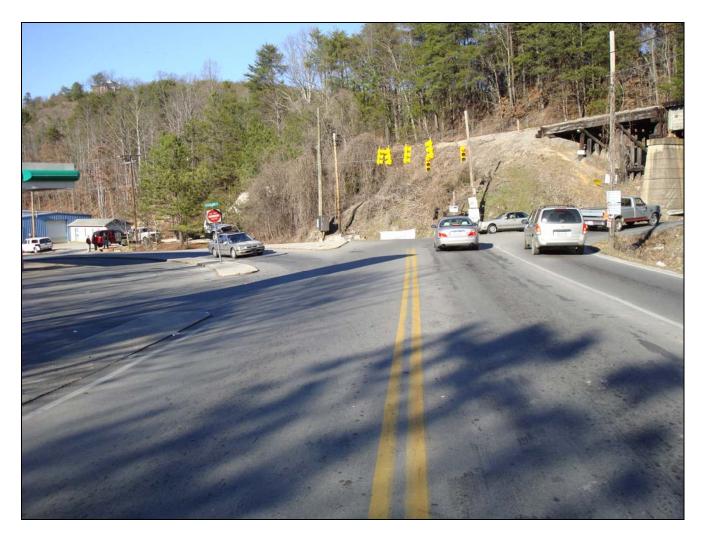
In this incident, the difficult road conditions encountered were a long downgrade approach to the intersection, a significant grade change at the intersection, reduced visibility due to darkness and a railroad trestle, and a complex intersection.

Photo 2. Intersection approach. Note the railroad trestle on the right, restricting the view of oncoming traffic. (Photo by NIOSH.)

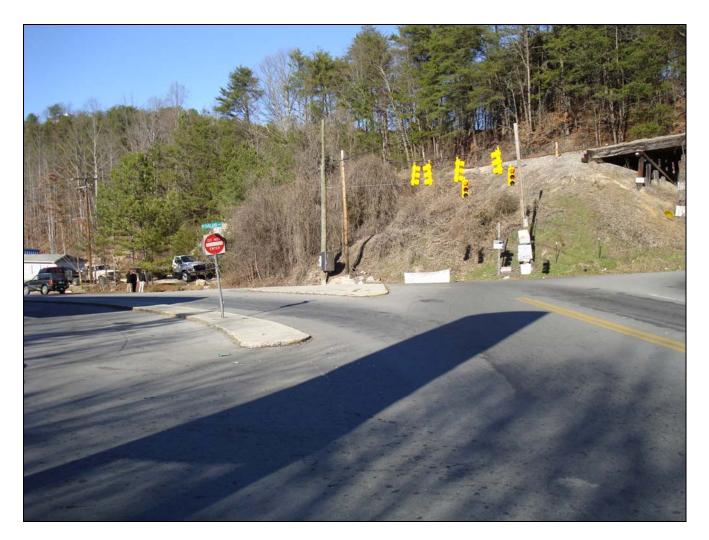
Photo 3. Intersection grade. Note the grade change of the intersecting roadway which would cause a vehicle to lean significantly to the right while making a left turn. (*Photo by NIOSH.*)

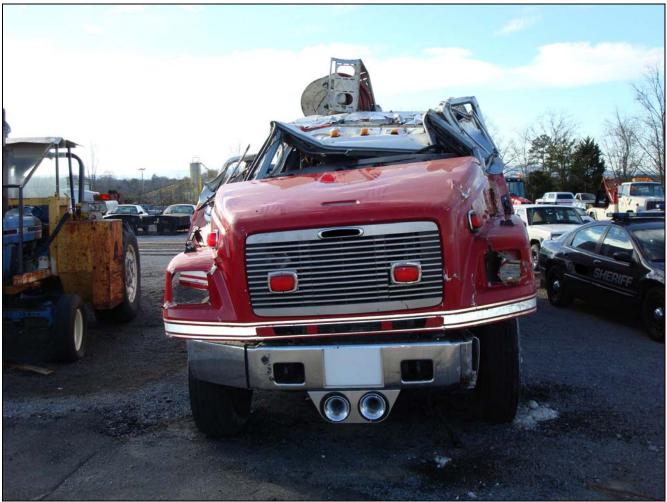
In this incident, the fire truck was a 1998, four-door commercial chassis that met all of the minimum requirements for fire truck safety standards and design in effect on the date of manufacture. The victim was properly belted in the driver's seat with a three-point shoulder-lap seat belt. The driver had the air-adjusting seat in the upper position and likely had very little clearance between the top of his head and the ceiling of the cab (see Photo 6). The victim was pinned between the collapsed roof of the cab and the seat and died from injuries associated with the impact.

Photo 4. Cab roof intrusion into driver and passenger compartment. (Photo by NIOSH.)

### **Recommendation #4:** Fire departments should consider rollover protection for the crew areas of fire apparatus when upgrading or purchasing new apparatus.

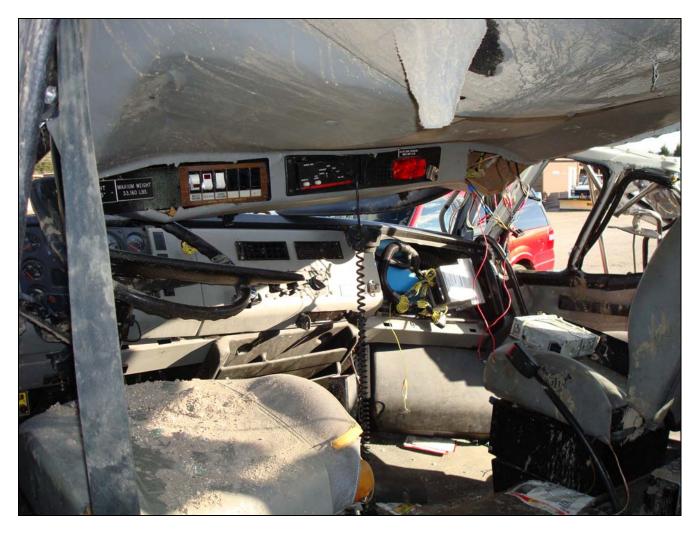
In this incident, the driver had adjusted the suspension seat elevation to the upper most travel point, and it is likely that there was minimal clearance between the top of his head and the ceiling of the cab (see Photos 5 and 6). The driver's seat lacked a mechanism to automatically retract the seat down, and the cab roof was not strong enough to prevent the intrusion into the driver's compartment. The victim was pinned upside down with the roof collapsed around his head.

Photo 5. Roof of cab intruding into driver's area. Note: Seat back was removed during extrication. (Photo by NIOSH.)

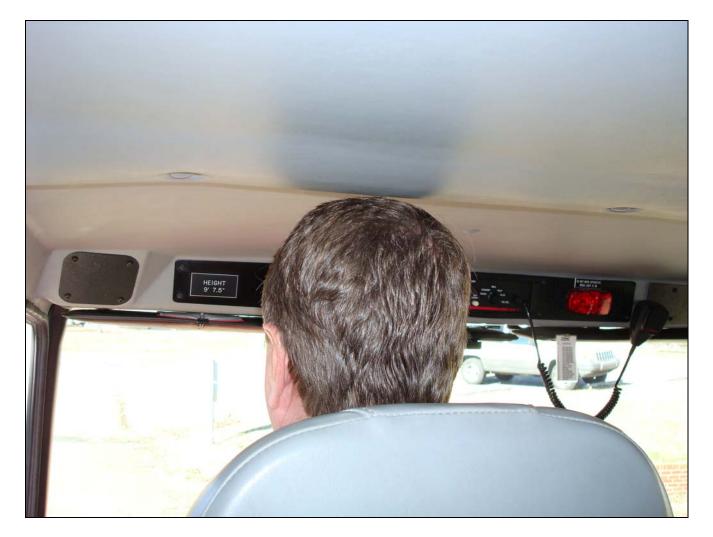
Photo 6. Similar fire truck showing clearance between head and cab ceiling. Note: Seat is raised and subject is close to the height of the victim. (Photo by NIOSH.)
