## **Two Career Fire Fighters Die after Falling From Elevated Aerial Platform – Texas**

On January 25, 2009, two male career fire fighters, age 28 (Victim #1) and age 45 (Victim #2), died after falling from an elevated aerial platform during a training exercise in Texas. The fire fighters were participating in the exercise to familiarize fire department personnel with a newly purchased 95-foot mid-mount aerial platform truck. A group of four fire fighters were standing in the aerial platform which was raised to the roof of an eight-story dormitory building at a local college. The platform became stuck on the concrete parapet wall at the top of the building. During attempts to free the platform, the top edge of the parapet wall gave way and the aerial ladder sprung back from the top of the building, then began to whip violently back and forth. Two of the four fire fighters standing in the platform were ejected from the platform by the motion. They fell approximately 83 feet to the ground and died from their injuries.

## Fatality Assessment and Control Evaluation Investigation Report # F2009-06

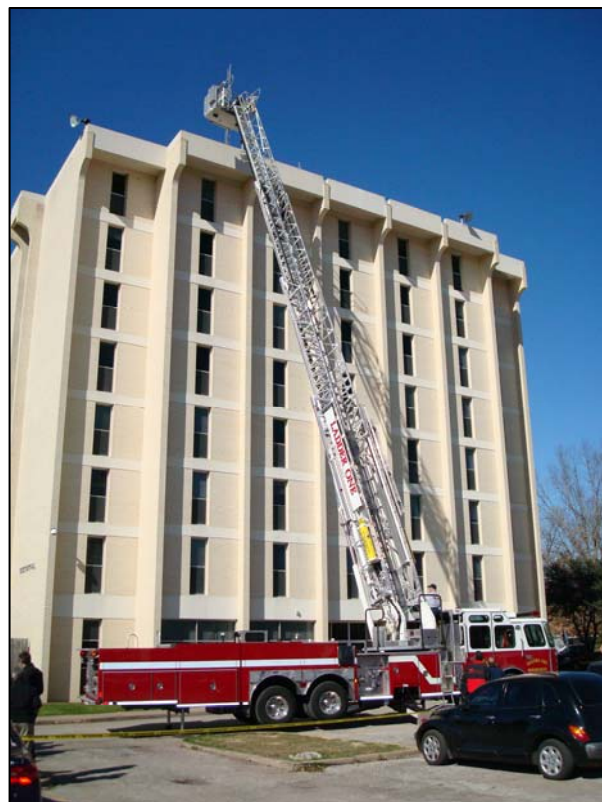
**Aerial platform positioned at dormitory building to recreate incident scene.**

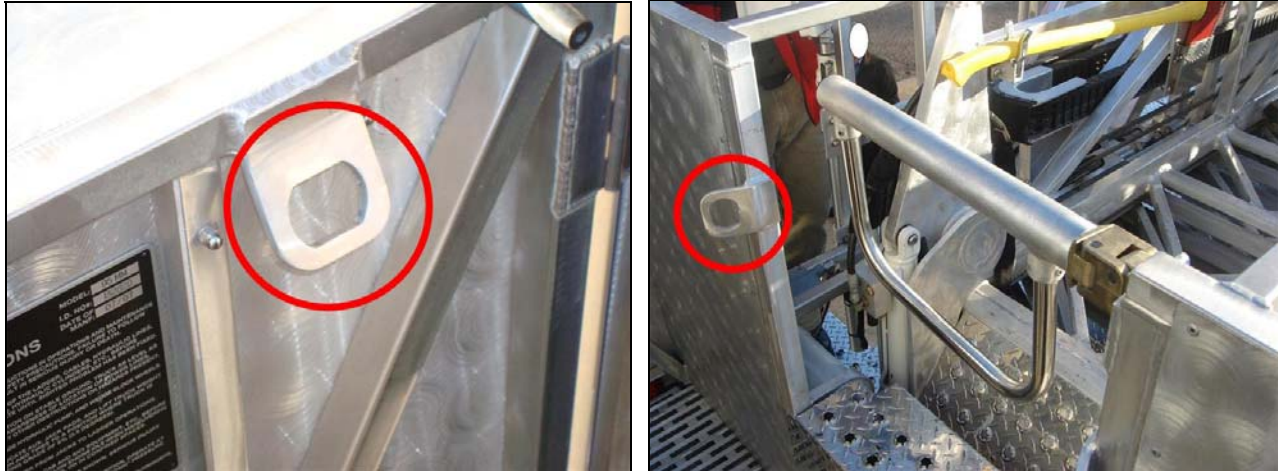
**Photos 1 and 2. Photo 1 shows anchor point on left side of platform (1 of 6 inside platform). Photo 2 shows the ManSaver™ Aerial Bar located to separate the platform from the ladder. Also note anchor point at rear of platform to left of the ManSaver™ Aerial Bar in Photo 2.**  
*NIOSH photos.*

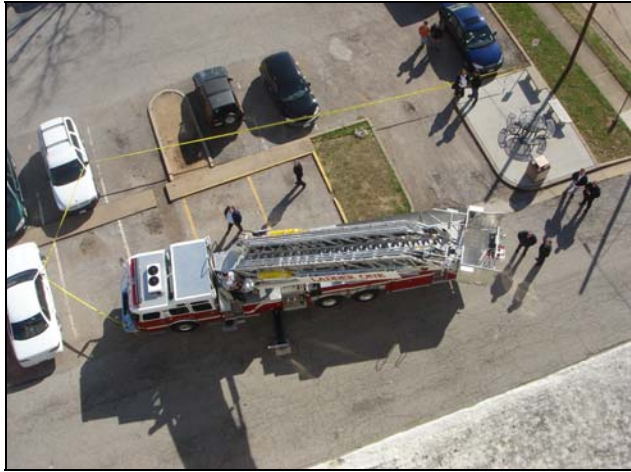
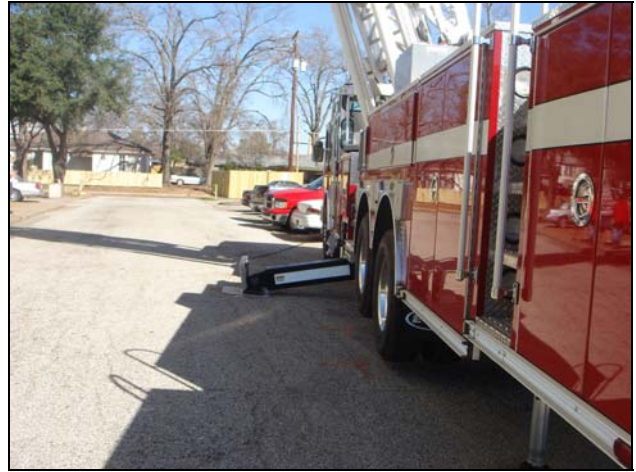
**Photos 3 and 4. Photo 3 shows an overhead view of the location of Ladder One.**

**This is almost the exact position as at the time of incident.**

**Note that L-1 is not square to the building and the aerial is slightly rotated toward the building.**

**Photo 4 shows outrigger and rear stabilizer jack (driver side of Ladder One).**

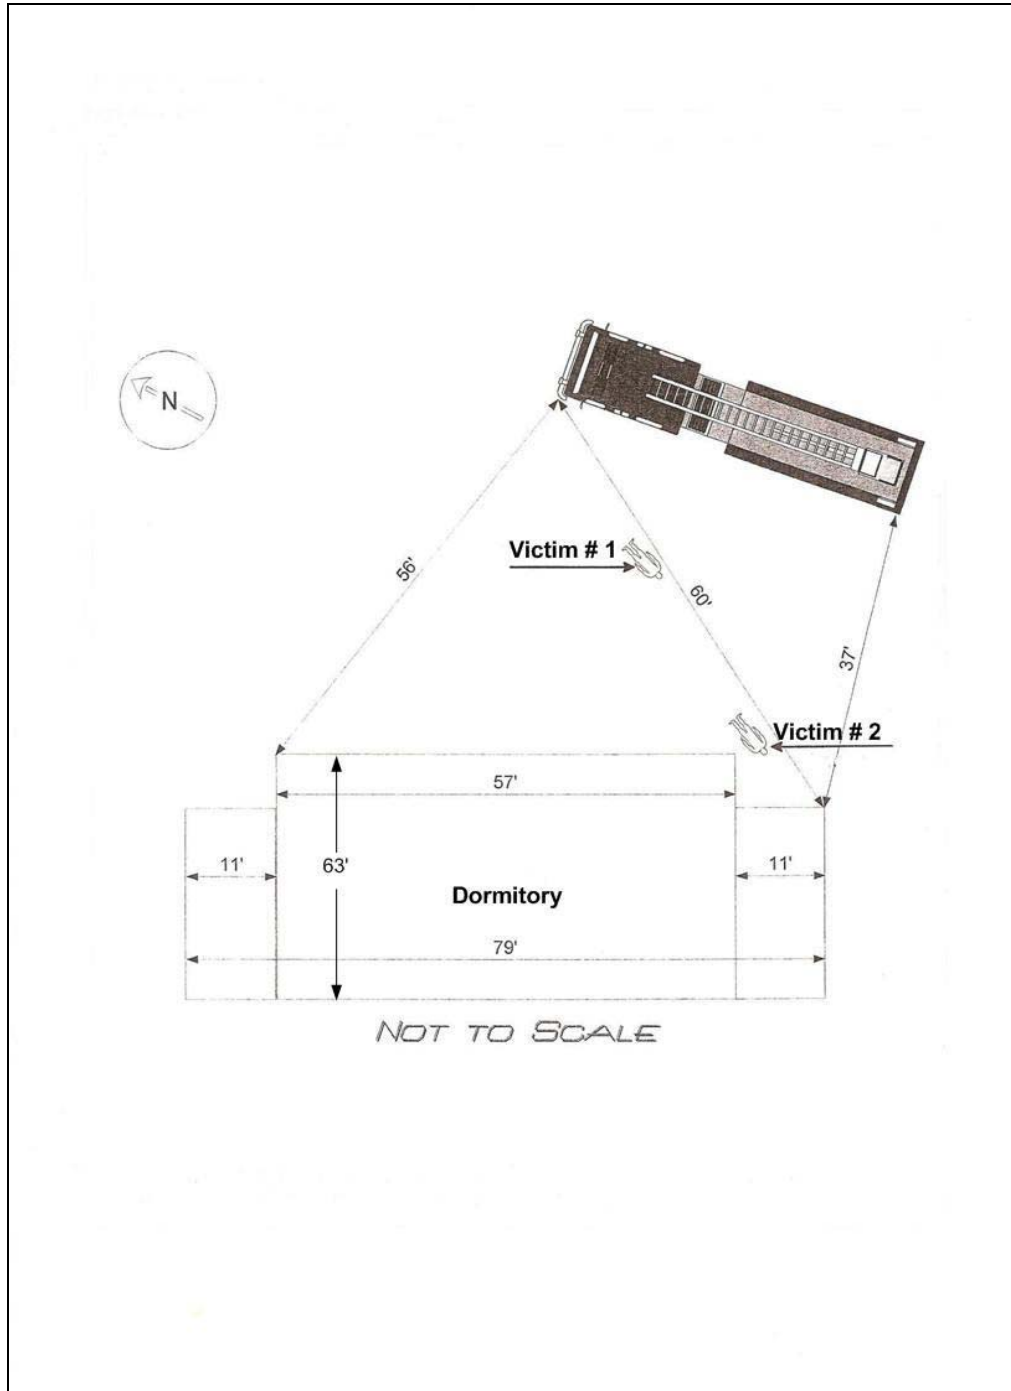
**Diagram 1. Simplified layout of incident scene. For reference only.**  
Note that diagram depicts a rear-mount ladder apparatus rather than a mid-mount apparatus as was involved in the incident.  
*Adapted by NIOSH from drawing provided by fire department*

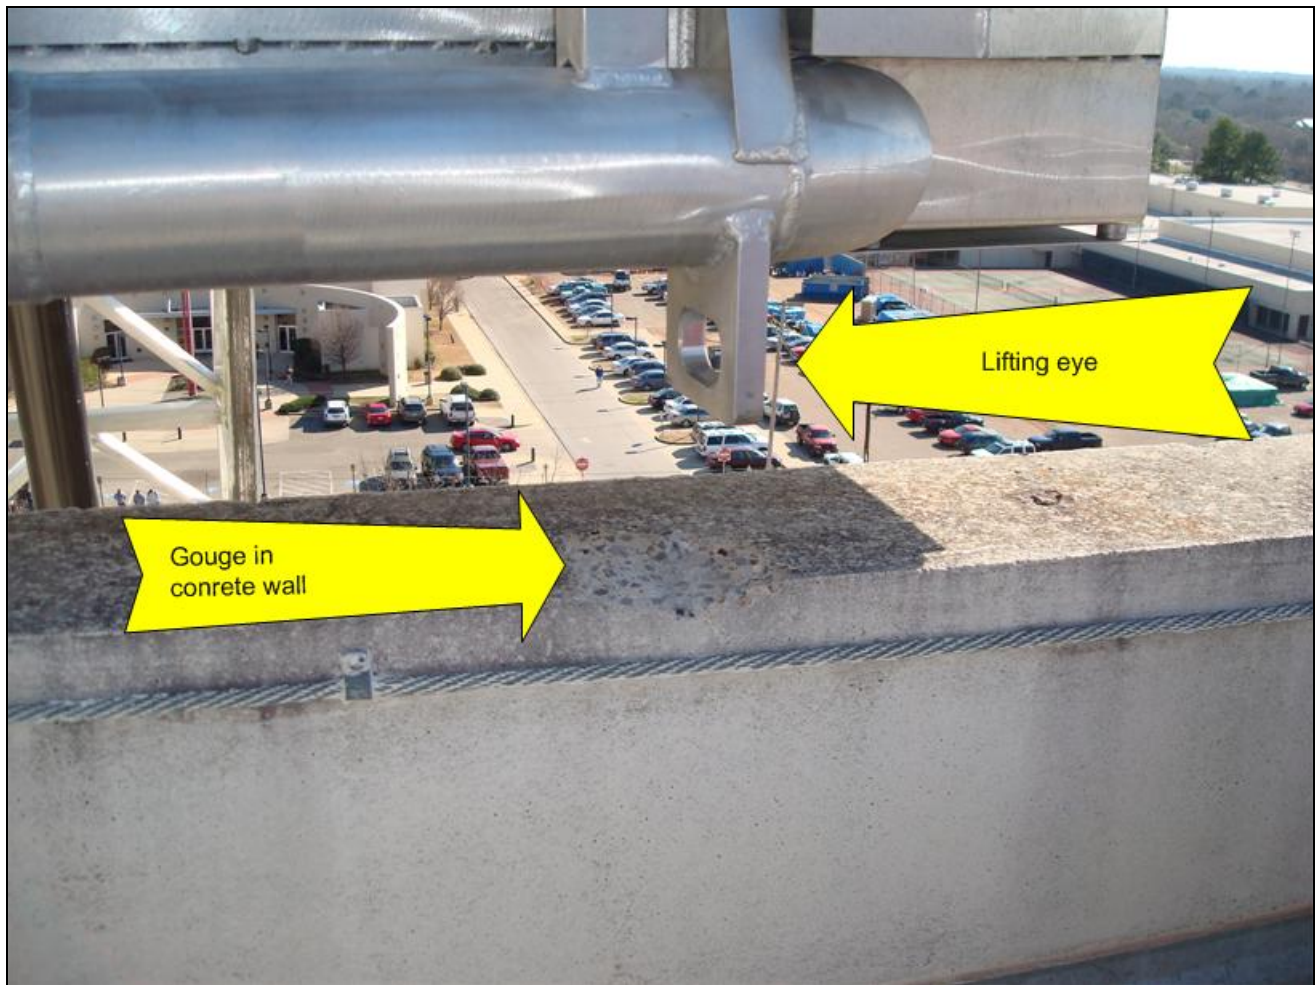
On the third attempt to raise the platform off the parapet wall, the top inside edge of the parapet wall that was holding the lifting eye suddenly and without warning broke (see Photo 9), causing the platform to spring away from the building and then whip back and forth violently (see Photo 11).

**Photo 5. Photo shows location where the lifting eye caught on the top of the parapet wall. The gouge in the concrete wall resulted when the inner surface broke as pressure was applied to the lifting jack to raise the platform off the parapet wall.**

***Recommendation #6: Fire apparatus manufacturers should ensure that aerial platforms and other aerial devices are designed to reduce or eliminate the potential for snagging on buildings or other elevated surfaces***

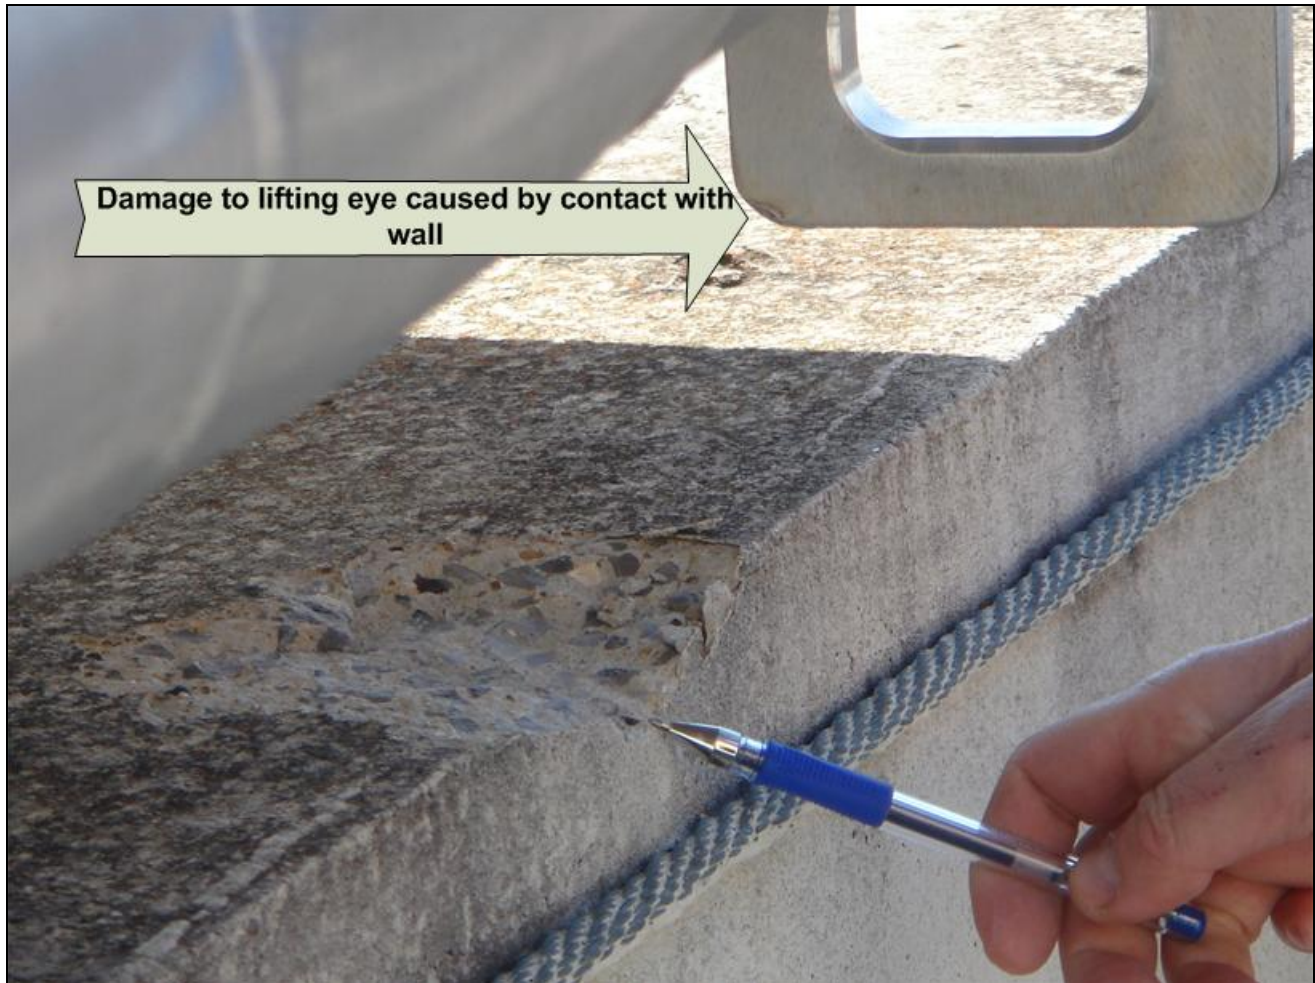
**Photo 6. Note damage to inner bottom edge of lifting eye matches up with top edge of parapet wall. This demonstrates the lifting eye was caught on the inner edge of the wall. Police investigators removed samples of aluminum shavings from the site immediately after the incident.**

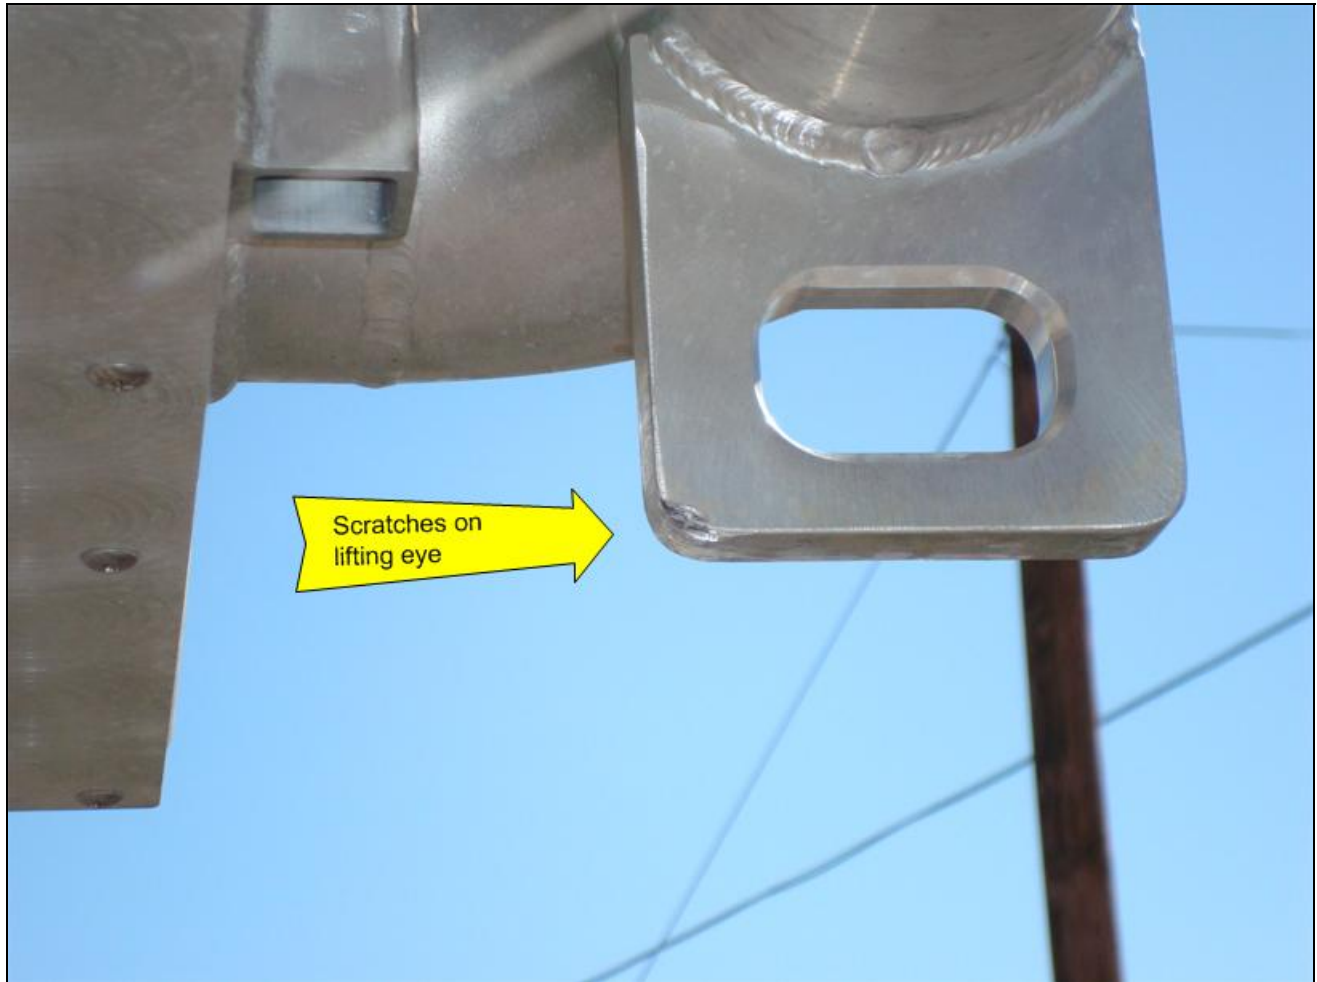
**Photo 7. Close-up of scratches and burrs on the inner bottom surface of the lifting eye.**  
*NIOSH photo.*

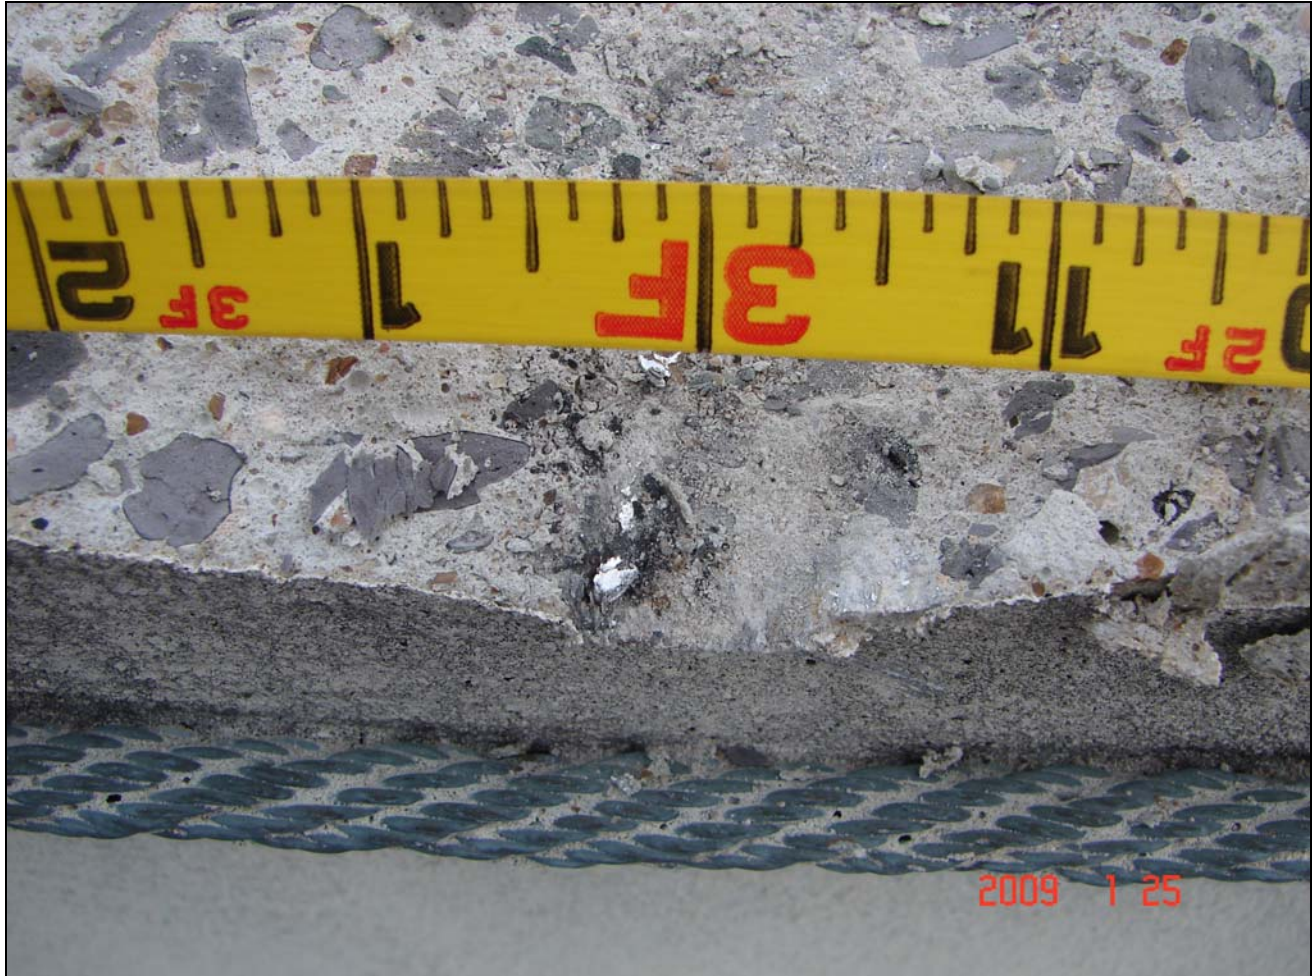
**Photo 8. Slivers of metal visible in the gouge on parapet wall.**  
**Photo taken immediately after the incident by police detectives.**  
*Photo courtesy of police department*

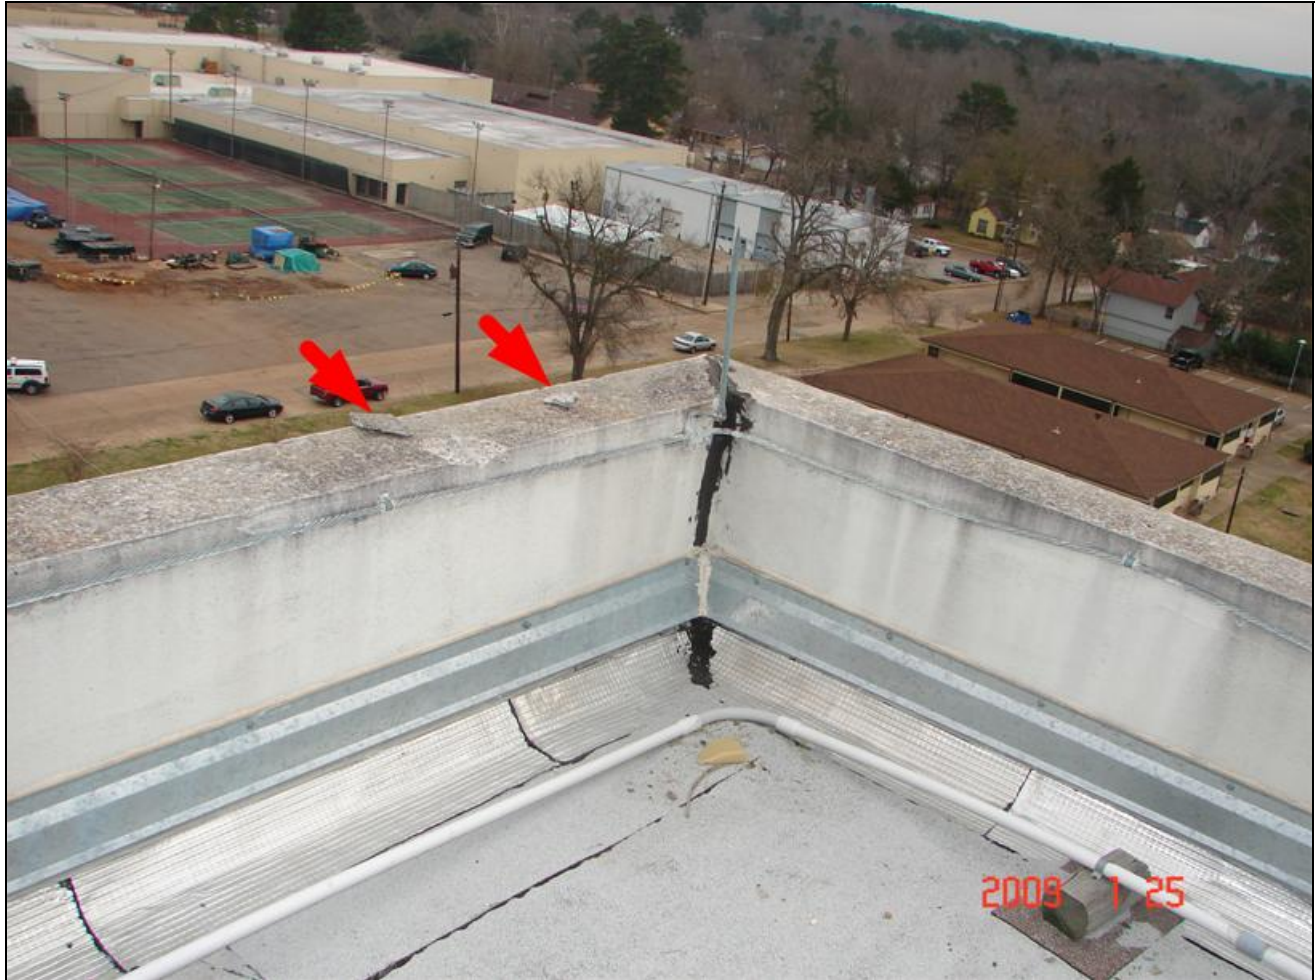
**Photo 9. Photo shows chunks of concrete on top of parapet wall beside the gouge where the lifting eye was caught. The concrete chunks were found on the roof by police detectives immediately after the incident.**

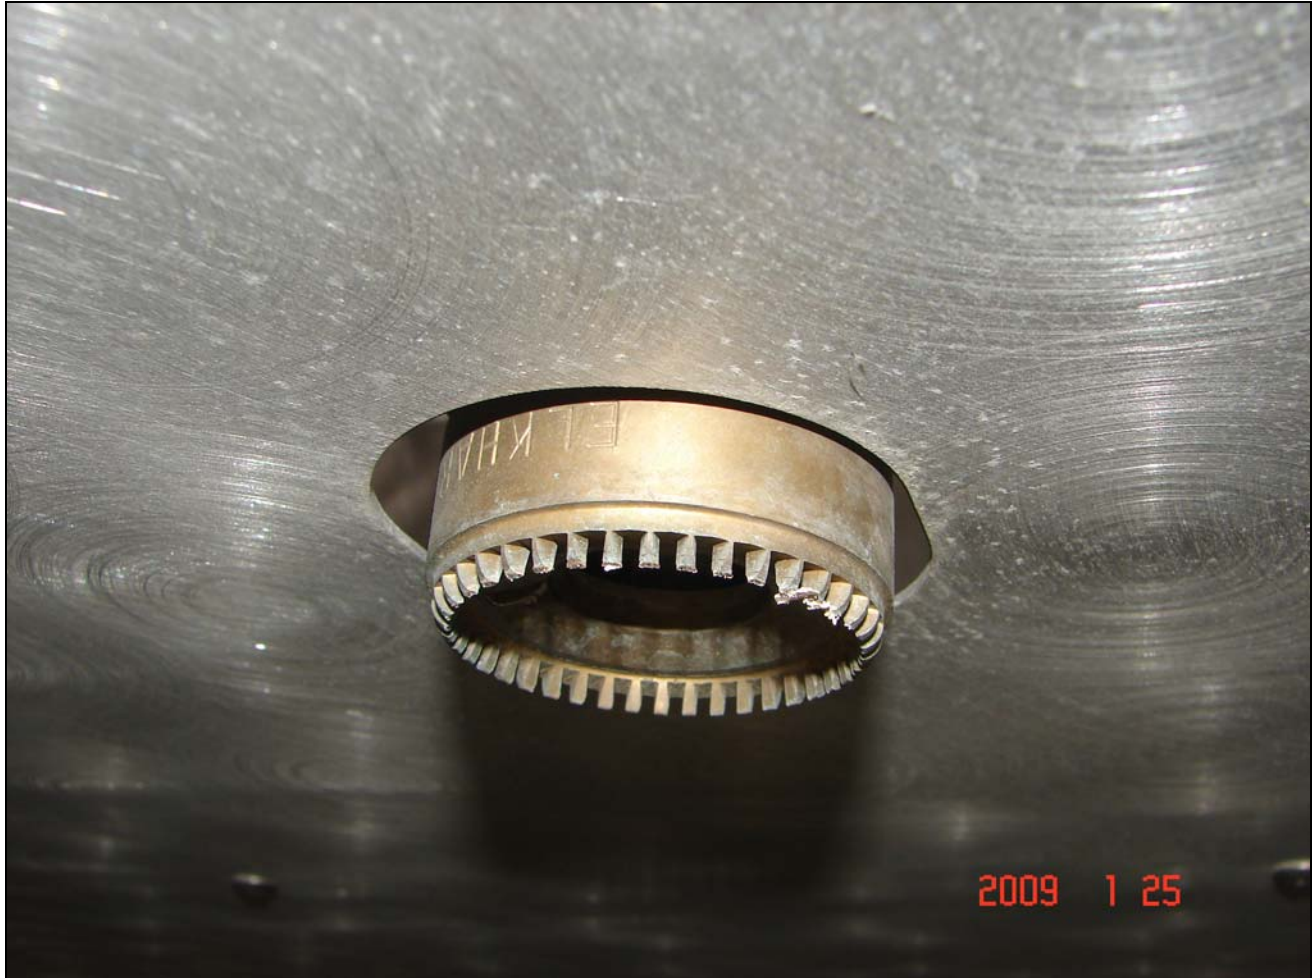
**Photo 10. Bits of concrete debris on water curtain nozzle located at bottom of platform.**  
*Photo courtesy of police department.*

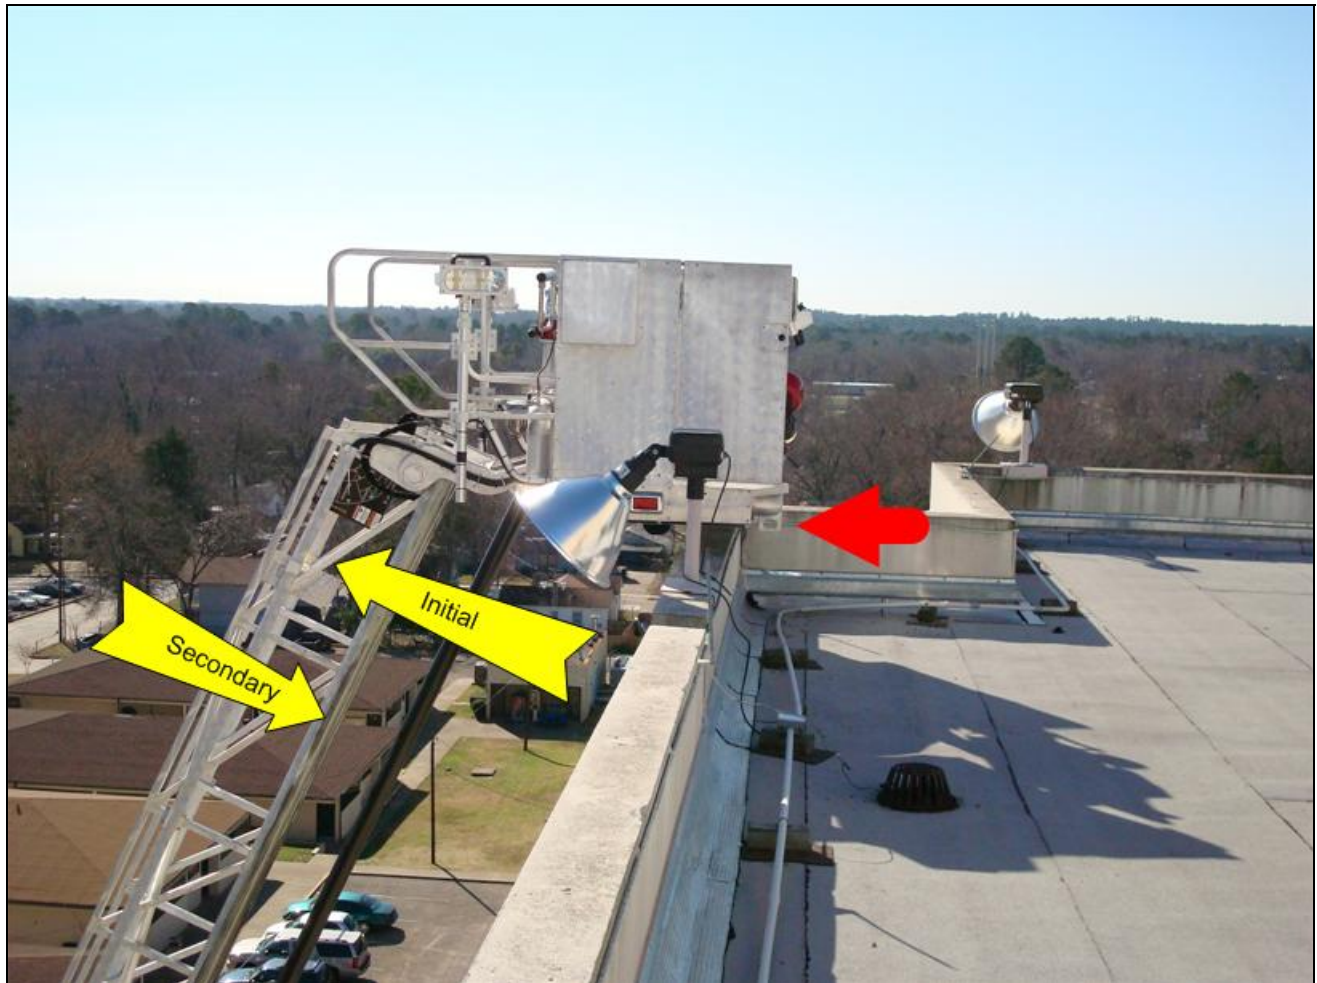
**Photo 11. Red arrow indicates location of lifting eye under platform that caught on inside edge of parapet wall. Pressure was applied to the lifting pistons in an attempt to raise the platform off the parapet wall. When the concrete surface gave way, the ladder sprung away from the building, then rocked back and forth several times. The yellow arrows depict the rocking motion that propelled the victims out of the platform.**

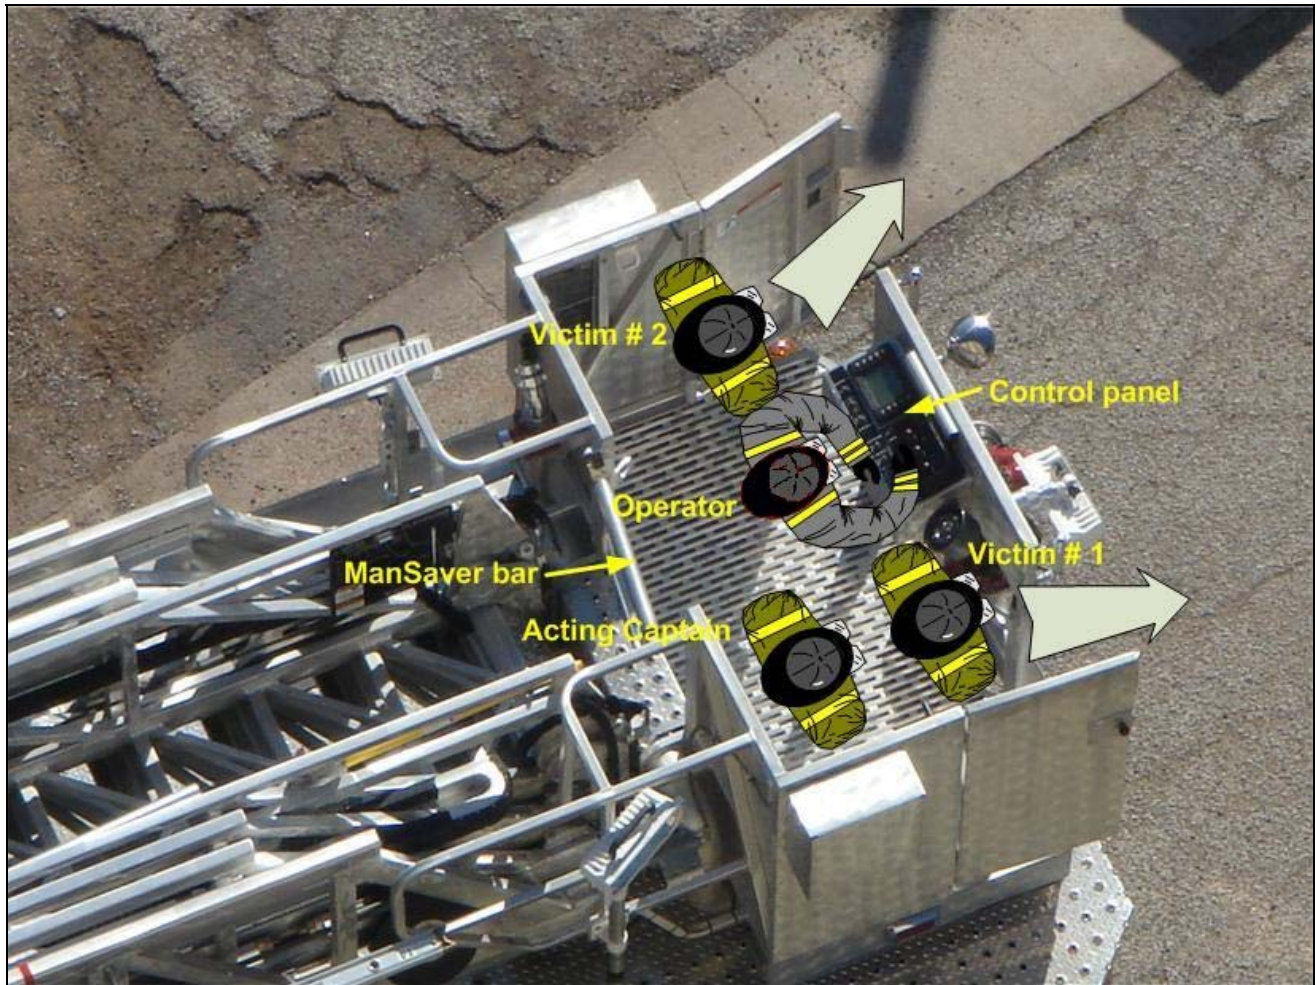
**Diagram 2. Approximate location of crew in platform at time of incident. Note that this diagram shows the platform nested at rear of the apparatus and not elevated. Also note that both platform doors are sprung outward past their intended stopping points. Both doors are designed to swing inward (into the platform) only.**

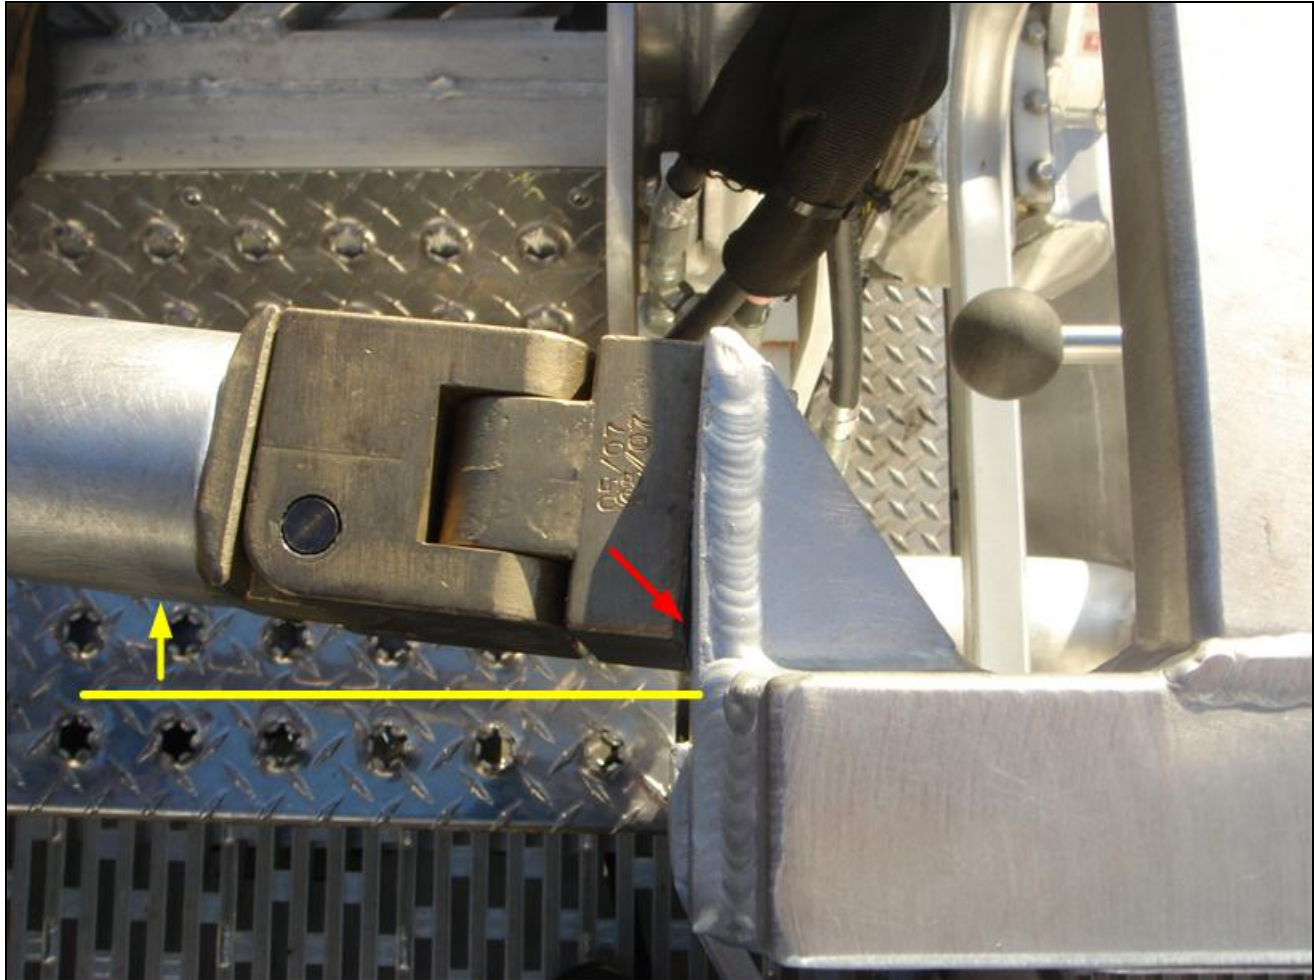
**Photo 12. Note how the ManSaver™ Aerial Bar mounting base is bent back toward ladder (indicated by yellow arrow) indicating one or more of the fire fighters struck the bar with force as the crew was tossed about the platform. Red arrow indicates separation between bar mounting base and support bracket where bar is mounted.**

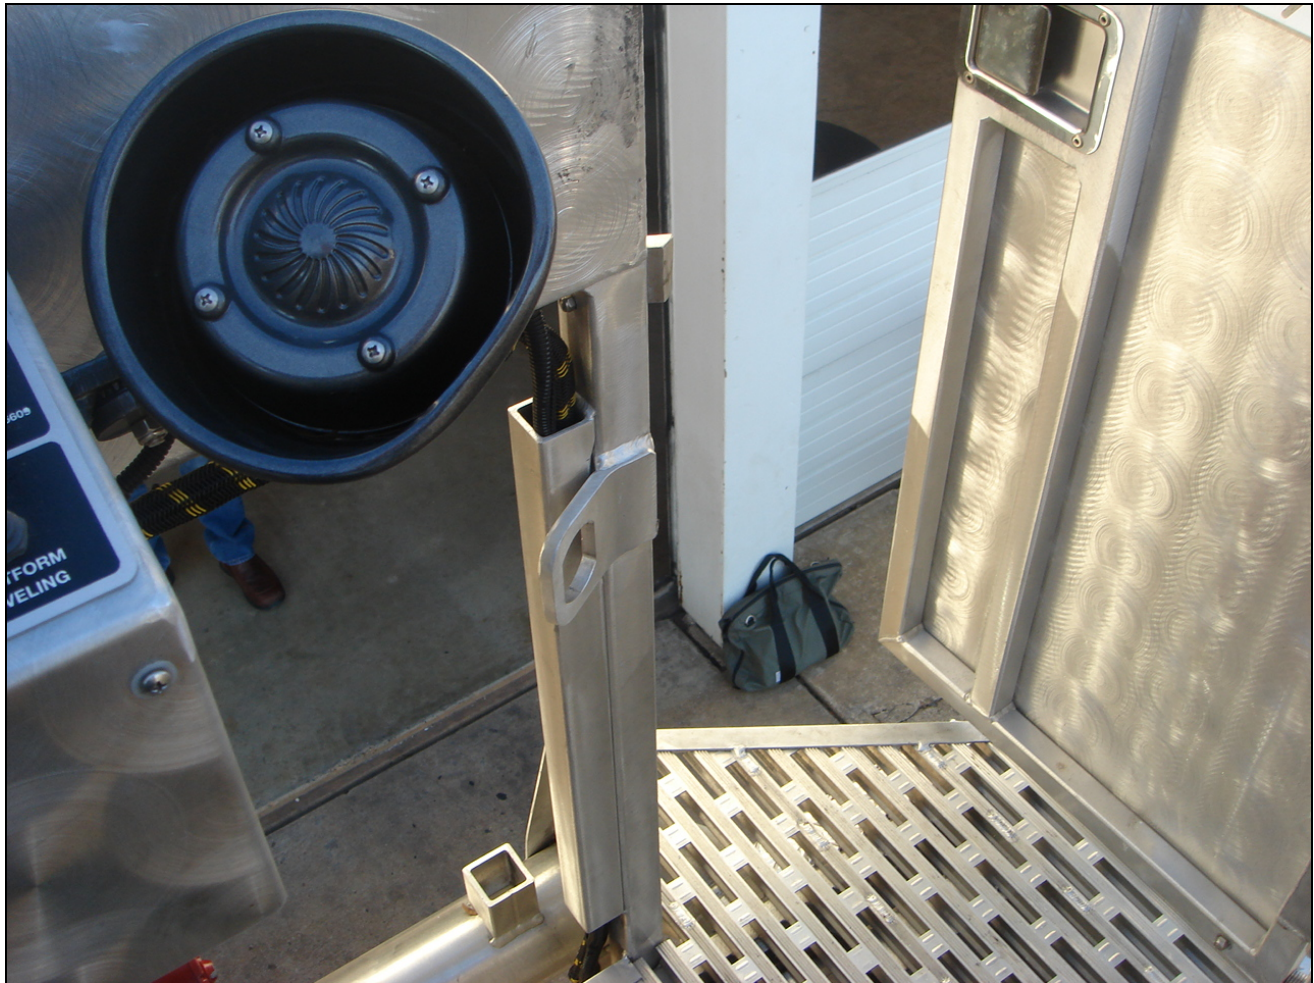
**Photo 13. Note intercom speaker in center of photo is bent. It is believed that the acting captain struck the speaker as he was being tossed about the platform. Also note proximity to the open door at the right side of the platform.**

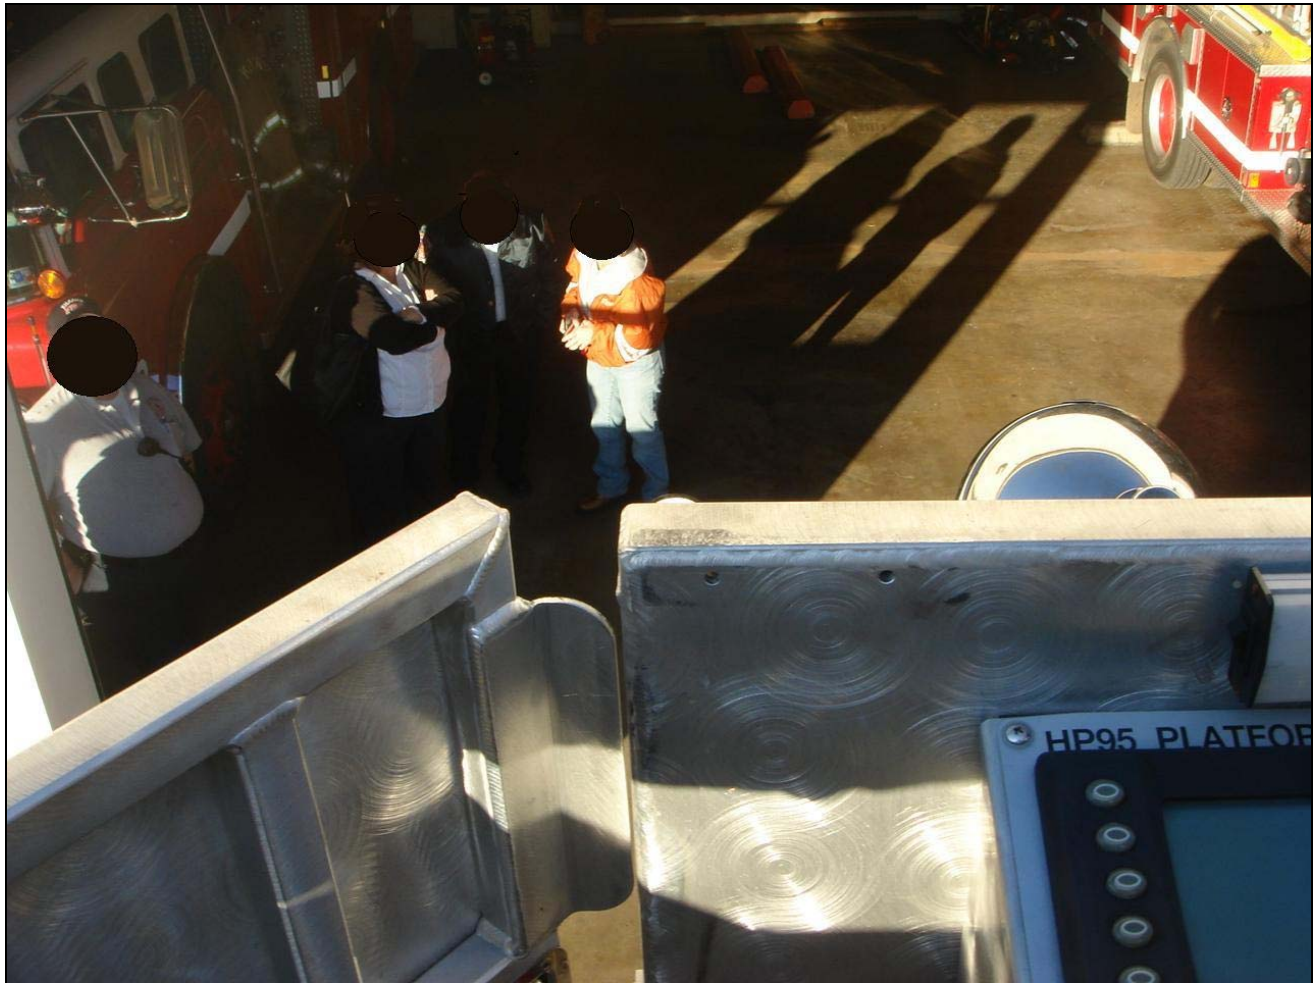
When examined by NIOSH investigators after the incident, it was possible to move the front railing (containing the door frame) approximately one-half inch without exerting much pressure on the railing. It is possible that when the operator struck the control panel and fell partially over the front railing as he was tossed about inside the bucket, this force moved the door frames on both sides to flex away from the door restraint strip, allowing both doors to be individually forced outward when struck by the two victims in rapid succession.

**Photo 14. Left platform door. Note door latch and retaining strip designed to keep the door from swinging outward and how door is sprung outward. The door is designed to swing into the platform and when closed, the door is designed to be an integral part of the guard rail system required by NFPA 1901, Chapter 20.7.6.1.2.**

***Recommendation #7: Fire apparatus manufacturers should ensure that aerial platform doors or gates are designed to prevent opening in the outward direction.***

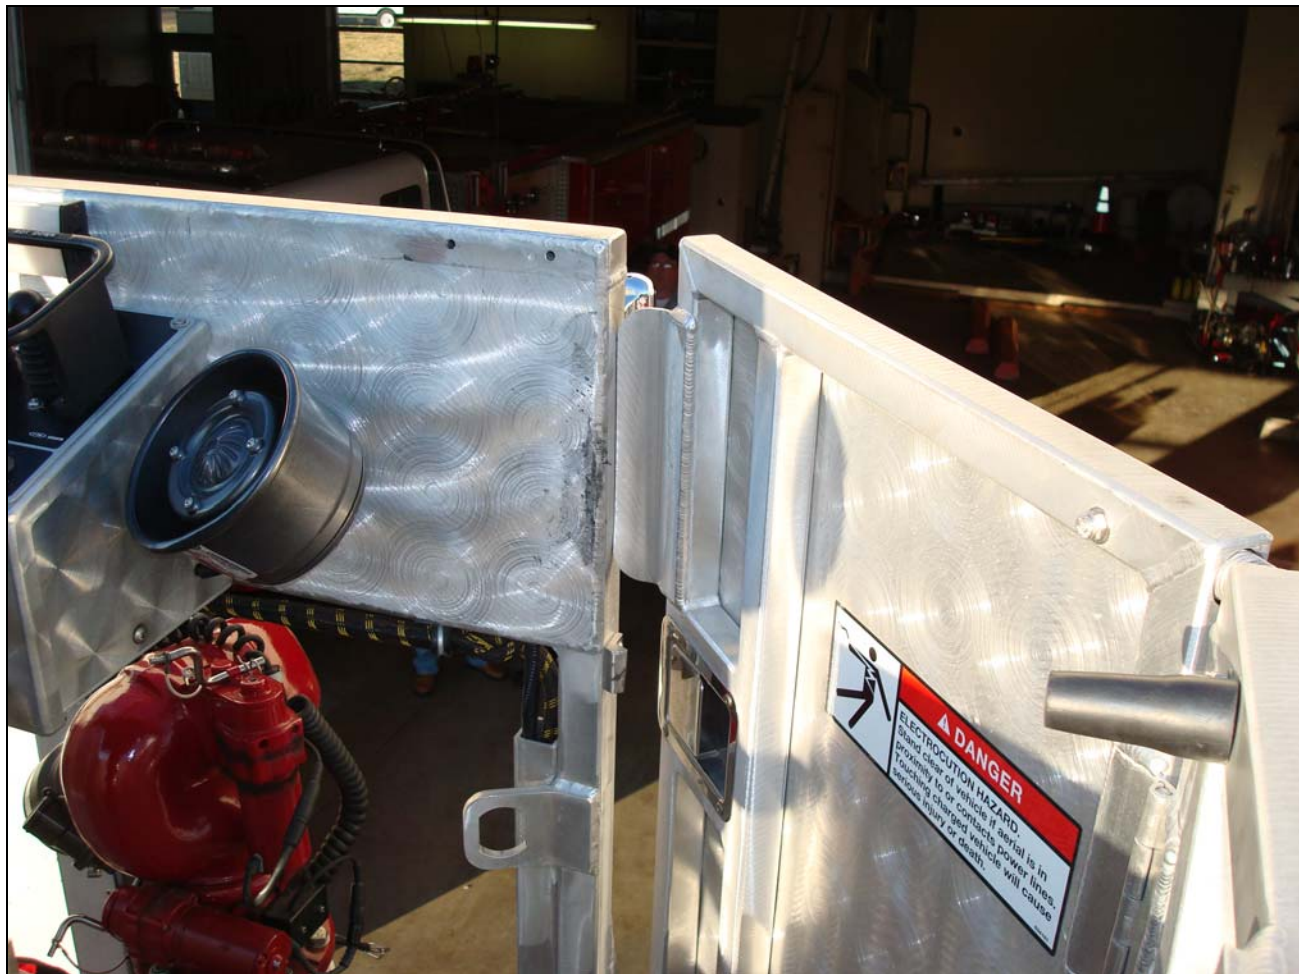
**Photo 15. Right platform door. Note the retaining strip to keep the door from swinging outward is located above the door latch only. There is no retaining strip below the door latch.**  
*NIOSH photo.*

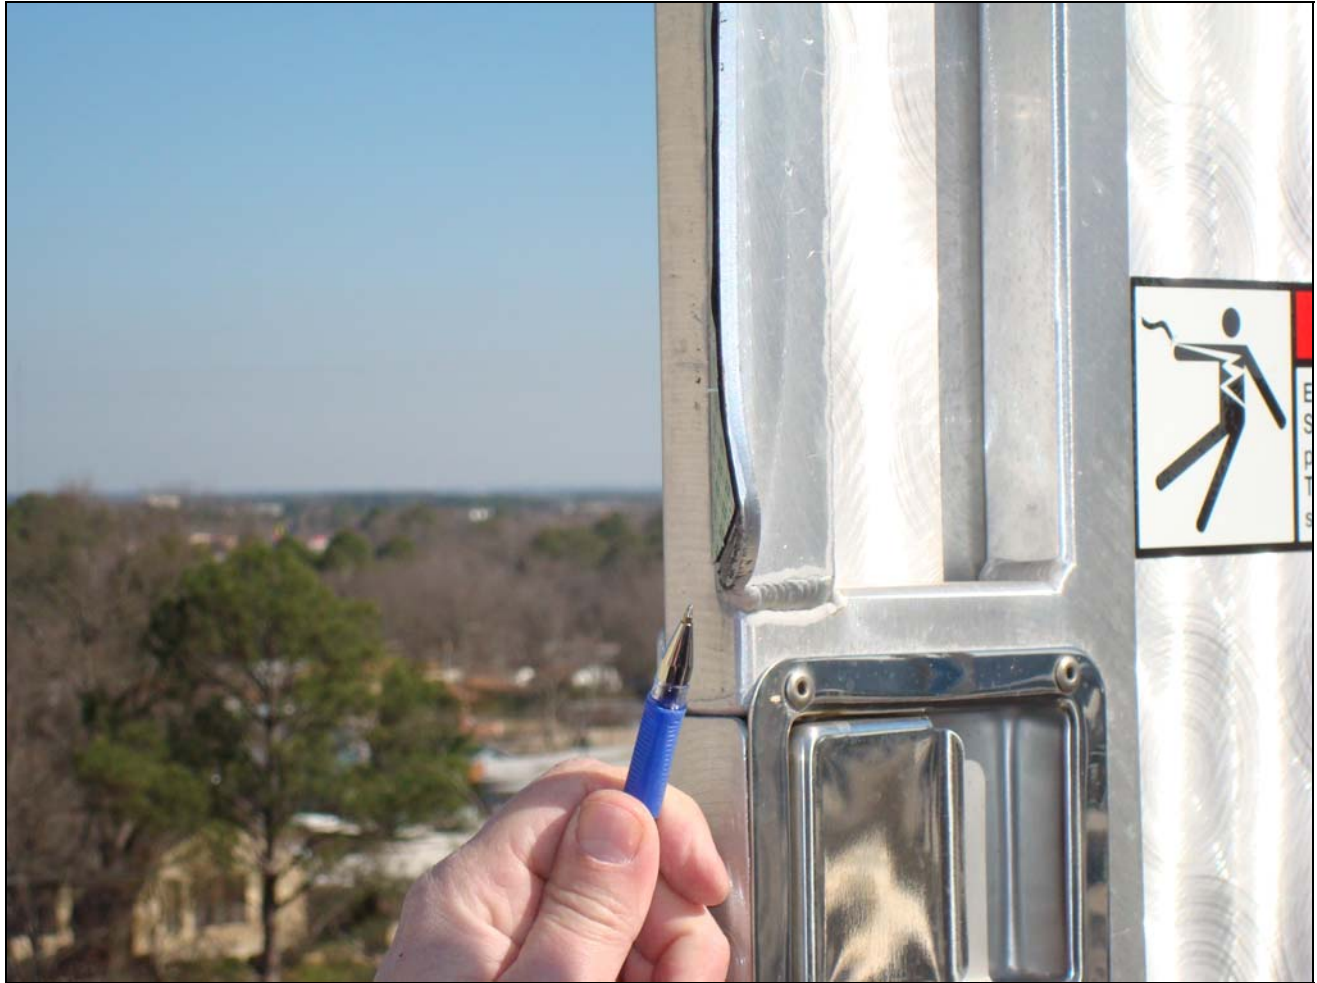
**Photo 16. Photo shows the retaining strip on the right platform door is bent inward. One possible cause would be a force applied to the door from within the platform when one of the fire fighters came in contact with the door, causing the door retaining strip to bend inward, allowing the door to open outward.**
