Career Fire Fighter Dies When Backed Over While Spotting an Apparatus—New Jersey

Fatality Assessment and Control Evaluation
Investigation Report # F2009-10

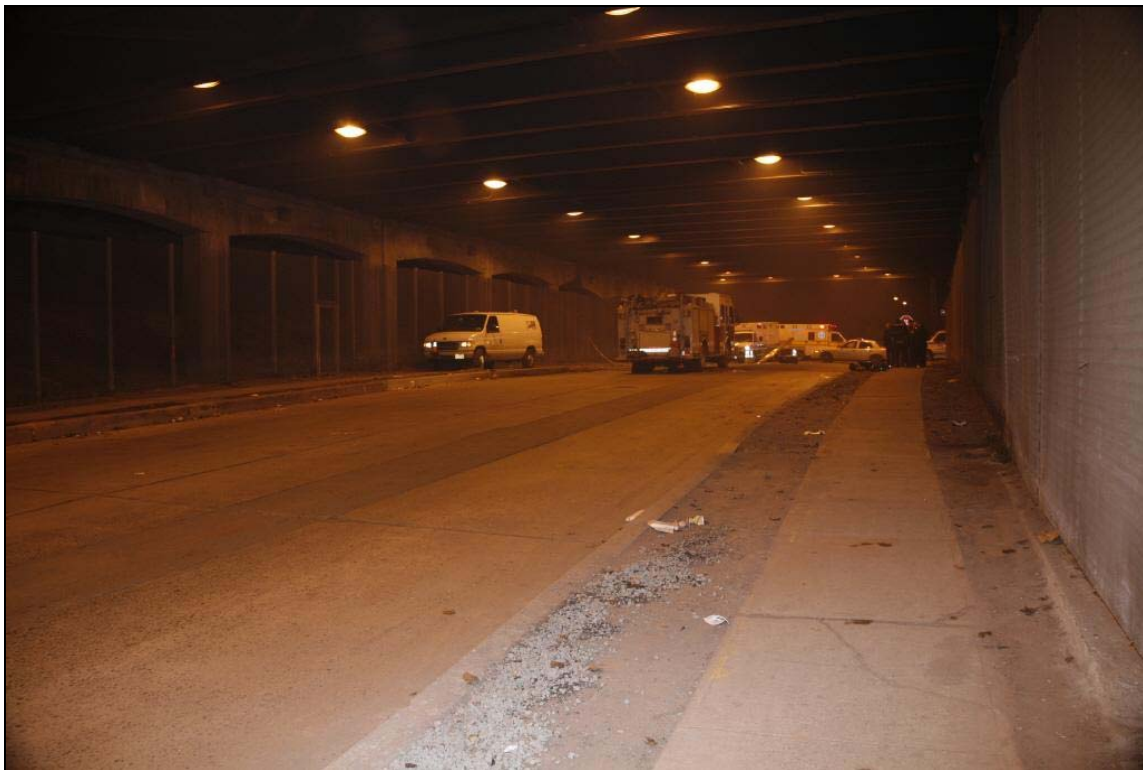
*Incident scene
(Photo courtesy of police department.)*

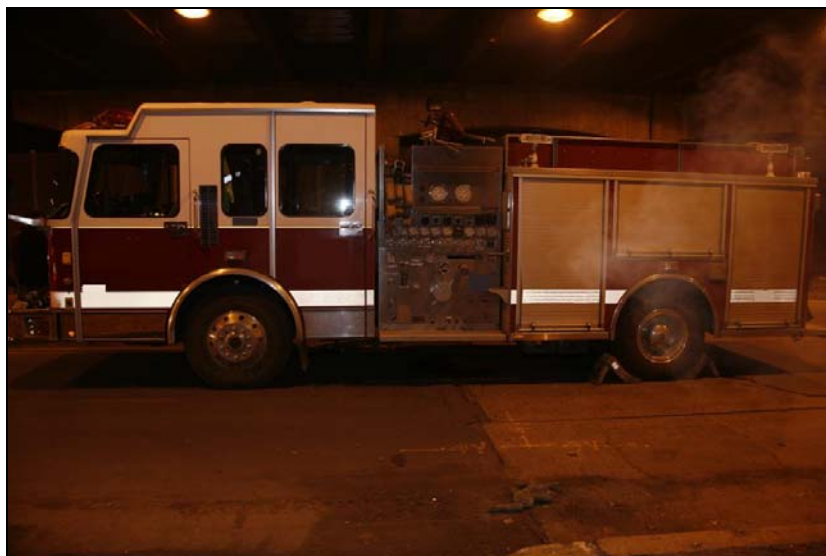
The victim was the acting officer on the engine along with the chauffeur and fire fighter. The apparatus involved in the incident was a 1996 enclosed cab engine with an automatic transmission, diesel engine, and an air brake system (see Photo 1). The apparatus' gross vehicle weight rating (GVWR) was 32,360 lbs. The engine had two axles with six wheels (two in the front and four in the rear). The engine measured 28 ft (length) x 8 ft 7 in (width) x 9 ft 5 in (height). The apparatus was also equipped with an automatic reverse braking system³ mounted to the rear step of the apparatus (see Photo 2).

Photo 1. Apparatus involved in the backing incident.
(Photo courtesy of police department.)

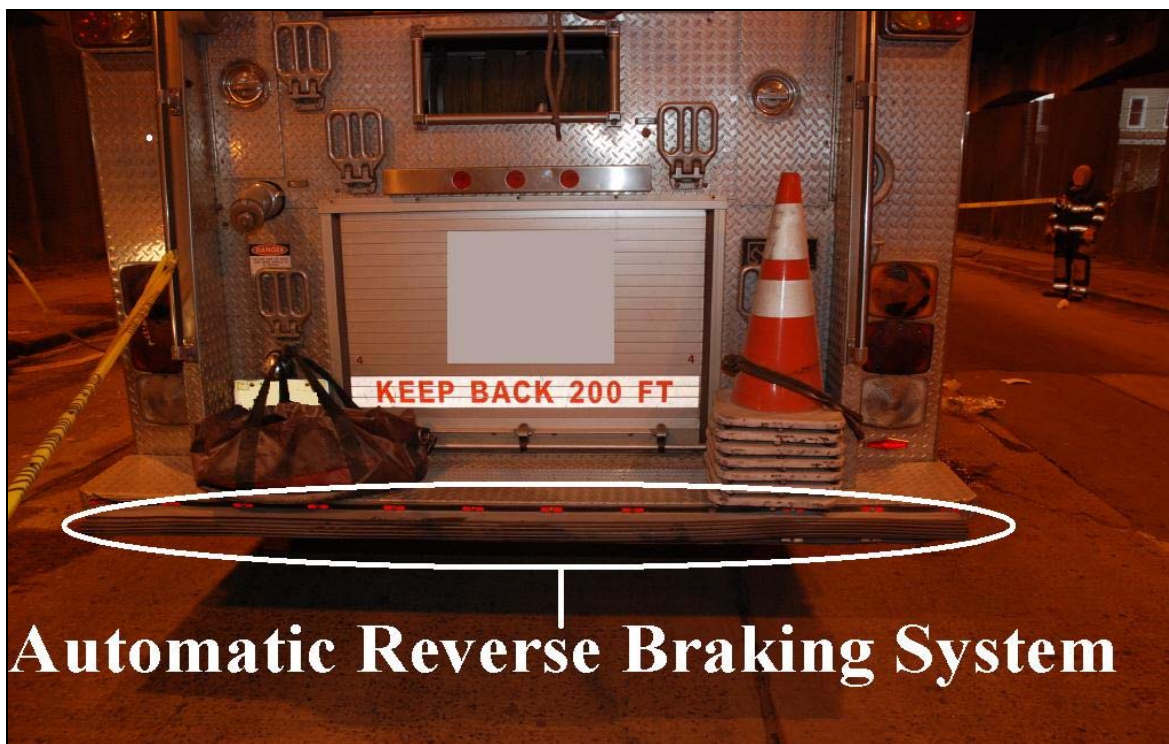
Automatic Reverse Braking System

Photo 2. This reverse braking system is attached to the rear bumper of the apparatus and is designed to actuate the rear brakes when pressure is applied to the rubber sensor.
(Photo courtesy of sheriff's office.)

This automatic reverse braking system was developed in the early 1980s, introduced in the United Kingdom in 1983, and then became available in the United States in 1986. This reverse braking system was an optional safety feature that was installed on the apparatus prior to the fire department taking possession in 1996. The system aids driver/operators while backing an apparatus by locking the rear brakes when the system comes in contact with an object. *Note: The manufacturer's manual notes that this system does not exempt the driver/operator from using conventional backing aids such as side and rear mirrors or spotters.*³ The rubber sensor is mounted six inches beyond the vehicle's rear end to provide an area where vehicle damage could be reduced due to the short distance traveled after automatic brake application. The sensor has an air chamber which is sealed at either end. The air chamber detects or senses a compression of the wall of the chamber, as little as 0.05 psi, causing the pressure inside to increase and then transmit down to a control/switch unit which triggers the brakes to actuate. The system is designed to operate when the apparatus is in reverse gear and backing at a slow rate of speed. The instruction manual recommends a function test be done after initial installation and at least once a week thereafter. For the involved apparatus, the last documented function test was performed in March 2008; at that time, the system was working properly.

The apparatus involved in this incident was equipped with an after-market reverse braking system which was mounted to the rear bumper. The last documented service test was performed more than eight months prior to the fatal incident. The manufacturer recommends the system be checked daily or weekly to insure proper operation.³ The system was found to be not working when examined by New Jersey Fire Safety Division investigators during the state police commercial vehicle inspection. However, the system was not tested by the manufacturer or a third-party certification facility to verify that the device failed to actuate the rear brakes. A component for this reverse backing system needed to be replaced to allow it to operate again. *Note: It has not been determined beyond a reasonable doubt that the system failed to operate during the fatal incident or that the victim came into contact with the sensor, but these cannot be ruled out as potential contributing factors in the fatal incident.* Three other apparatus within the fire department’s fleet also needed maintenance performed on their installed systems.

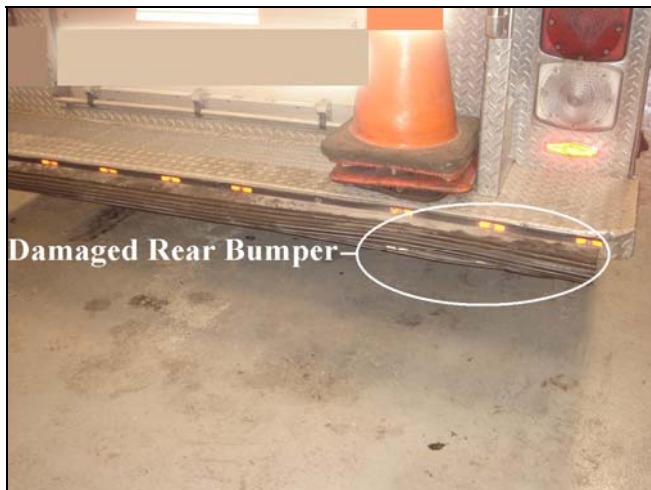
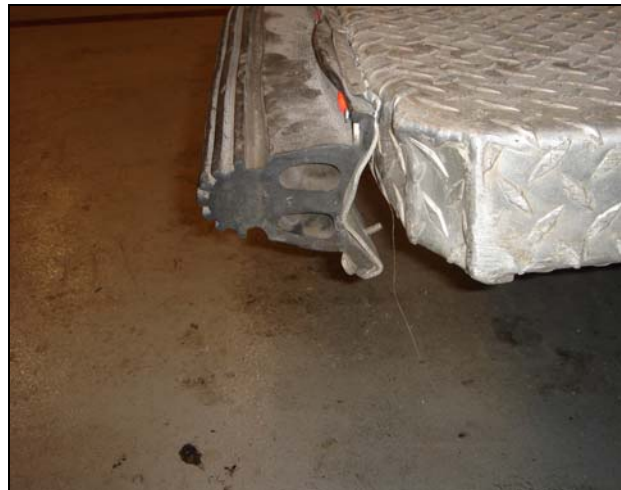
After the incident, the apparatus and scene were processed by local police before the apparatus was escorted by state police to the fire department’s headquarters. The apparatus was secured there until state police could perform a vehicle inspection. The state police performed a standard commercial vehicle crash inspection in the presence of a fire department mechanic and investigators from the New Jersey Division of Fire Safety. Items inspected included the air brake system, brakes, steering, suspension, tires, lighting, and low air pressure indicators. The inspection was completed within three days of the incident and the apparatus was found to have no mechanical violations. The state police inspection did not include an inspection of the automatic reverse braking system because it was an optional device and their investigators were not certified to test it. However, when pressure was applied to the rubber sensor while backing, the system failed to actuate the brakes. It could not be determined whether the backing system was functional at the time of the incident, but there was damage to the bumper and rubber sensor that could not be attributed to the fatal incident (see Photos 3 and 4).

Photos 3 and 4. Pictures show damage to rear bumper and rubber sensor.
(Photo courtesy of PEOSH.)

From these findings, the New Jersey Division of Fire Safety recommended that repairs be made before placing the apparatus back in service. The automatic reverse braking system control unit was replaced following the inspection, and then placed back in service. The fire department also inspected eight other apparatus that had the same reverse braking system installed. Three of these apparatus had damaged or insufficient operating parts within the system that affected proper operation. These three systems were also repaired.
