Death in the line of duty...

A summary of a NIOSH fire fighter fatality investigation

April 8, 2010

Career Probationary Fire Fighter and Captain Die as a Result of Rapid Fire Progression in a Wind-Driven Residential Structure Fire – Texas

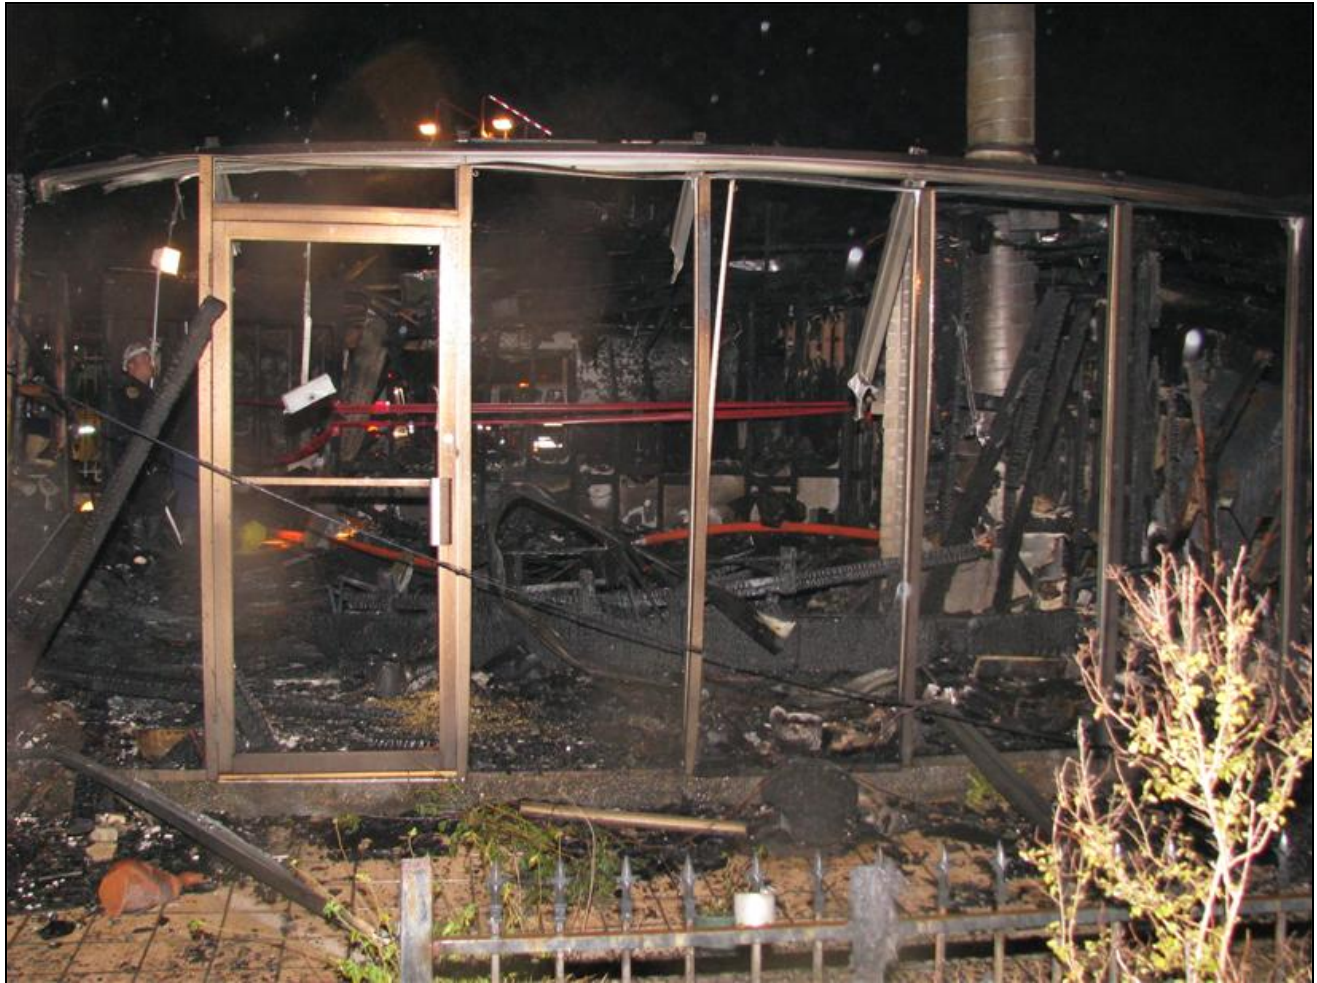
Photo 1:

Photo shows remains of glass atrium at C-side of structure. The glass atrium was added to enclose a patio at the rear of the family room. Failure of one or more windows on the C-side would have opened a path for wind blowing from the southeast to penetrate the living area.

have resulted in failure of windows on Side C providing a flow path for wind driven fire from Side C through the door on Side A.

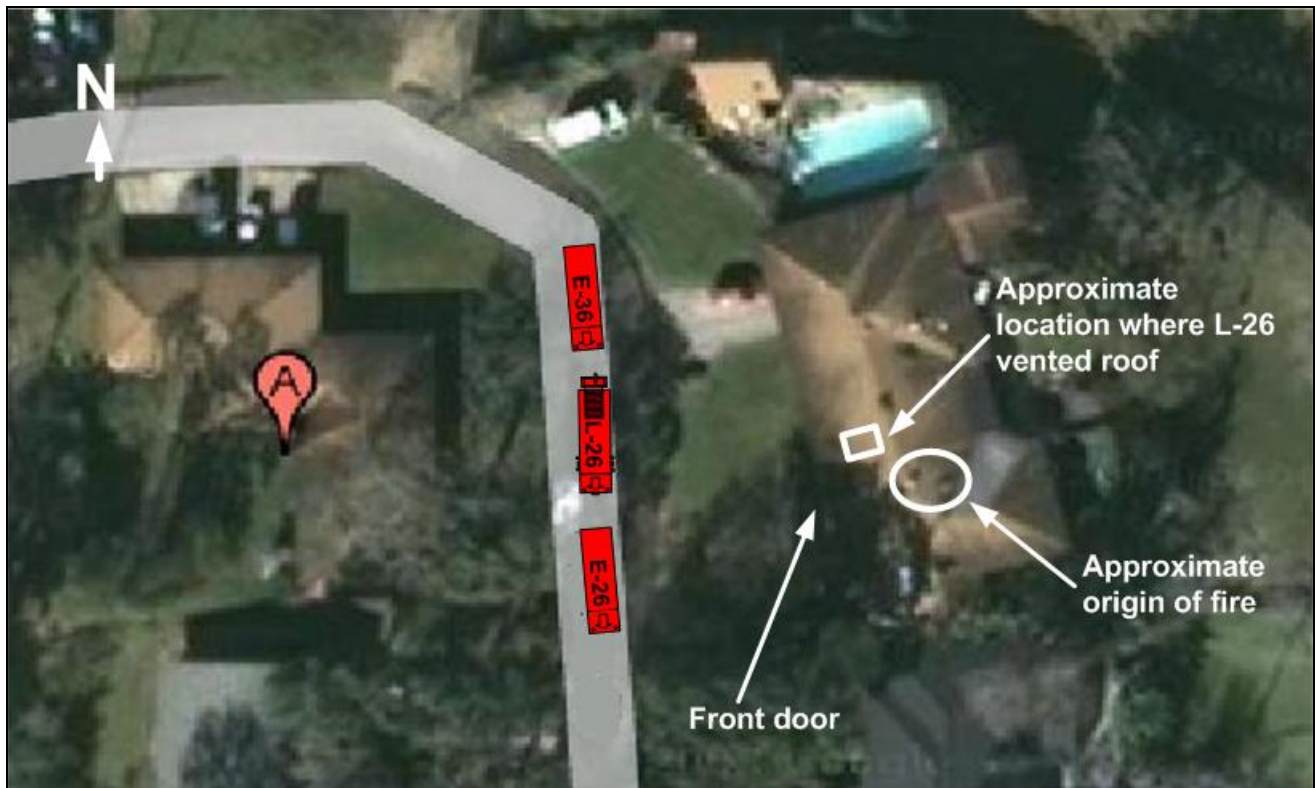
Diagram 1

Satellite view of property showing approximate location of fire origin and where L-26 crew vented the roof. Also note the approximate origin of the fire. The objects within the highlighted oval are believed to be the roof vent and sky light where fire fighters observed flames showing above the roofline early into the event.

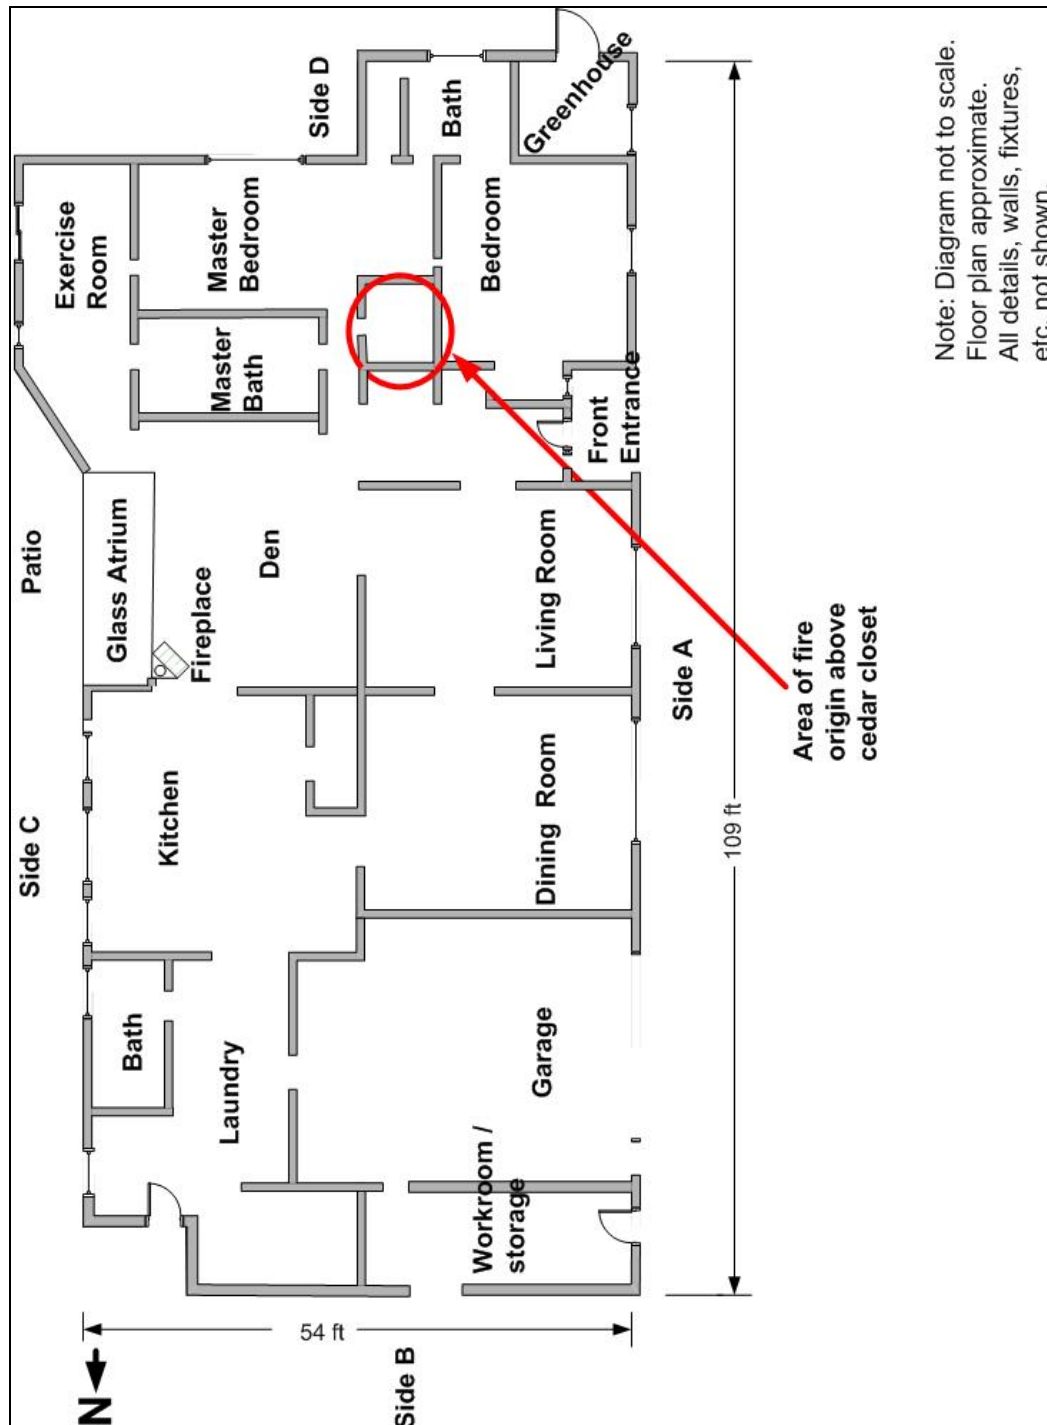
Diagram 2
Layout of residential structure

According to the arson investigator's report, the fire originated in the electrical wiring above a hallway closet near the master bedroom and was accidental in nature (see Diagram 2). It is unknown how long the fire burned before the residents observed fire in the closet and exited the structure.

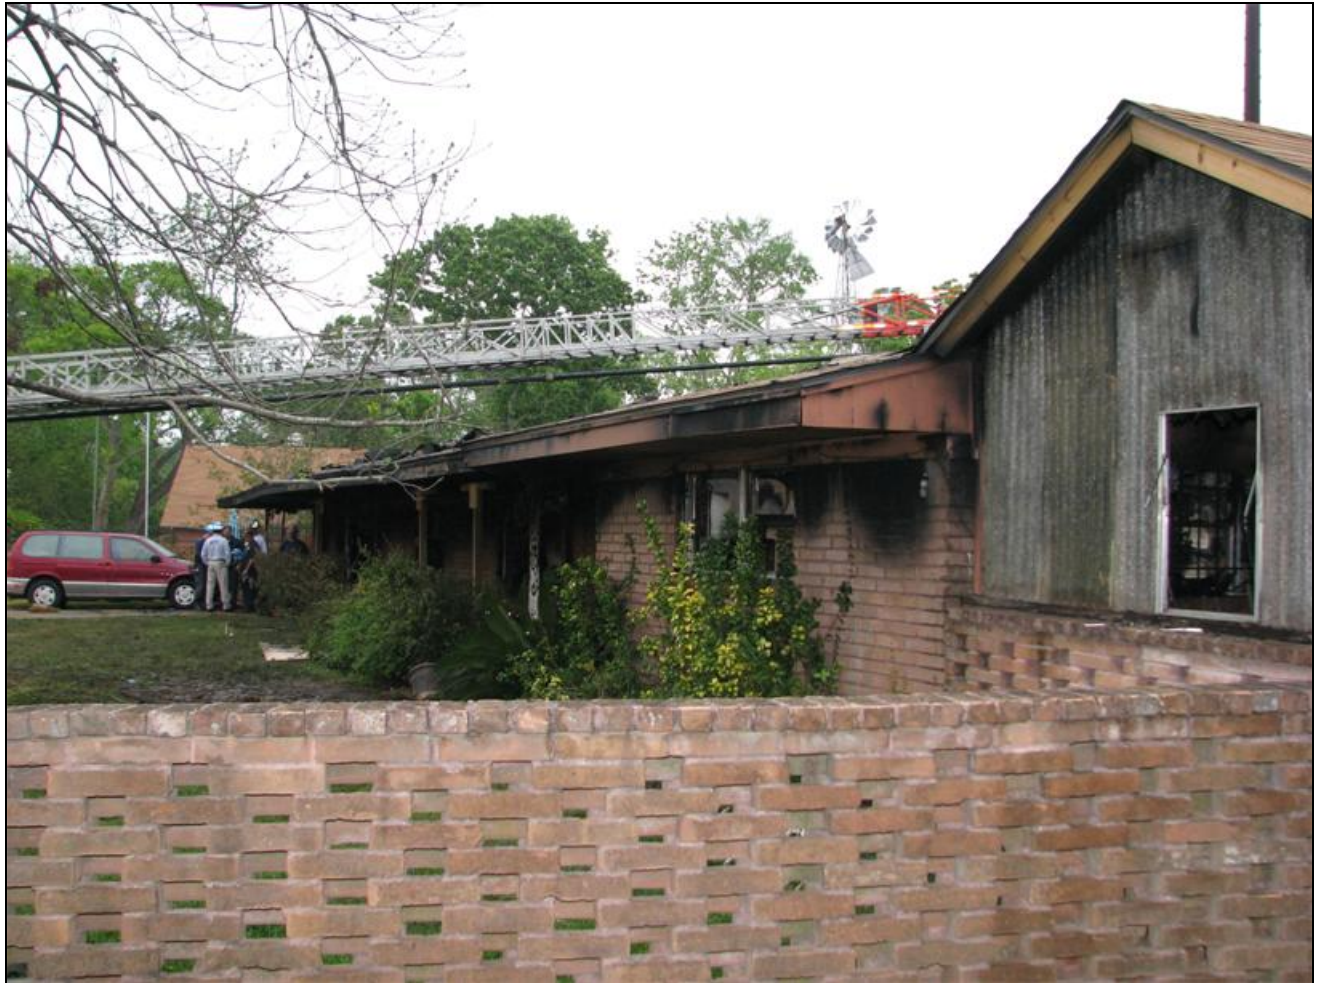
Photo 2:

Photo taken from the A-D corner of the fire structure shows how access to the D-side of the structure was limited by the masonry wall.

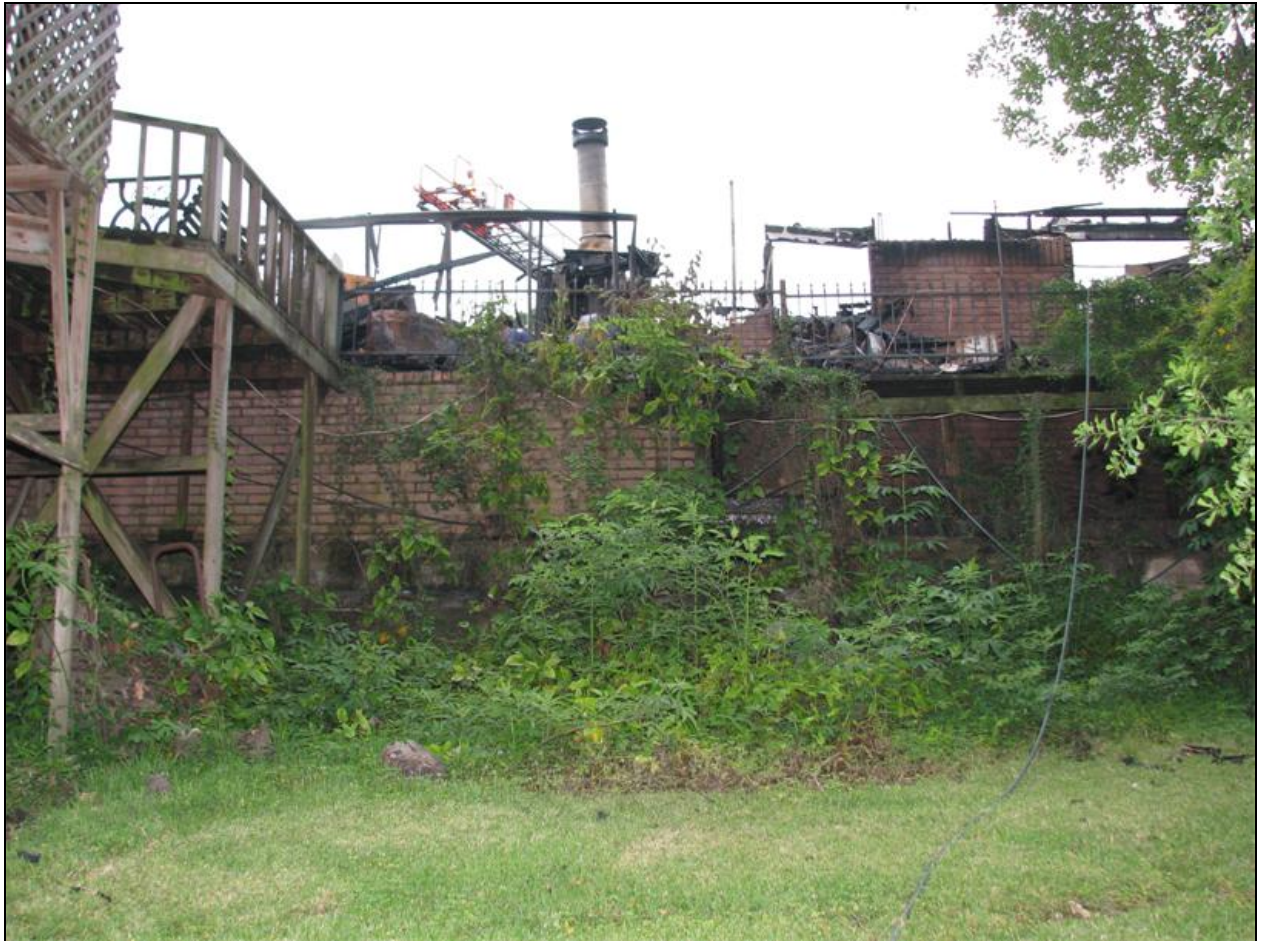
Photo 3:

Photo taken from rear of structure standing in back yard shows how access to the C-side of the structure was limited by the location of the structure at the top of a steep embankment and fences enclosing the rear of the house. The rear patio extended to the fence visible in the photo. The fence sat at the top of a masonry retaining wall approximately 11 feet high with a steeply sloping bank below the wall that extended into the rear yard.

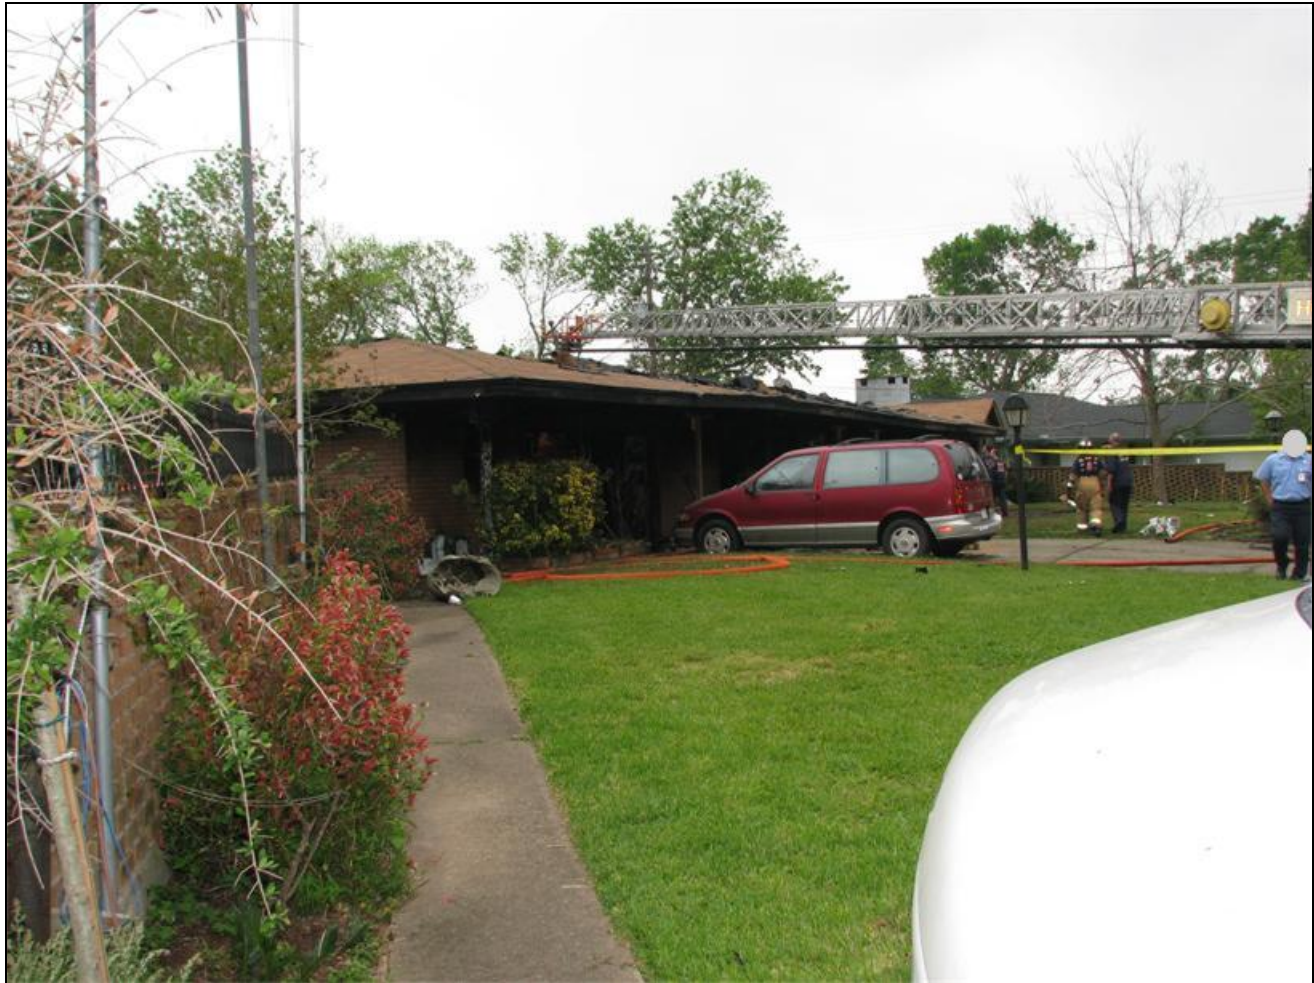
Photo 4:

Photo taken from A-B corner in front of structure shows how access to B-side of structure was limited by the masonry and chain link fences enclosing the rear of the house.

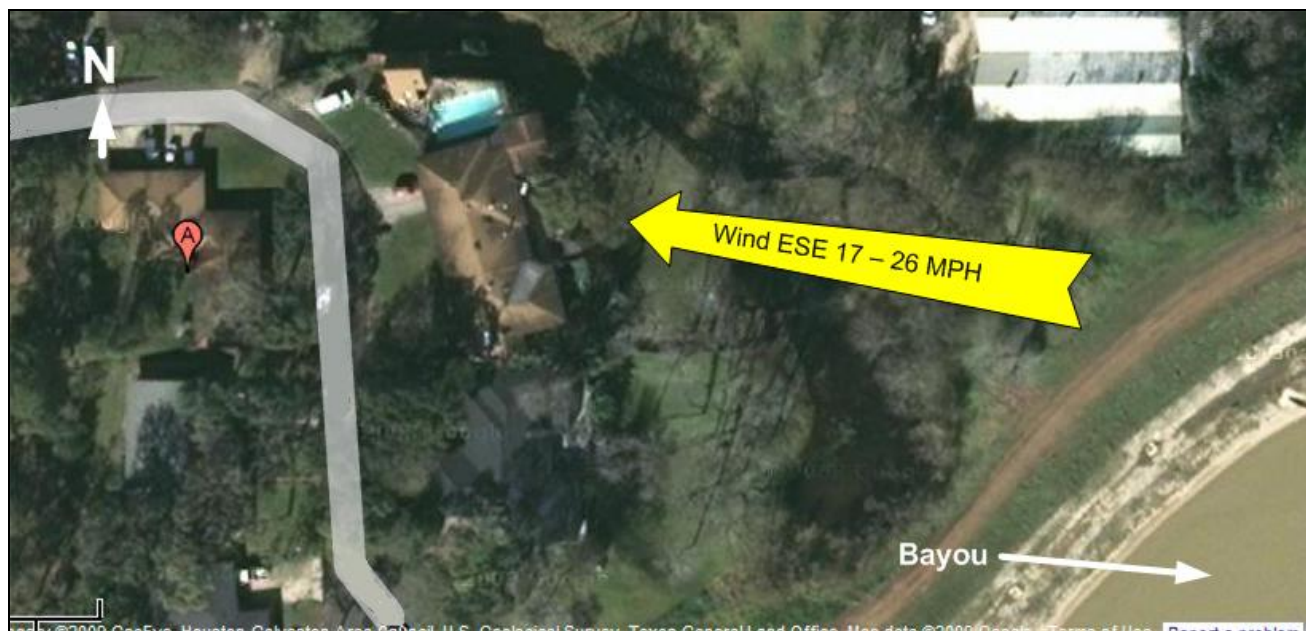
Diagram 3

Satellite view of property showing proximity to bayou and wind direction at time of fire. Wind speeds were recorded at 17 to 26 miles per hour from the east - southeast.¹⁰

High winds may have been a contributing factor in this incident. At the time of the fire, weather conditions in the area included a temperature of 69 degrees Fahrenheit (21 degrees Celsius), 68 to 75 percent relative humidity, with sustained winds from the east / south-east at 17 miles per hour (mph) (27 km/hr) gusting to 26 mph (42 km/hr).¹⁰ Fire fighters interviewed by NIOSH investigators reported changing winds during the incident. At times, smoke blew across the street obstructing vision in front of the fire structure. Wind from the east / southeast was blowing against Side-C of the structure, increasing the air pressure on Side-C in relation to Side-A. After crews opened the front door, any failure of windows or self ventilation on Side C would have provided a flow path for hot gases and flames to be pushed by wind from Side C through the entrance on Side-A (see Photo 1 and Diagram 4). Research by the National Institute of Standards and Technology (NIST) has shown wind speeds on the order of 10 to 20 mph (16 to 32 km/hr) are sufficient to create wind-driven fire conditions in a structure with an uncontrolled flow path.¹¹

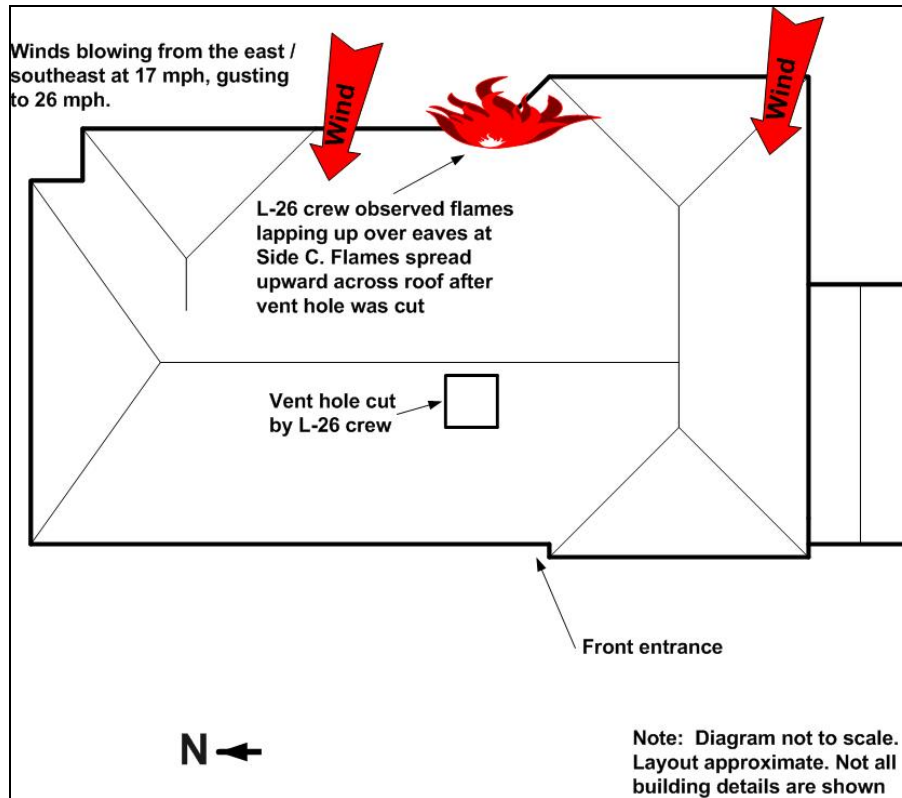
Diagram 4
Approximate location of roof vent hole cut by L-26 crew. Also see Diagram 1.

The L-26 captain observed fire coming from a roof vent that was located on the back side of the roof and near the ridge line between the front door and D-side of the house. *Note: This may have been a vent or skylight over the master bathroom.* The L-26 captain surveyed the roof as an L-26 fire fighter began to cut a ventilation hole on the front side of the roof located above and to left of the front door. Fire was observed coming through the cut just behind the saw. The L-26 captain also observed a small amount of fire (approximately 1-2 feet wide) lapping up over the eave at the back (C-Side) of the roof below him (see Diagram 4). As the ventilation cuts were being finished, the IC radioed the

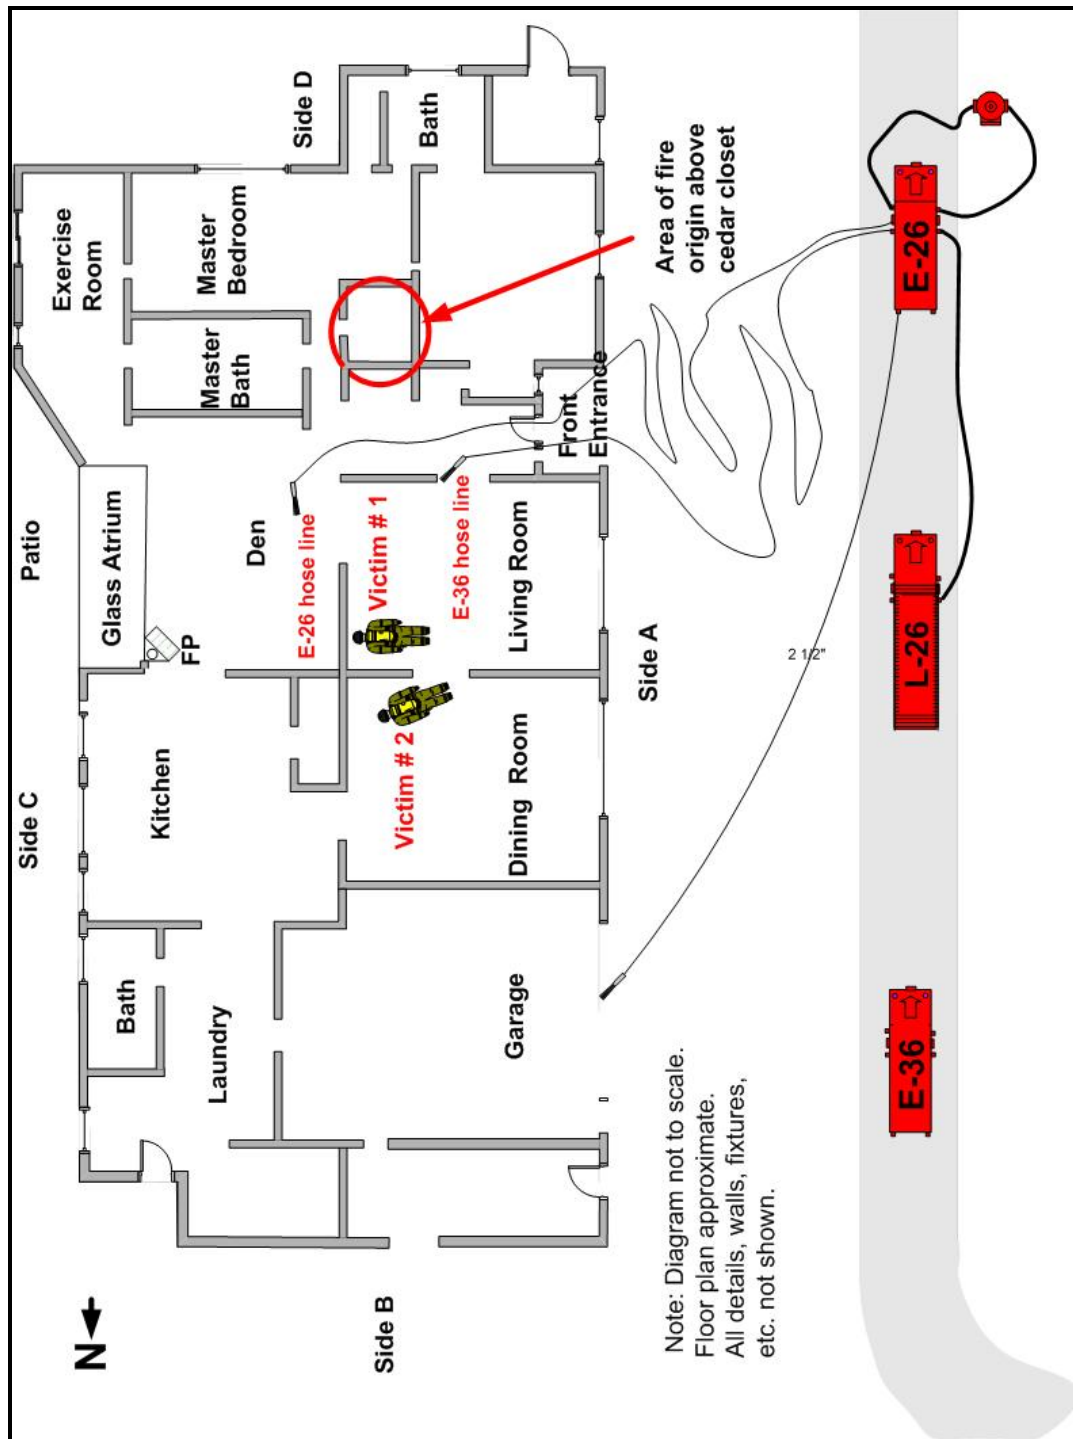
Diagram 5

Diagram shows location of initial attack lines and locations where victims were found.

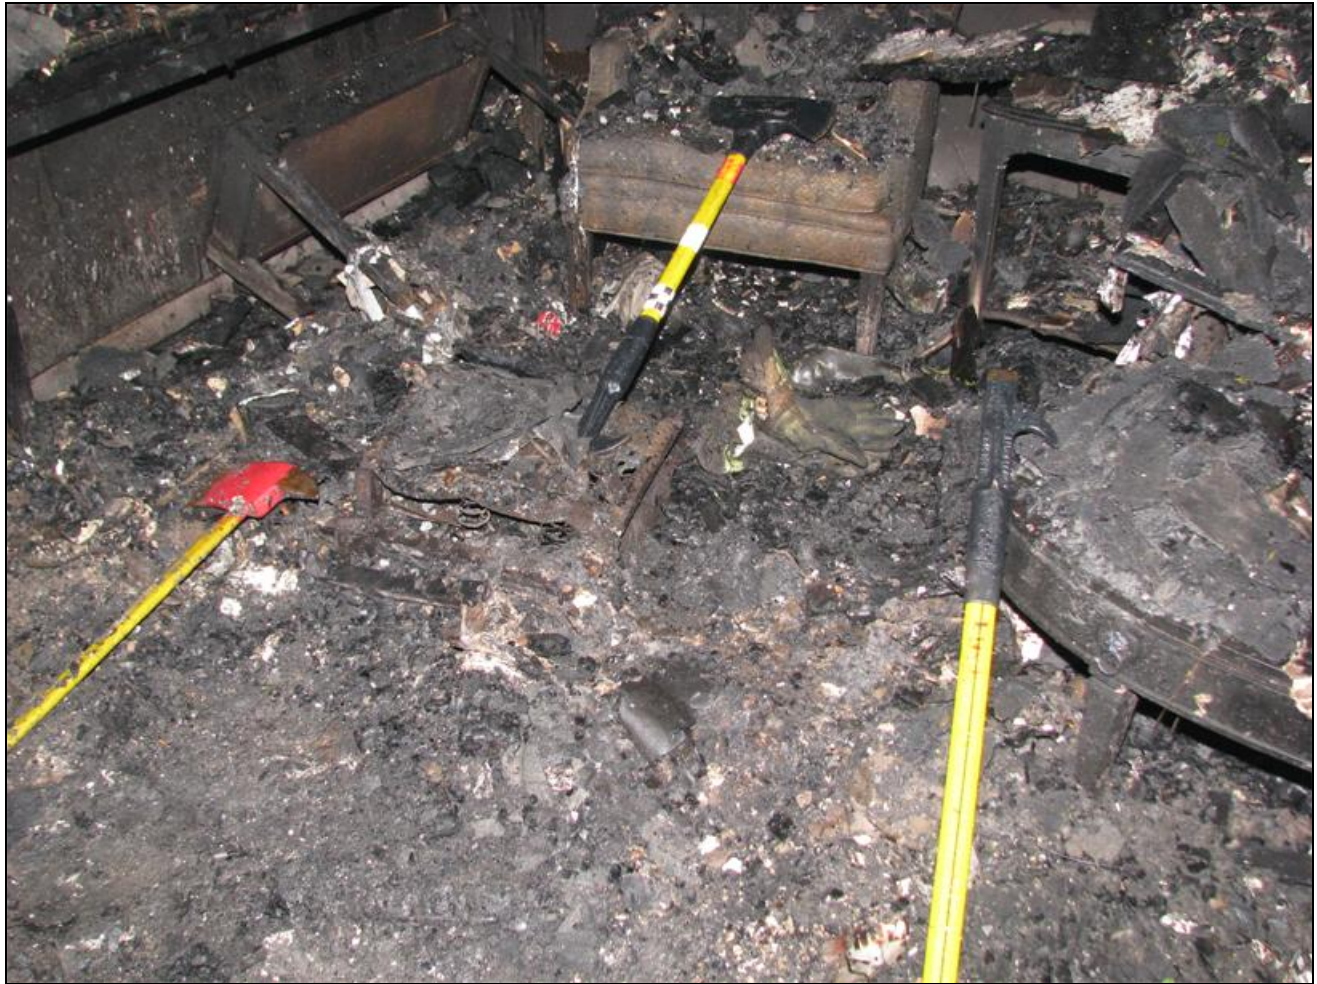
Photo 5:

Photo shows location where Victim # 1 was located in living room. The middle tool marks location where victim was found slumped against the chair at top of photo. Note that the upholstery on the chair is not burned, indicating that a flashover did not occur in this area.

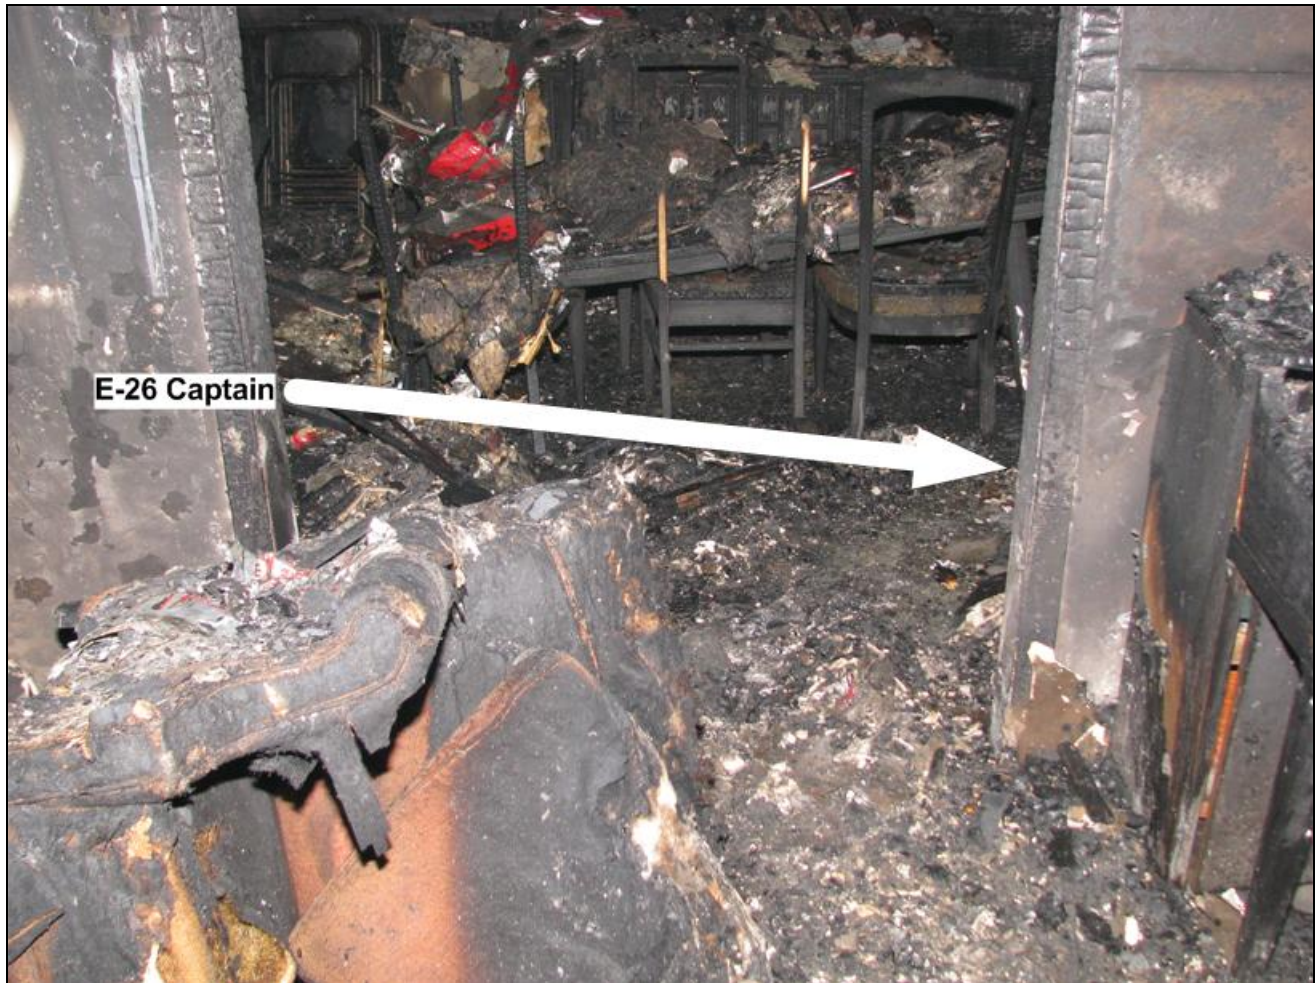
Photo 6:
Photo shows location where Victim # 2 was located in dining room just through doorway separating the dining room from the living room.
Photo provided courtesy of the fire department.
