## Volunteer Fire Chief Dies After Being Crushed Between Two Fire Trucks - Kansas

### Executive Summary

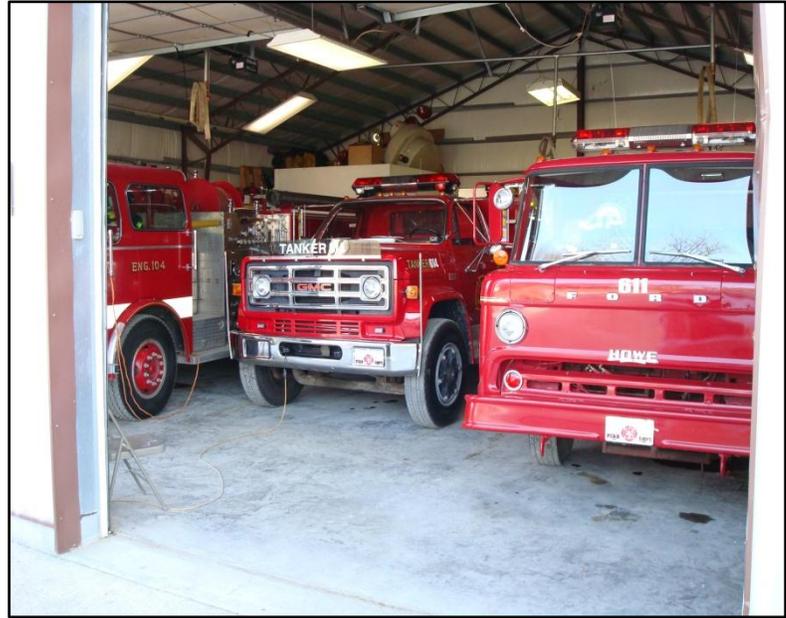
**Position of the apparatus involved in this incident.**  
*(NIOSH Photo)*

- *Inadequate policies for backing apparatus.*
- *Inadequate facility space for the number of apparatus.*
- *Inoperative backup warning system and possibly obscured side view mirror.*

- *Ensure that standard operating procedures are developed, implemented, and enforced on safe backing of fire apparatus and include adequate training to ensure fire fighter comprehension.*
- *Ensure that apparatus storage bays are well lit and have adequate room to store apparatus.*

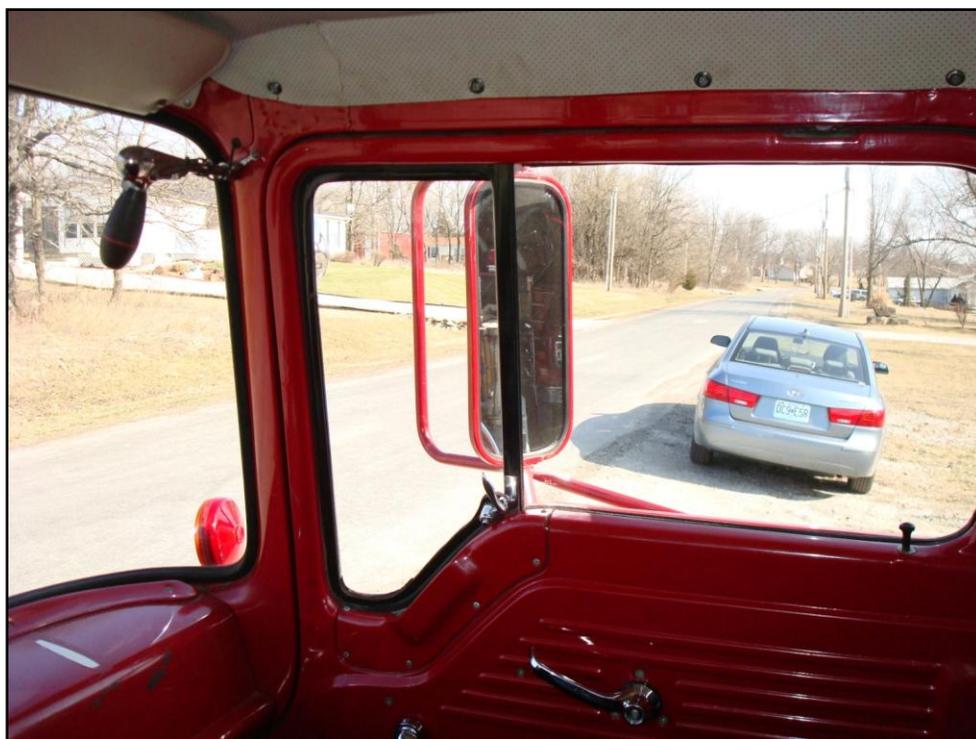
**Driver's view of apparatus bay through passenger side rear-view mirror. Note vent window frame obstructing view. (NIOSH Photo)**

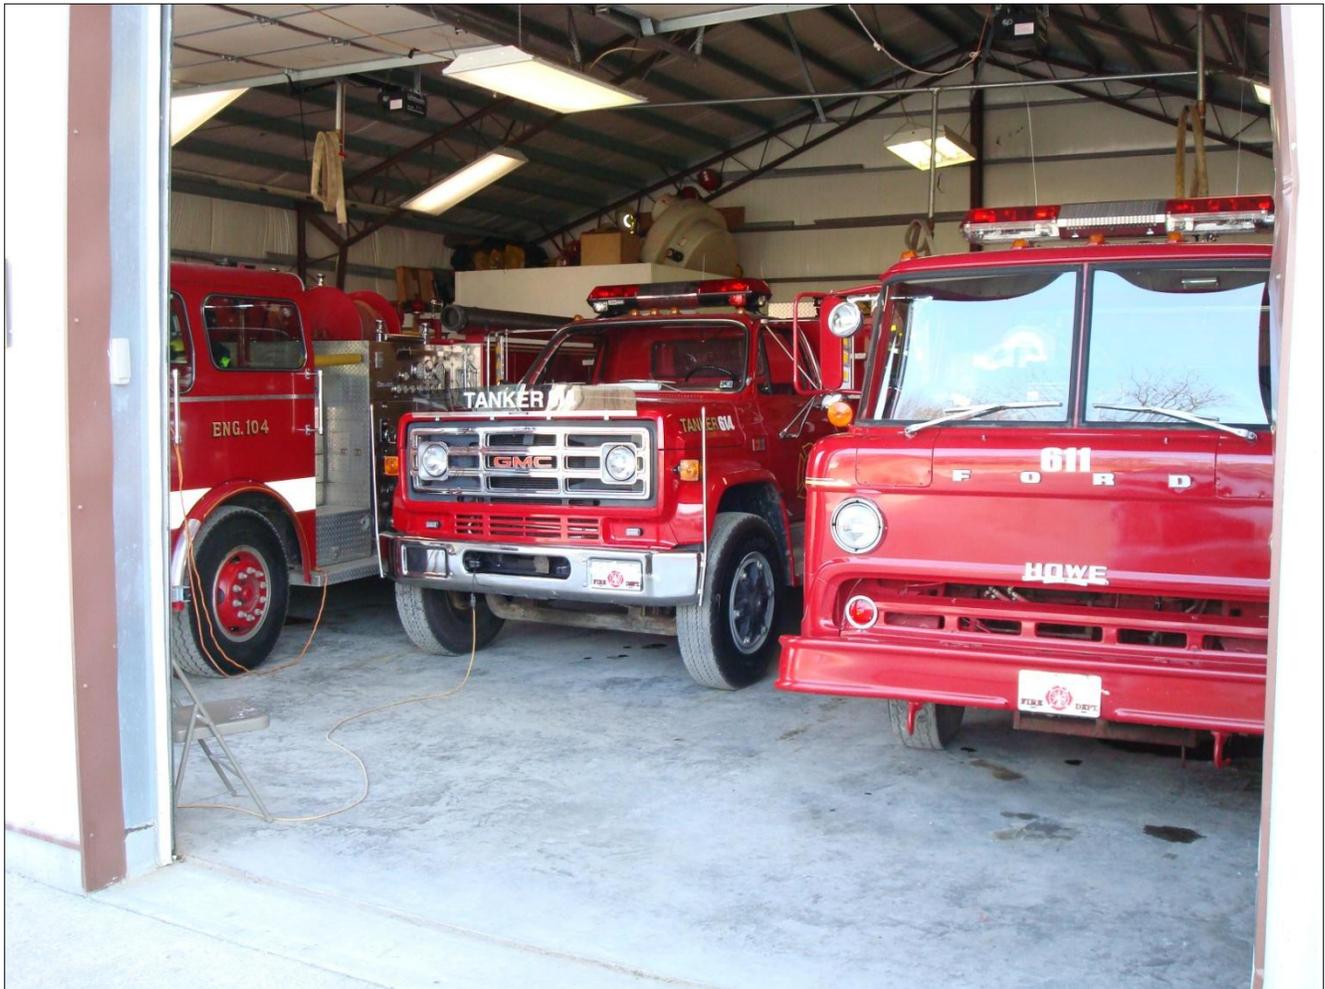
The apparatus involved in this incident was a 1977, 750-gallon-per-minute commercial pumper (see Photo 1). In 1994, the fire department purchased this pumper as a used vehicle from another department, and the pumper was in service with this department from 1994 until after this incident. The gross vehicle weight rating of the pumper was 27,500 lbs. The pumper had a manual transmission, gasoline engine, and two axles with six wheels (two in the front and four in the rear). The pumper had

an audible reverse warning device and lights, which were found by the state police investigators to be not operating after the incident. The right side rear view mirror was rigidly mounted and a frame for the vent window possibly caused a partial obstruction to the driver's view (see Photo 2 and Photo 3). *Note: The department hired a private firm to inspect the apparatus after this incident and corrosion problems were found on the main frame rails. After the inspection, the apparatus was removed from service permanently.*

**Photo 1. Pumper involved in this incident is on the right.**  
(NIOSH Photo)

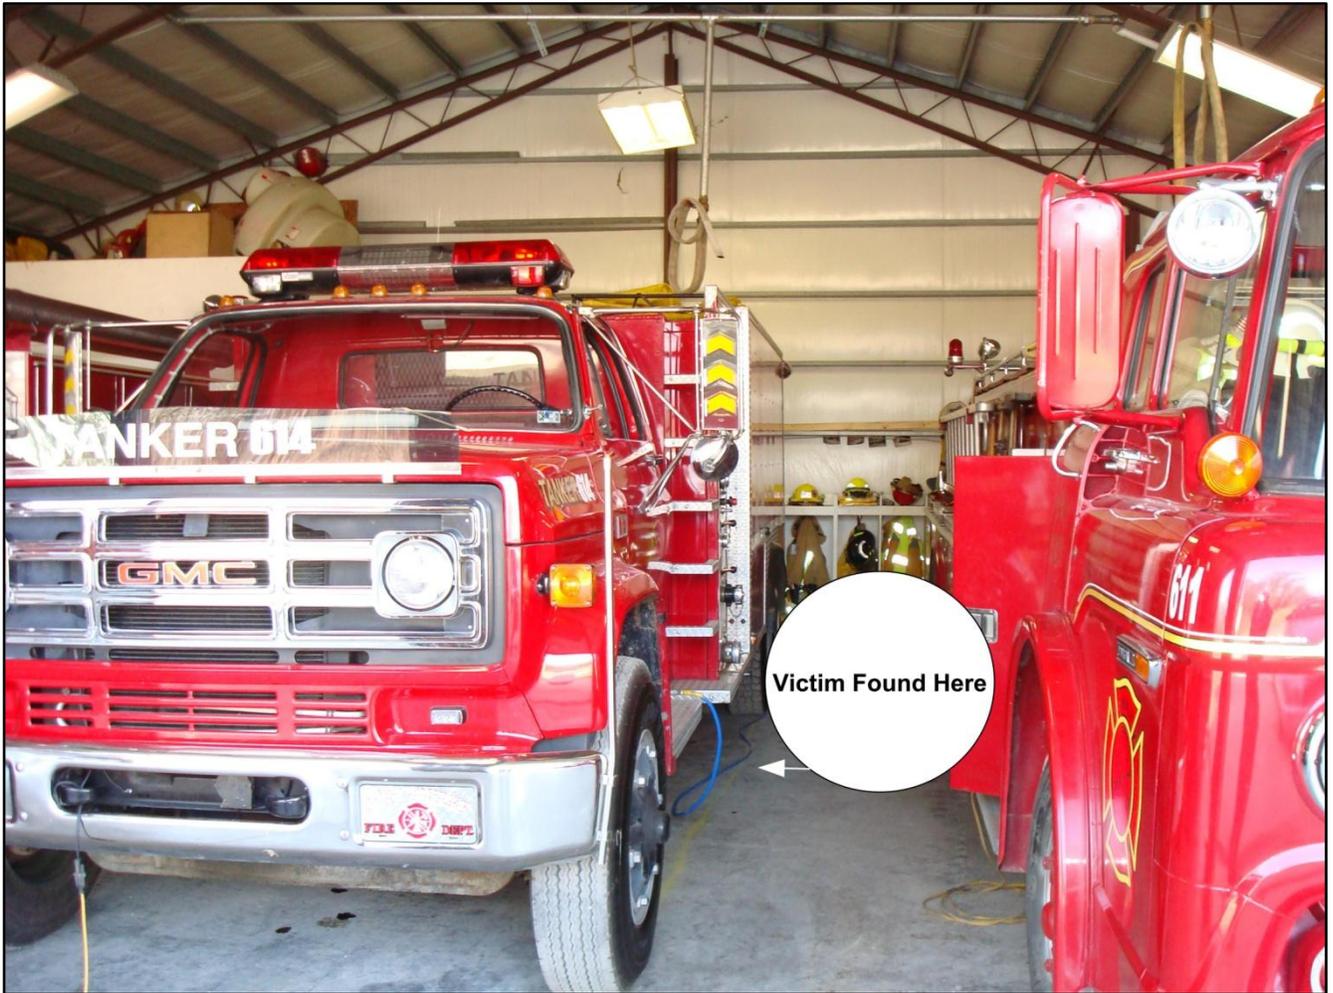
The fire fighter responded to the mutual aid call with Tanker 614. Shortly after leaving the station, the response was canceled and Tanker 614 was directed to return to the station. The fire fighter stated during interviews that when he returned to the station he observed the Chief get into Pumper 611 and pull it out of the station. The fire fighter backed Tanker 614 into the station, then walked over to Pumper 611 and got into the driver's seat to back it into the station. The fire fighter told the NIOSH investigator that he had trouble seeing the inside of the station bay due to poor lighting and glare from the sun. The fire fighter stated that when he was backing Pumper 611 into the station he observed, by line of sight, the Chief standing outside the station next to a man door (see Diagram). The fire fighter realized that he was too close to Tanker 614 (parked in the middle of the two station bays), and he pulled the pumper forward to straighten up and then backed into the station. He did not have a spotter helping him to back in, and there was no verbal communication between the Chief and himself. He then got out of Pumper 611 and came around the front of the truck and yelled for the Chief. He did not get a response. He then walked between Pumper 611 and Tanker 614 and found the Chief lying on the bay floor beside the pump panel of Tanker 614, unresponsive (see Photo 2). The fire fighter called 911 and started CPR on the victim.

**Photo 2. Location of the victim. (NIOSH Photo)**

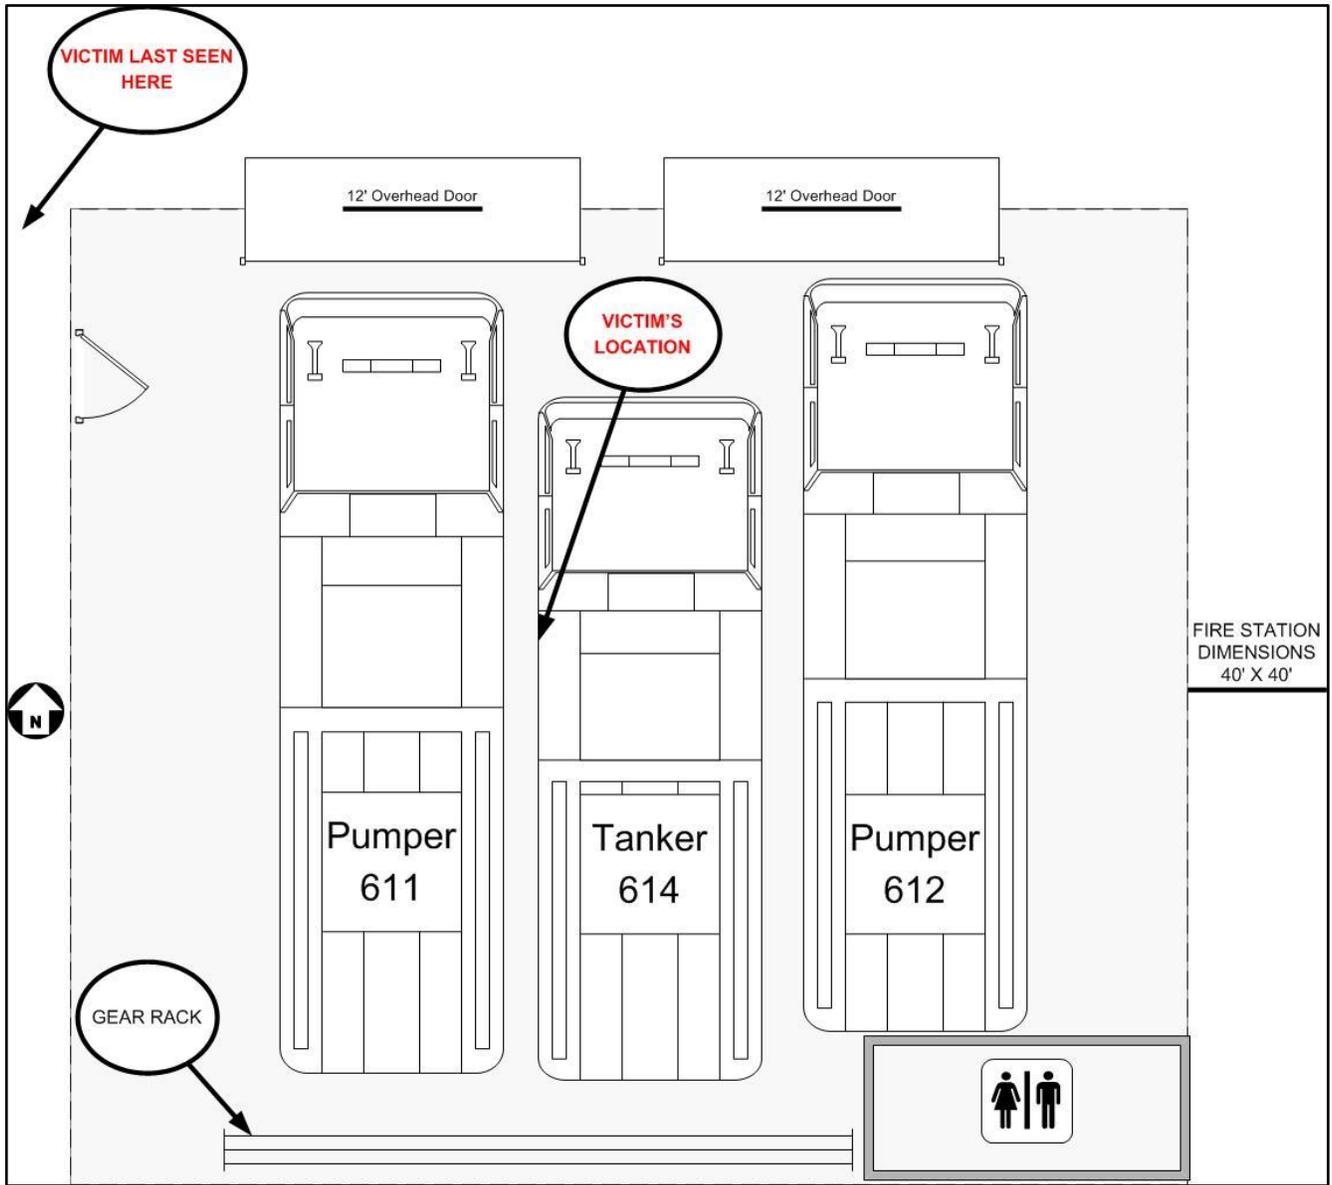
- **1519 Hours**  
Tanker 614 is canceled by dispatch and directed to return to the fire station.
- **1532 Hours**  
Tanker 614 arrives back at the fire station. The fire fighter observes the Chief pull Pumper 611 out of the fire station, and then the fire fighter backed Tanker 614 into the middle of the fire station. The fire fighter then got out of Tanker 614 and walked over to Pumper 611, got in on the driver's side, and proceeded to back Pumper 611 into the station. The fire fighter then realized he had backed the pumper too close to the tanker parked inside of the station, pulled forward to reposition the pumper, and then finished backing it into the station. The fire fighter stated during interviews that he observed the Chief (line of sight) standing outside the station next to the man door (see Diagram) and that there were no verbal communications between the two.

**Diagram. Layout of the incident scene.**

In this incident, the Chief and the fire fighter had no communication regarding backing responsibilities, and the driver did not know the victim was going to go behind or between the trucks. The Chief was last seen by the fire fighter standing by the main door outside the station (see Diagram), and his intentions were unknown to the fire fighter. The fire department did not have any formal standard operating procedures or policies for driving or operating fire apparatus at the time of the incident, but has since instituted a backing policy.

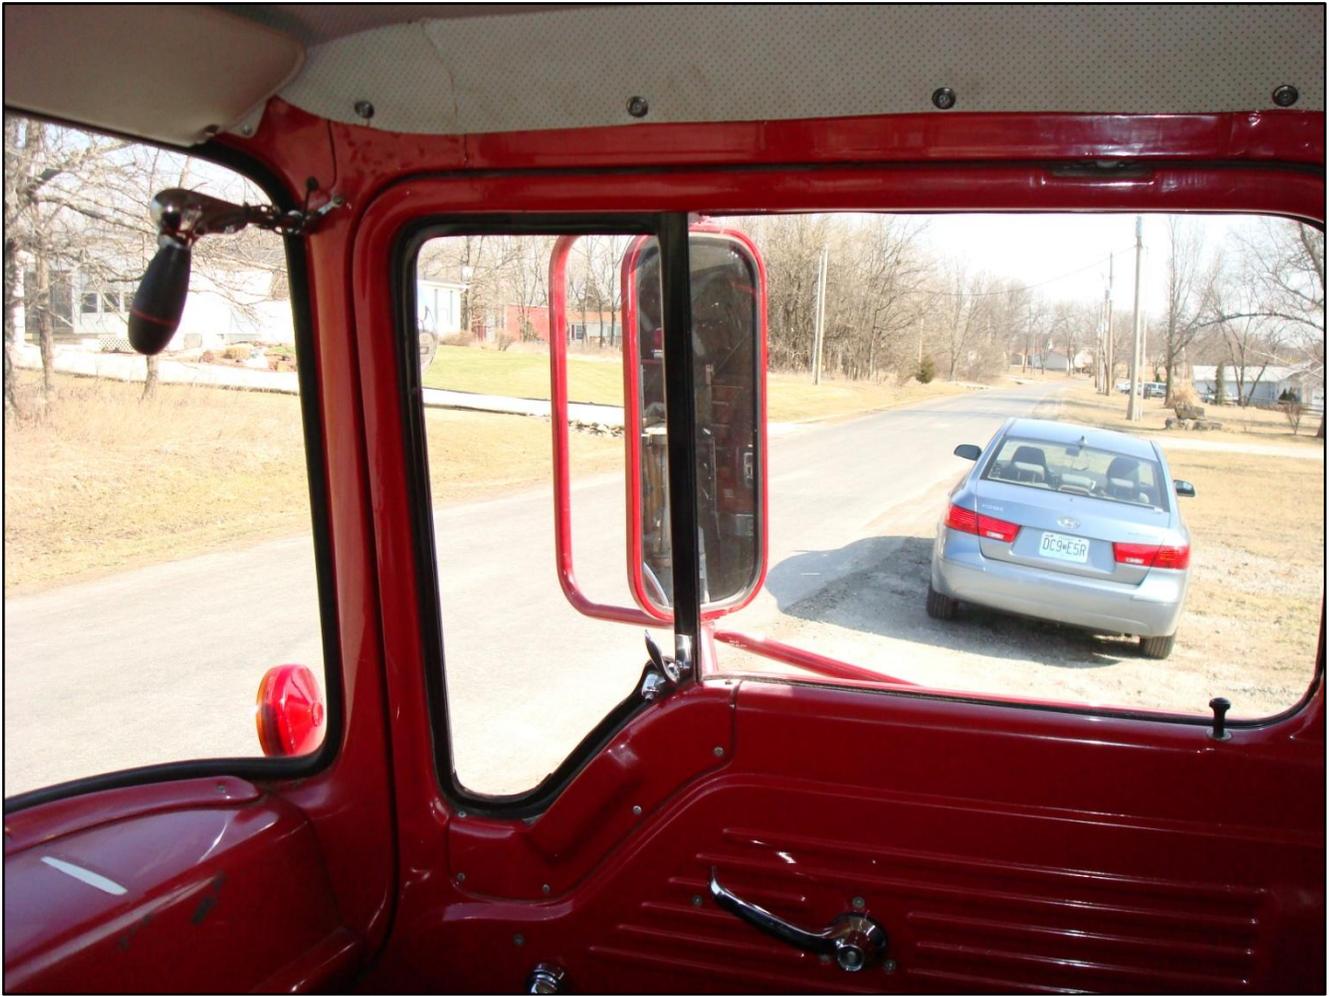
In this incident, the driver’s view of the passenger side rear view mirror was possibly obstructed by a window vent frame. The mirror was a fixed mounted assembly and may not have allowed adequate adjustment to alleviate the obstruction due to its age (see Photo 3).

**Photo 3. Driver's view of apparatus bay through officer's side rear-view mirror. Note vent window frame obstructing view. (NIOSH Photo)**

In this incident the truck was over 25 years old and had the original mirrors that were not adjustable by the driver. The drivers view of the passenger side rear view mirror was possibly obscured by the window vent frame (see photo 3). The audible and visual back-up alarms were not operational at the time of the incident. After the incident the fire department hired a private firm to inspect the apparatus and corrosion problems were found on the main frame rails. After the inspection, the apparatus was removed from service permanently.

***Recommendation #4: Fire departments should ensure that fire apparatus drivers have unobstructed views from their rear view mirrors.***
