## Career Fire Fighter Dies While Conducting a Search in a Residential House Fire – Kansas

### Executive Summary

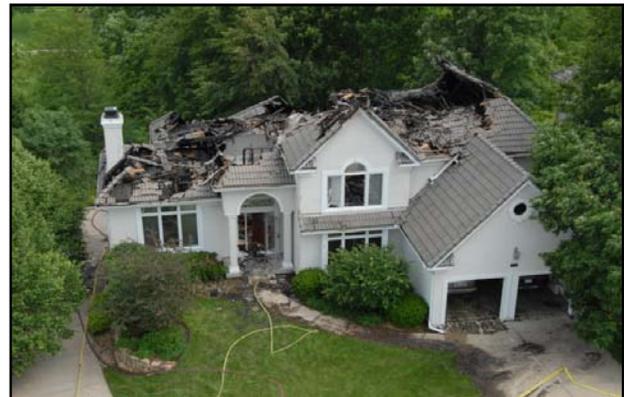
**Residential House – Post Incident**  
(Courtesy of the State Fire Marshal Office)

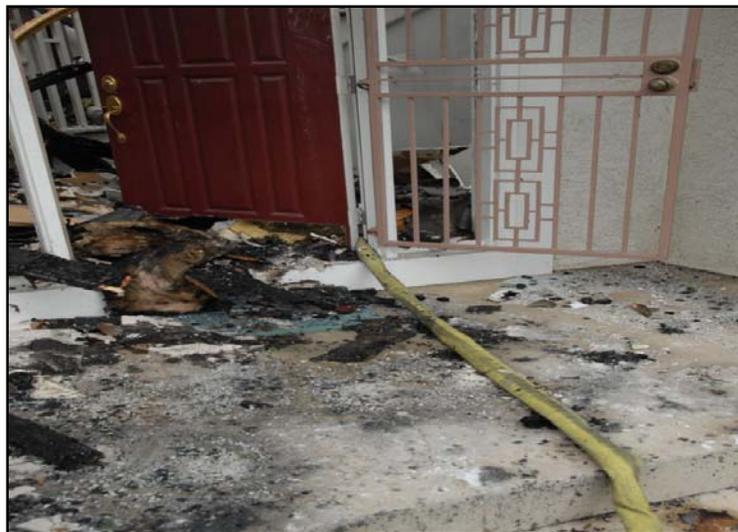
**Uncharged Hoseline at Front Door**  
*(Courtesy of the State Fire Marshal Office)*

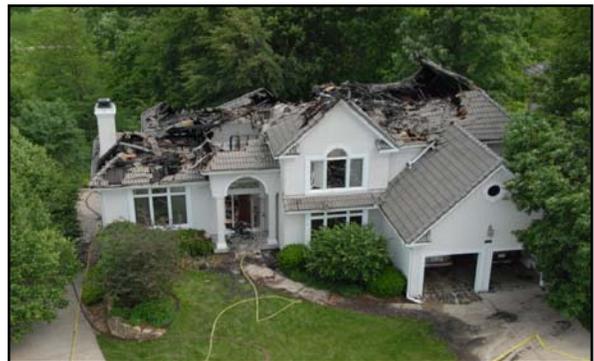
**Photo1: Residential House**  
*(Courtesy of the State Fire Marshal Office)*

The incident involved a non-sprinklered 6,000 square foot two-story single family residence with a full basement that was built in 1998 (see Photo 1). Currently, the state of Kansas does not require residential structures to be sprinklered. The lower level included a walk-out basement and secondary lower level garage. The main floor consisted of a great room, dining room, kitchen, breakfast room, master bedroom and bath with make-up room, utility room, office and a two car garage. The top floor consisted of three bedrooms and 2 full bathrooms. The structure had 2” x 6” exterior wood frame construction, solid 2”x 10” wood floor joists, and 2” x 8” roof rafters. The exterior was stucco with wood trim and the roof had Spanish style cement tiles. The interior walls were 2” x 4” wood studs covered with ½” sheetrock and the floor coverings were primarily carpeting throughout the house. The basement/secondary garage area contained shelves of paint and cans of refinishing materials along the interior south wall and 3 cars. The basement area contained an unfinished half bath and large area containing the hot water heater and furnace (see Diagrams 1, 2, and 3).

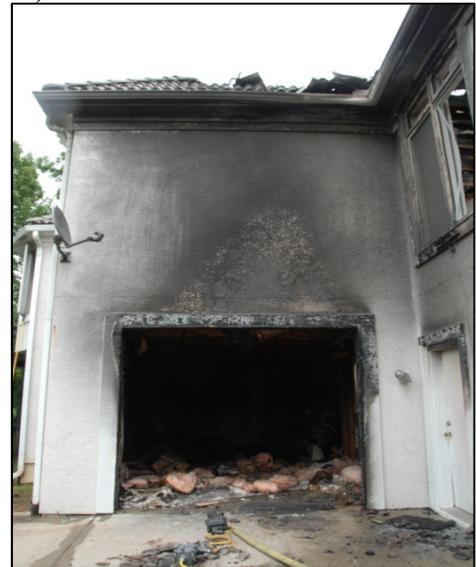
**Photo 2: Basement/Lower Level Garage on B/C corner.  
(Courtesy of the State Fire Marshal Office)**

The E92 crew made entry at the lower garage door and the heavy fire was converting the water to steam as the crews kept fighting the fire (see Photo 2).

The area of origin was in the lower level garage bay along the south wall where storage shelves were present. A clock radio was the probable ignition point in the area of origin. Per the State Fire Marshal Report, the house electrical circuits and attached components could not be eliminated as a cause. The fire is listed as accidental.<sup>2</sup>

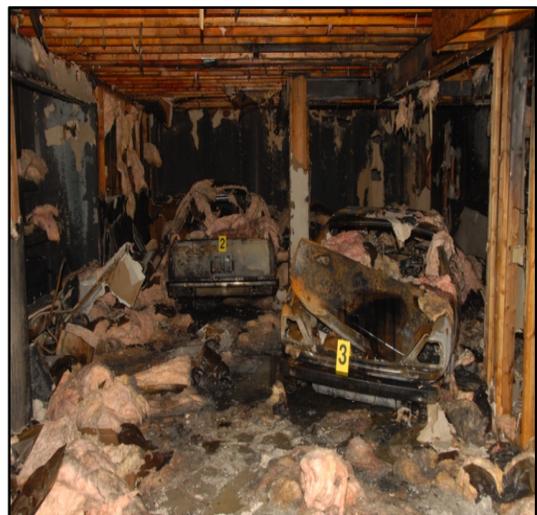
In the lower level garage, the E92 crew had advanced to the cars halfway in the garage and could see an orange glow towards the D-side wall (see Photo 3).

**Photo 3: Cars in Lower Level Garage**  
*(Courtesy of State Fire Marshal Office)*

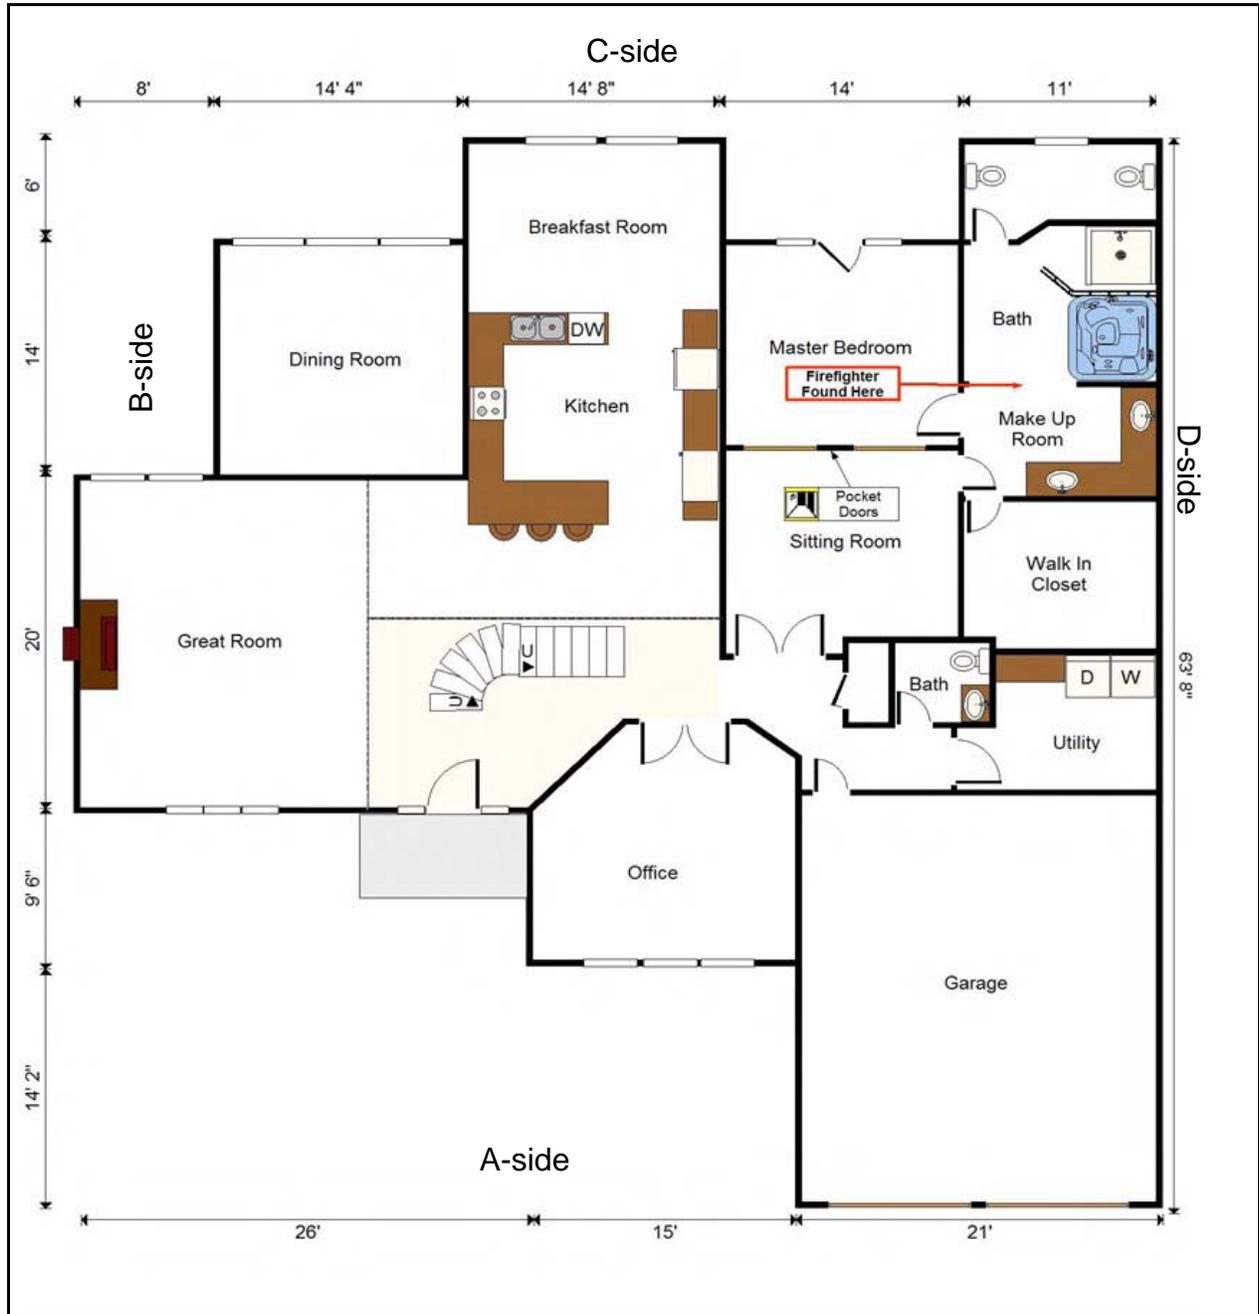
**Diagram 2: First Floor Layout**  
(Courtesy of the State Fire Marshal Office)

The first RIT crew went back to the sitting room and went to the right where they opened a door to a make-up room. One RIT team member's flashlight hit the reflection tape on the victim's bunker pants. The TIC showed the location of the victim and the crew heard his personal alert safety system (PASS) device. They radioed command that they had found the victim (see Diagram 2).

The victim was lying on his back in the make-up room without his helmet, gloves, and facepiece on. The RIT crew him and carried him out to the yard where medic crews began taking off his gear and put him on a power cot and into Medic 1132. Inside the medic unit, they started an IV and noticed the victim was not breathing and had a faint pulse. The victim was intubated to clear his airway of vomit and soot. CPR was rendered and he was placed on a life-aid machine. The victim was transported to the hospital and later pronounced dead.

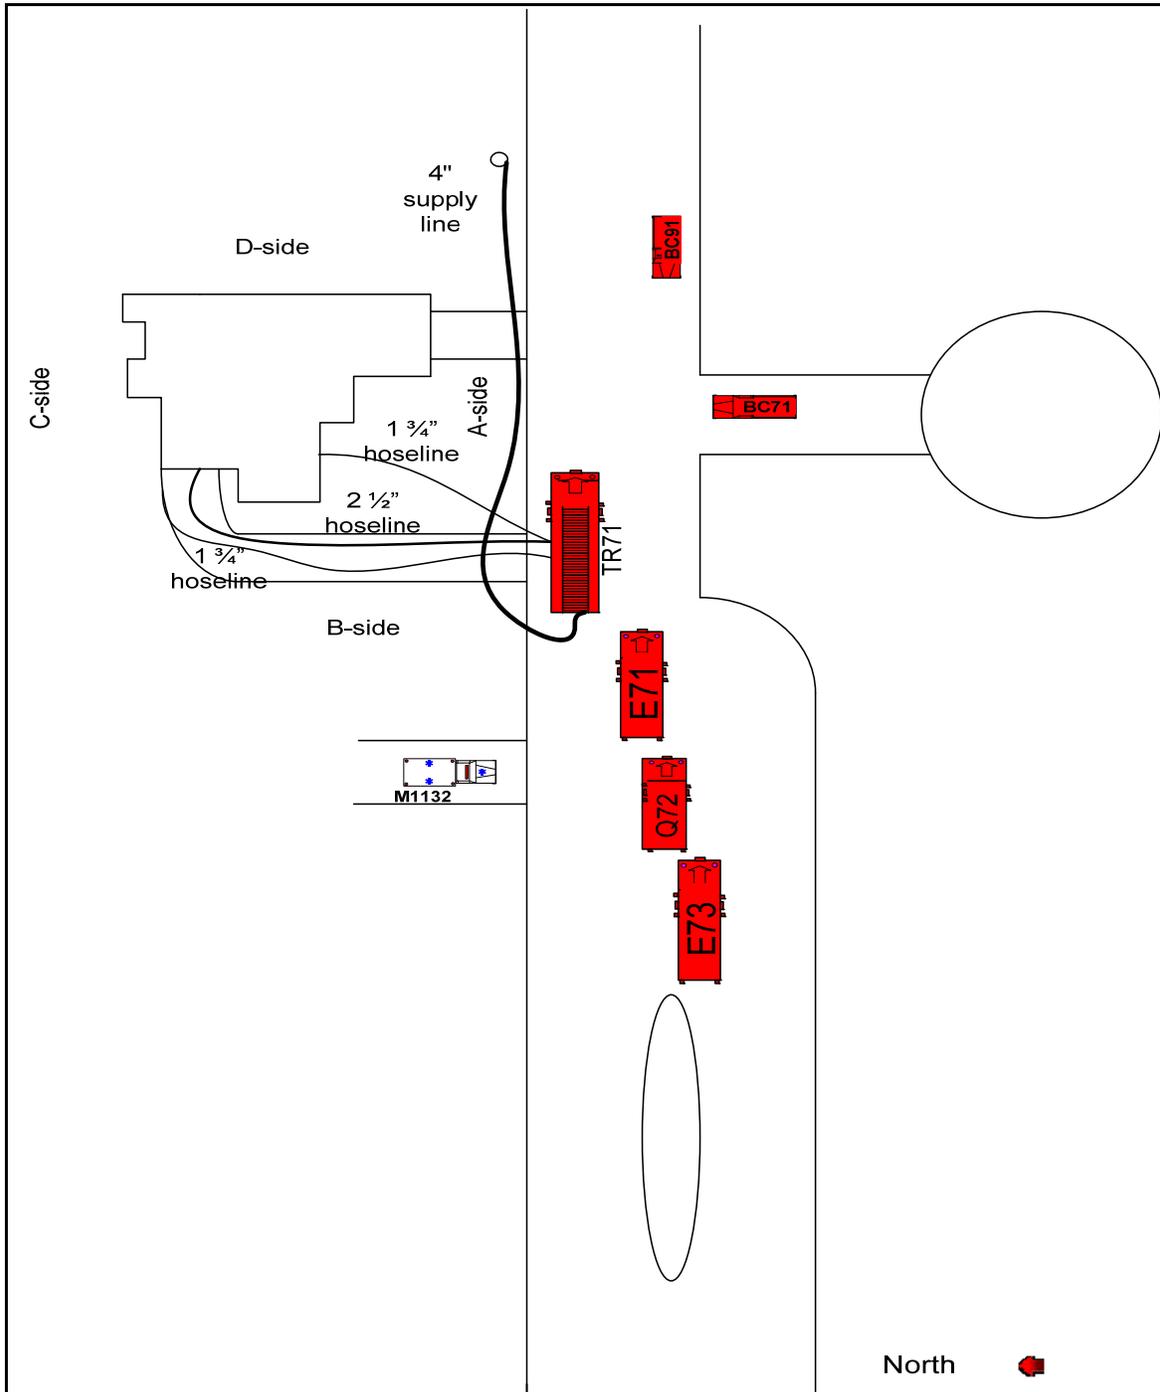
Diagram 4: Apparatus Placement and Hoselines

On May 22, 2010, at 2052 hours, an automatic fire alarm dispatched Truck 71 (TR71) per normal protocol. At 2055 hours, dispatch called in a residential structure fire. First alarm companies Battalion Chief 71 (BC71), Engine 71 (E71), Engine 73 (E73), mutual aid Engine 92 (E92), Quint 72 (Q72), and Medic 1132 (M1132) were assigned. Three minutes later, BC71 and TR71 arrived on-the-scene. BC71 assumed incident command (IC) and notified dispatch of a large residential structure with heavy smoke and fire visible on the B-side. Incident command was established on the A-side of the structure in the adjoining intersection directly across the street (see Diagram 4).
