## **Volunteer Fire Chief Killed When Rubber-Tracked Vehicle Overturns at Brush Fire – Washington**

### **Executive Summary**

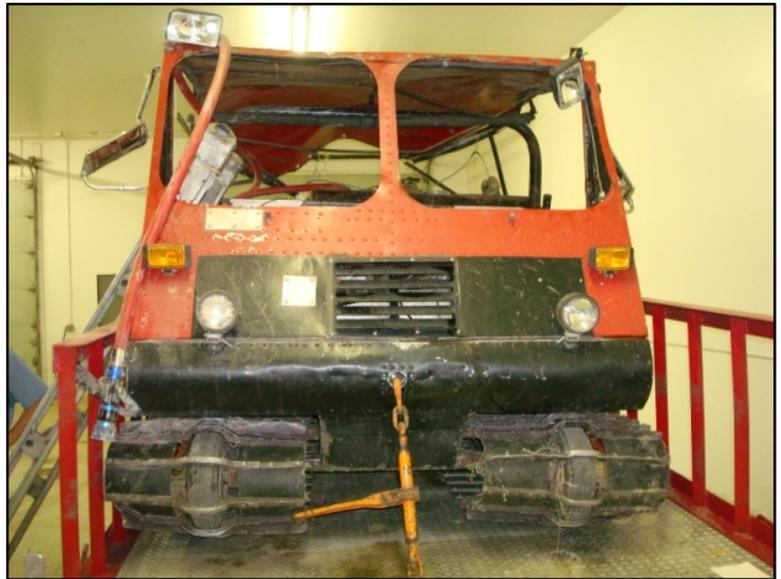
**1960s vintage vehicle was obtained by the fire department in 2008 through the state's surplus fire fighter property program.**  
*(Photo NIOSH)*

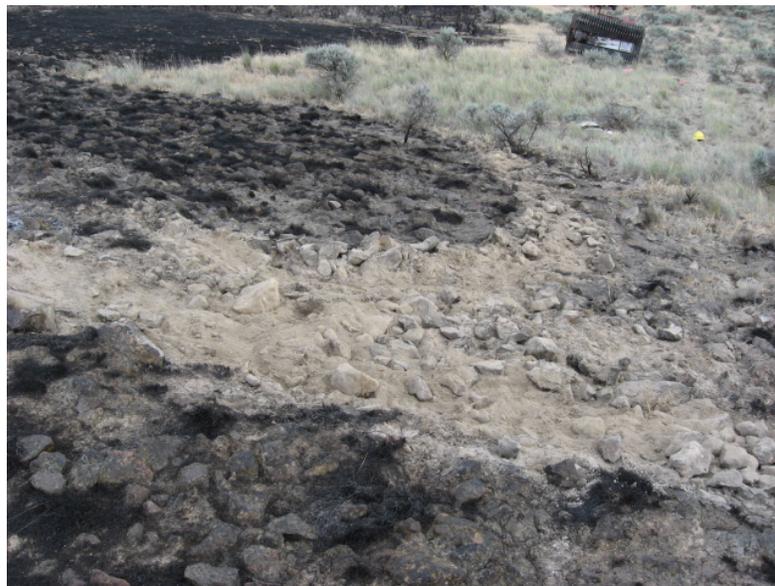
**Rocky terrain where vehicle lost traction and overturned. Light-colored area in center of photo is where the vehicle lost traction and the tracks spun on loose rocks and soil before overturning. The overturned vehicle is seen in the top right hand corner of the photo.**

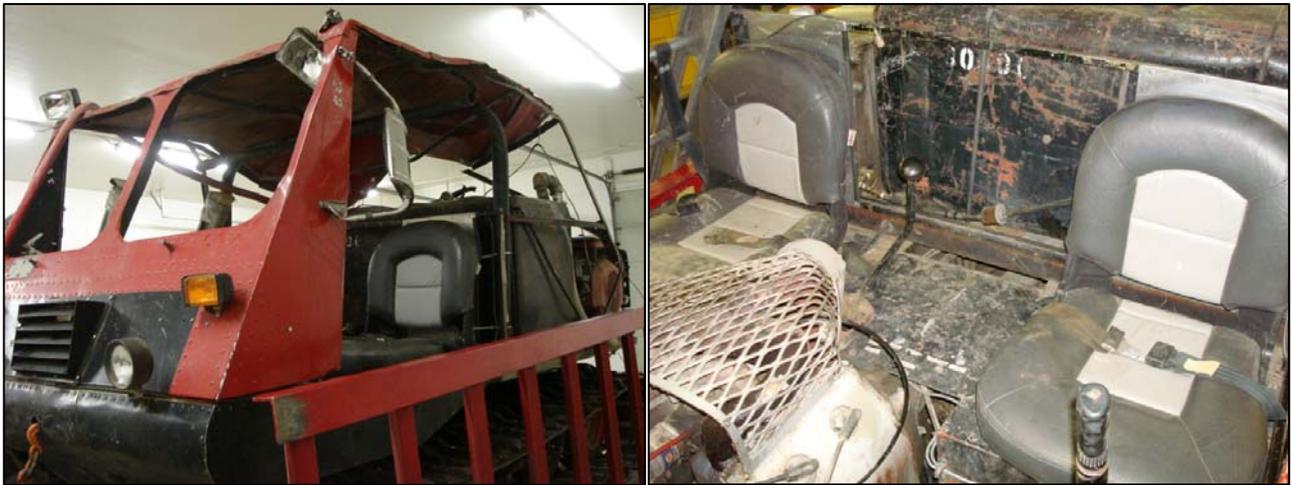
The vehicle involved in this incident was a 1960's vintage rubber-tracked off-road vehicle designed for operation in snow, mud and rough-terrain environments. The vehicle's manufacturer has been out of business since the 1980s. Due to the utility of this type of vehicle, there is a well-established secondary market for used vehicles of this model as well as other manufacturers' models. The vehicle was originally designed with an enclosed cab equipped with two side-by-side bucket seats separated by the engine and transmission housing (see Photo 1 and Photo 2). The vehicle was powered by a 4-cylinder, 30 horsepower, 107.7 cubic-inch gasoline engine. The drive train included a manual transmission (4-speed forward and 1-speed reverse) equipped with a hand-controlled pressure clutch and a rear-mounted planetary differential drive. The vehicle was steered by manipulating two floor-mounted hydraulically-operated steering levers that manipulated the differential drive. Shifting gears required a two-handed operation – one to engage the clutch lever and one to manipulate the gear shift lever, thus the operator did not have control over the steering levers while shifting gears. The vehicle was operated from the left seat position. Both seats included lap-style seat belts (see Photo 2).

**Photo 1 (left) and Photo 2 (right). Views of rubber-tracked vehicle showing operator’s seat. In Photo 1, the vehicle is setting on the department’s trailer inside a secure location. Photo 2 shows a close-up view of the interior of the cab and the bucket seats equipped with seat belts.**

Both seats in the vehicle were equipped with lap-style seat belts. Photos taken by the sheriff's office investigators showed that the victim was not wearing his seat belt at the time of the incident. The injured fire fighter advised the NIOSH investigators that he was not wearing his seat belt during the incident.

***Recommendation #4: Fire departments should ensure that seat belts are properly worn at all times.***

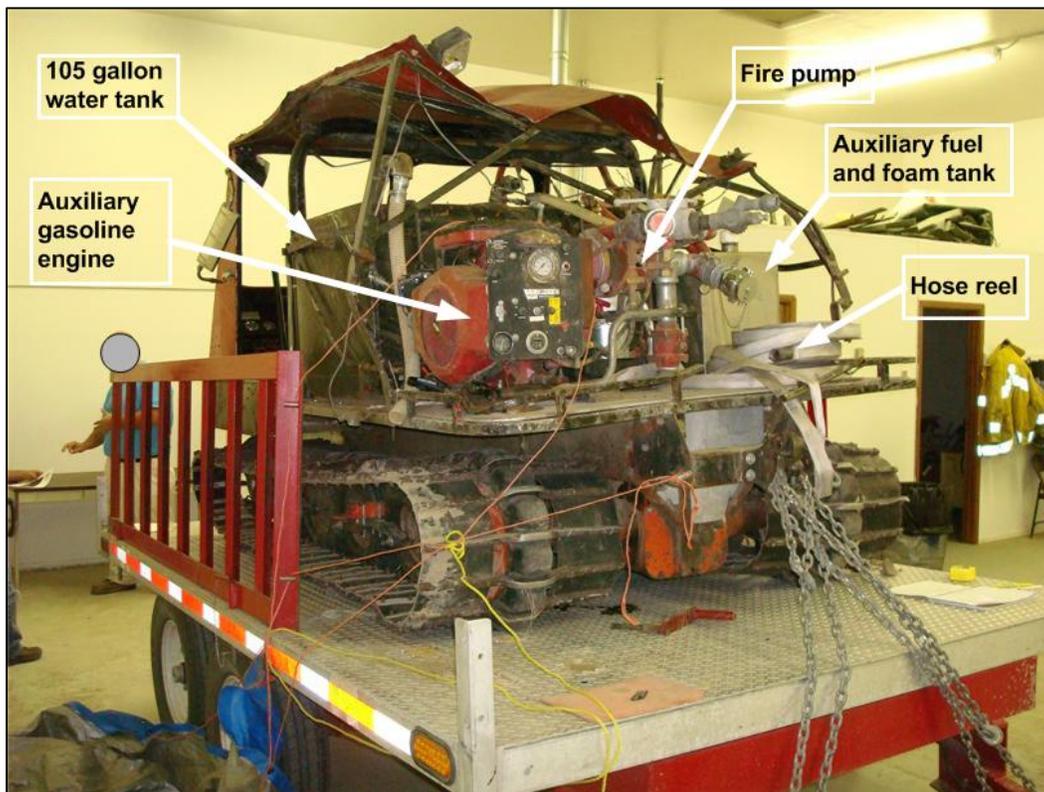
**Photo 3. View of equipment added to the rear of the rubber-tracked vehicle, showing the 105-gallon water tank, auxiliary gasoline engine, hose storage reel, auxiliary fuel and foam tank, and fire pump. Additional items such as hand tools were stored between the fire pump and vehicle's cab.**

The total weight of the vehicle at the time of the incident is unknown. The available vehicle spec sheets<sup>10, 11</sup> list an empty weight of 1900 pounds. At some point (undetermined in this investigation), the vehicle's doors, windows and miscellaneous equipment (windshield wipers, etc) were removed. The fire department added extra lights, mirrors, a roll-bar and a variety of fire suppression equipment including a steel water tank (originally designed and produced for use as a diesel fuel tank), a two-compartment steel tank used as a fuel tank for the auxiliary fire pump and as a storage tank for class A foam solution, a gasoline engine-powered fire pump, hose storage reel, multiple fire hoses, and a variety of hand tools for wildland fire suppression activities. *Note: The fuel tank (used as a water tank) contained steel plates inside the tank mounted at the top and bottom near the center and perpendicular to the tank's long axis. These plates were likely included as reinforcing plates and did not appear to meet the requirements specified in NFPA 1906, Chapter 11 for water tank baffles.*<sup>3</sup> A rough estimate shows that just the weight of the water and gasoline in the auxiliary tanks plus the estimated weight of the two fire fighters on the vehicle likely exceeded the rated 1400 pound payload.

The combined weight of the fire pump and gasoline motor, hoses, hose reel, foam solution and hand tools likely added several hundred more pounds of cargo weight. It is likely that the weight of the

vehicle could have exceeded the rated payload by several hundred pounds. *Note: the exact weight of the payload is unknown, including the volume of water in the auxiliary tank at the time of the incident. The injured fire fighter reported flowing a small amount of water (four quick bursts from the hoseline) on spot fires prior to the roll-over. Witnesses reported both water and fuel leaking from the vehicle after it overturned. The only way to know whether the vehicle was overloaded would have been to weigh the vehicle after the incident.*

Additional weight added to the back of the vehicle would have the potential to raise the center of gravity above the original center of gravity, reducing the vehicle's stability. It is difficult to know for certain whether issues with the vehicle's center of gravity were a contributing factor in this incident. The water tank was mounted directly behind the operator's seat and was not centered over the vehicle's long axis. The auxiliary gasoline engine and fire pump were mounted near the rear end of the vehicle's bed (see Photo 3). In addition to the possibility that the added equipment raised the center of gravity, the asymmetrical mounting location of the water tank likely shifted the center of gravity to the driver's side, which was on the downhill side preceding the rollover. The water (in the tank) comprised approximately 25 percent of the total vehicle weight (weight of water divided by the vehicle's empty weight plus estimated partial payload). Water tanks are usually installed as low as possible, centered along the fire vehicle's long axis to minimize asymmetrical loading and shifting of the vehicle's center of gravity. Appendix 1 contains additional information including center of gravity estimations for rubber-tracked vehicles similar to the one involved in this incident.

***Recommendation # 2: Fire departments should ensure that all vehicle retrofits are completed by a qualified source and that retrofits are designed and installed within the original manufacturer's specifications.***

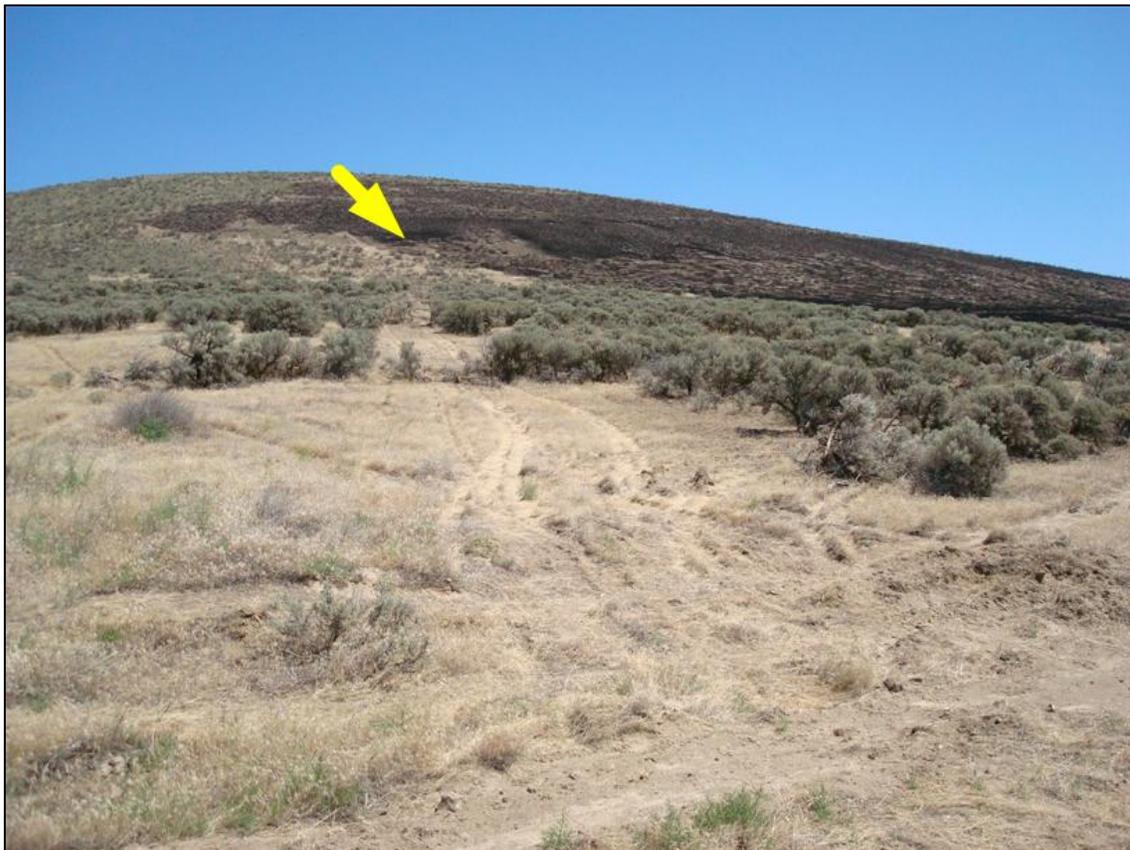
The incident occurred on a sloped hillside covered with sage brush and short dry grass at an elevation of approximately 1,510 feet above sea level. Rough measurements at the incident site indicated the hillside slope to be approximately 55 degrees. A commercial orchard was located at the bottom of the hill and approximately 400 yards south of the incident site (see Photo 4 through Photo 8).

**Photo 4. View of hillside facing north. Arrow marks approximate location where vehicle overturned crossing the rock outcropping. Note change in grade below this location.**

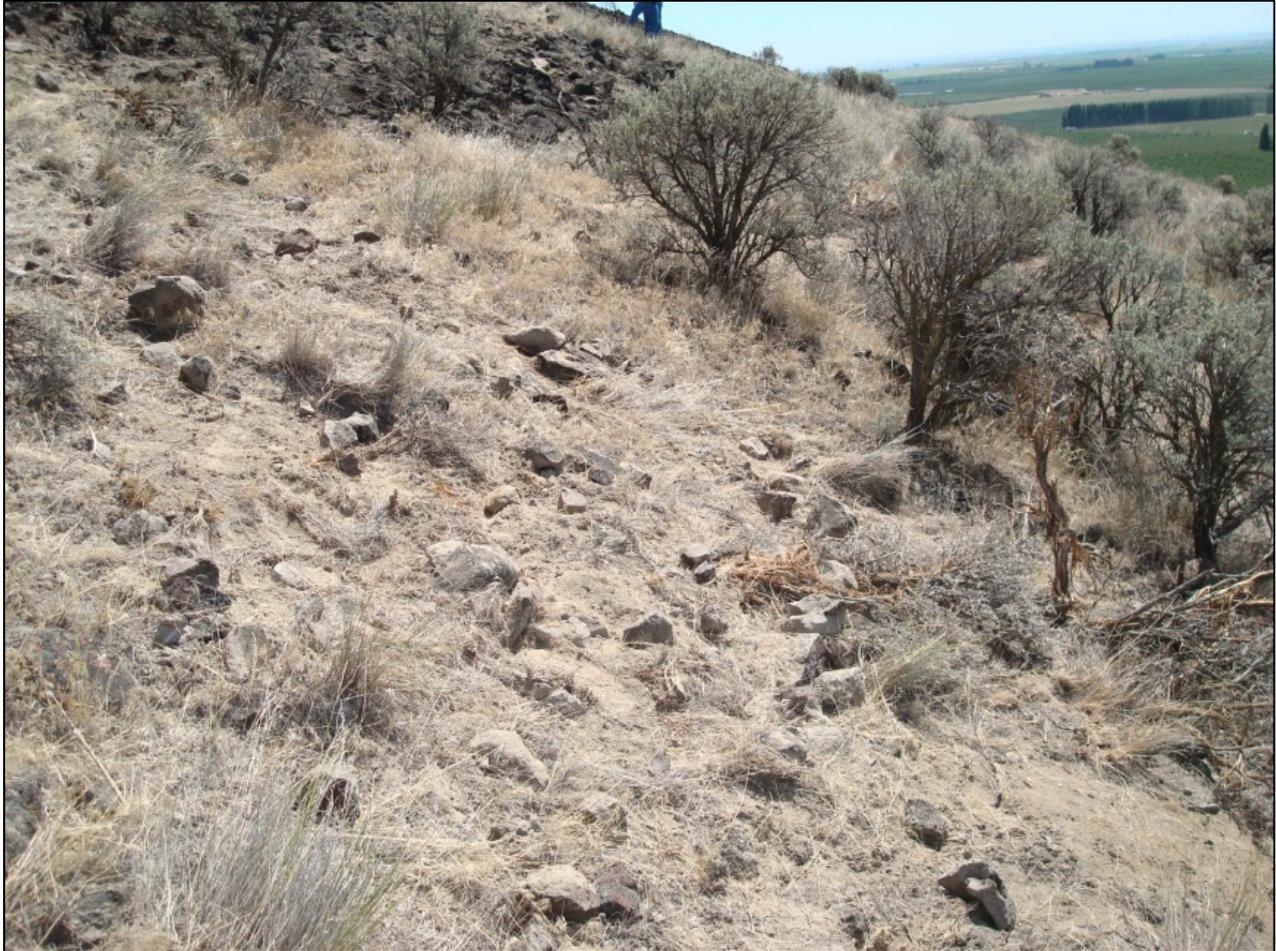
**Photo 5. Hillside where rubber-tracked vehicle first lost traction before turning to east. View is facing east. Slope was measured at approximately 55 degrees.**

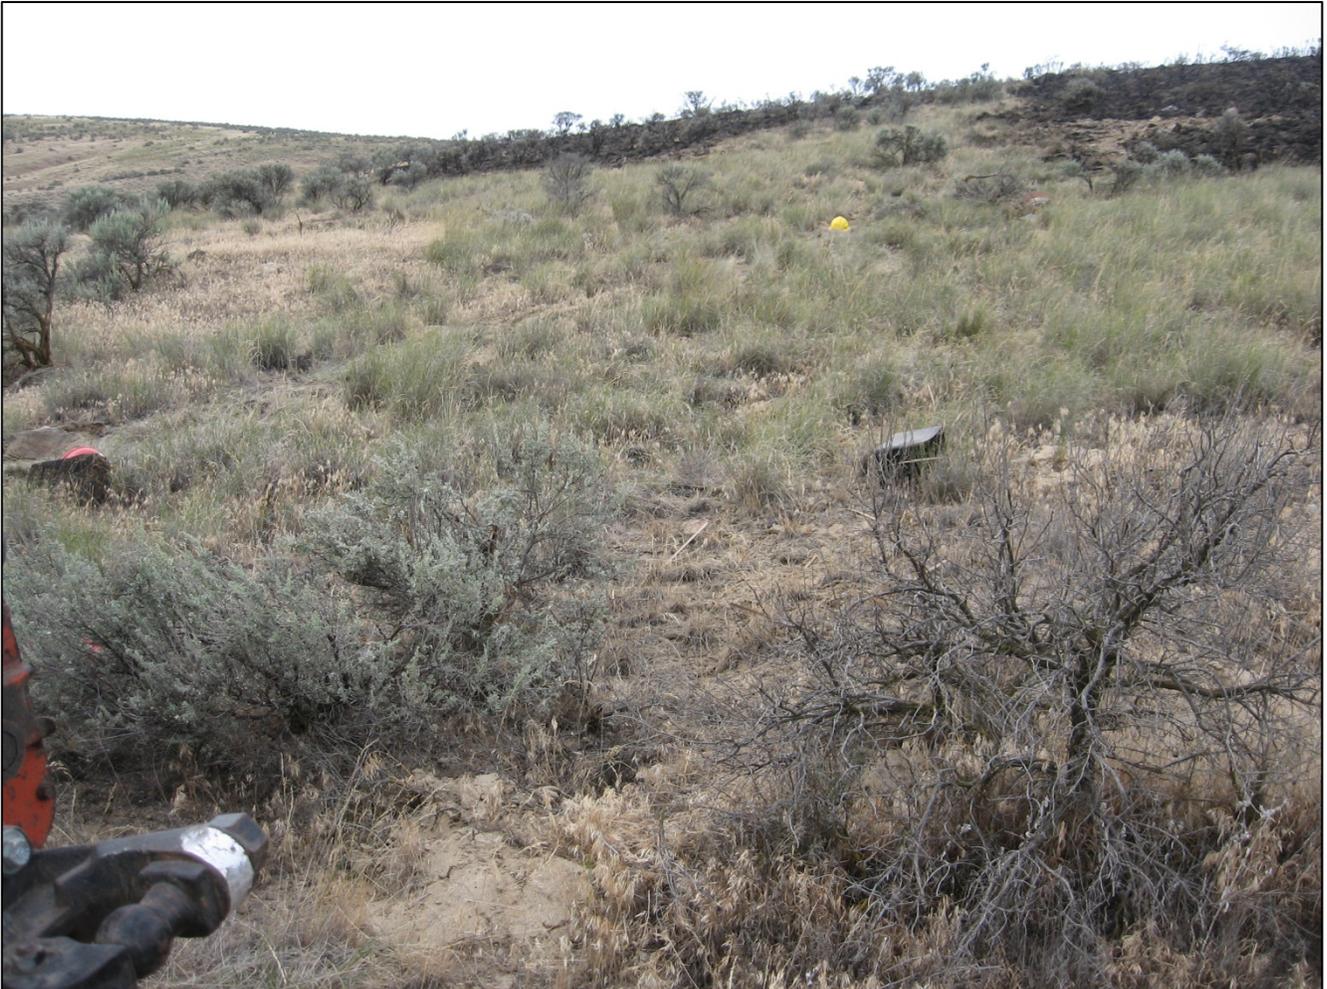
**Photo 6. Photo looking upslope from the vehicle's final resting place to the point to where vehicle overturned.**

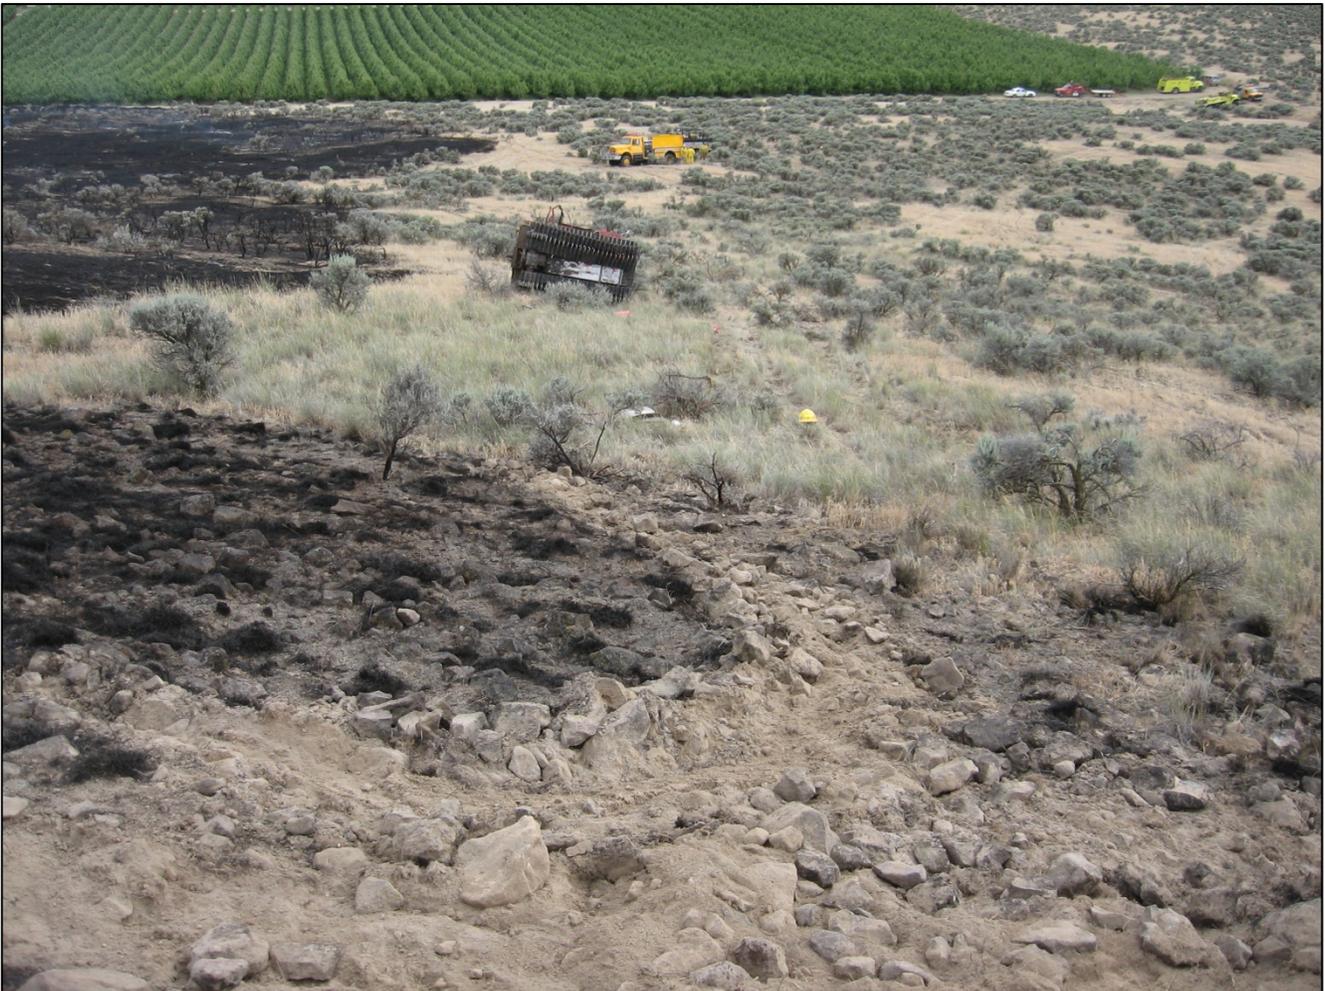
**Photo 7. Photo looking downslope from the point where vehicle overturned to the vehicle's final resting place. Debris field is visible along path of rollover. Note the size and shape of loose rocks. Dark areas to the left are where the fire burned and the lighter colored areas at the bottom of the photo are where the vehicle's tracks spun on the loose rock and soil.**

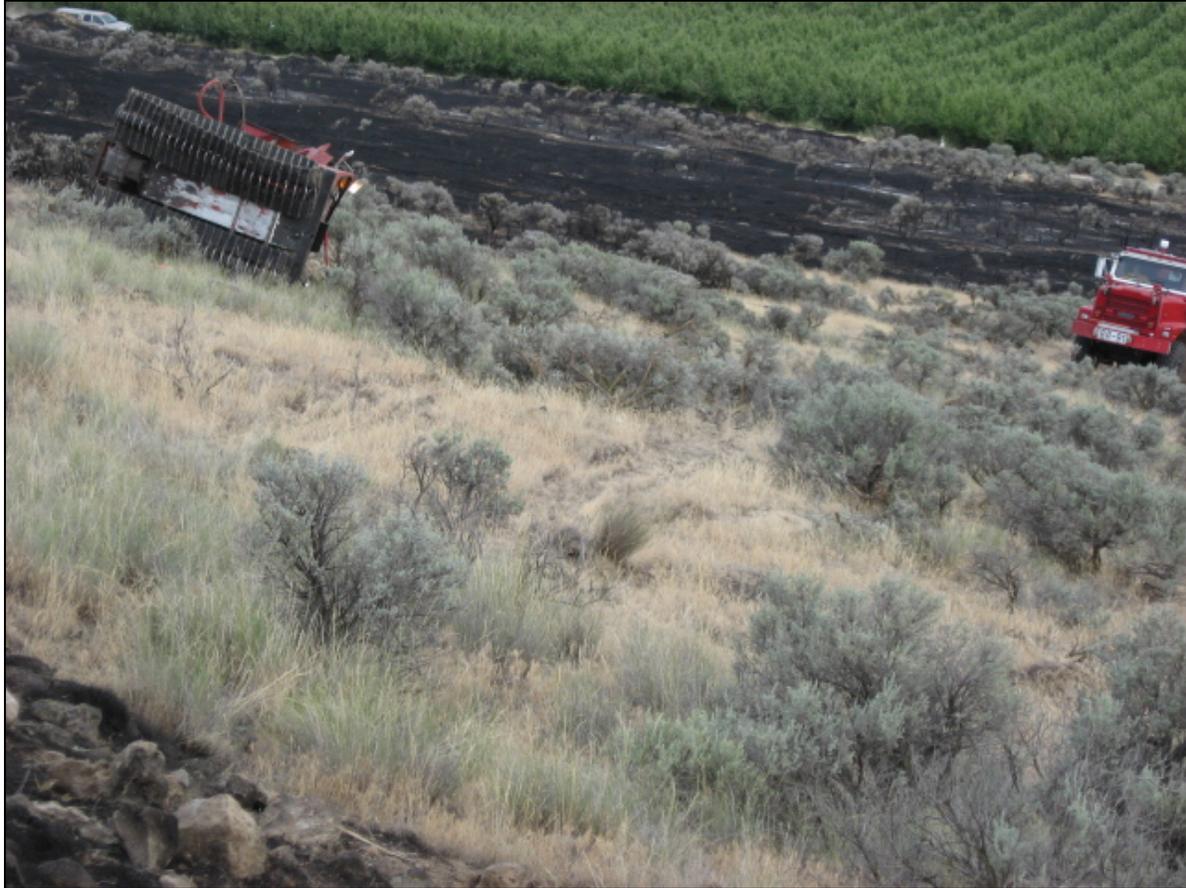
**Photo 8. Photo looking downhill to the vehicle's final resting place. Tracks are visible where a brush truck backed up hill to lay down wet line to stop westward spread of fire. Loose rocks on the outcropping are visible at the lower left corner of photo.**

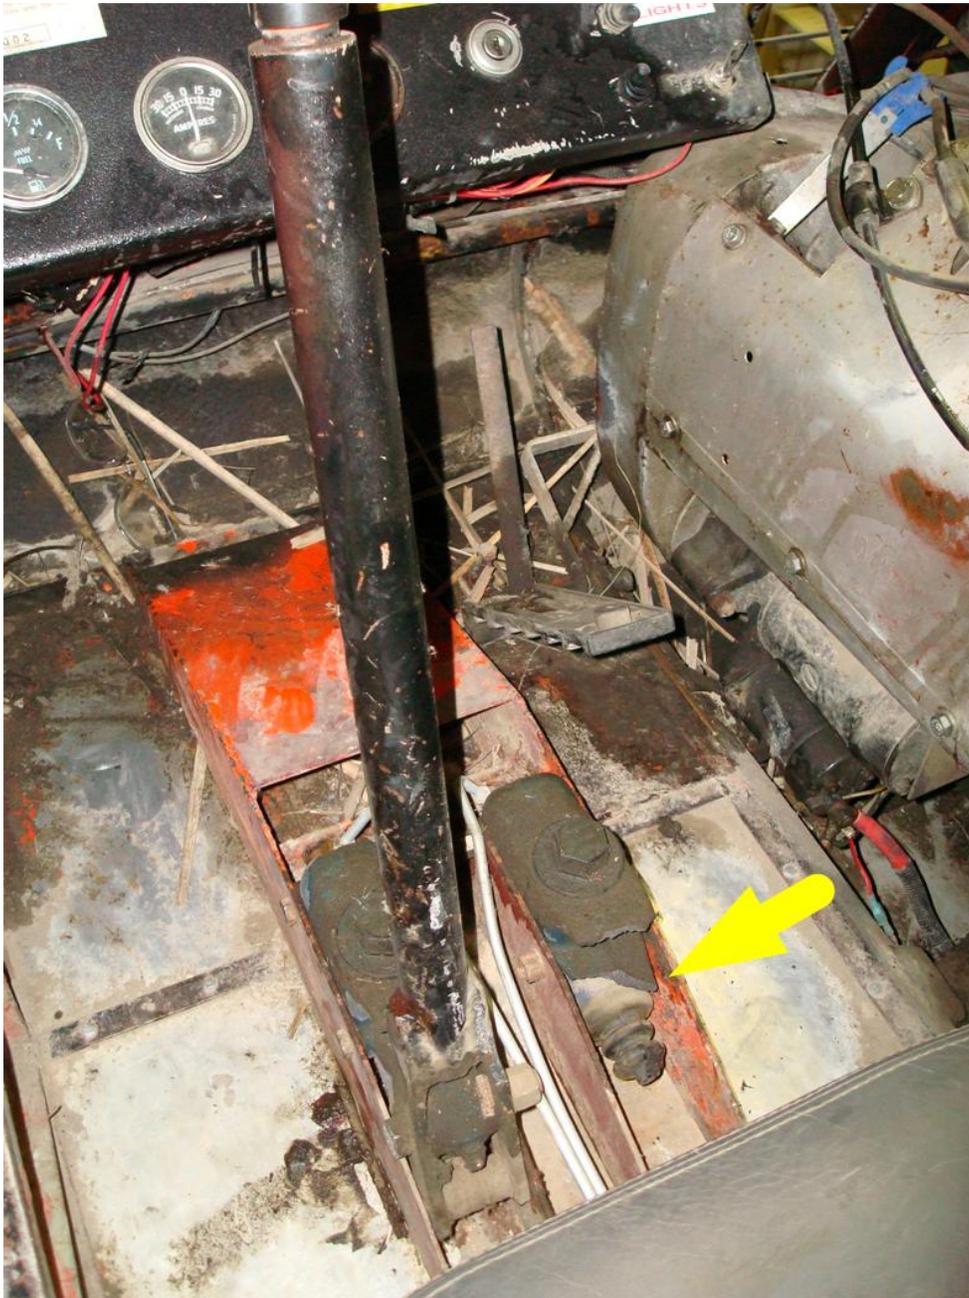
During the vehicle examination, it was noted that the right steering lever and the clutch handle were both broken off, probably during the rollover event (see Photo 9 and Photo 10). Other damage included damage to the canopy and to the left track mechanism. The injured fire fighter told NIOSH investigators that it did not appear that there were any mechanical problems with the vehicle prior to the rollover and the victim did not mention any problems prior to the rollover. The injured fire fighter did indicate that verbal communication was difficult due to the sound generated by the vehicle.

**Photo 10. Photo shows that the right steering lever has broken off. The injured fire fighter, who was riding on the vehicle at the time of the rollover, did not notice any mechanical problems prior to the rollover.**

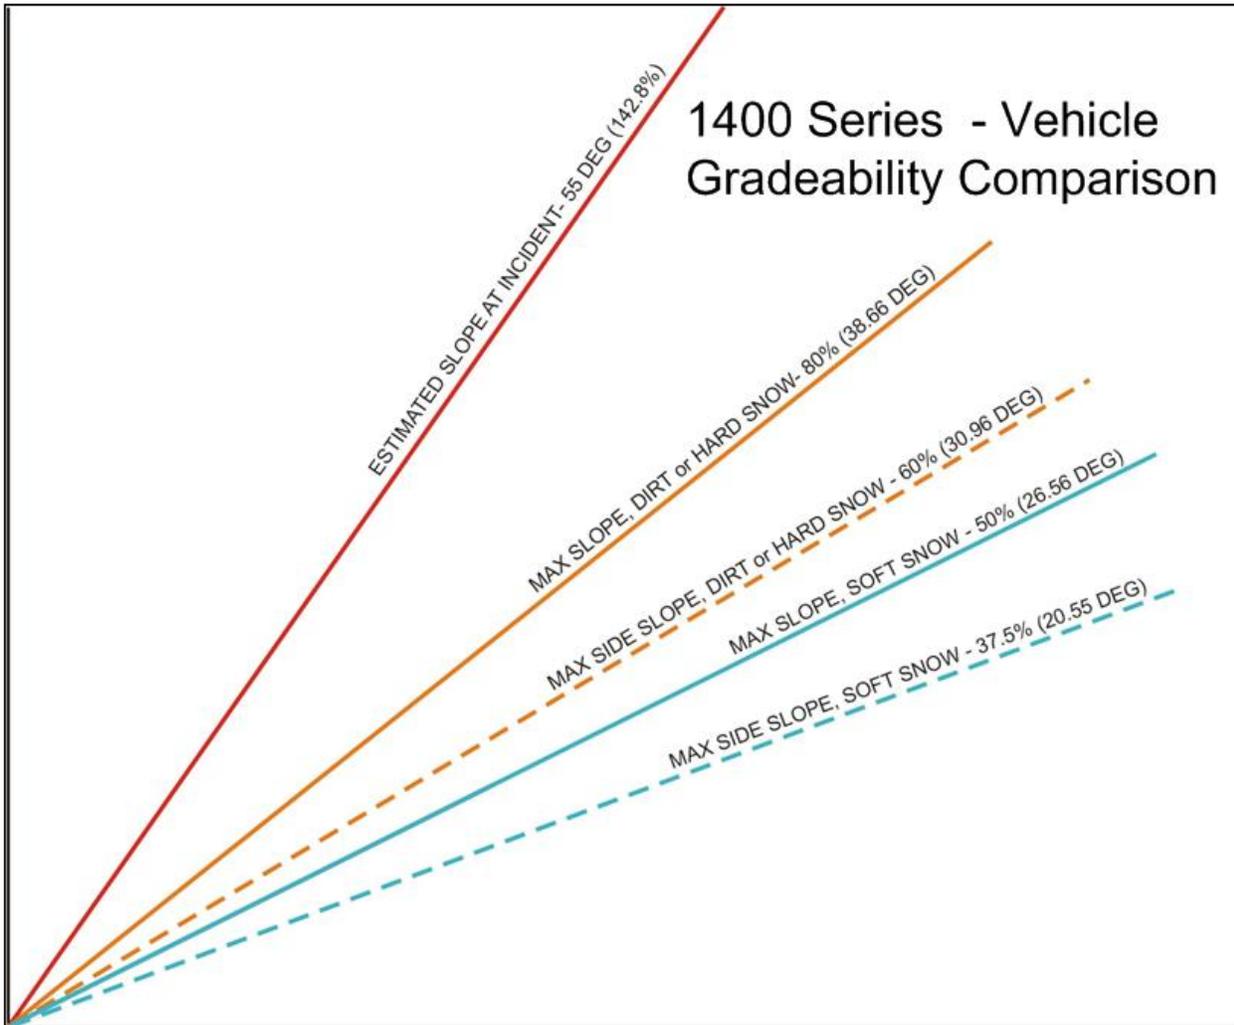
Knowing the capability of your vehicle is a prime consideration for all vehicle operators but is especially important in off-road operation. The hillside slope where the incident occurred was roughly measured at 55 degrees (142.8 percent slope). For comparison, the *NFPA 1906 Standard for Wildland Fire Apparatus* requires fire department vehicles to remain stable on a slope of 30 degrees during a tilt-table test.<sup>3</sup> Most vehicles have significantly less side stability than fore and aft so if there is a problem going straight up the slope, turning sideways only increases the potential for an incident. During off-road operation, if a vehicle reaches a point where it cannot progress straight up an incline, turning sideways on the incline is not an option. Any tracked vehicle using a skid-steering system that loses traction on one track will turn toward the track that is spinning. This results in the potential for the vehicle to change direction without operator interaction. This problem may be compounded in steeper terrain where stability becomes an issue.<sup>f</sup> See Appendix 1 for additional information concerning stability issues on sloped surfaces.

The graph below illustrates the difference between the slopes the vehicle was rated for and the estimated 55 degree slope of the incident site.
