Two Career Fire Fighters Die and 19 Injured in Roof Collapse during Rubbish Fire at an Abandoned Commercial Structure – Illinois

Executive Summary

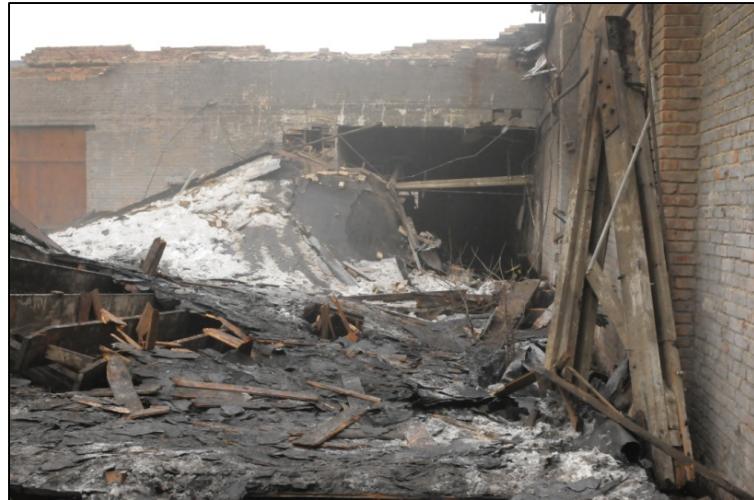
Collapse scene as viewed from building rear facing building front. Note portion of bowstring truss leaning against wall at right side of photo.

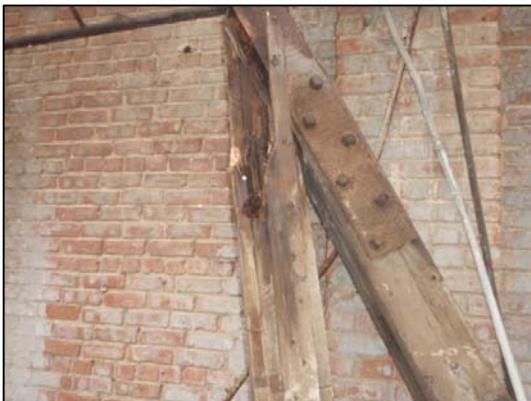
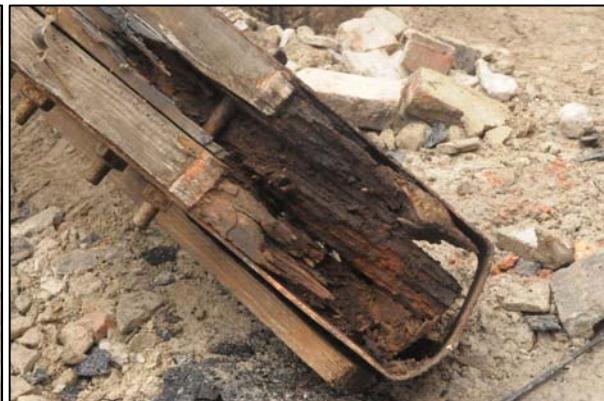
Photos show the deteriorated condition of bowstring roof trusses. Note the truss end in the left photo and the deteriorated condition caused by water damage in right photo.

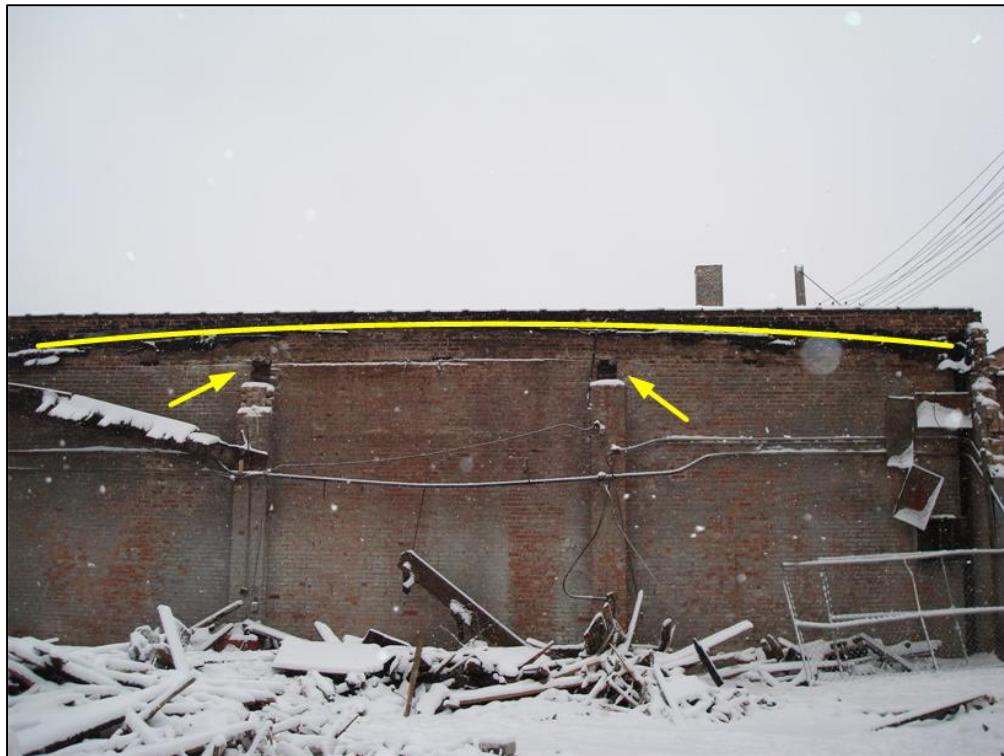
Photo 2. Photo shows the Sector 2 wall that supported western end of the bowstring truss roof. The two arrows indicate the truss-end pockets in the brick masonry wall at the top of the brick pilasters where the ends of the two bowstring trusses rested. The roof was supported in the middle by the two bowstring trusses while the north and south ends were supported by the front and rear non-load bearing walls. The line indicates the approximate curvature of the roof.

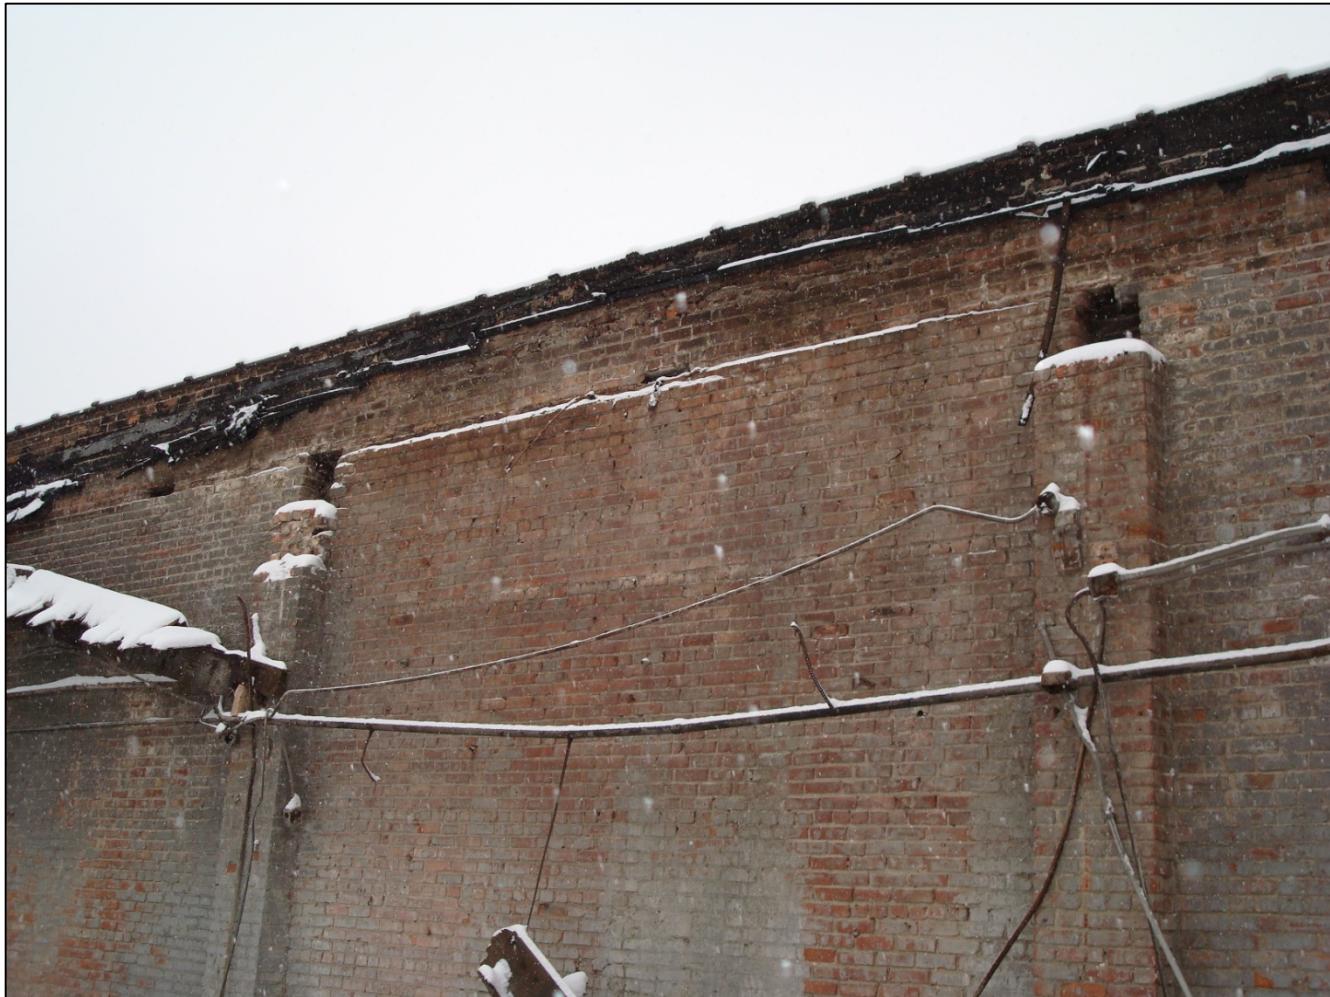
Photo 3. Photo shows the truss support pilasters built into the Sector 2 (west) wall. The Sector 4 (east) load bearing wall also contained support pilasters. The Sector 4 wall partially collapsed during the incident and was demolished after the recovery operations.

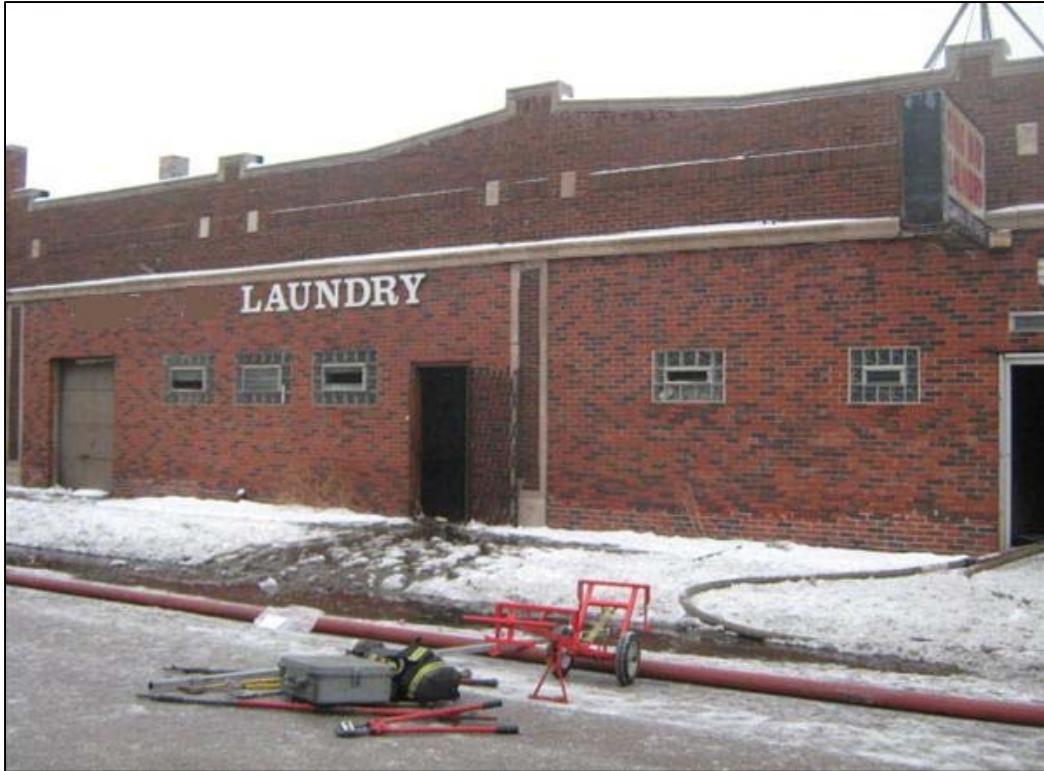
In 2007, the city Department of Buildings (DOB) cited the building owner for the deteriorated condition of the structure and ordered the owner to either repair or demolish the structure. When viewed from the street, the structure appeared to be in good repair (see Photo 5), but the structure was open and unsecured at the alley (Sector 3) and courtyard (Sector 4). An overhead roll-up door that fronted the alley (Sector 3) was missing and access doors to the courtyard had also been removed. The courtyard was overgrown with brush and small trees and had been used as a dumping area for rubbish and construction materials.

Photo 5. Front view of structure as viewed from the street (Sector 1). Buildings along the street appeared to be in good condition from this view. The deteriorated condition of the roof was not visible from street level. Photo taken the day of the incident.

Some of the code violations cited in the 2007 written complaint included: failure to maintain parapet wall in good repair; failure to maintain lintel in good condition; failure to securely fasten loose plate glass in windows; failure to cut or remove weeds, grass and other growth; failure to remove accumulation of refuse and debris; failure to maintain roof in sound condition; failure to remove sewage and stagnant water from basement; failure to maintain exterior walls free from holes, breaks...or other conditions that might admit rain or dampness; and, failure to maintain building in a structurally safe and stable condition.

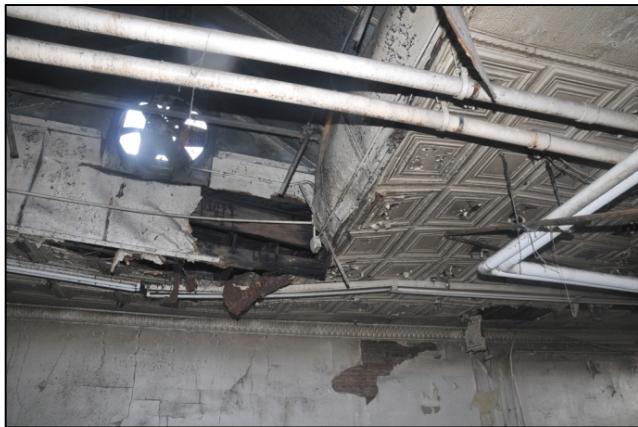
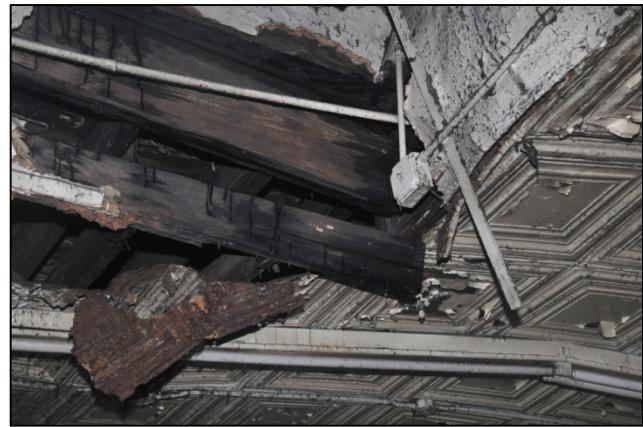
Photo 6 and Photo 7 show some of the deteriorated ceiling conditions observed by fire fighters when they entered the front portion of the structure during the incident. This deterioration appears to have been caused by water penetrating the roof.

Photo 6 and Photo 7. Photo 6 (left) and Photo 7 (right) show the deteriorated ceiling conditions inside the front part of the structure.
(Photos courtesy of fire department)

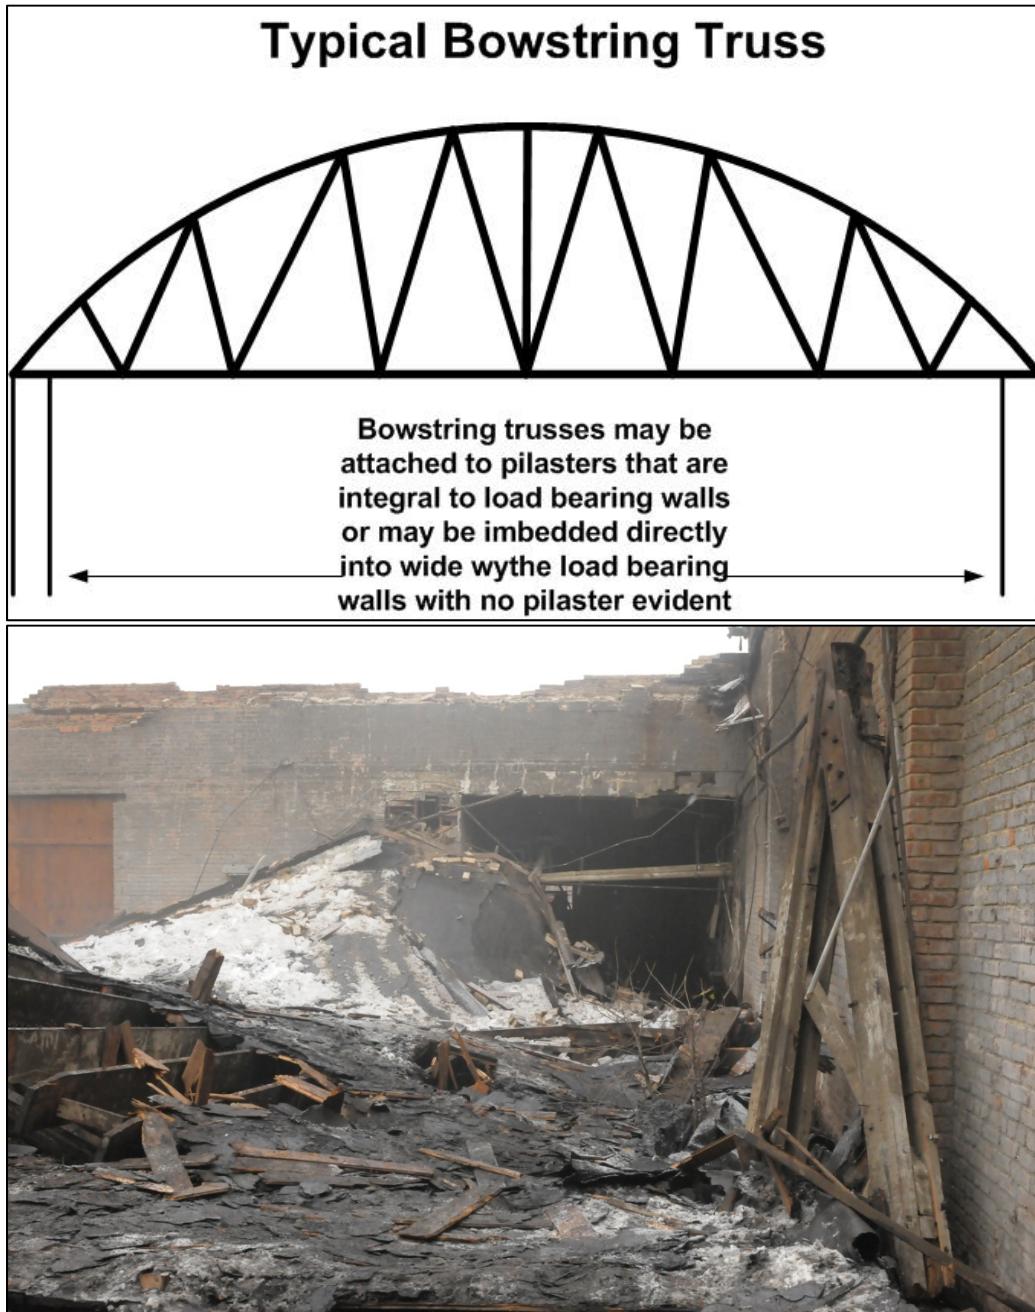
Diagram 2 (top) and Photo 8 (bottom). Diagram 2 shows typical bowstring truss design. Photo 8 shows portion of bowstring truss leaning against support pilaster built into Sector 2 wall at right.

The foreground in Photo 8 is the area where Victim # 2 was recovered.

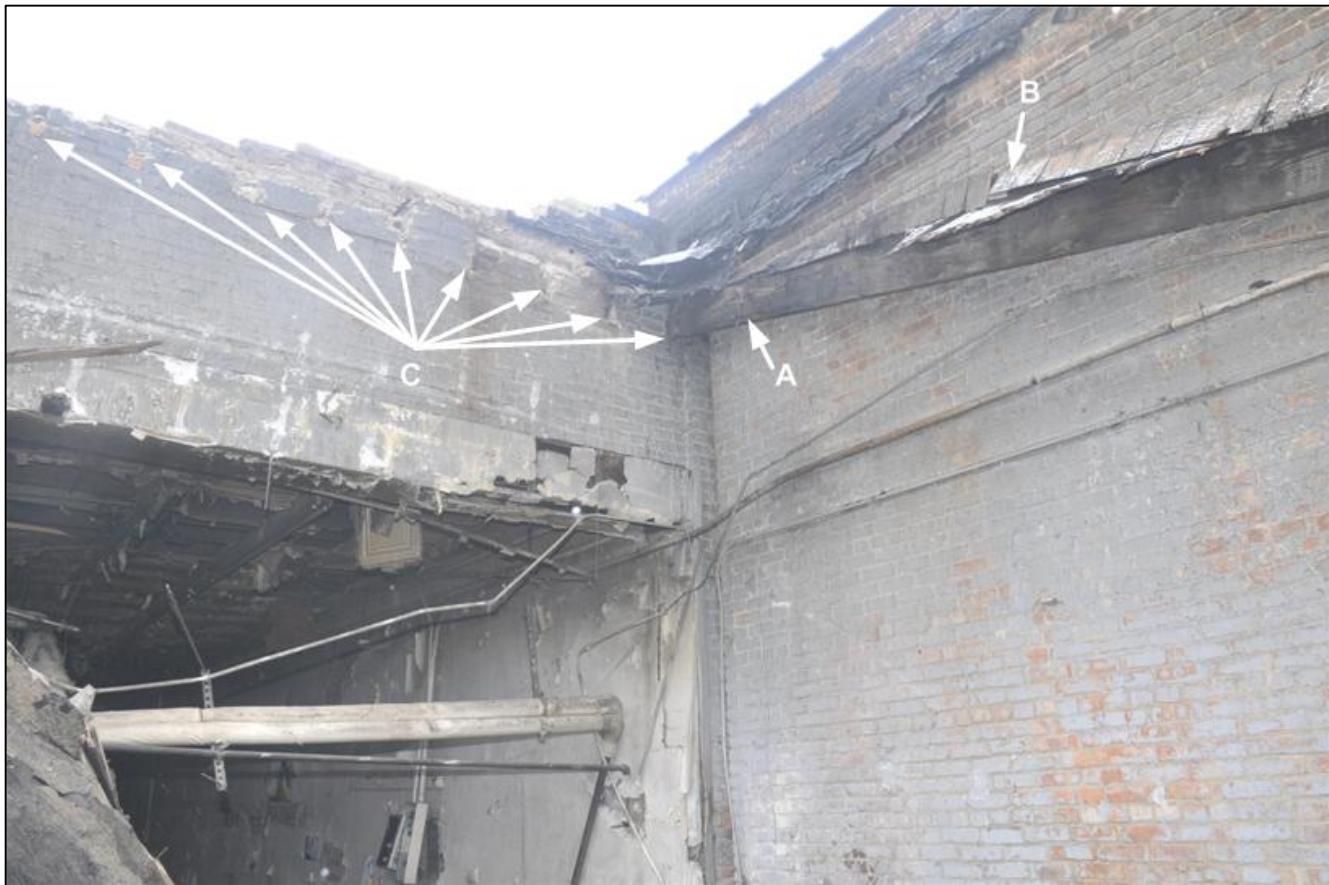
Photo 9. Photo shows connection of the front and rear portions of the structure as viewed from Sector 3 facing Sector 1 (same view as Photo 8). Note the roof purlin still attached to the Sector 1 wall (A) and the remains of tongue and groove roof deck boards attached to the top of the purlin(B). Also note how the end of the remaining purlin sets into a recessed pocket in the brick masonry wall and the locations where other roof purlins pulled away from wall (C). Vertical marks on the wall above the opening indicate where the roof purlins contacted the wall as the roof collapsed.

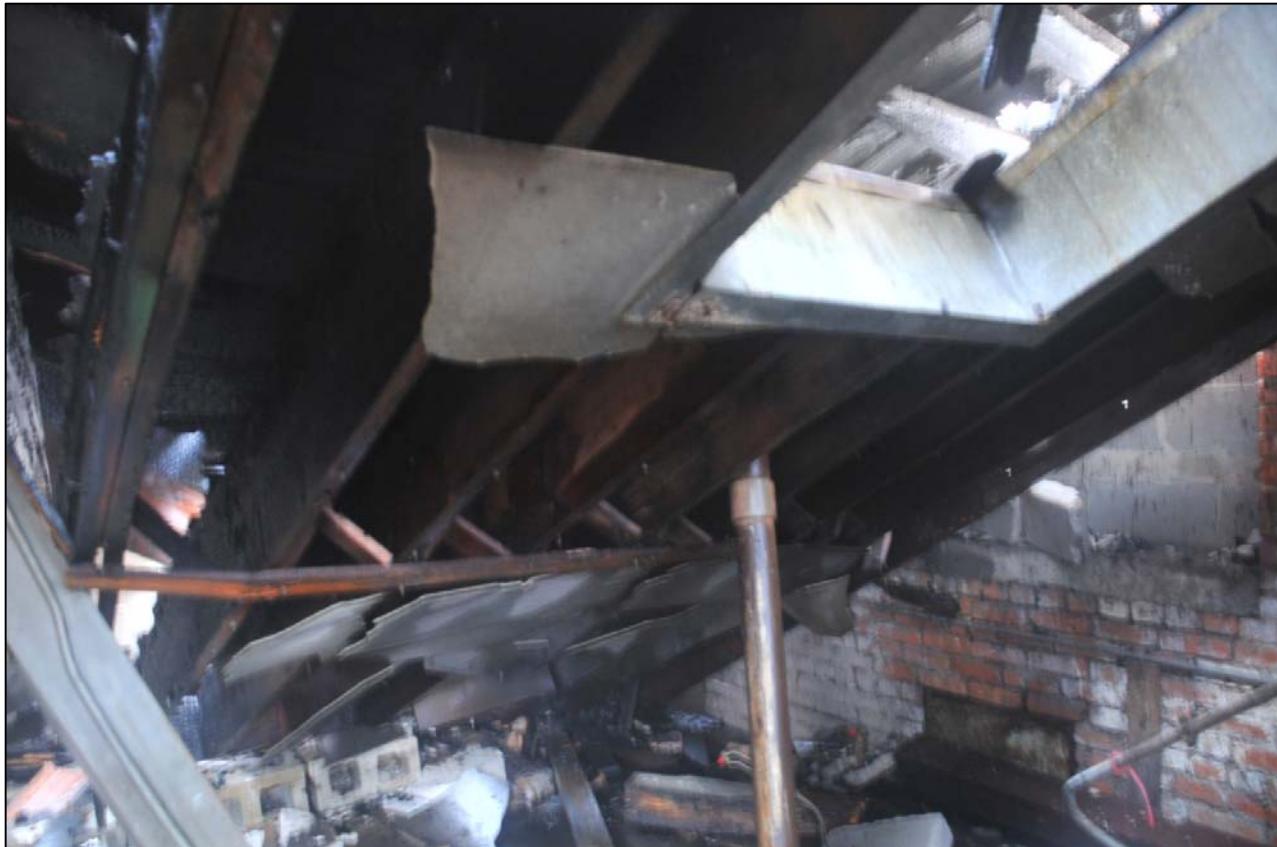
Photo 10. Photo shows the scuttle hole in the roof where the E-126 lieutenant looked into truss void for fire extension. Note condition of roof rafters indicates little fire damage in this area.
(Photo courtesy of fire department)

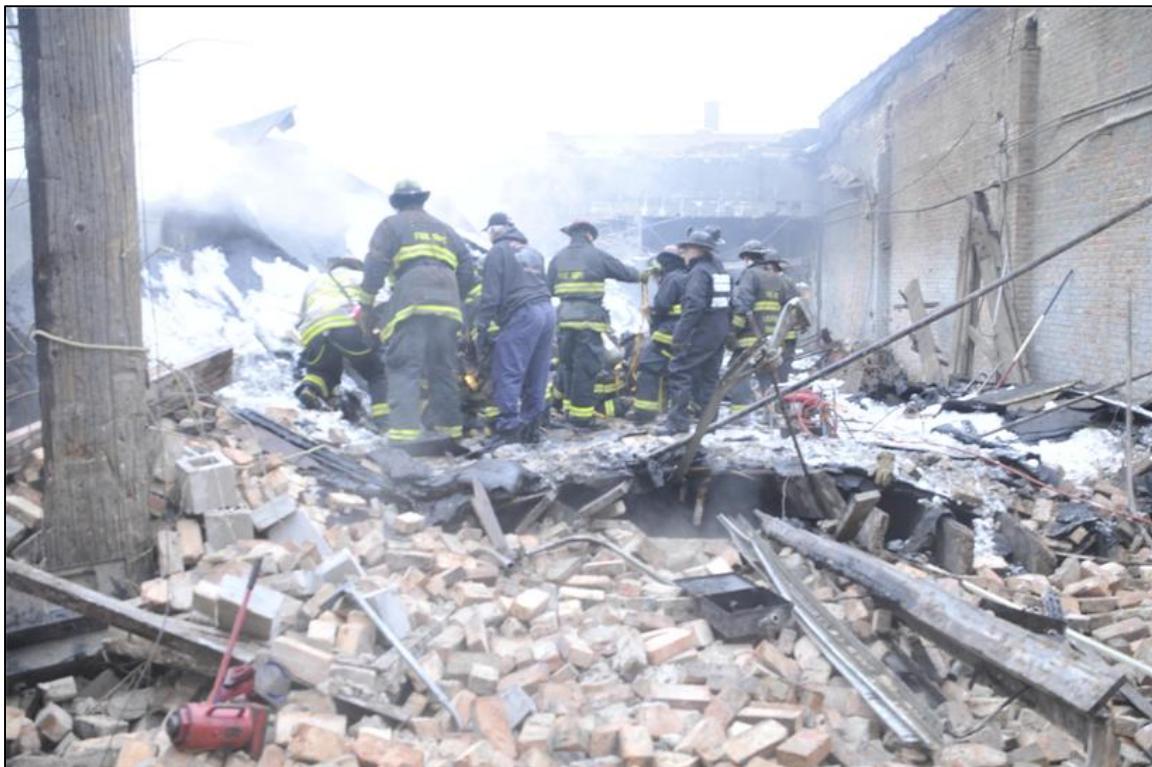
Photo 11. Crews work to free fire fighters from Engine 72, Truck 49 and Truck 16 trapped under collapse.

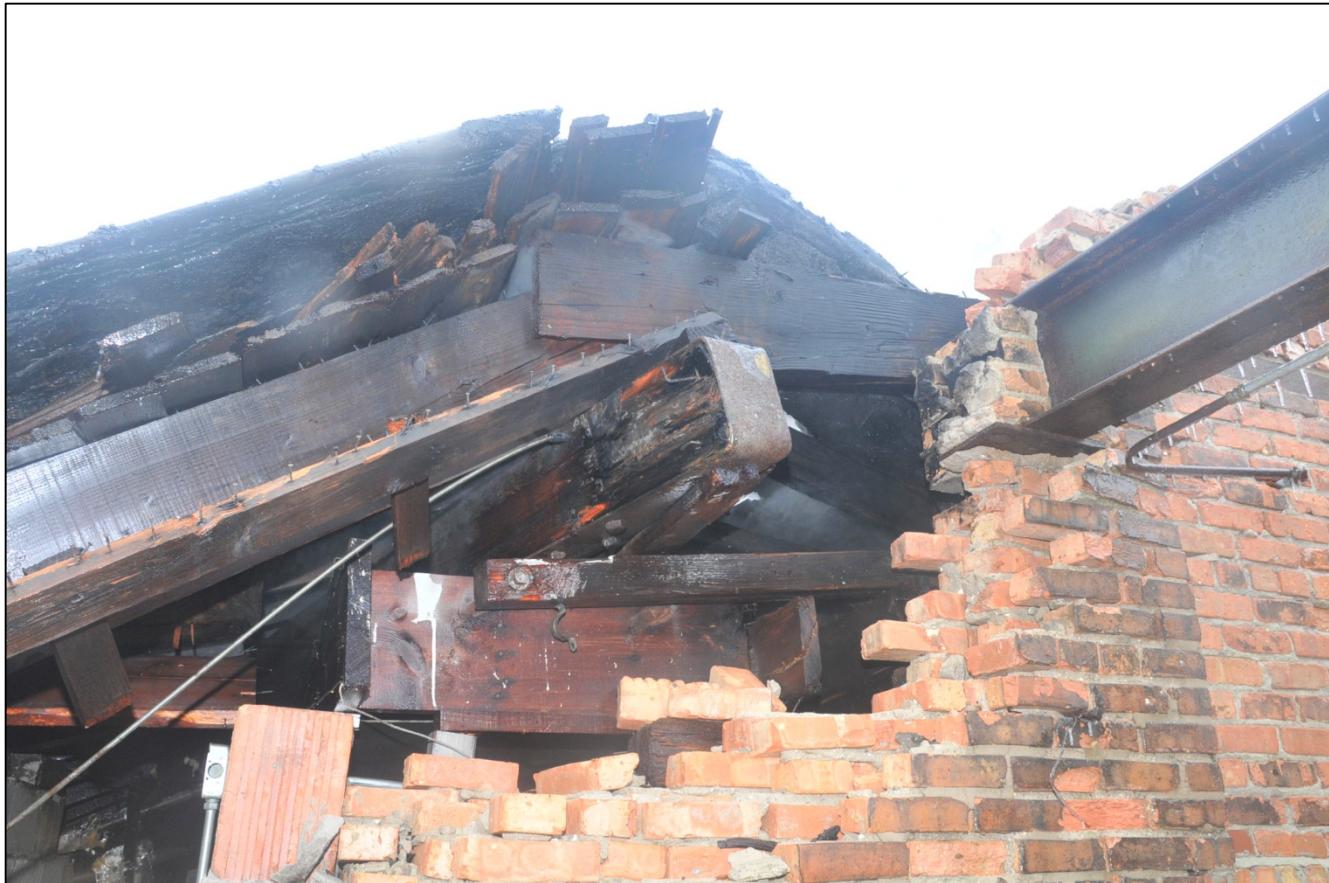
Photo 12. One end of heavy timber roof truss can be seen in center of photo. The truss has rolled over onto its side with the end penetrating through the Sector 4 wall. Photo was taken from the court yard on the Sector 4 side (facing west).
