Career Lieutenant Dies from Injuries Received after Vehicle Undergoing Maintenance Crushes Him – Massachusetts

Executive Summary

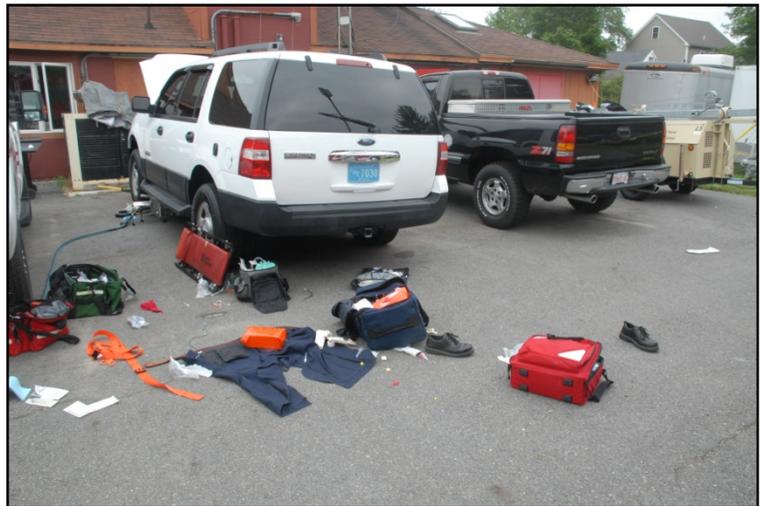
View of incident scene after the victim was removed.

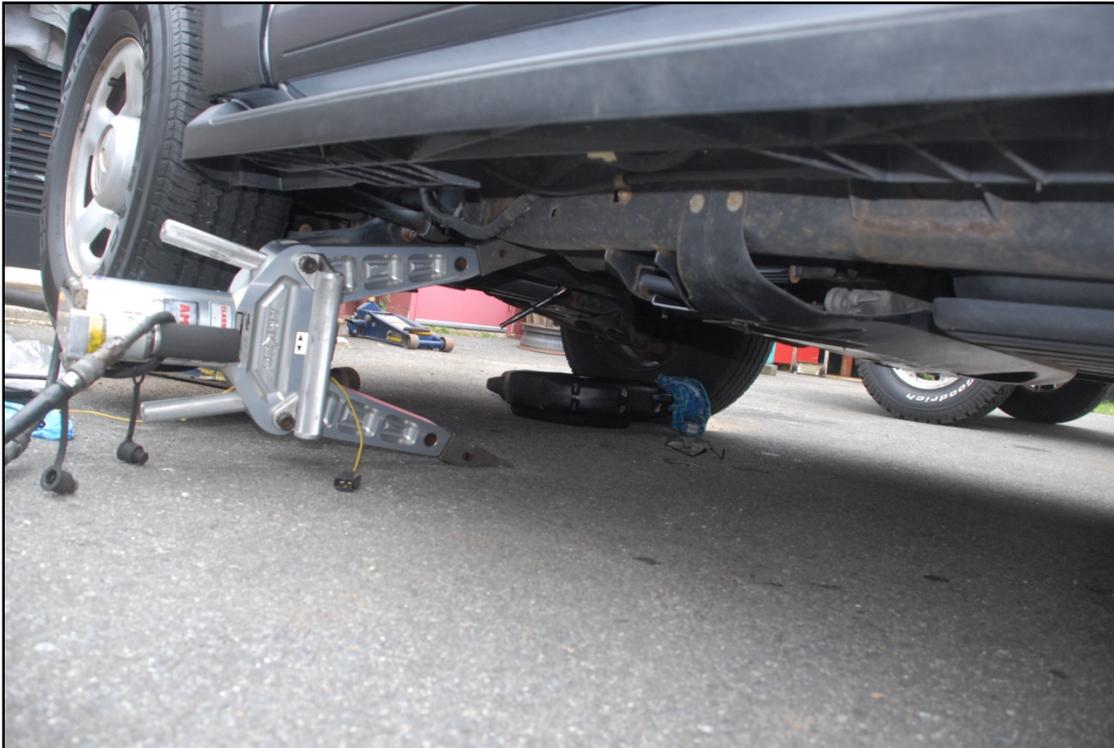
Spreaders were used to lift vehicle off the victim.
(Photo courtesy of police department.)

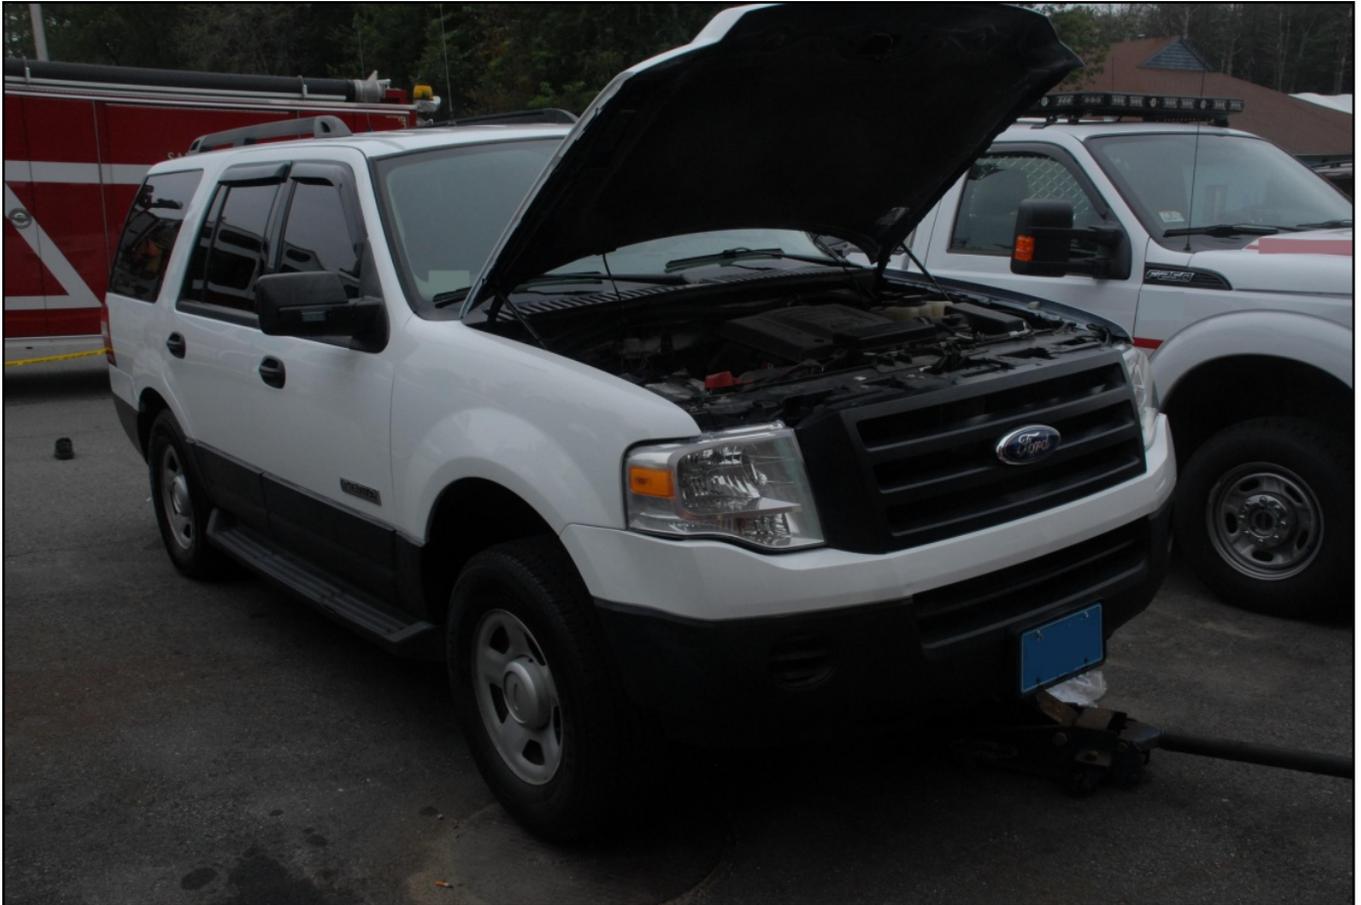
Photo 1. Vehicle involved in incident.
(Photo courtesy of police department.)

The recommended tire size for this vehicle was P265/70R17 and was observed on the vehicle at the time of the incident. The fire department recently took possession of the vehicle and had not yet placed it in service when the incident occurred. No fire/EMS equipment or emergency lighting equipment had been placed on the vehicle.

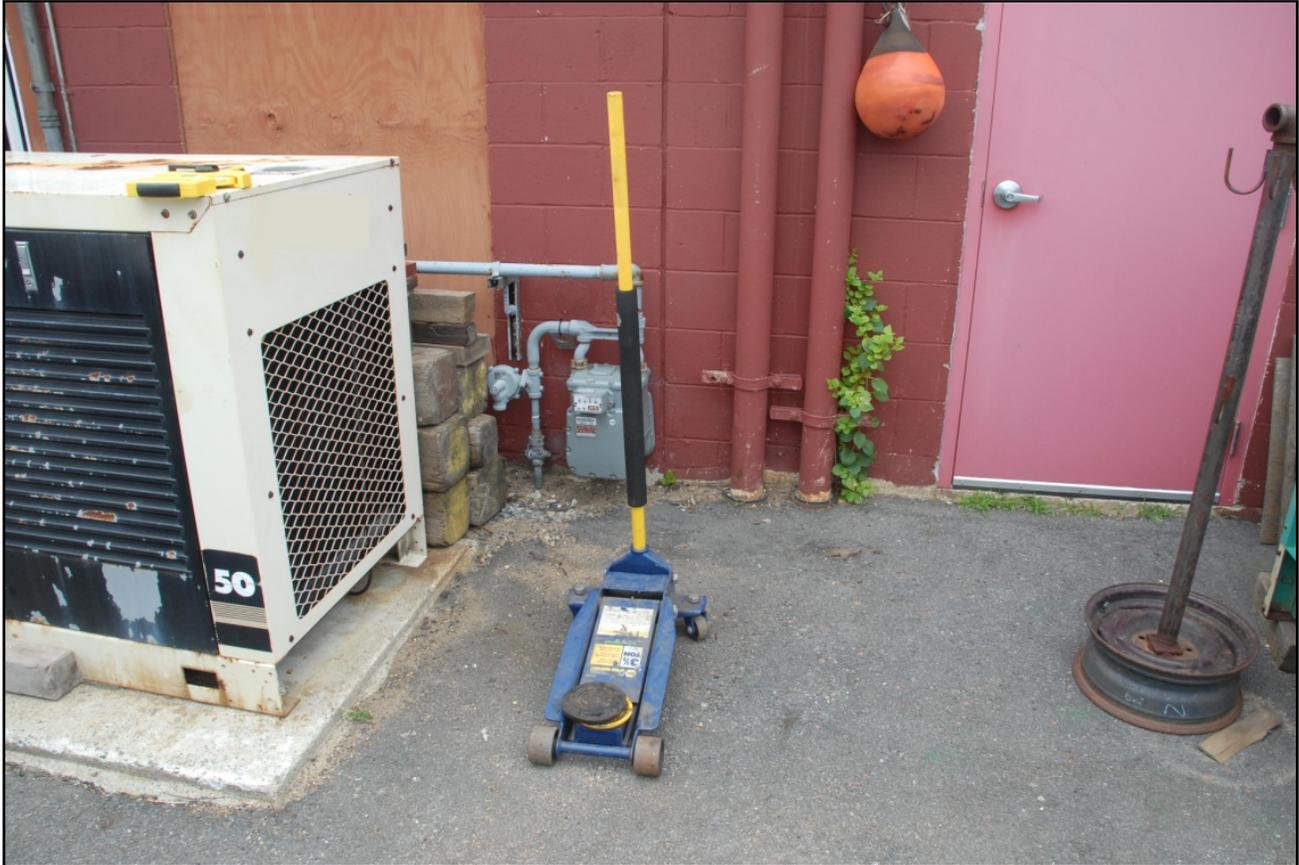
A hydraulic, portable floor jack, believed to have been purchased in 2008, used during this incident was a 3½-ton (7,000-pounds) capacity floor jack measuring approximately 5 inches by 11 inches by 26 inches (see Photo 2). The jack had rotating 2½-inch metal casters located at the handle end of the jack and stationary 3-inch metal wheels located at the lifting arm end of the jack. A manual pump arm handle would move a small-diameter piston, which pushed and pressurized the hydraulic fluid into a larger-diameter piston, which then pushed against a lever, lifting the main lift arm (or saddle). *Note: The handle needed to be turned clockwise to lock the arm (close the relief valve) in place and counterclockwise to unlock the arm (open the relief valve).* The pump arm handle measured approximately 48 inches long, which provided more leverage and lift per stroke. The jack was

Photo 2. Portable floor jack used during the incident.
(Photo courtesy of police department.)

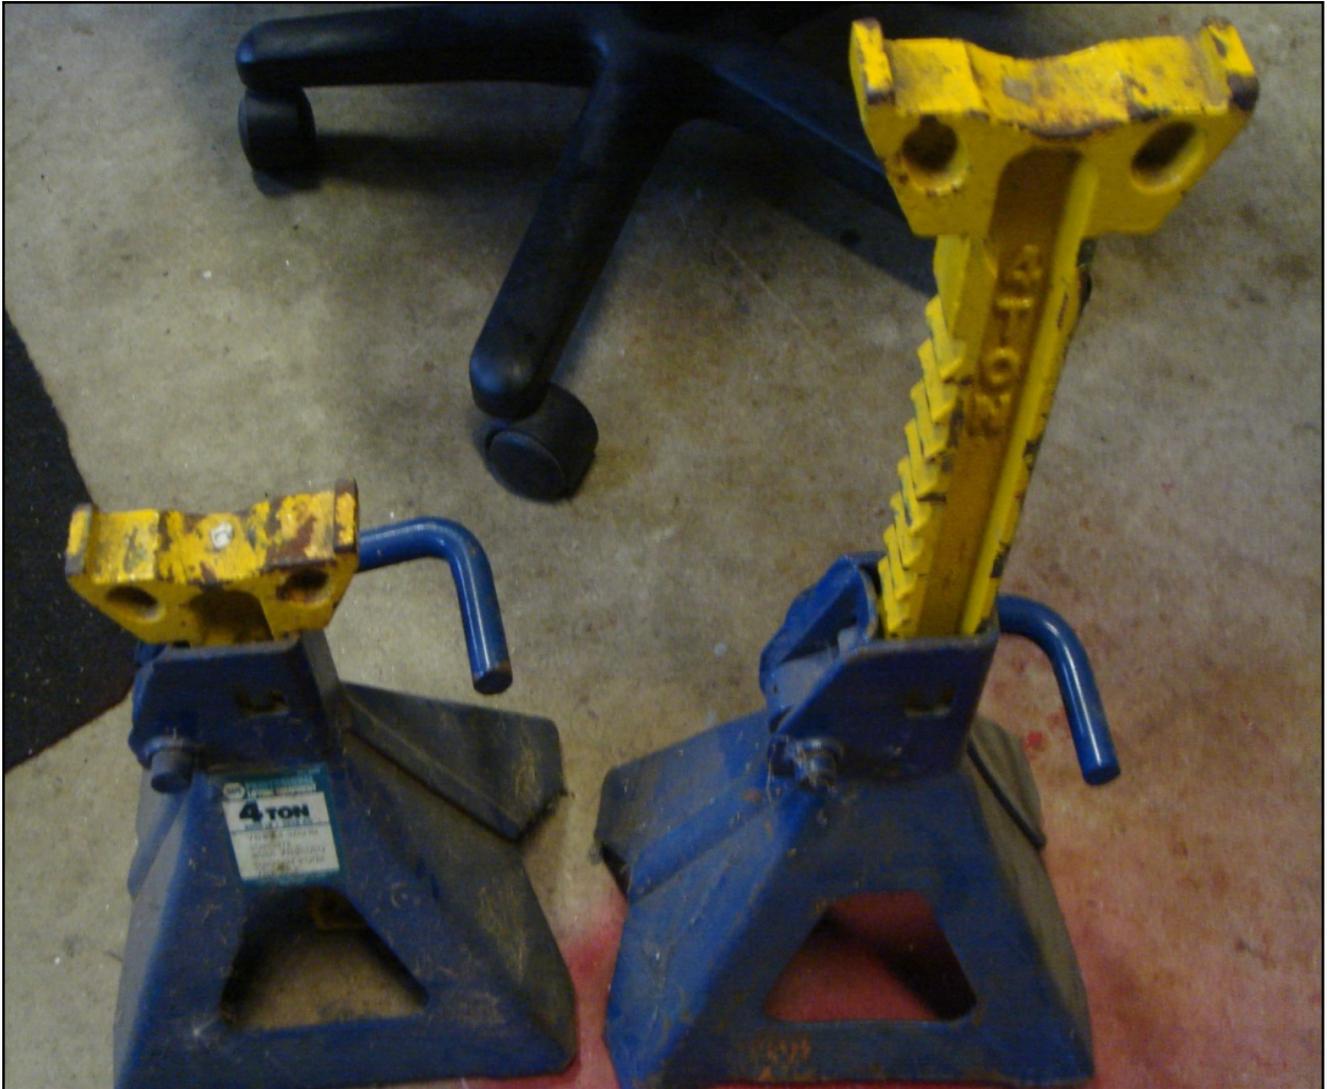
Two jack stands, rated for 4 tons (8,000 pounds) each, were available within the maintenance room, but not used the day of the incident (see Photo 3). The base of the jack stands measured 6¾ inches by 9 inches and the retractable support measured 4 inches by 2½ inches, with a maximum elevated height of 19 inches. The jack stands were observed to be in good repair and operated correctly when raised.

Photo 3. Jack stand.
(NIOSH photo.)

Recommendation #1: Fire departments should ensure that vehicles are adequately supported while personnel are performing maintenance underneath and that vehicles are protected against inadvertent movement.

During this incident, the victim was crushed under the vehicle after it lowered on top of him. The fire department had jack stands available but they were not used by the victim. Prior to beginning any type of work under a vehicle, individuals should always verify that the vehicle is properly supported and stabilized.

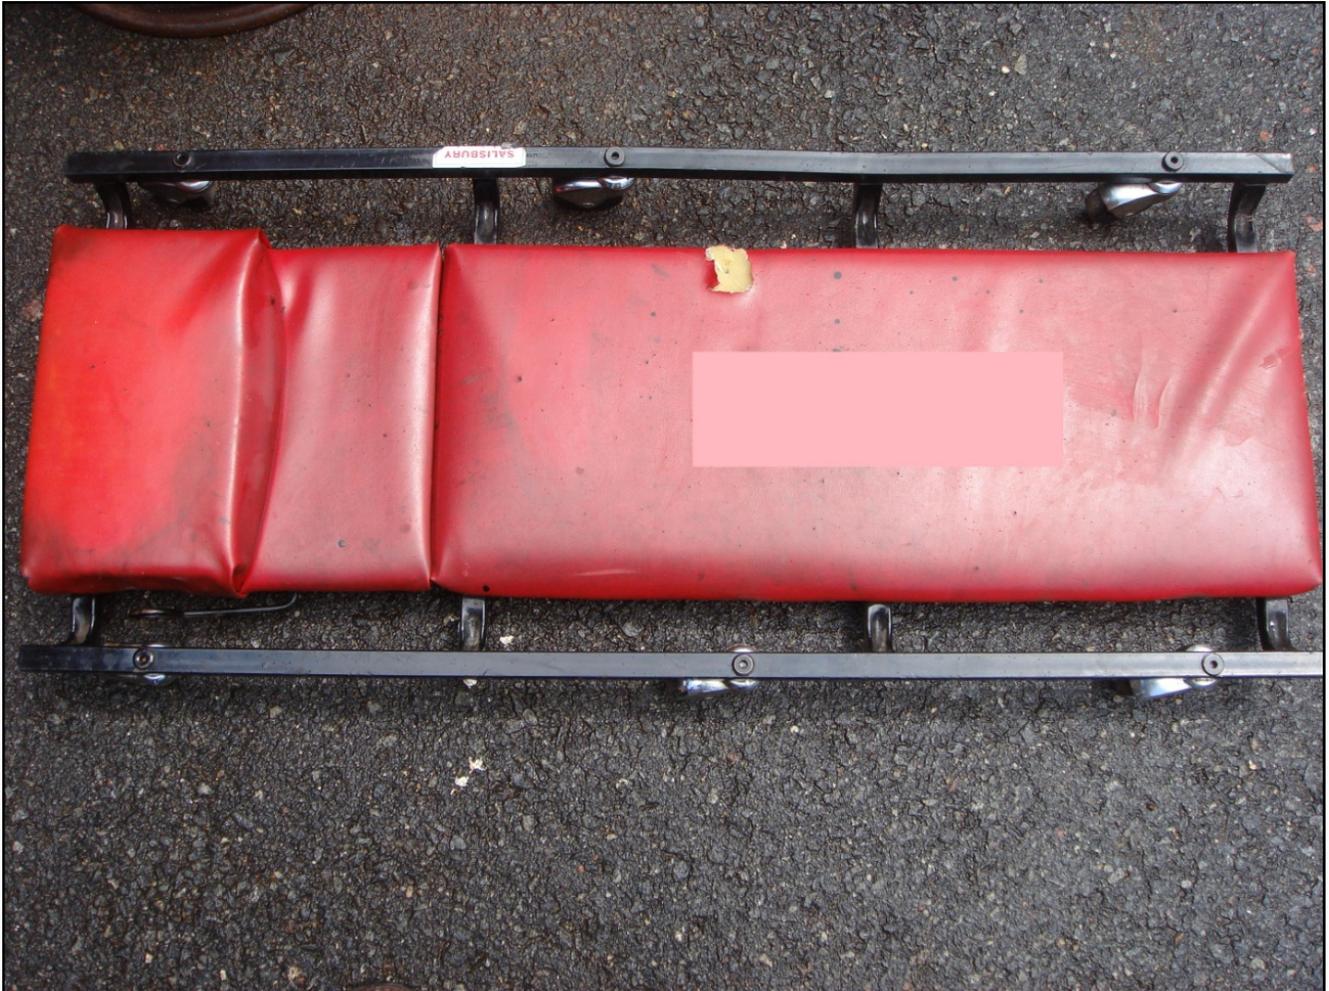
A creeper was used by the victim to work under the vehicle when the vehicle was raised. The creeper (positioned on casters) measured approximately 39 inches by 16¾ inches by 3½ inches (see Photo 4). The vehicle had an overall ground clearance of approximately 8½ inches, but only 5 inches of clearance were noted when the creeper (without anyone on it) was staged in the area of where the victim was found (see Photo 5).

**Photo 4. Creeper used by victim during the incident.
(NIOSH photo.)**

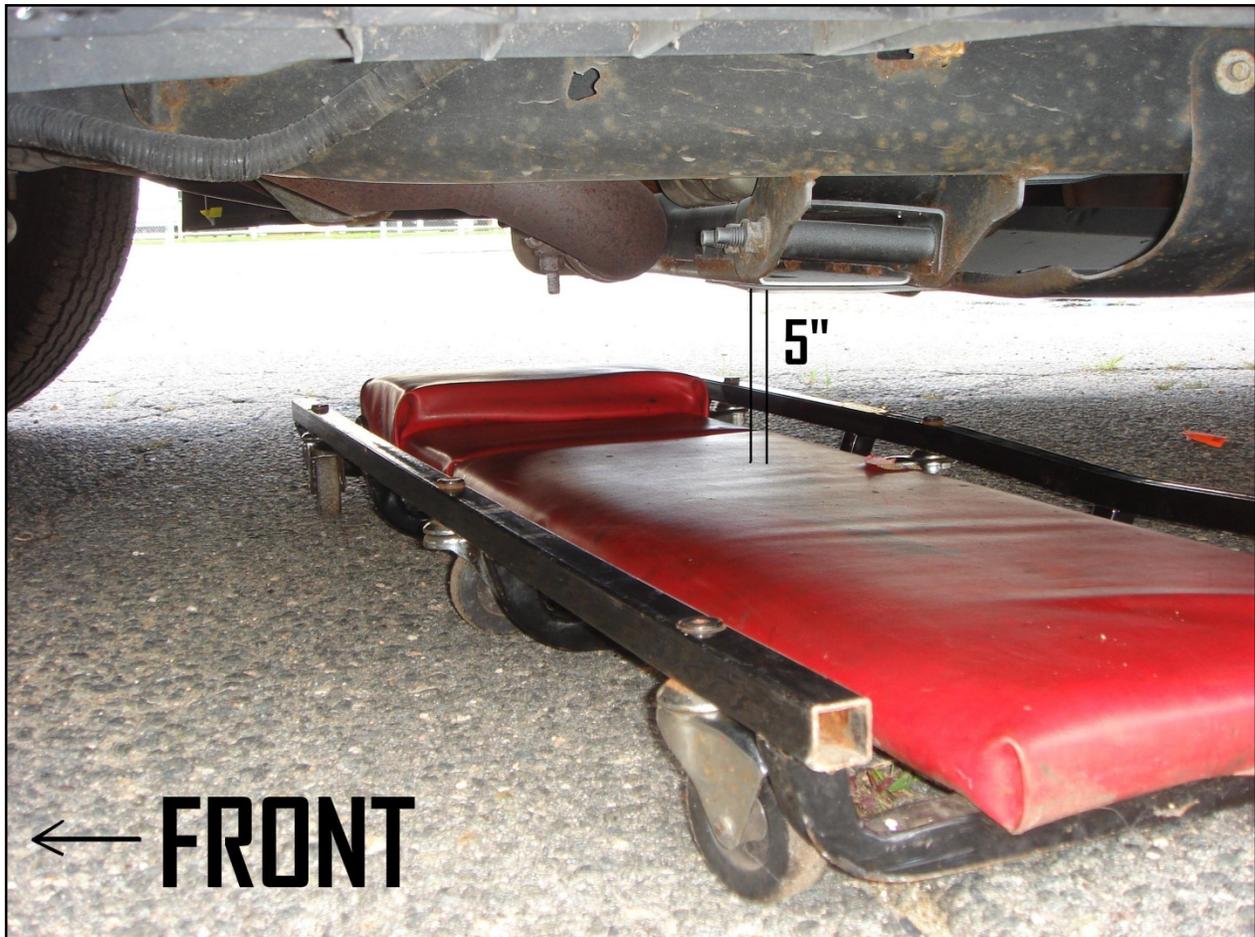
Photo 5. Picture taken from the driver's side, shows the suspected position of the creeper when the victim was discovered. Clearance between the creeper and undercarriage of the vehicle was limited (see black lines above). (NIOSH photo.)

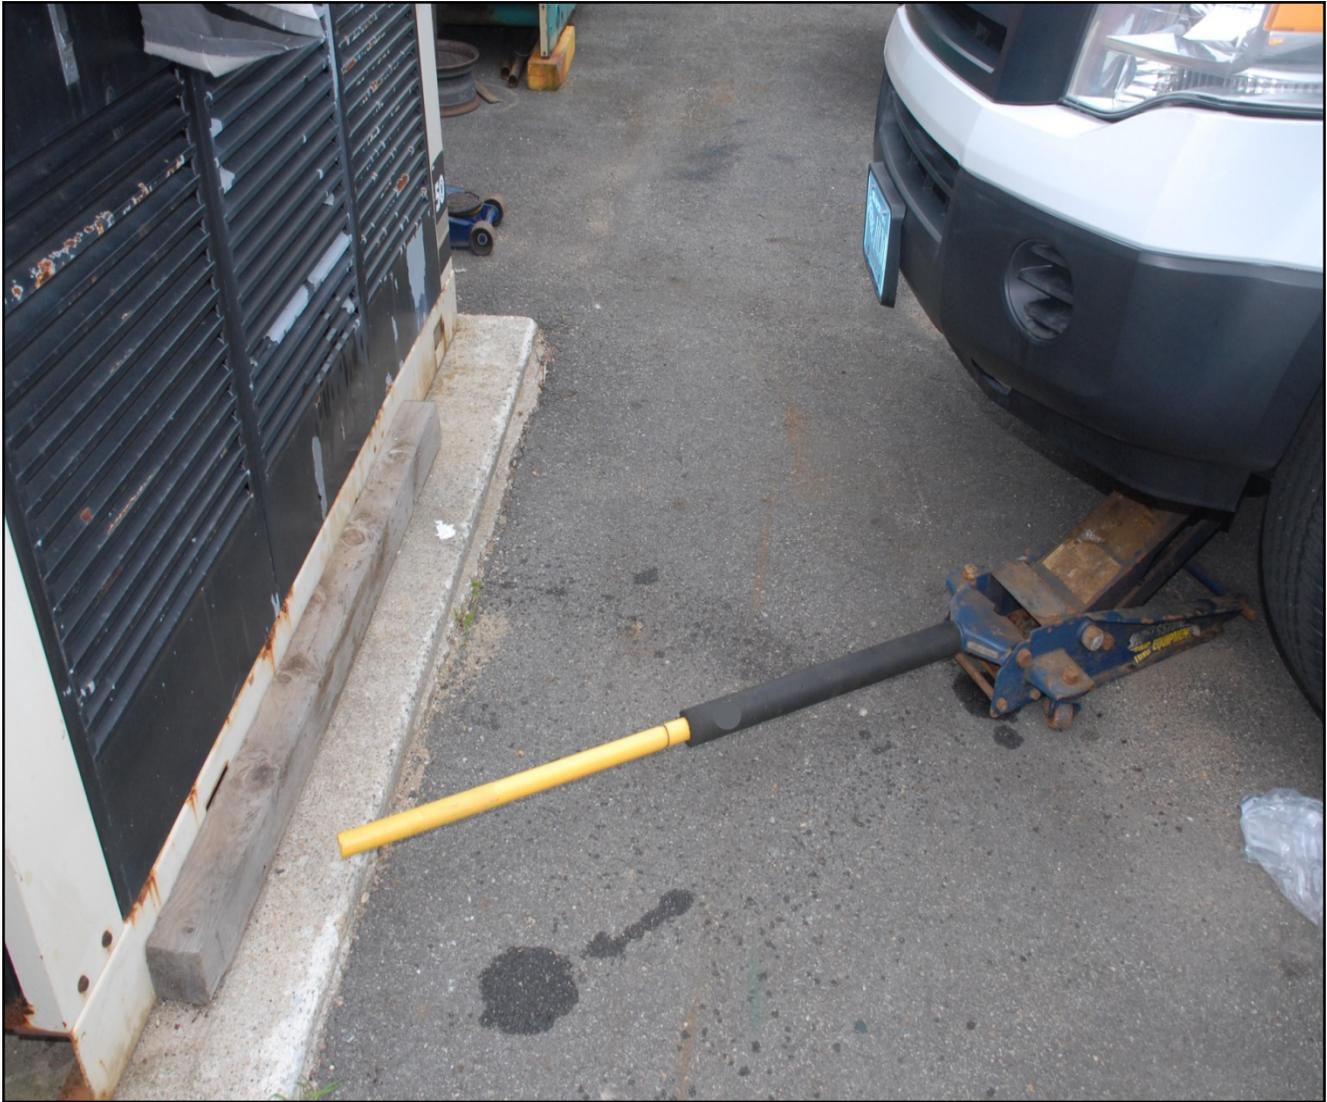
when for an unknown reason, the jack lost pressure spraying hydraulic fluid over the pavement and lowering the jack to the ground (see Photo 6 and photo 7).

Photo 6. Jack positioned at front of vehicle in an attempt to raise the vehicle off the victim. *Note: The jack in the picture is not the jack that was used during the incident but is the same exact model and size of jack and was used to recreate the scene.*
(Photo courtesy of police department.)

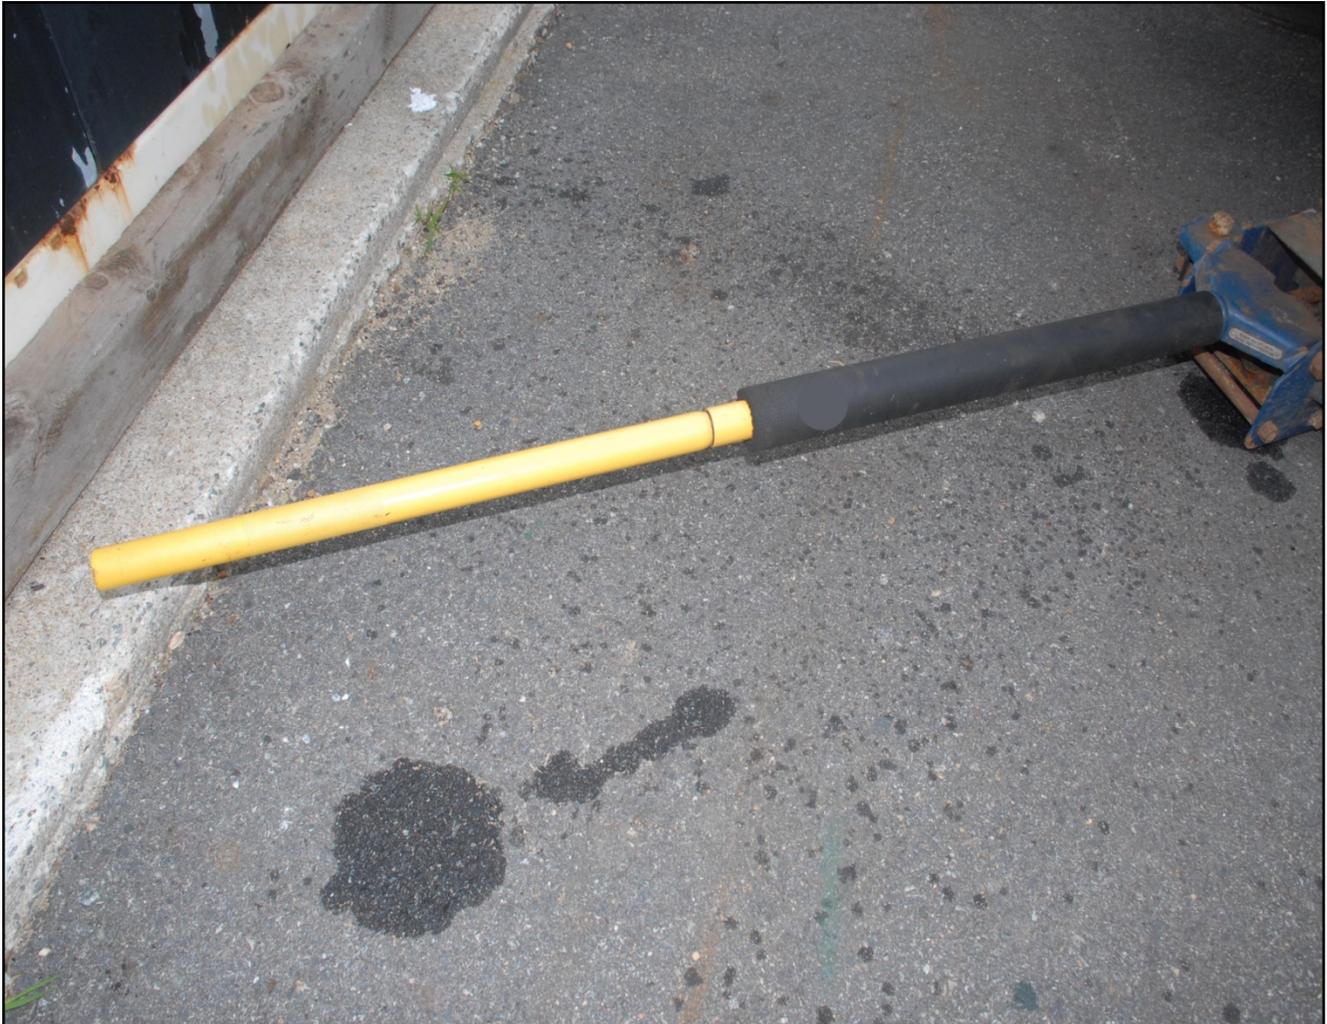
Photo 7. Close-up of wet, darkened areas on pavement showing the spray pattern of the hydraulic fluid when released under pressure from the jack assembly. *Note: The jack in the picture is not the jack that was used during the incident, but is the same exact model and size of jack and was used to recreate the scene.*
(Photo courtesy of police department.)

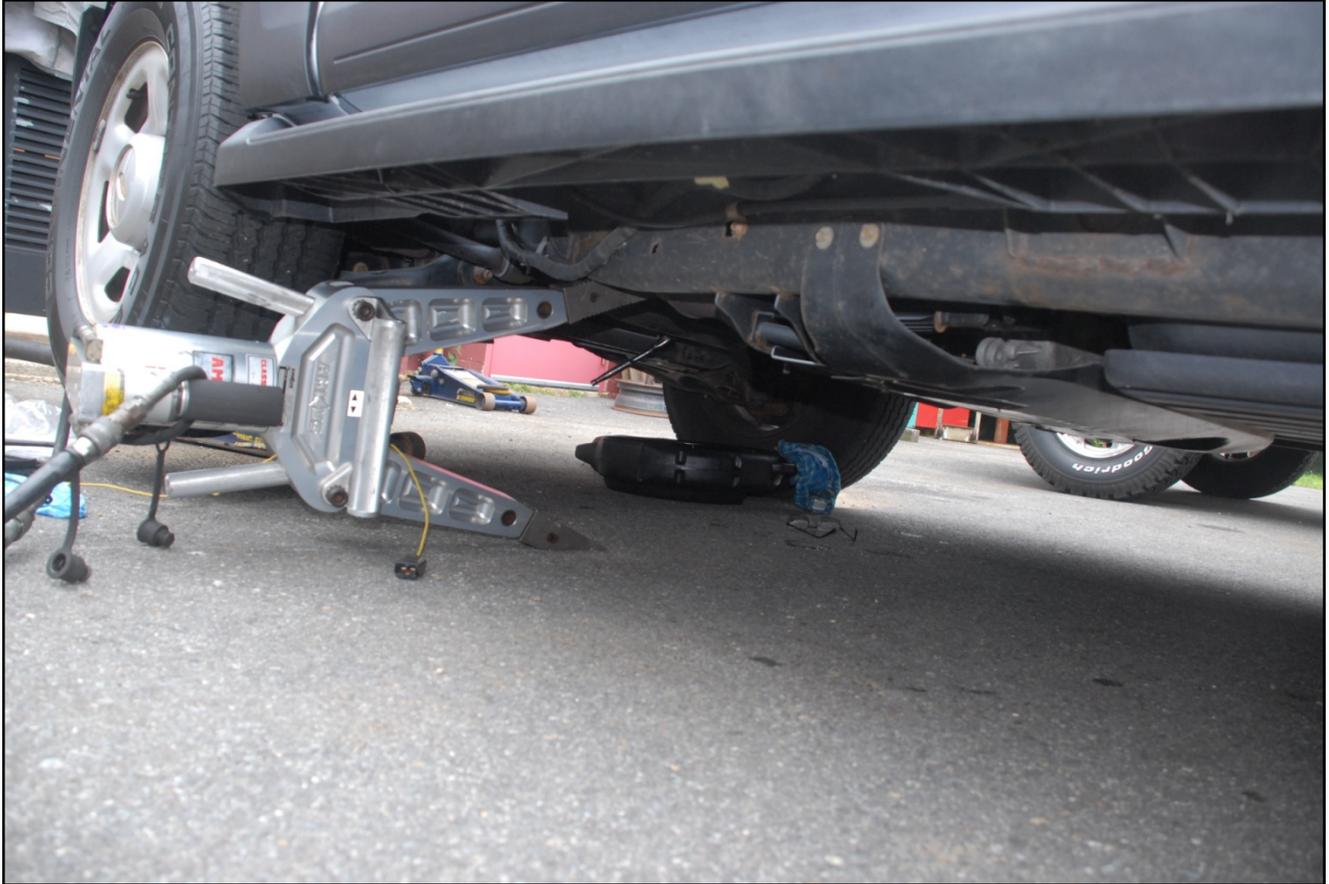
Photo 8. Spreaders raised the vehicle off the victim and enabled the fire fighters to safely remove the victim.

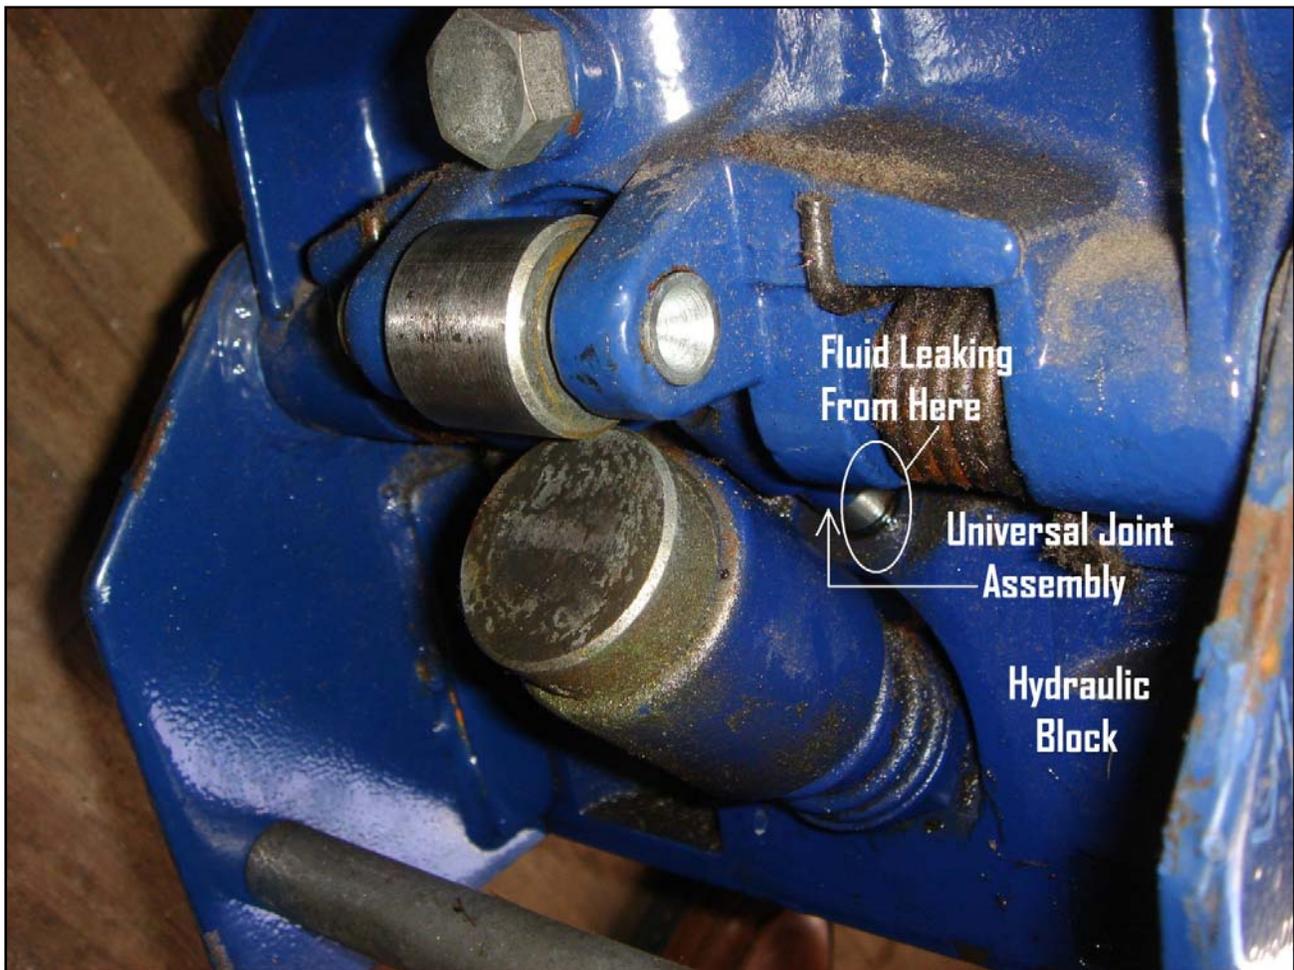
The NIOSH investigator traveled to the local police department's evidence lock-up to inspect the jack. The jack exhibited evidence of repetitive use but visually appeared in good condition. The jack was also easily maneuverable. The pump arm handle was resting at a 90-degree angle (not locked) and appeared to manually operate freely. The pump arm handle could be rotated clockwise and counterclockwise and manually pumped up and down without resistance, however, the pump arm handle would not lock in position when rotated clockwise and the lift arm never rose. The NIOSH investigator noticed that there was a small amount of fluid dripping on the floor while actuating the pump arm handle. Upon a closer examination, the NIOSH investigator noticed fluid bubbling out and around where the universal joint assembly is attached to the thread lock valve in the hydraulic block

(part of power assembly) (see Photo 9). The universal joint assembly, which is connected at the base of the pump arm handle, is a joint that allows the pump arm handle to move in most directions through a rotary type motion. It has a threaded end that threads into the hydraulic block, which is the lock valve for the jack. The hydraulic block holds the hydraulic fluid, so when the power unit pump is moved, by way of the pump arm, the jack will go up. The threaded lock valve, when turned clockwise, locks the fluid in the piston area of the jack, forcing the jack to go up and lift the vehicle. The hydraulic fluid is retained in the power unit assembly (the device that holds and pressurizes the hydraulic fluid) through a means of seals, o-rings, gaskets, and bearings. If any of these things were to wear overtime, then hydraulic fluid could leak out of the system, potentially through any cracks, loose areas, seals, o-rings, or thread(s). Following NIOSH's initial on-site visit, the fire department's insurance company took possession of the jack to conduct a further evaluation. *Note: Those findings were not available at the time of this report.*

Photo 9. Photo taken from the underside of the floor jack, showing the location where the fluid was bubbling or leaking.
(NIOSH photo.)

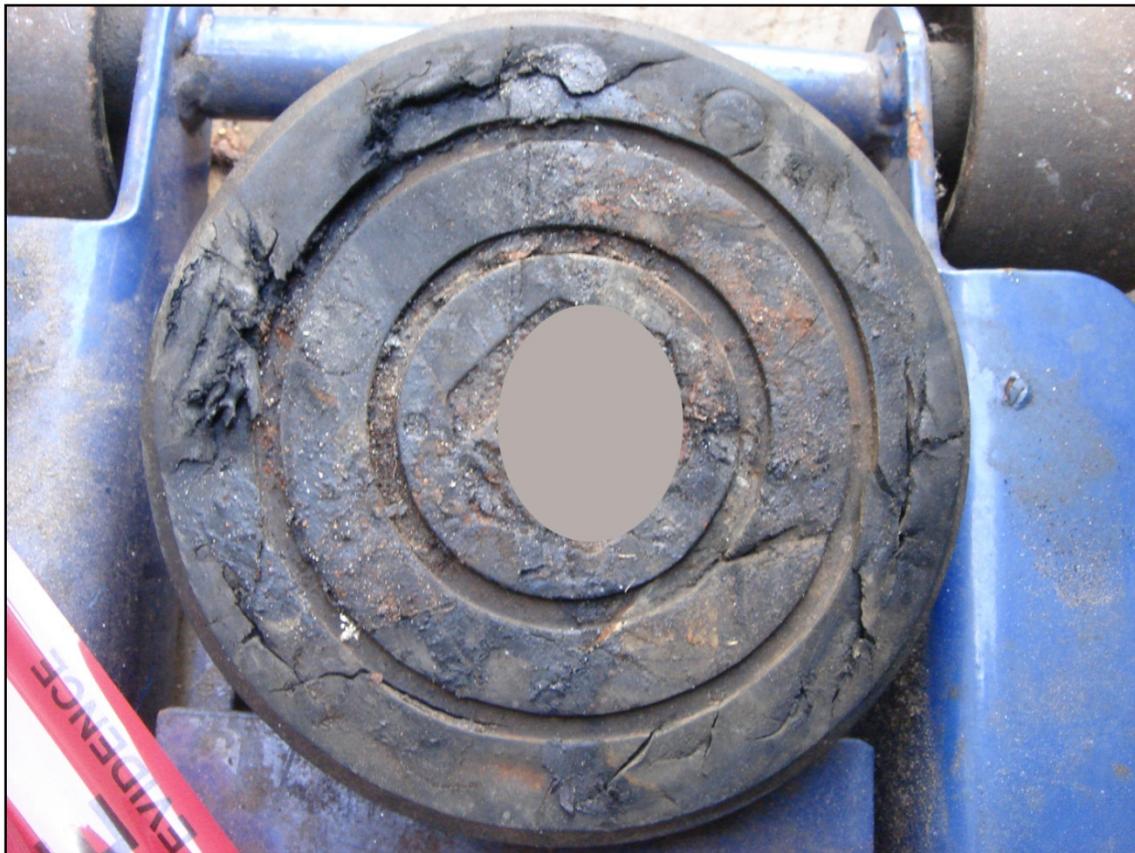
The NIOSH investigator noted that the rubber saddle pad was extremely worn and not secured to the lift arm (see Photo 10 and photo 11). *Note: The saddle pad makes contact with the desired lifting point under the vehicle.* The NIOSH investigator also discovered a circular indentation (that measured the circumference of the saddle) and what appeared to be yellow paint transfer from the jack lift arm's saddle onto the vehicle's lift point, which was believed to have been used by the victim (see Photo 12). *Note: The NIOSH investigator could not determine beyond a reasonable doubt that the paint transfer occurred during this incident.*

Photo 10. Saddle pad on lift arm. *Note: Jack manufacturer identifier is covered up. (NIOSH photo.)*

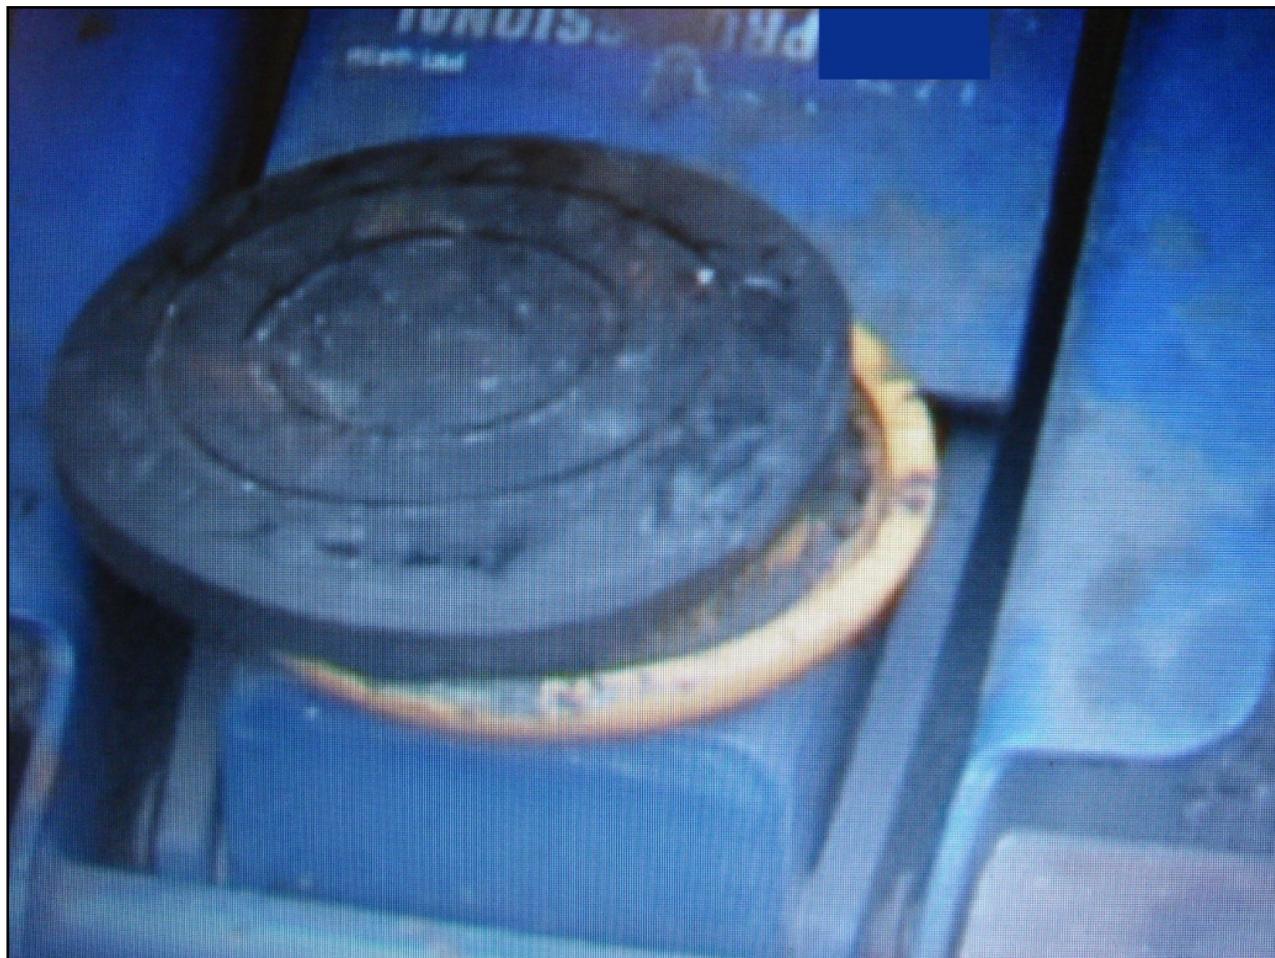
Photo 11. Rubber saddle pad not secured to saddle.
(NIOSH photo.)

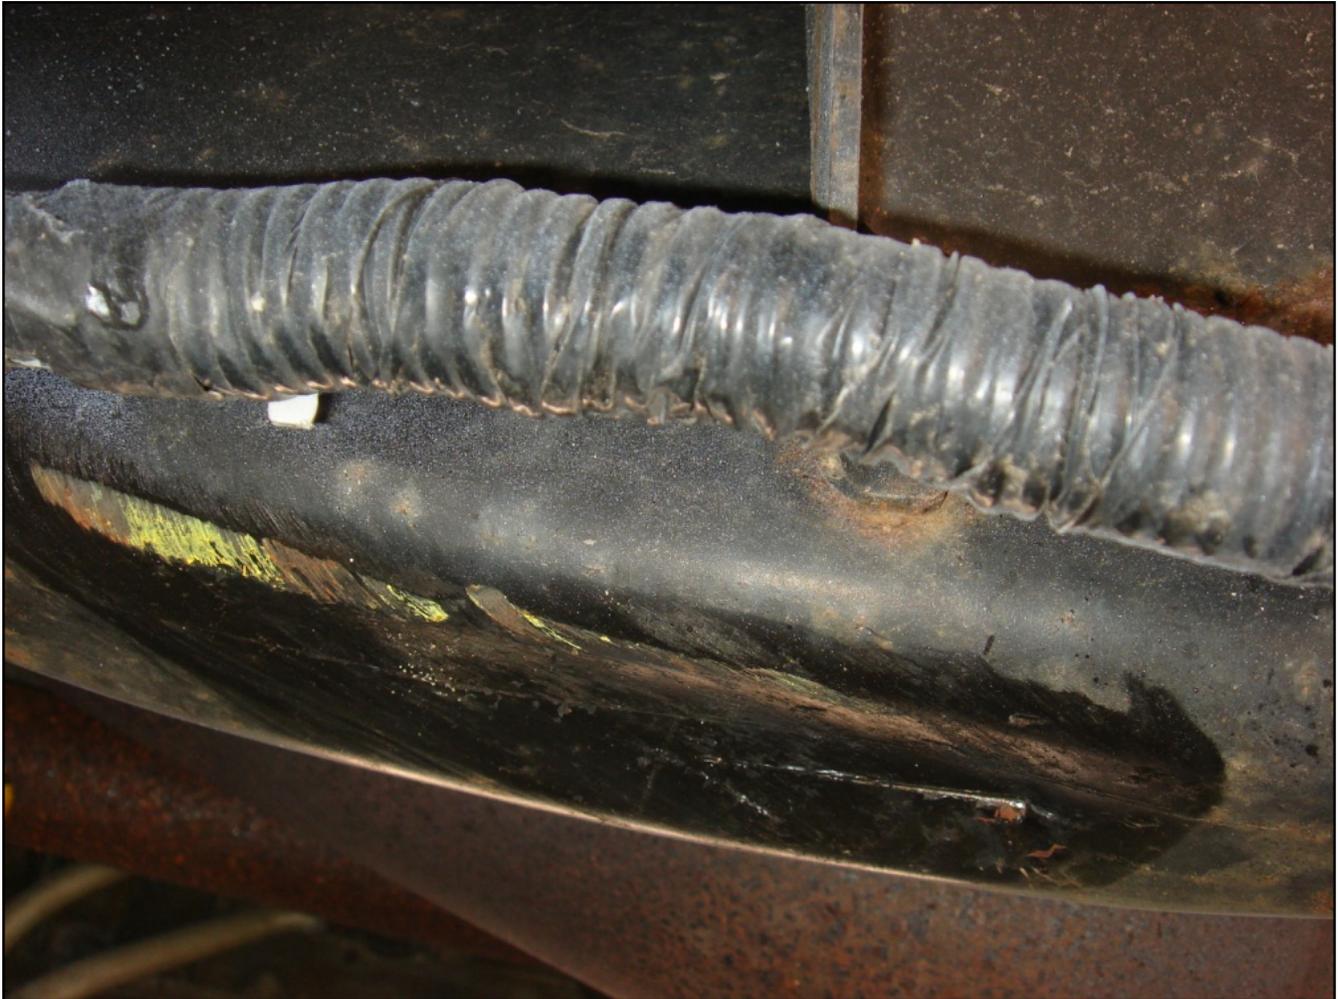
Photo 12. Photo taken from the undercarriage shows indentation and yellow paint transfer believed left by the saddle.
