## **Career Lieutenant Dies After Being Trapped in the Attic After Falling Through a Roof While Conducting Ventilation – Texas**

### **Executive Summary**

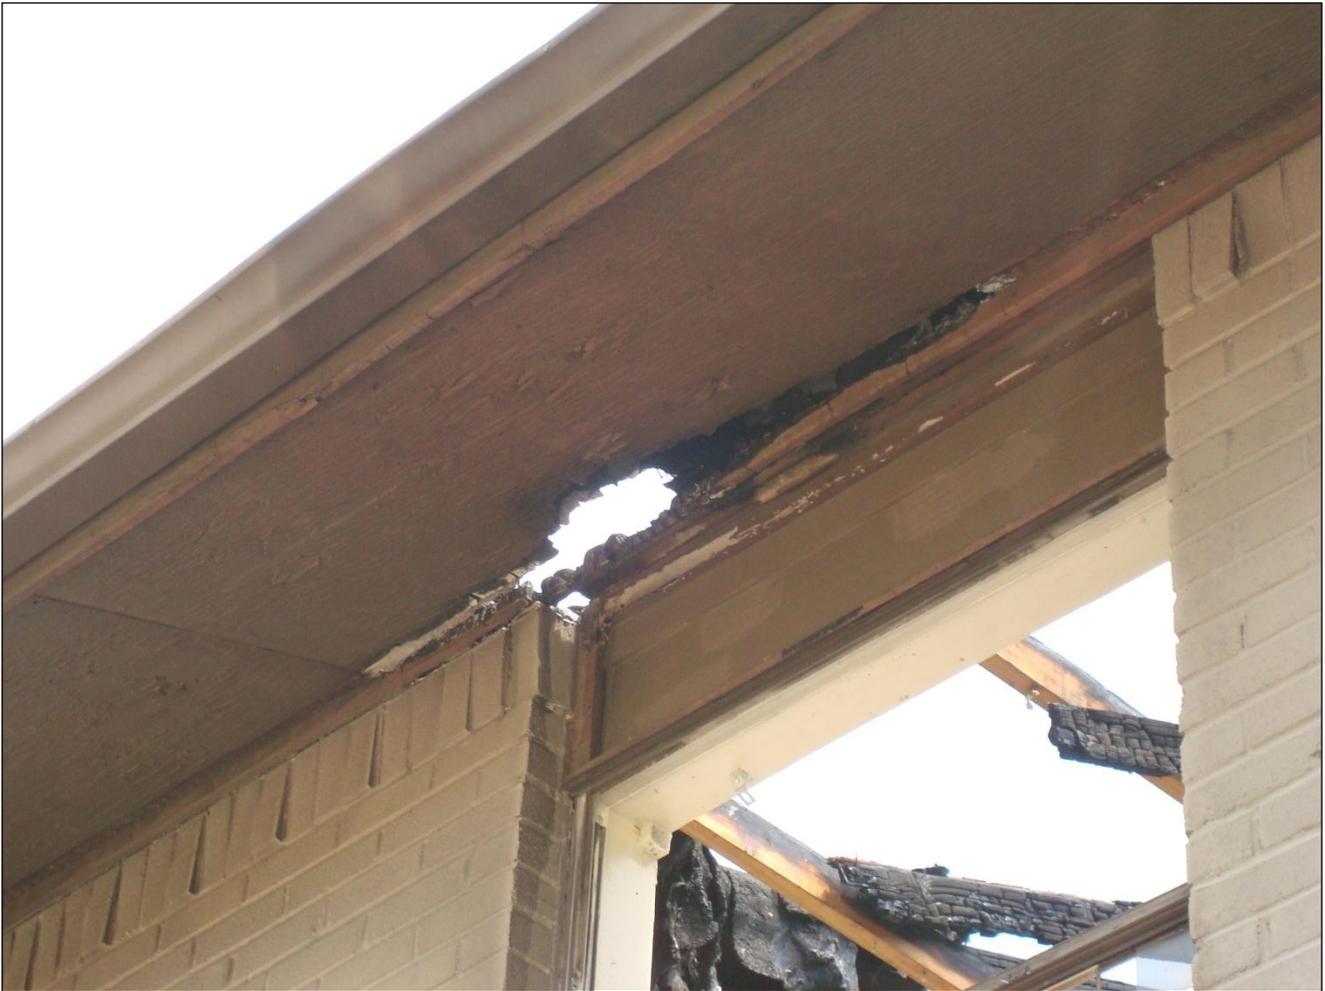
According to the arson investigator's report, the fire originated in the electrical wiring in a first floor bedroom located at the end of a hallway. The fire was immediately called into the dispatch center and had already self-vented through a ground floor window of the first floor apartment when the first crew arrived on scene. The fire spread out the window and was channeled upward by the wooden window wells until the fire impinged on the soffit, which extended out approximately two feet from the exterior wall (see Photo 1). It then spread to the attic above the second floor apartment through the soffit.

**Photo 1. Wooden soffit above second story window where fire entered the attic from first floor room of origin located directly below.**  
*(NIOSH photo.)*

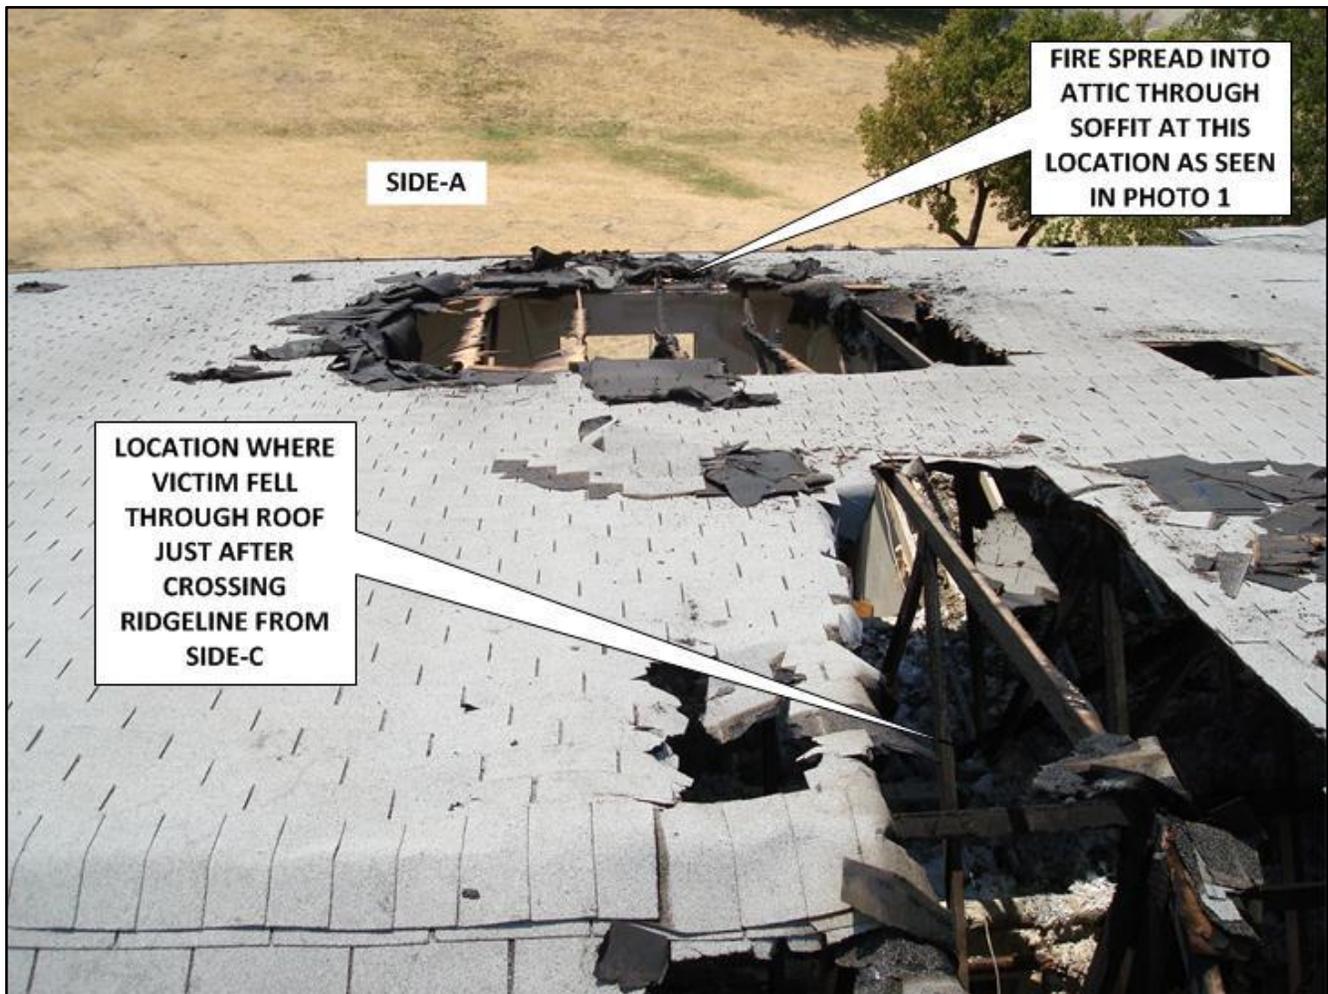
Photo 3. Side-A of the gable roof where incident occurred.  
(NIOSH photo.)
