Career Fire Fighter Dies and Another is Injured Following Structure Collapse at a Triple Decker Residential Fire – Massachusetts

Executive Summary

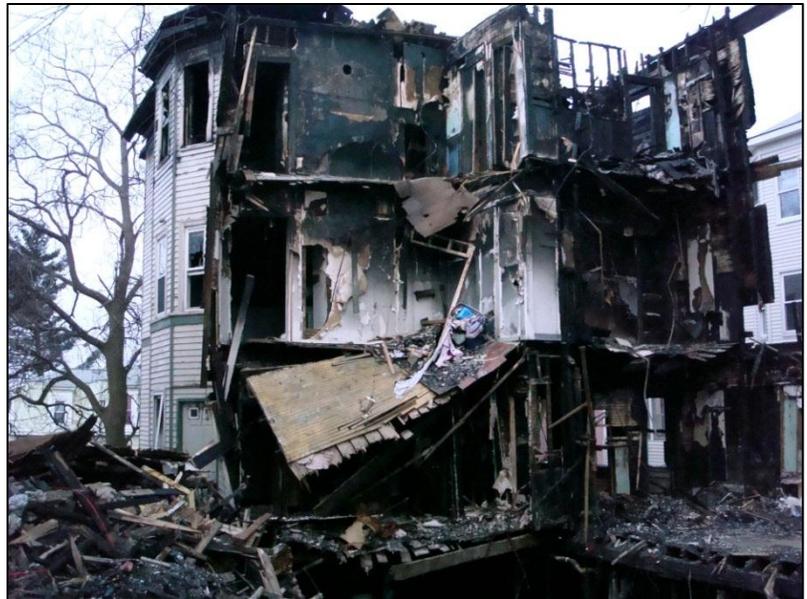
Rear view of the “triple decker” residential structure following partial cleanup of collapse debris. Search crews were on the second floor at the time of collapse. (NIOSH Photo)

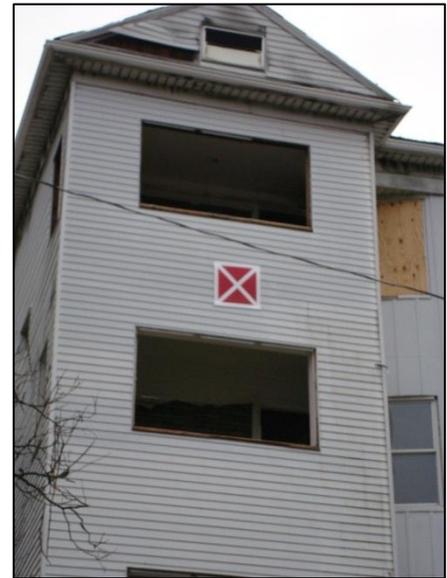
Hazardous building placard attached to exposure structure located just south of the fire building.
(NIOSH Photo)

- *Fire departments and city building departments should work together to ensure information on hazardous buildings is readily available to both*
- *Authorities having jurisdiction should ensure that hazardous building information is part of the information contained in computerized automatic dispatch systems*
- *Fire Departments should train all firefighting personnel on the risks and hazards related to structural collapse*
- *Fire Departments should use risk management principles including occupant survivability profiling at all structure fires*

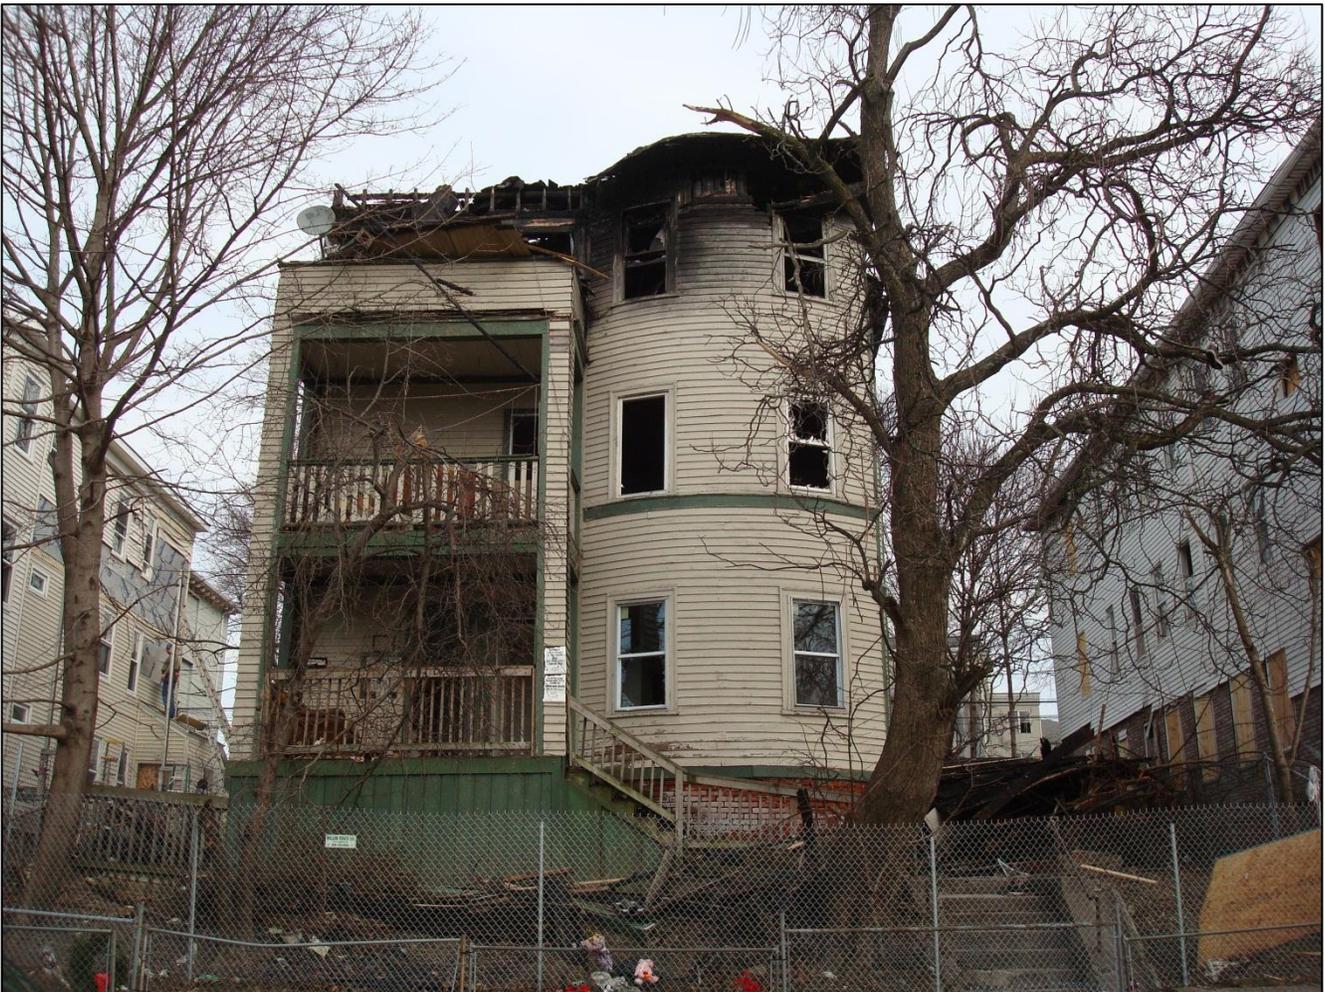
Photo 1. Front of the triple-decker residential structure viewed from the street. All structures on the east side of street on this block were elevated above street level. The first and third floors were vacant at the time of the fire.

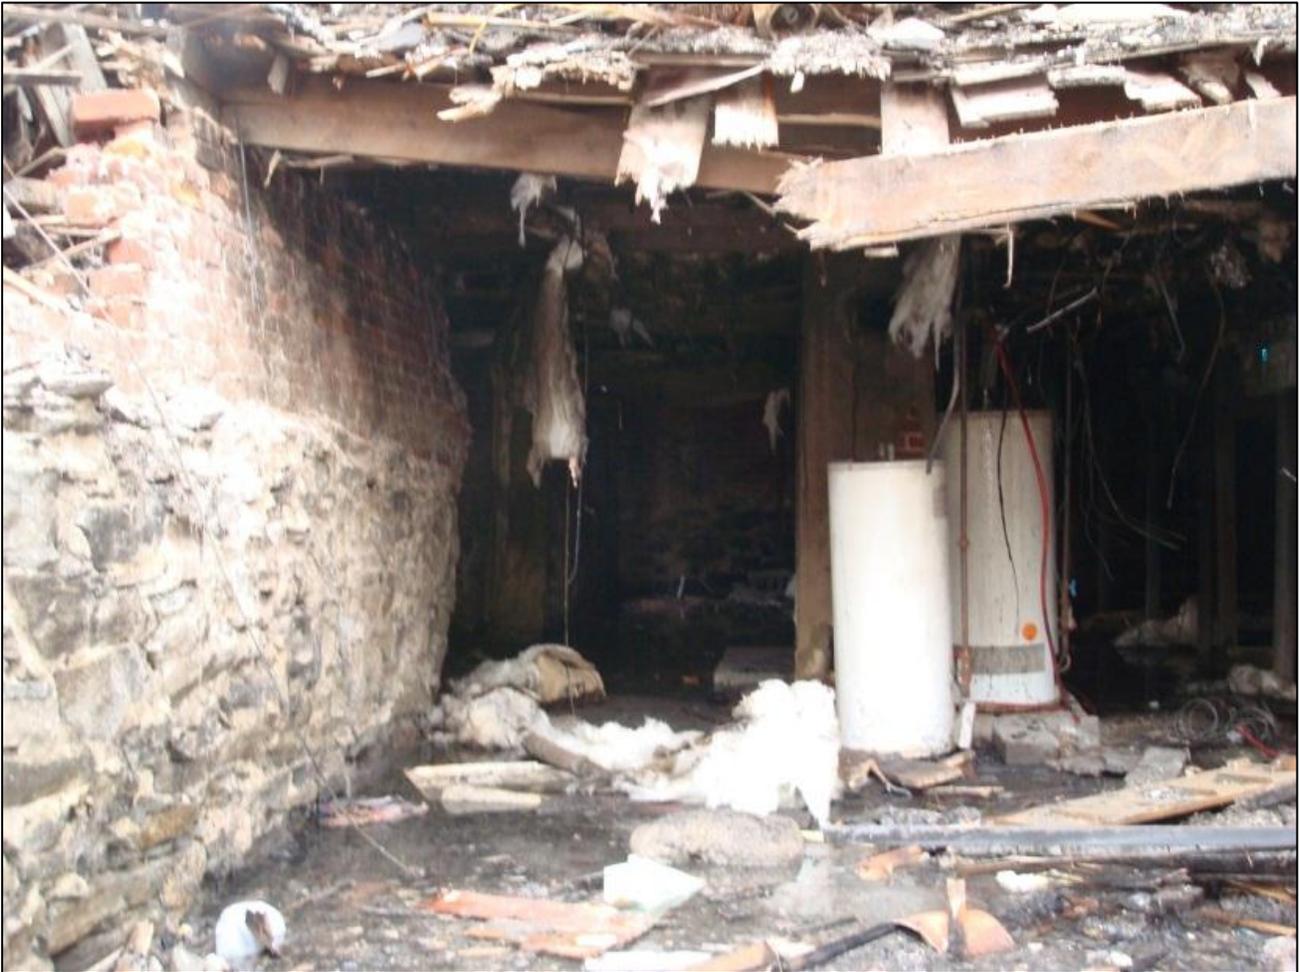
The structure featured typical balloon frame construction and measured roughly 28 feet wide by 50 feet long. It was built over an unfinished basement. The basement walls were of mixed construction. The lower portion of the basement walls were stacked field stone. The top portions of the walls, (extending above ground level) were constructed of brick and mortar (see Photo 2 and Photo 3). Some of the building code violations cited by the city included cracks and deterioration in the exterior brick walls.

Photo 2. View of the D-side basement wall. Note the brick and mortar wall laid over top of the field stone. View is close to the area where the injured fire fighter was extricated.
(NIOSH Photo)

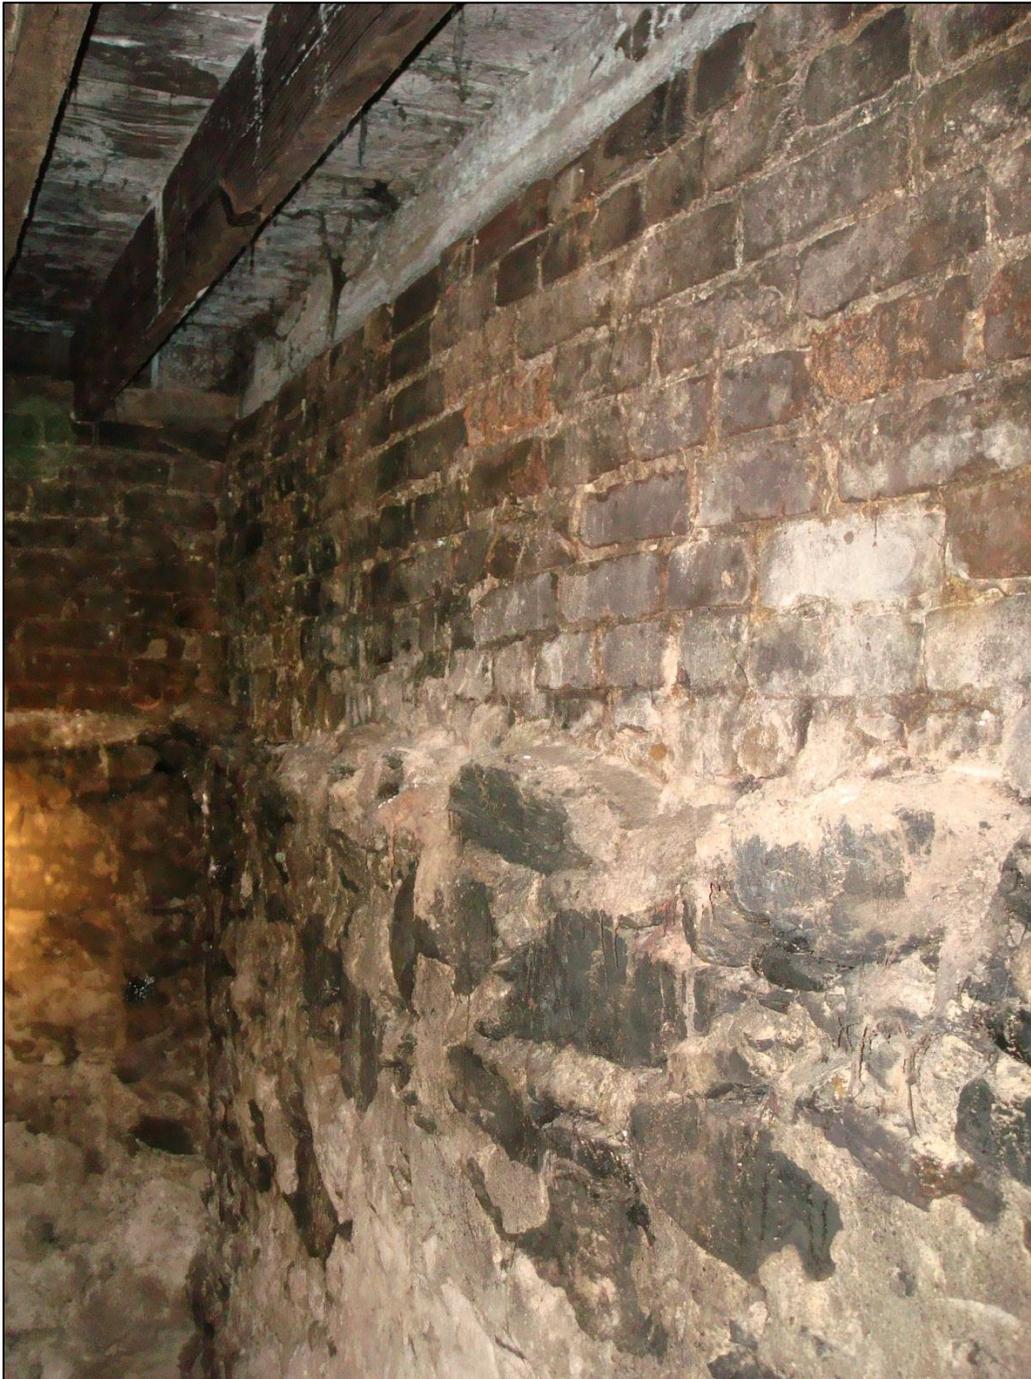
Photo 3. Photo shows the basement wall in the vacant structure located adjacent to the fire structure. This structure was built during the same time period as the fire structure. Photo was taken at the Side A/D corner.

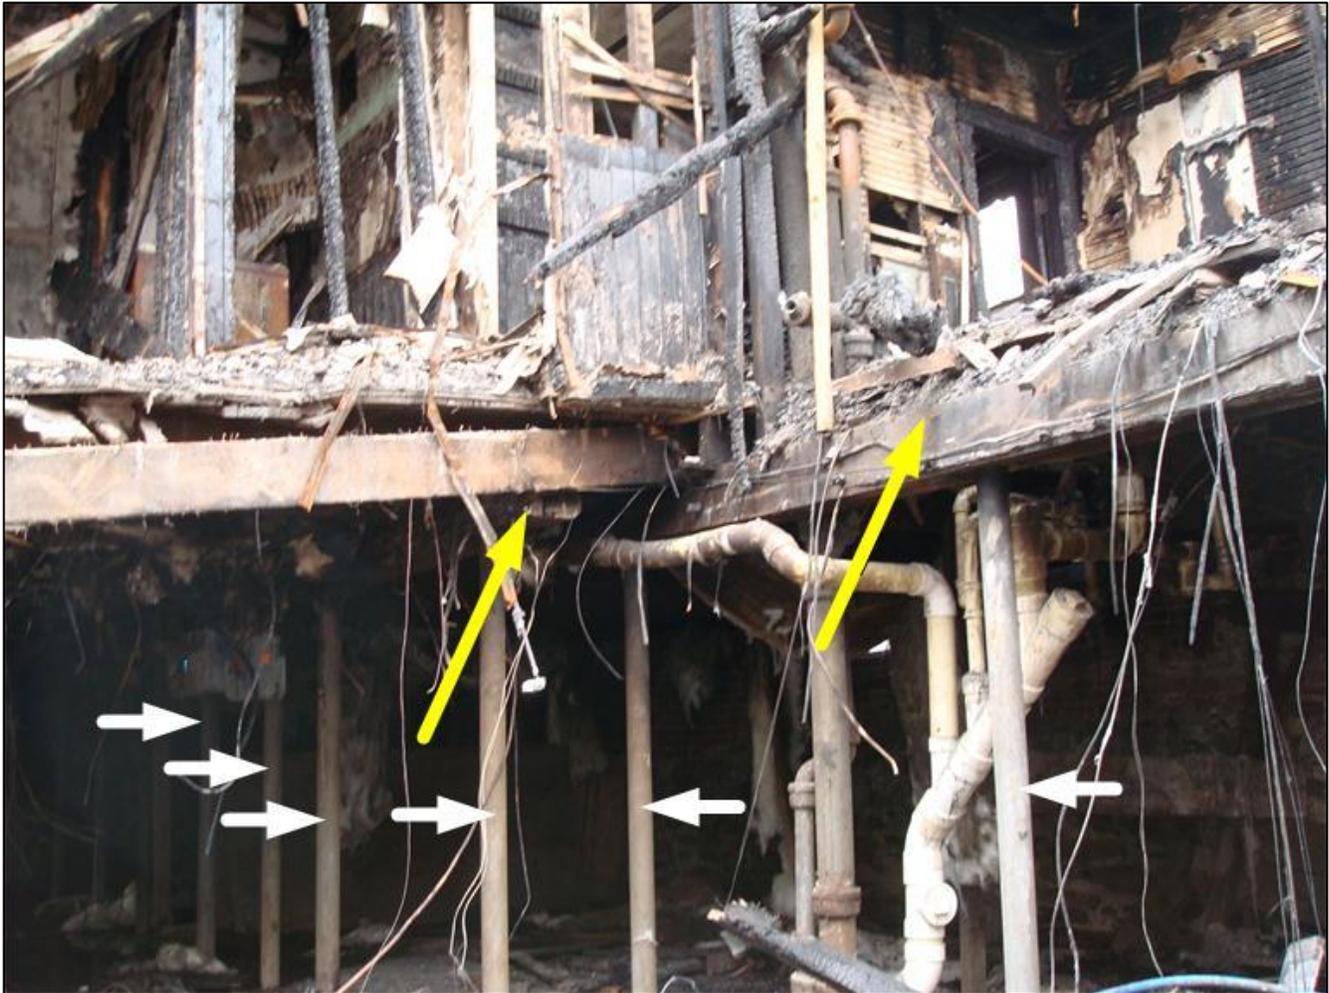
The structure was supported by the exterior walls resting on top of the basement walls and by two heavy timber beams running from front to back near the center. Each beam spanned approximately one-half of the length of the structure and were likely offset to provide support for the interior load bearing walls (See Diagram 2 and Photo 4).

Photo 4. Yellow arrows indicate the two heavy timber support beams running front to rear and located near the center of the structure. White arrows indicate tubular metal support posts commonly referred to as lally columns or lally posts. Note the off-set between the two support posts as indicated by the two supports at the lower center of the photograph.

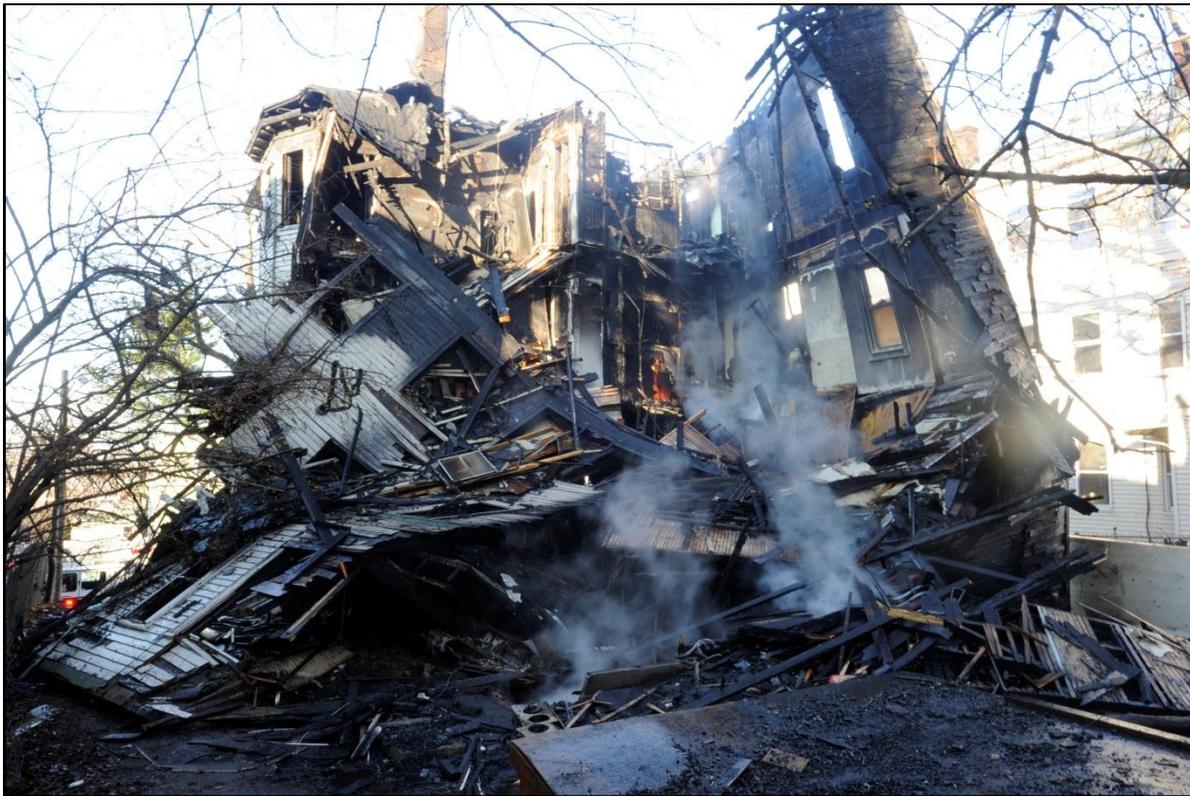
Following the fire, local and state fire investigators determined that the collapse was unusual for the type of building and size of the fire. Due to the unexpected collapse, both the city and state commissioned engineering analysis of the structure in an attempt to identify the cause(s) of the collapse. The main support beams (see Diagram 2) were examined and found that they were not unduly damaged by the fire. The support beams were determined to not have been the cause of the collapse. Further analysis revealed that Side D foundation wall near the C/D corner had blown outward at some point during the incident, possibly due to the deteriorated condition of the mortar joints and the general decay of the wall. The resulting loss of support when the foundation wall gave way caused the rear of the building to collapse. This is consistent with eye-witness reports from fire fighters on scene who stated that the C/D corner collapsed. Photographs taken by state fire investigators following the fire showed the Side D wall collapsed outward with debris located near the fence at the property line to the south (see Photo 5).

Photo 5. Photo taken from the rear of the structure just hours after the collapse. The left side of photo shows the remains of the collapsed portion of the Side D wall.
(Photo courtesy of the State Fire Marshal's Office)

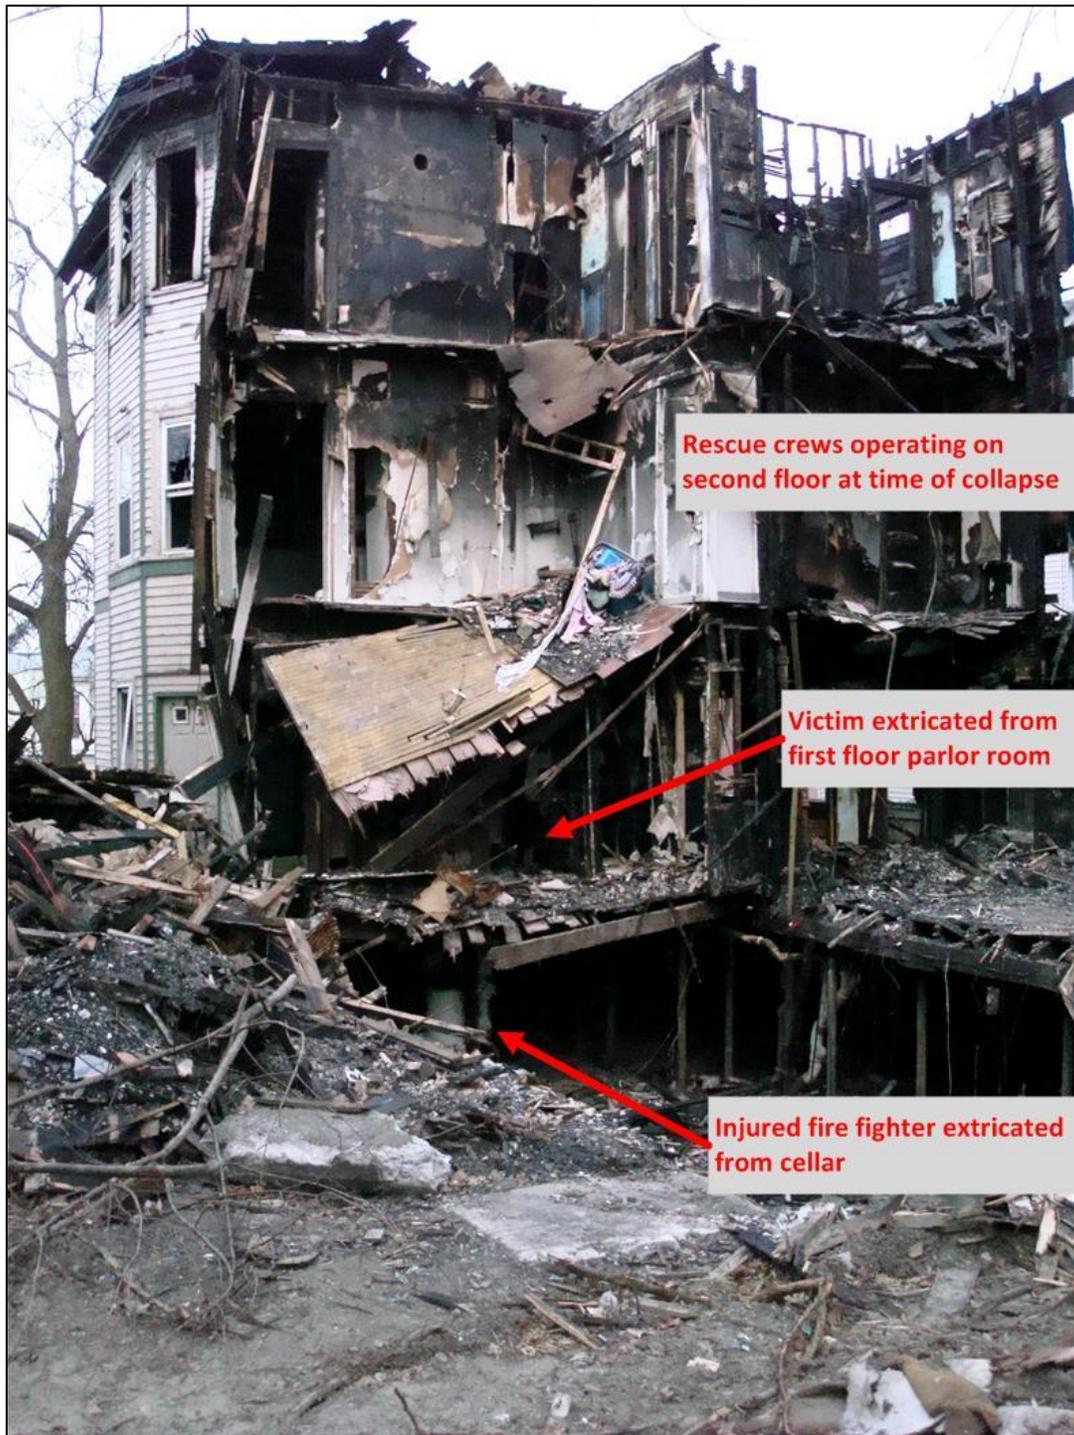
**Photo 6. Locations of Victim and injured fire fighter post collapse Photo taken after partial cleanup of the debris.
(NIOSH Photo)**

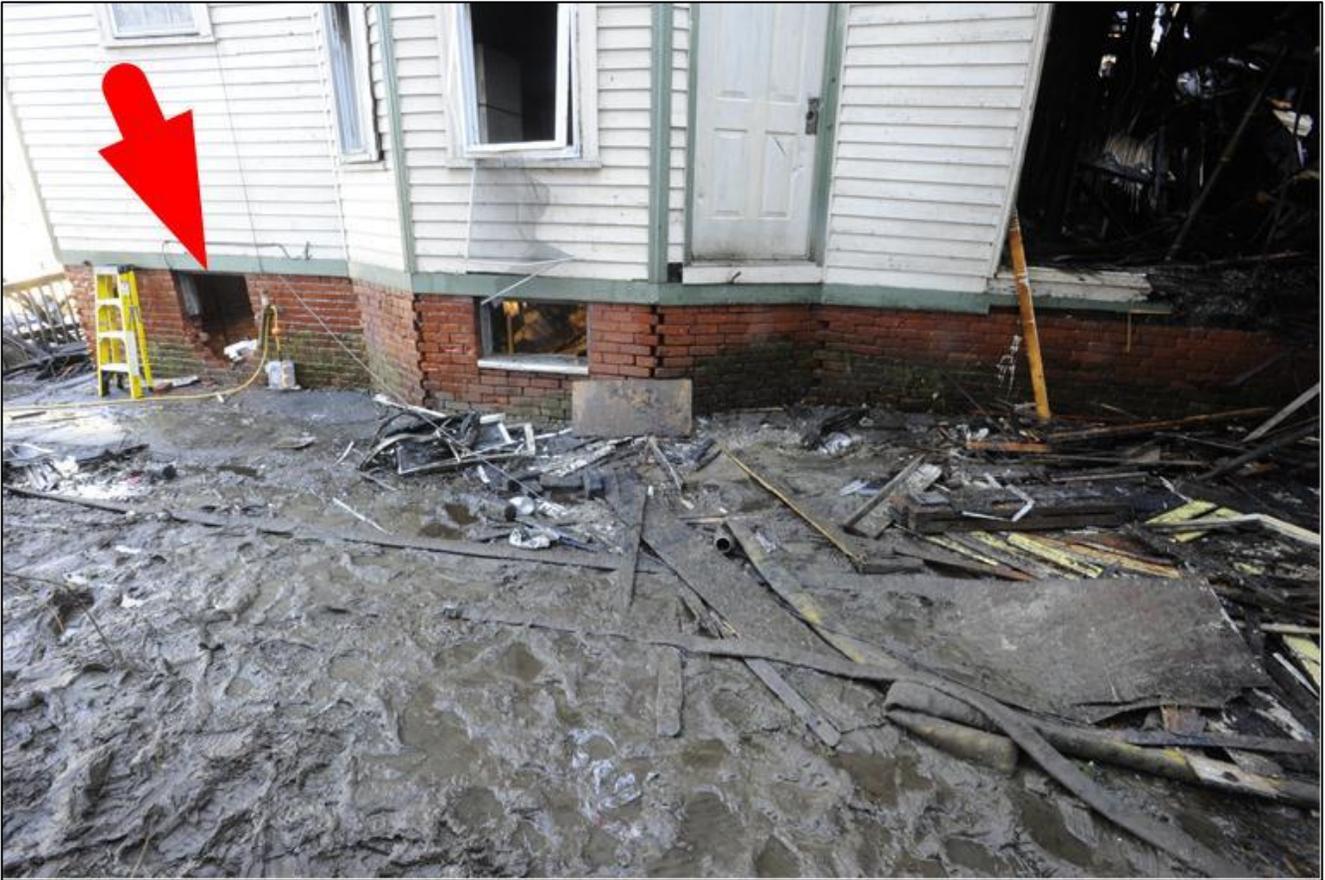
The Special Operations Task Force team (Engine 5 and Ladder 4 crews) arrived on-scene and were instructed to breach the cellar wall near the A/D corner to gain access to the cellar to work on extricating the injured fire fighter (see Photo 6). Fire fighters took out a window in the foundation wall near the A/C corner and enlarged the opening for access into the basement (see Photo 7). The Special Operations team leader (the Engine 5 Lieutenant) went inside the basement to size up the rescue operation. Limited access was established at the opening in the foundation wall to control who was going in and out of the basement.

Photo 7. Arrow marks location where foundation wall was breached to access the cellar to extricate the injured fire fighter.

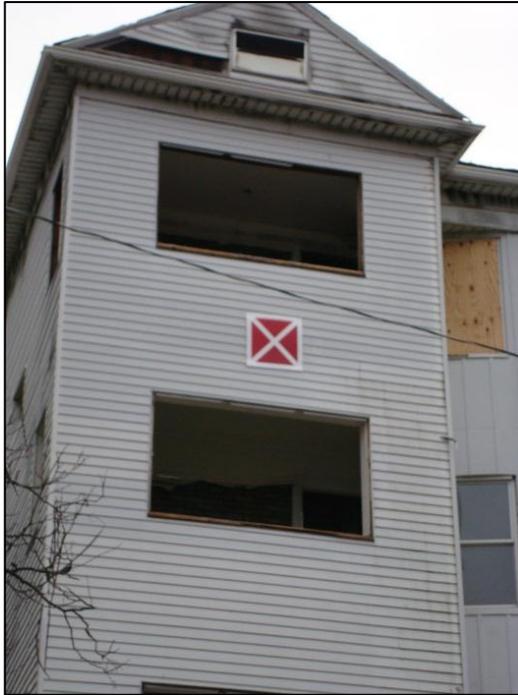
In this incident, the fire department responded to a structure that had been cited by the city building department for a number of code violations including structural deterioration. This information was not available in the city dispatch system so it was not readily available to the fire department. The fire department did have a process to mark hazardous buildings identified by the fire department. The fire department had responded to a fire at an adjacent triple decker apartment building just a few months prior to this incident. The fire department had marked that structure as a hazardous structure (see Photo 8). The structure where the fatality occurred had been cited by the city building department for structural deficiencies but there was no formal process for the building department to notify the fire department of the deficiencies or to make this information readily available through the dispatch system. Information about structural deficiencies should be considered by fire officers when making operational decisions.

**Photo 8. Hazardous building placard attached to exposure structure located just south of the fire building.
(NIOSH Photo)**

Recommendation # 2: Authorities having jurisdiction should ensure that hazardous building information is part of the information contained in computerized automatic dispatch systems.
