## **Career Captain Injured in Aerial Ladder Collapse - Pennsylvania**

### **Executive Summary**

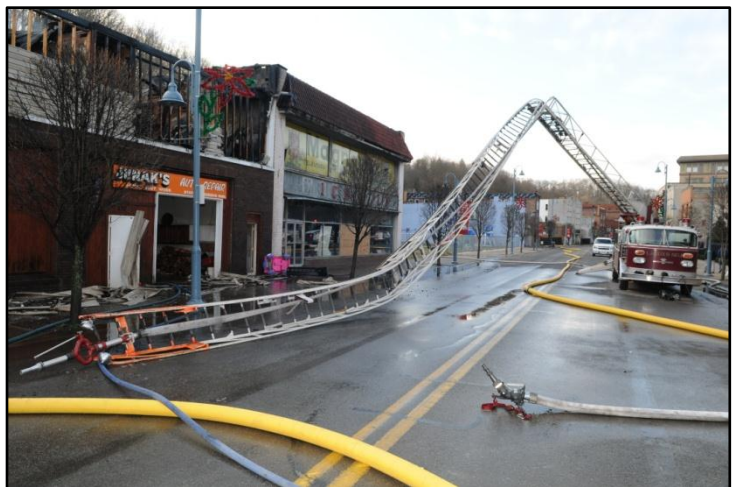
**The collapsed aerial ladder**  
*(Courtesy of Fire Department)*

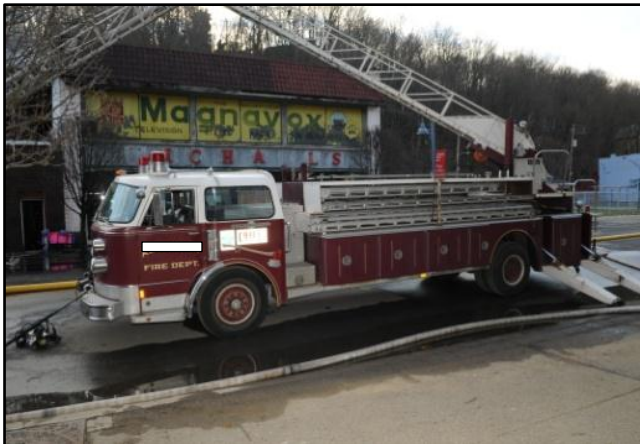
**Photo 1. The Aerial Ladder Truck**  
*(Courtesy of the Fire Department)*

The incident involved a 1975 custom fire apparatus with a 100-foot rear-mounted aerial ladder (see Photo 1). The aerial device was constructed of welded steel, assembled in four sections. The vehicle was stabilized by two sets of hydraulically controlled outriggers (see Photo 2). The aerial ladder movements of raise/lower, extend/retract and rotation were powered hydraulically and controlled from a pedestal located at the turntable (see Photo 3). The fire department did not have a manufacturer's operator manual for this apparatus for review during this investigation.

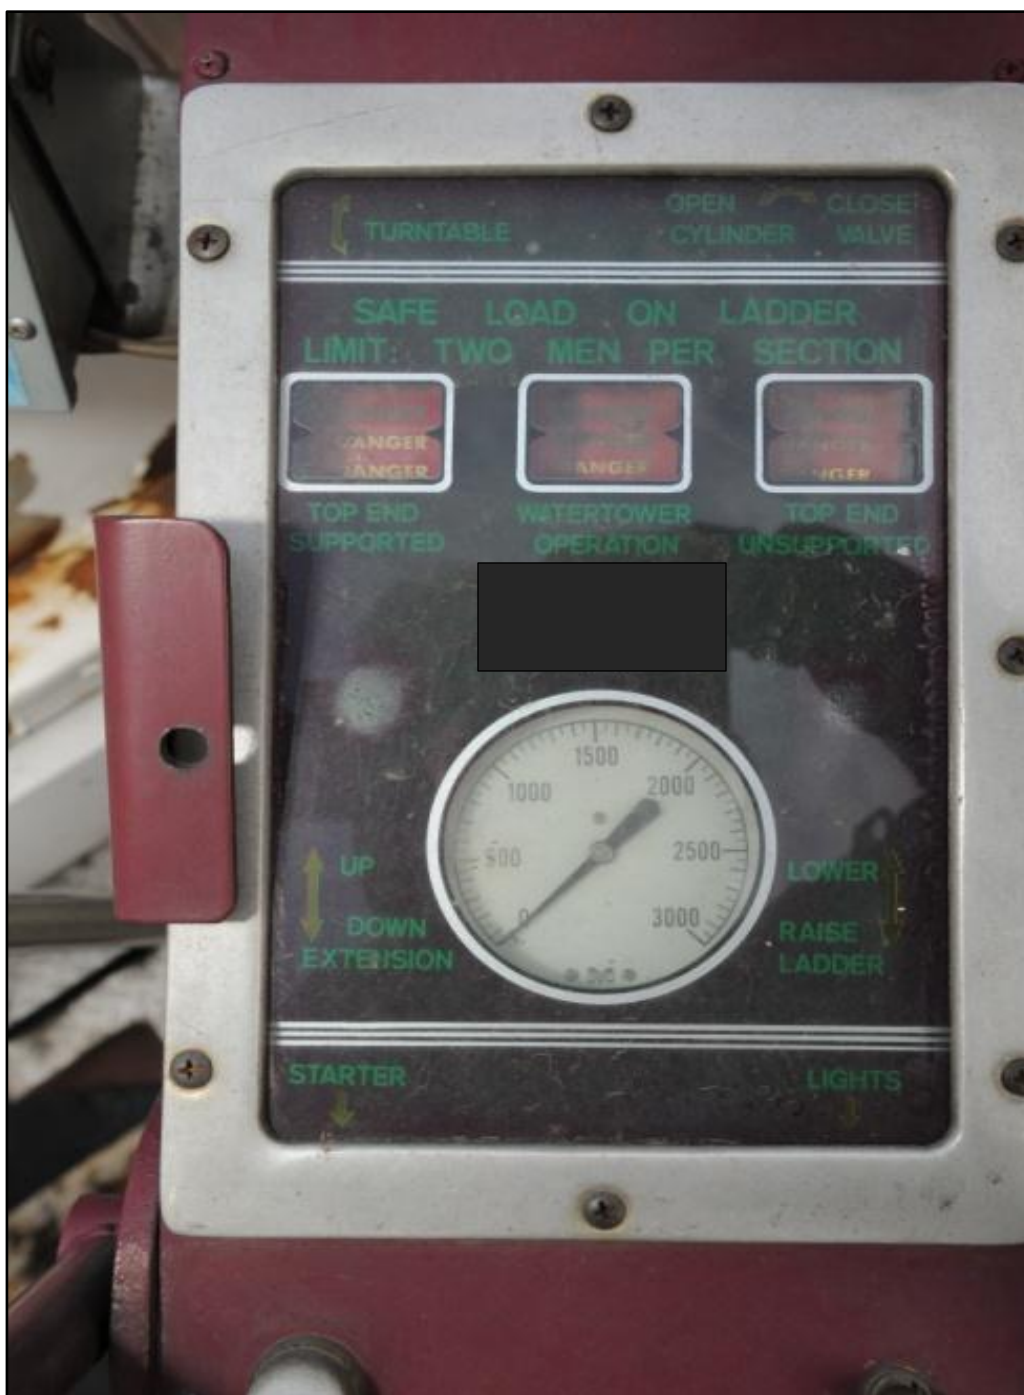
The control pedestal has an indicating device consisting of three windows displaying a message relative to the safe operation of the aerial device (see Photo 4). From left to right, the displays indicated conditions for: Top End Supported, Water Tower Operation and Top End Unsupported.

**Photo 4. Three message windows displaying “Danger”**  
*(Photo taken after collapse, courtesy of the Fire Department)*

Discussion: The apparatus was equipped with a load indicating device for the aerial (see Photo #4). This device displayed warnings for three different load factors. This indicator was stated to have worked correctly prior to the incident. As part of an SOP, fire departments should ensure that loud indicators are checked before any personnel ascend the aerial ladder.

In this incident, the "Danger" warning was displayed in all three windows. These warnings were not observed by the captain or the fire fighter on the turntable.

***Recommendation #3: Fire departments should ensure that all safety indicators are monitored and followed while operating the aerial.***

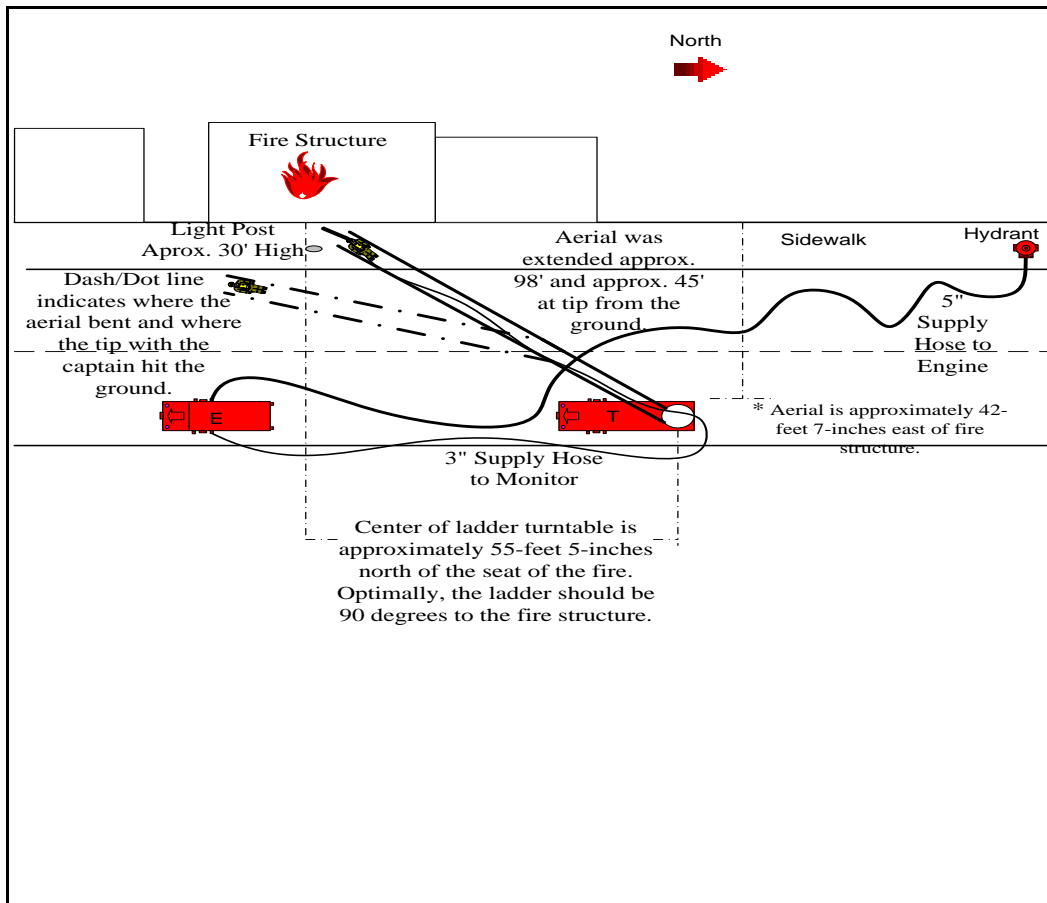
Diagram. Position of aerial at the time of the incident

The driver of the ladder truck then pulled forward to get closer to the fire but stopped short, approximately 55 feet behind the engine to avoid running over the 5-inch LDH that was supplying water to the engine. Both apparatus were on the far side of the street, away from the collapse zone (see Diagram).

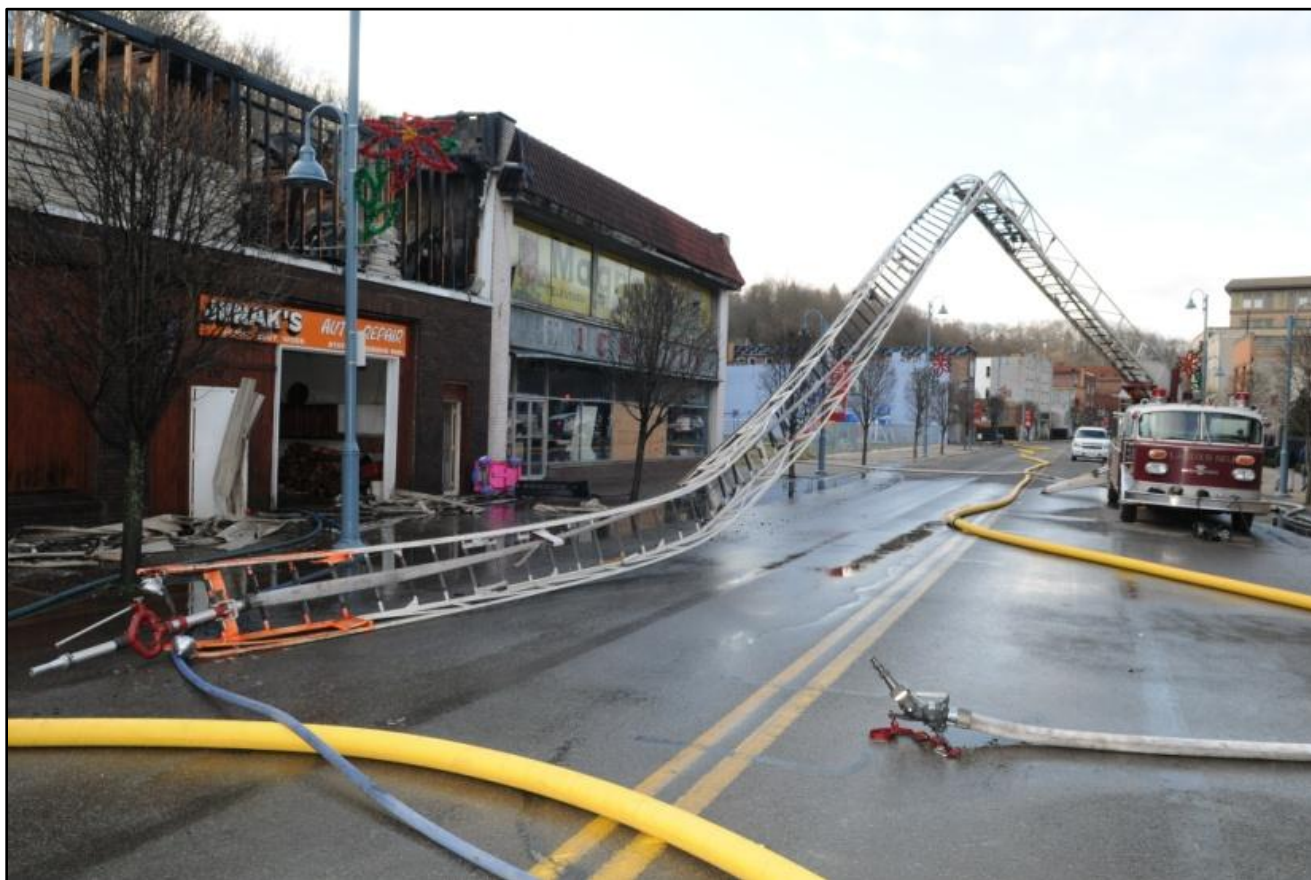
**Photo 5. Note 5-inch supply hose laid from one side of the street to the other causing the driver of the aerial apparatus to stop short of fire structure.**  
*(NIOSH Photo)*

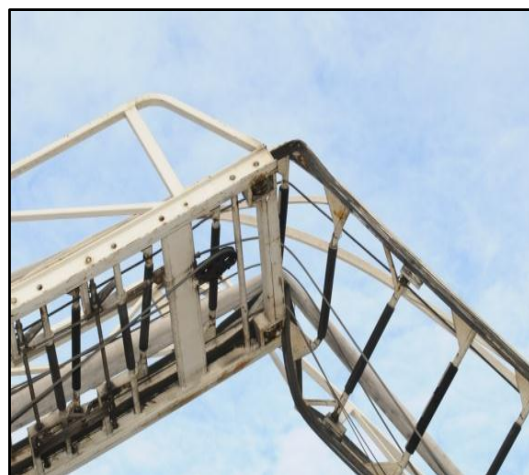
Some of the ladders that were still in production when the standard changed had evolved from basic designs that originated prior to 1940. There are hundreds of these aerial ladders still in service and have proven to be reliable at relatively steep angles; however, they were not designed to be extended and operated at low elevation angles. They are also limited in their ability to resist lateral forces (see Photo 6).<sup>3</sup>

**Photo 6. Structural failure occurred at end of the ladder bed section.**  
*(Courtesy of the Fire Department)*

In this incident, the failure did not appear to have been caused by any defect or damage to the ladder.
