A summary of a NIOSH fire fighter injury investigation

Career Captain Injured in Aerial Ladder Collapse - Pennsylvania

Career Captain Injured in Aerial Ladder Collapse – Pennsylvania

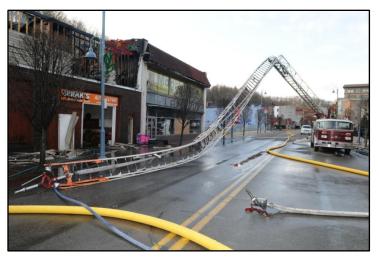
The collapsed aerial ladder (Courtesy of Fire Department)

turntable operator went to the engine and shut down the ladder pipe hose line. The captain was transported to the hospital with non-life threatening injuries.

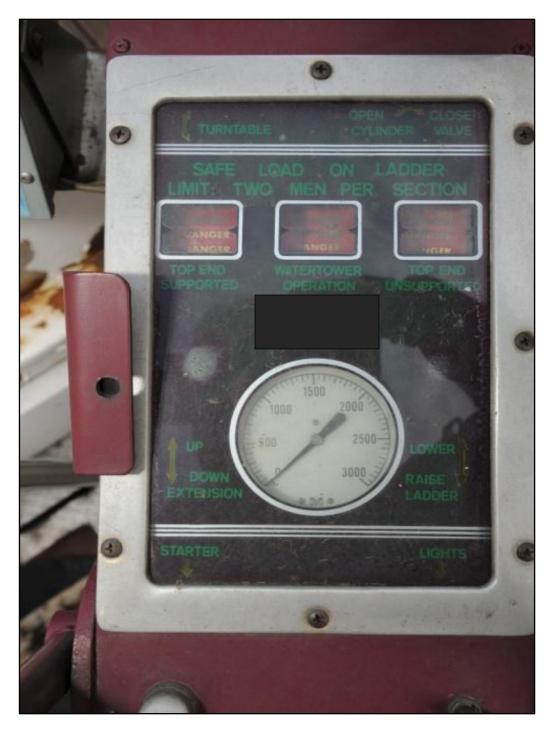
Photo 4. Three message windows displaying "Danger" (Photo taken after collapse, courtesy of the Fire Department)

In this incident, the "Danger" warning was displayed in all three windows. These warnings were not observed by the captain or the fire fighter on the turntable.

Recommendation #3: Fire departments should ensure that all safety indicators are monitored and followed while operating the aerial.

Discussion: The apparatus was equipped with a load indicating device for the aerial (see Photo #4). This device displayed warnings for three different load factors. This indicator was stated to have worked correctly prior to the incident. As part of an SOP, fire departments should ensure that loud indicators are checked before any personnel ascend the aerial ladder.

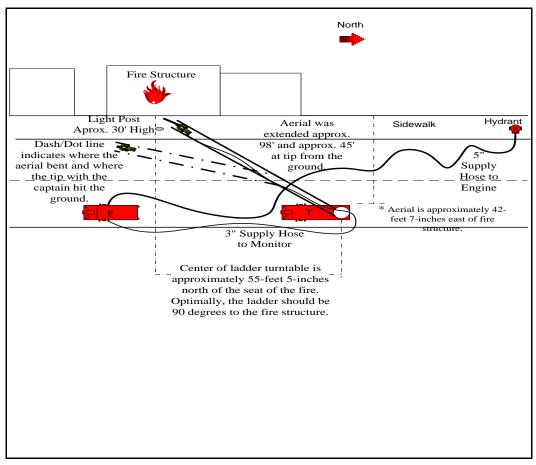
The captain began climbing the ladder and as he traversed the fly section the operator noticed that the tip was bouncing with each step he took. He also noticed that the ladder was twisting to the left. *Note: During the interview process, a fire fighter stated that the aerial ladder had a natural twist to the left when near fully extended.* When the captain reached the tip of the fly section, he got into a prone position to hook his safety belt on the ladder and begin operations. It was estimated that within a "few seconds" the ladder started to roll to the left and the captain moved to the right to hang on to the right rail of the ladder. It continued to twist to the left and the three ladder sections beyond the bed ladder began to slowly collapse. After collapsing approximately 10 feet it continued twisting to the left and descending. When the tip was approximately 15 feet above the ground, it began to pick up speed and struck the ground with the captain clinging to it. *Note: The total approximate distance the captain fell while on the ladder was 45 feet.* Several fire fighters rushed to assist the captain and the turntable operator went to the engine and shut down the ladder pipe hose line (see Diagram). The captain was transported to the hospital with non-life threatening injuries. *Note: After the incident, the aerial ladder had to be cut off at the end of the bed section with a power saw so that the vehicle and aerial ladder could be transported to an impound yard.*

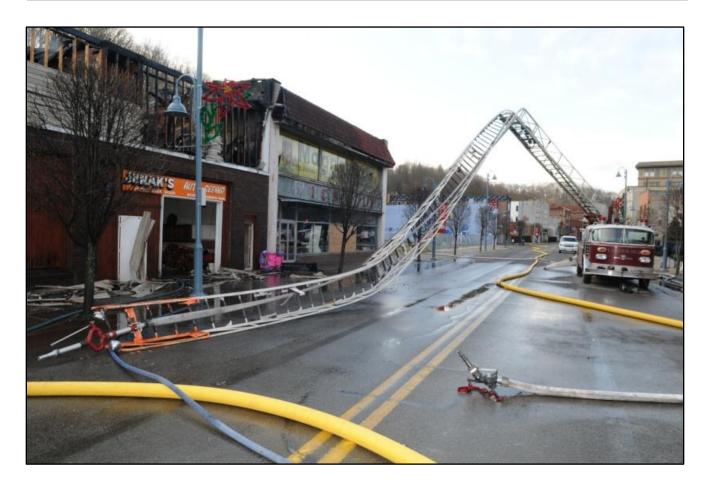
The driver of the ladder truck then pulled forward to get closer to the fire but stopped short, approximately 55 feet behind the engine to avoid running over the 5-inch LDH that was supplying water to the engine. Both apparatus were on the far side of the street, away from the collapse zone (see Diagram).

Photo 5. Note 5-inch supply hose laid from one side of the street to the other causing the driver of the aerial apparatus to stop short of fire structure. (NIOSH Photo)
