Volunteer Fire Fighter Dies After Falling From Tailboard of Tanker Truck—West Virginia

Executive Summary

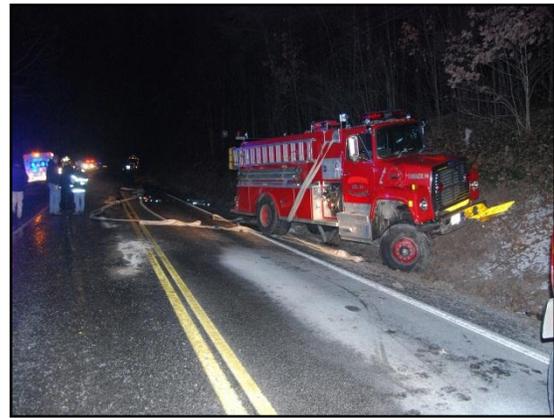
Crash site.

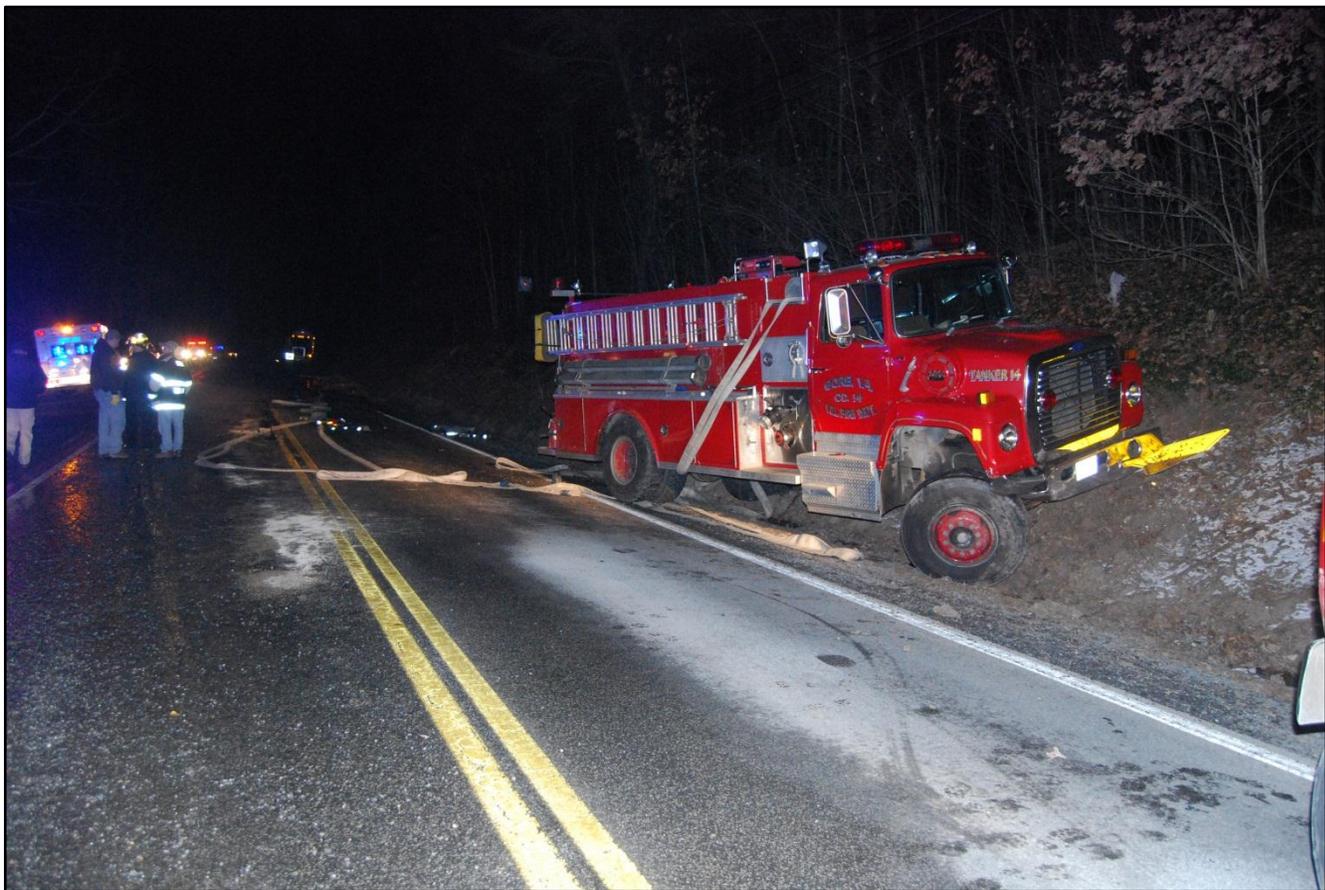
Photo 1. Crash scene. Note the black ice and dry spot on roadway.
(Photo courtesy of Fire Marshal's Office)

Tanker 14 was traveling on a two-lane asphalt state highway with a posted speed limit of 55 mph. The incident occurred after a slight left turn and 3% downgrade in the roadway that was covered with ice in both lanes for approximately 150 feet. The roadways in the area were reported as dry by other emergency personnel and police. At the time of the incident (approximately 0400 hours), the weather was scattered clouds with an approximate temperature of 28°F and a wind chill of 17°F. The relative humidity was 59% and the wind was from the west at 13.8 mph, with gusts of 20.7 mph.³ The icy road condition where the crash occurred was a contributing factor in this incident.

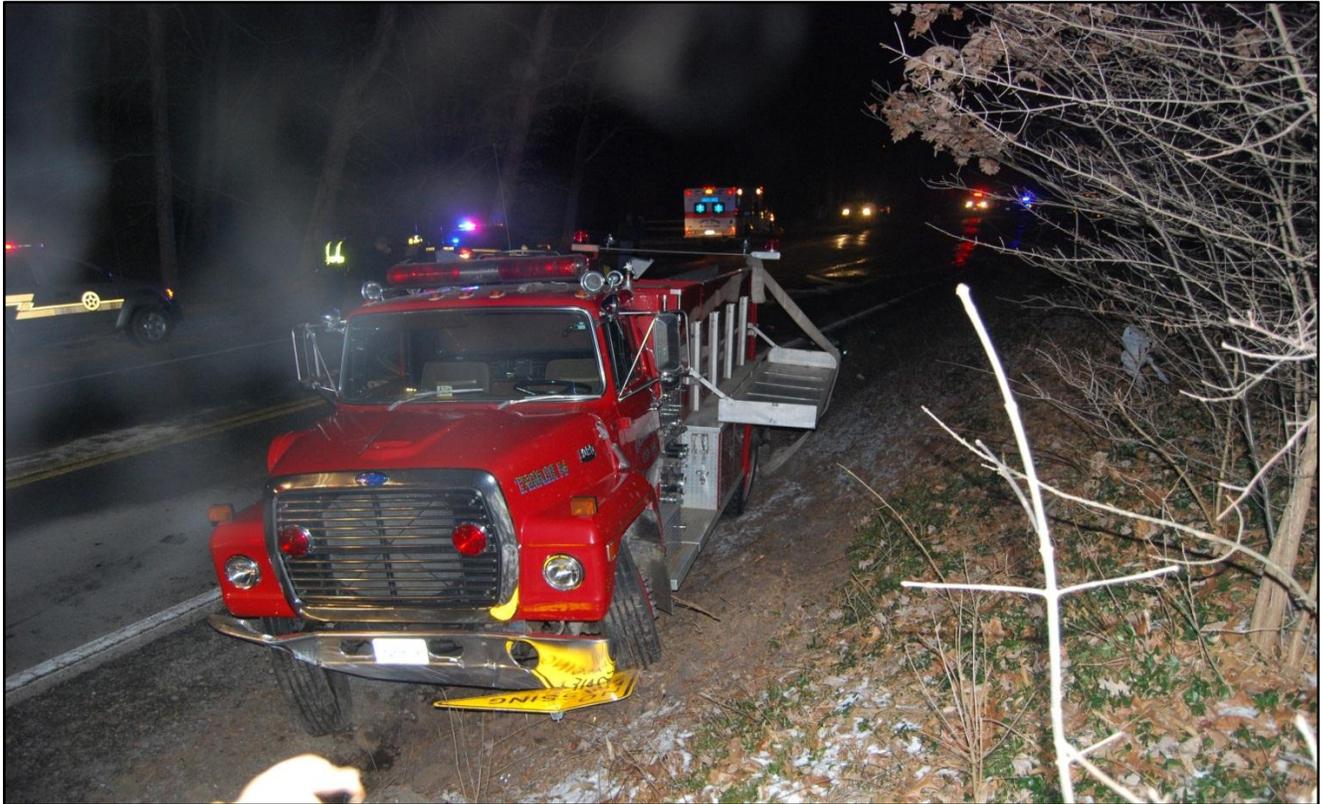
Photo 2. Tanker 14's final position against the berm. Note the reflection on the ice from the car headlights in the roadway.
(Photo courtesy of Fire Marshal's Office)

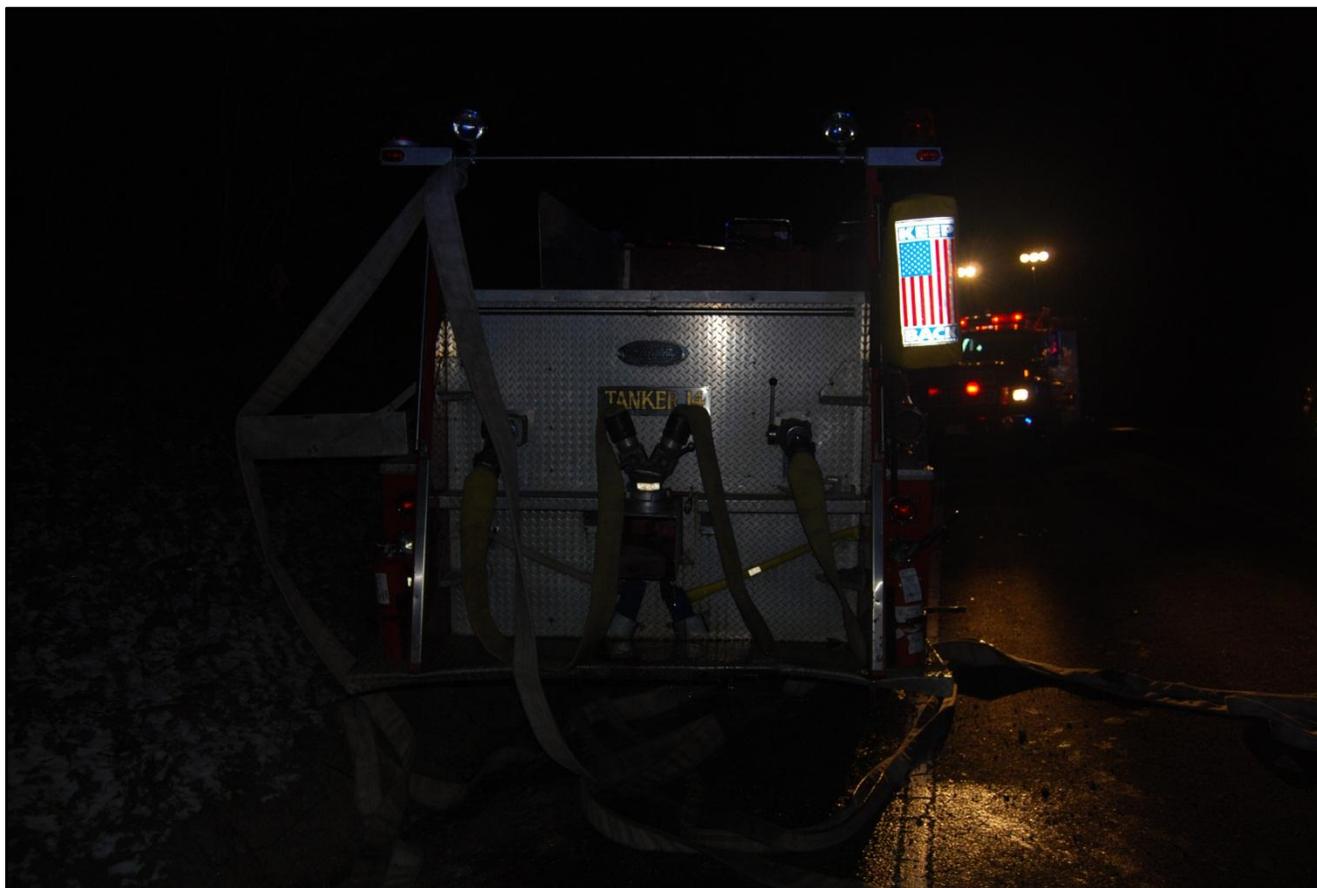
Photo 3. Crash scene of Tanker 14's tailboard after victim was ejected.
(Photo courtesy of Fire Marshal's Office)

Recommendation #1: Fire departments should ensure that fire fighters are properly trained to check the apparatus before leaving the scene (driver walk-around).

In this incident, the driver was operating according to a rural water shuttle training program that emphasized speed, with the driver remaining in the cab during the discharge of water. The training guide also emphasized that an adequate number of personnel be available to perform the job safely and effectively and that personnel are experienced in their assigned task. The victim was not experienced in his assigned task. Tanker drivers involved in a rural water supply operation must ensure that his/her truck is ready for the road when they pull away to go to the fill site. This can be accomplished by getting out of the truck or by communications from someone outside of the truck (water supply officer) who can insure that it is safe to proceed. Insuring crew accountability is everyone's responsibility and can be accomplished through positive communications with all crew members. The driver should not leave until everyone on the crew is accounted for. Performing a walk around could have been accomplished while the dump valve was filling the tank. The fire department involved in this incident has since instituted a policy that the driver of any apparatus must complete a walk around of the truck before moving the apparatus.

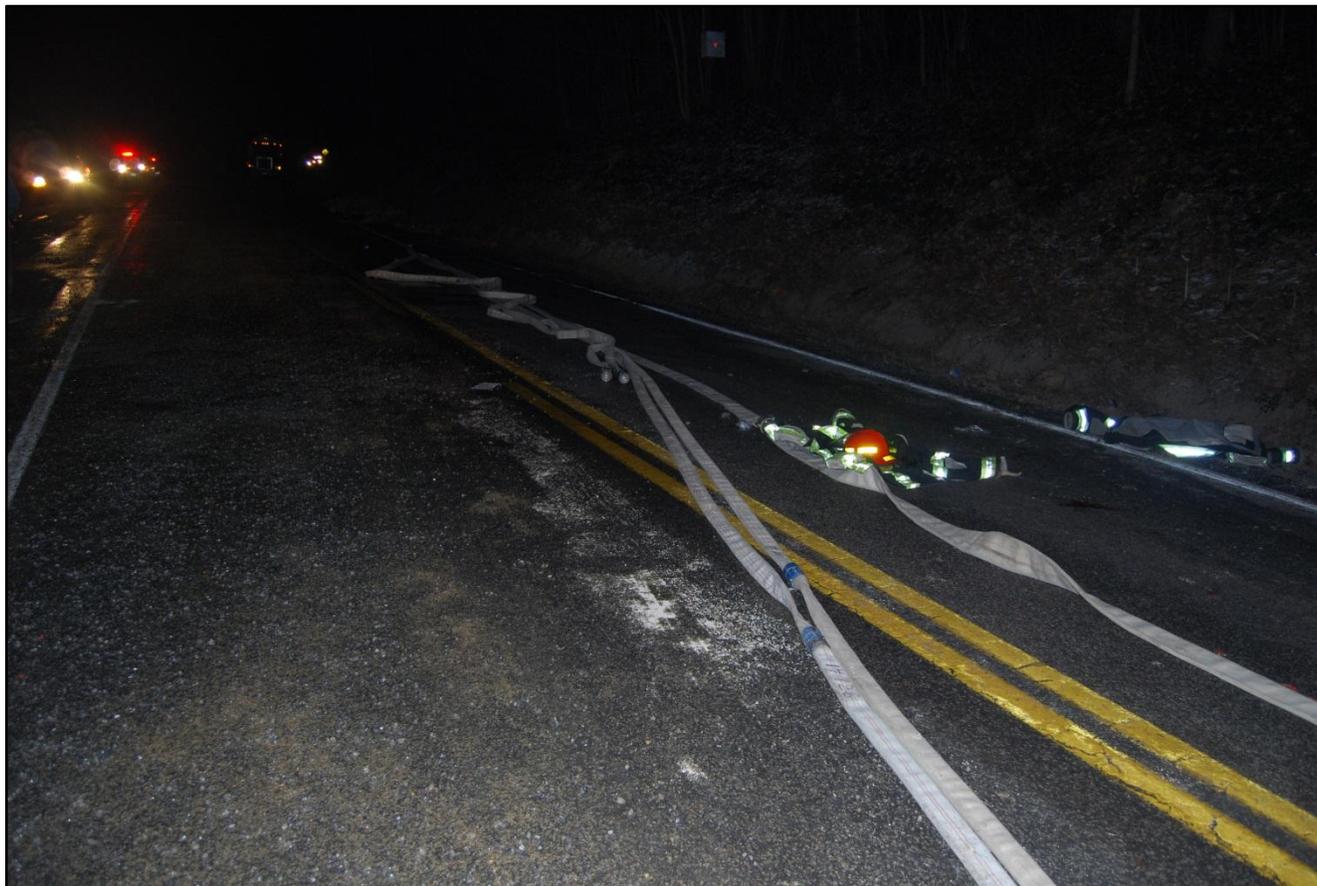
Photo 4. Victim's location (indicated by turnout gear) after being ejected from tailboard.
(Photo courtesy of Fire Marshal's Office)

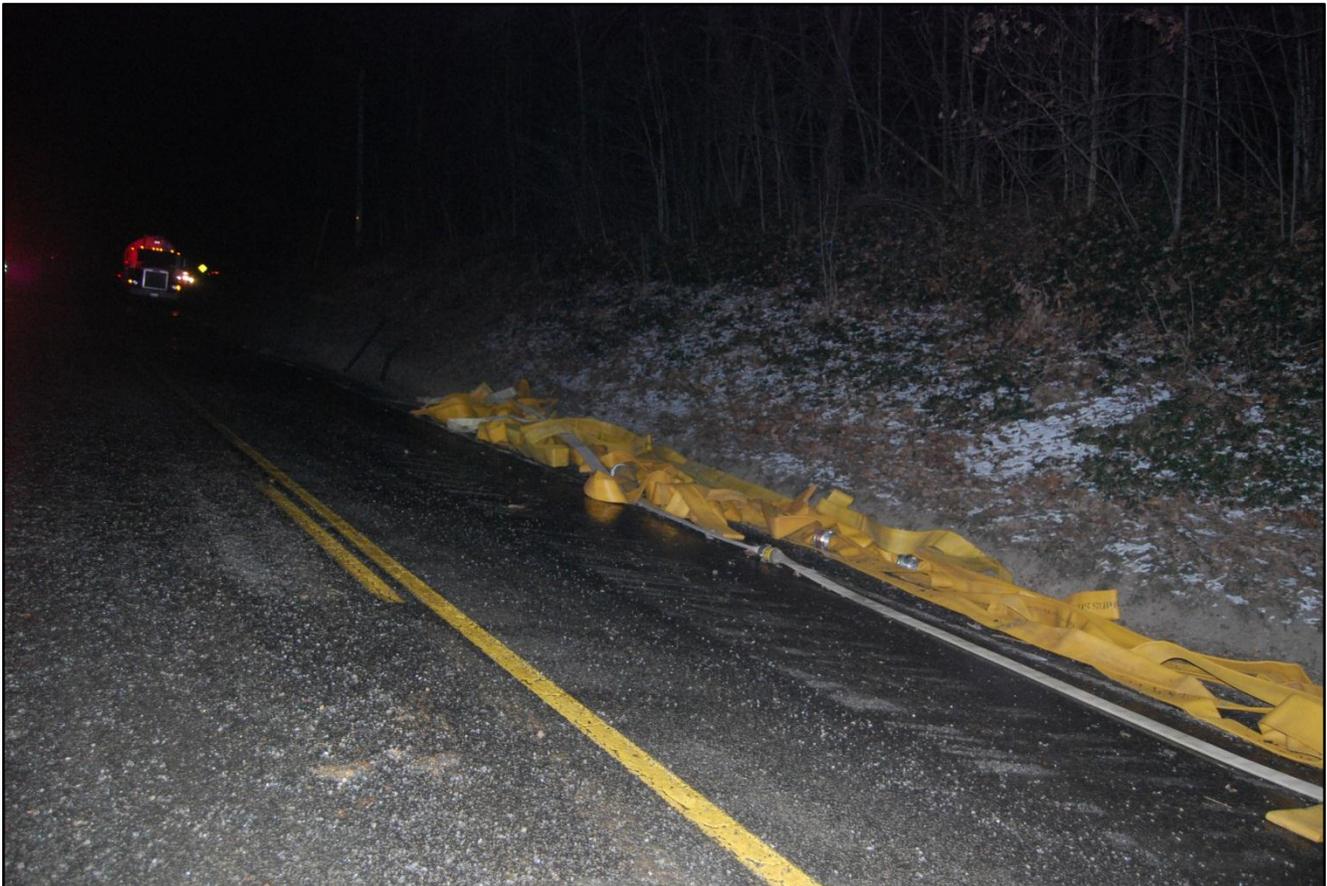
The Tanker 14 driver reported that he had not heard the communication about the icy road condition over his frequency and was unaware of the ice on the roadway. The driver of Tanker 14 reported during interviews that he was driving the truck at approximately 45 miles per hour and, when he came around a curve in the roadway, he lost control of the truck on a large sheet of black ice. The tanker spun around a number of times before impacting a berm on the left side of the road. The driver used the truck radio to tell the Virginia dispatcher that he had been involved in an accident and crawled out the passenger door. After he got out of the tanker he saw the victim lying unresponsive in the middle of the highway (see Photo 4). The victim was likely ejected from the tailboard while the truck was spinning. Hose and equipment from Tanker 14 were also ejected from the rear hose bed and the cross lay hose compartments. The folding tank was also ejected from the holding brackets on the left side (see Photo 5).

Photo 5. Hose and equipment ejected from Tanker 14.
(Photo courtesy of Fire Marshal's Office)

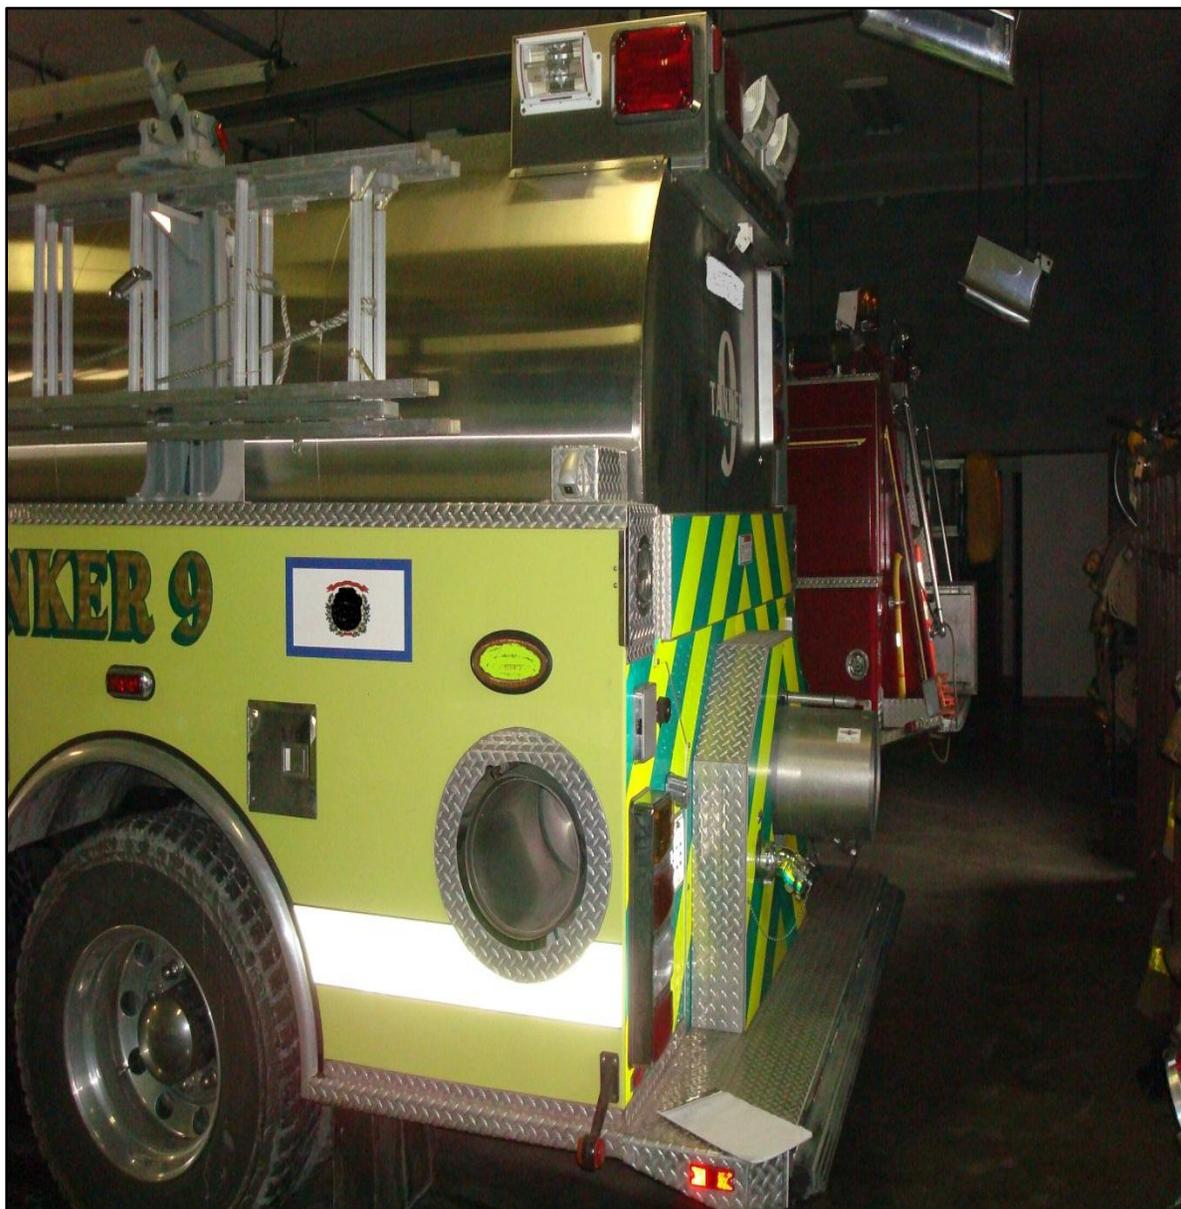
In this incident, Tanker 9 had a rear-mounted camera (see Photo 6) but Tanker 14 did not. If Tanker 14 had a rear-mounted camera or a rear mounted hyperbolic mirror, the driver may have been able to see the victim still on the tailboard, and when the victim did not dismount from the tailboard, the driver could have communicated with him before he left for the fill site.

**Photo 6. Tanker 9 side and rear discharge chutes.
(NIOSH photo)**

Recommendation #5: Fire departments should consider installing rear view camera(s) with monitor(s) inside the cab.

Discussion: Many manufacturers offer rear-mounted cameras, which allow the driver of fire apparatus to view the conditions at the rear of the truck from the cab. This is especially important in tanker operations when the driver could be expected to remain in the cab while filling a folding dump tank. Departments may also consider a rear mounted hyperbolic mirror as a less costly alternative to cameras on older tankers.

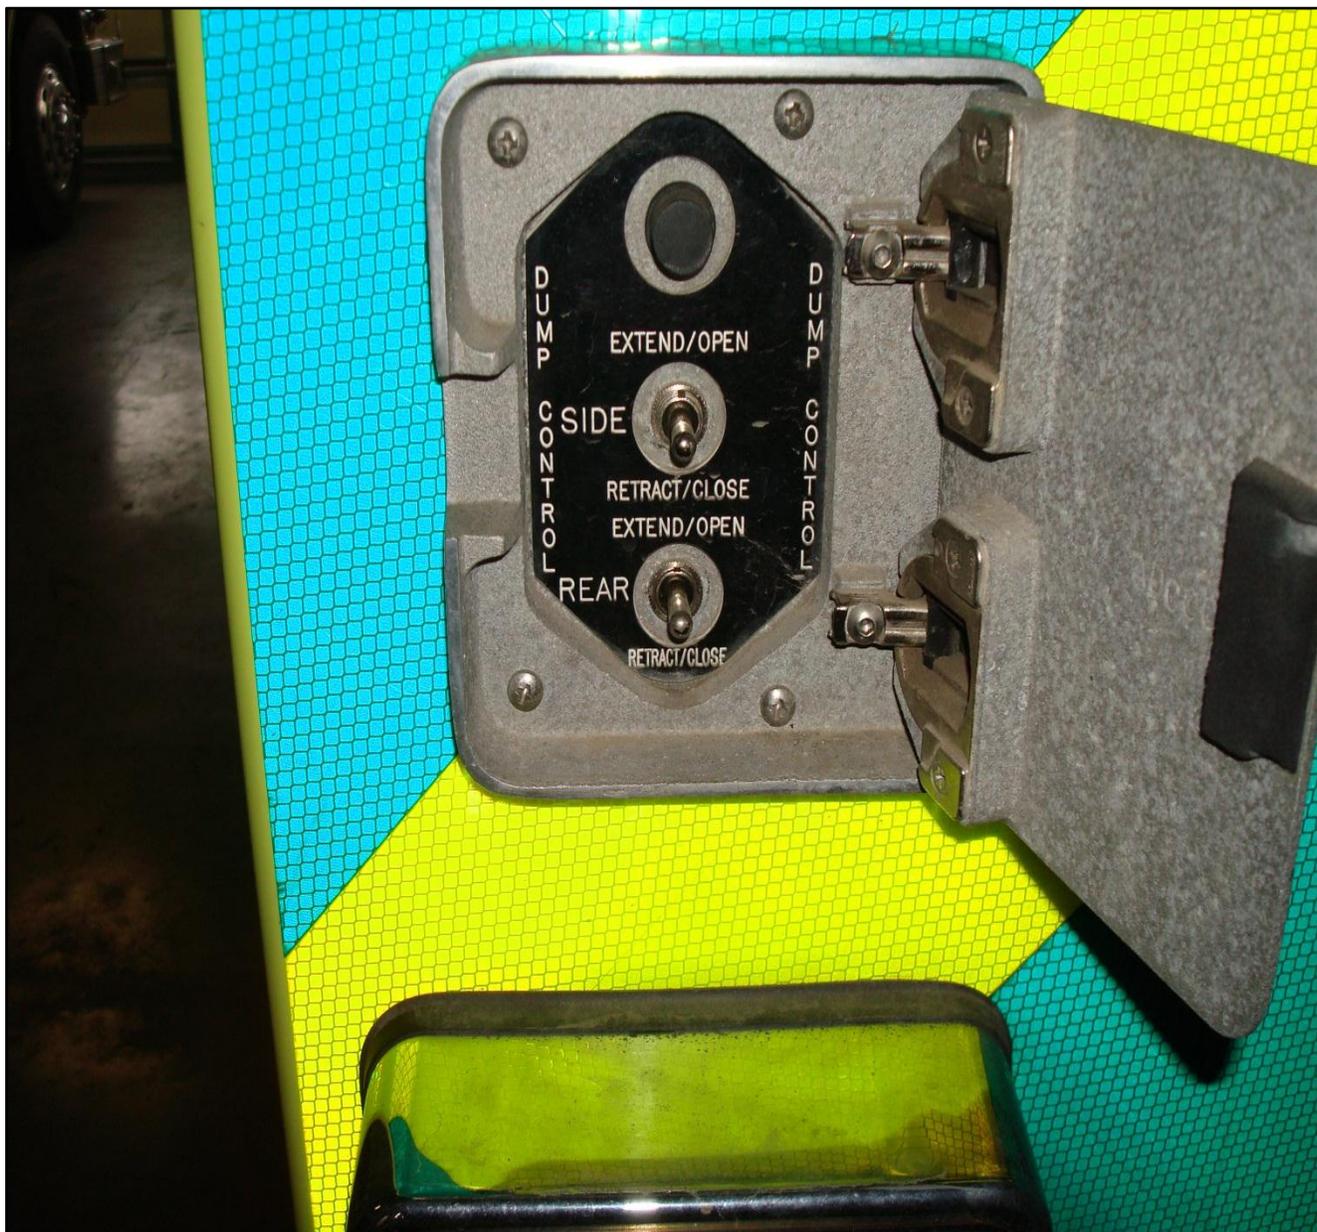
Discussion: Tanker 9 had experienced a malfunction 1 year prior to this incident. A control valve in the rear of the truck malfunctioned after the truck's engine was started, and water coming from the left rear discharge outlet flooded the floor of the fire station apparatus bay. The malfunction was traced back to a control box that was improperly operating due to moisture on the exterior left rear side of the truck (see Photo 7). The manufacturer replaced the control switches with sealed switches, and no other issues or reoccurrences were reported.

**Photo 7. Tanker 9 left rear discharge control switch that had been repaired in April 2011.
(NIOSH photo)**

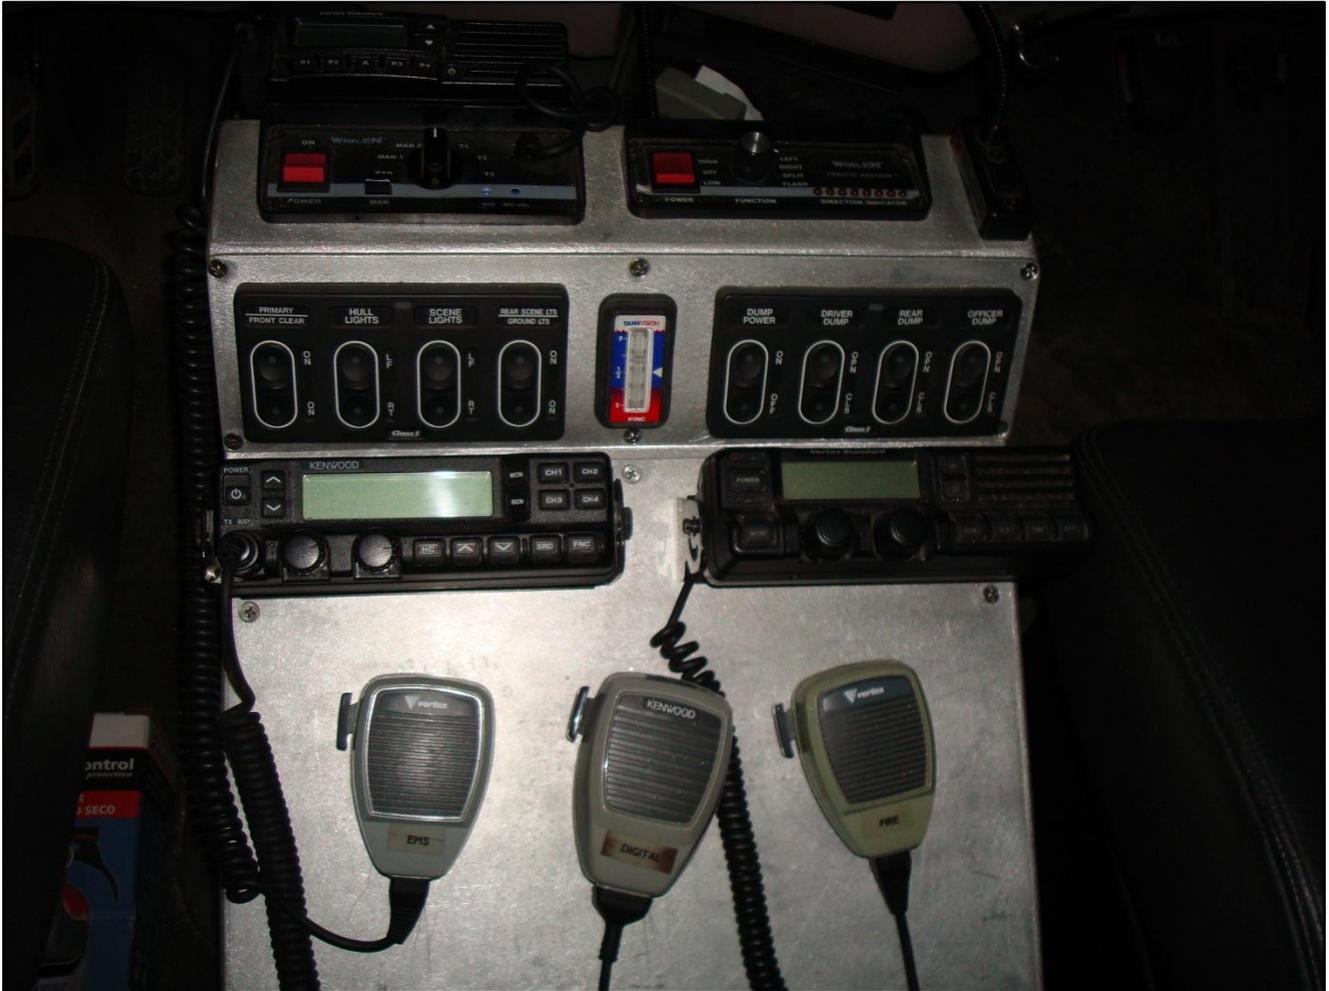
In this incident, it was noted that the tanker's controls for scene lighting and the rear discharge dump valves are identical rocker-style switches, positioned inline and close to each other on the drivers' cab control console (see Photo 8). Although the cause of the water drop could not be determined, a control switch could easily be accidentally activated if a member of the crew was attempting to activate or deactivate scene lights, or something similar, close to the water dump control switches. The use of switch guards, or covered switches, to control certain critical functions, such as water discharge, could guard against their unintended activation, especially by personnel in a dark cab responding to a call. The use of dissimilar-shaped switch buttons/levers may also provide protection against inadvertent activation, by providing the operator with tactile information to assist in identifying each switch.

Photo 8. Tanker 9 control console. Note the identical control switches for scene lights and discharge dump valves.
(NIOSH photo)

Recommendation #6: Fire apparatus manufacturers should ensure that water dump valves cannot activate unintentionally through engineering controls such as electronic lockouts on remote valves that only allow activation if the main brake system is engaged and switch guards over control switches in the cab.

The department contacted the manufacturer to help identify the problem. The apparatus manufacturer sent a representative to examine the tanker. No issues could be found other than a delay in the electric-over-air valve activation that occurred after engaging the switch that deploys the water chute. The department asked the manufacturer for an interlock to be installed that would not allow the cab water control switches to be active unless the maxi brake is engaged. The manufacturer stated in a phone interview that the exterior rear control switches are not active until the maxi brake is engaged, but the interior switches are active. Apparatus manufacturers should consider an interlock that will not energize any of the electric-over-air control switches unless the apparatus maxi brake is applied. Fire apparatus manufacturers should also consider placing a switch guard over the vital control switches
