Volunteer Fire Fighter Dies After Being Ejected From Front Seat of Engine—Virginia

Executive Summary

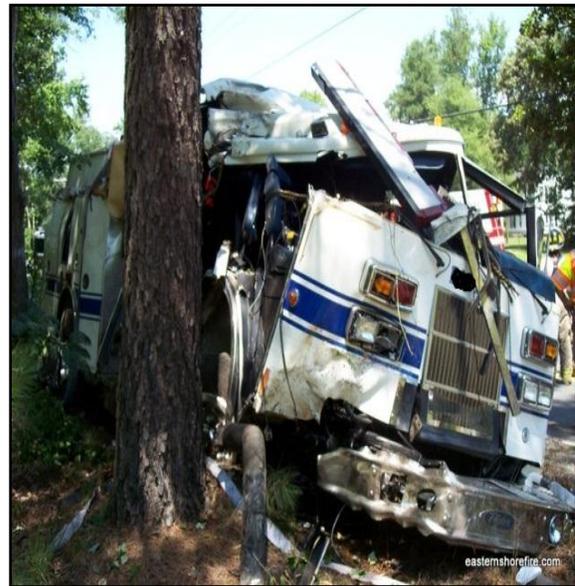
Crash site.

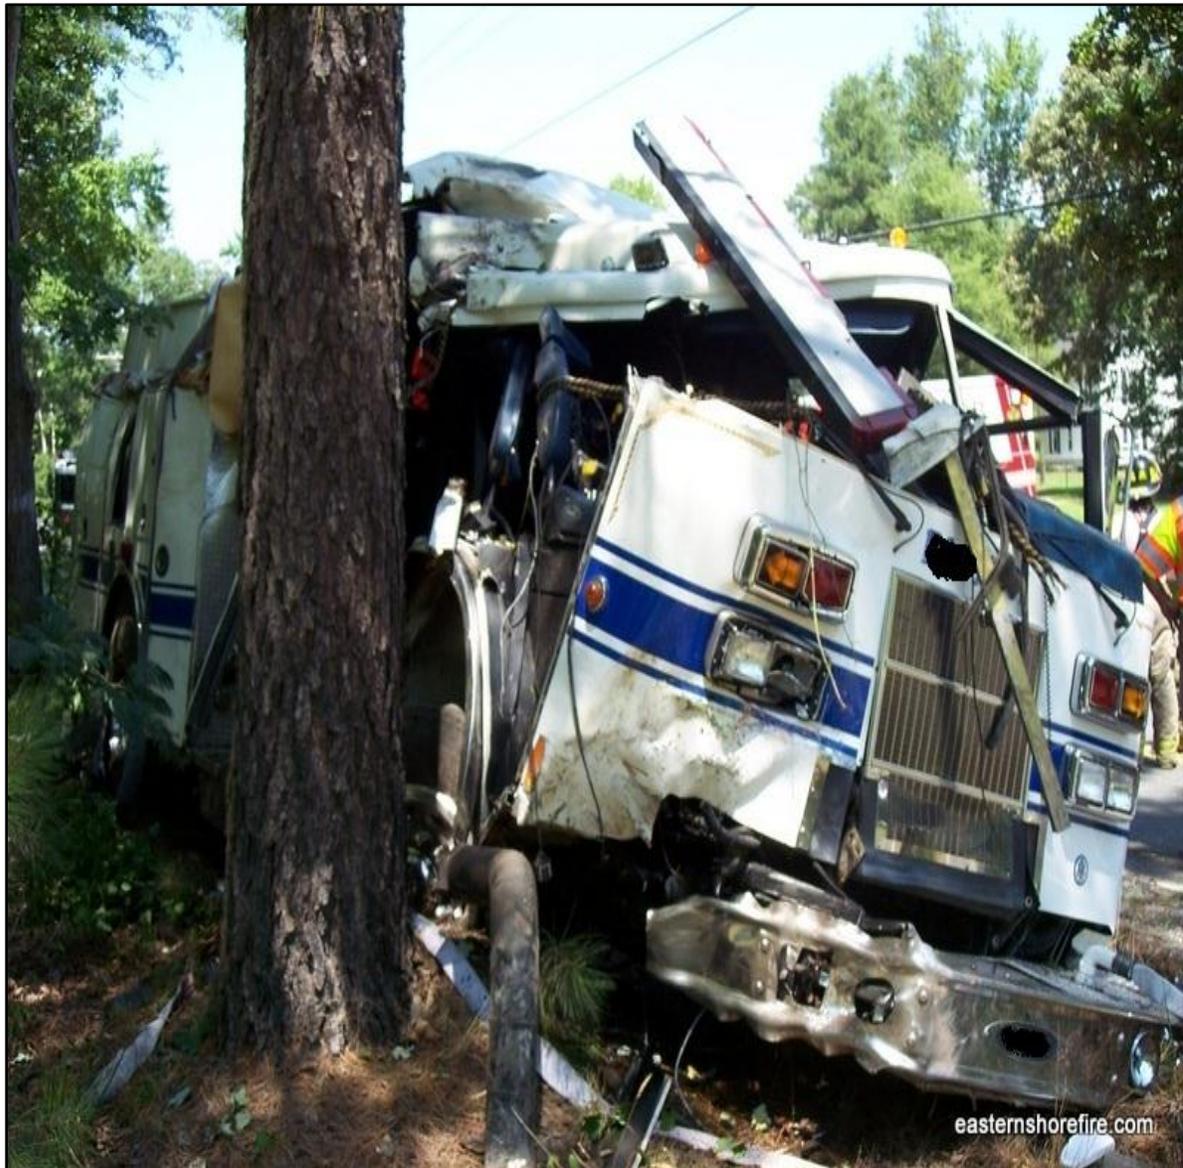
Photo 1. Crash site.
(Photo courtesy of easternshorefire.com.)

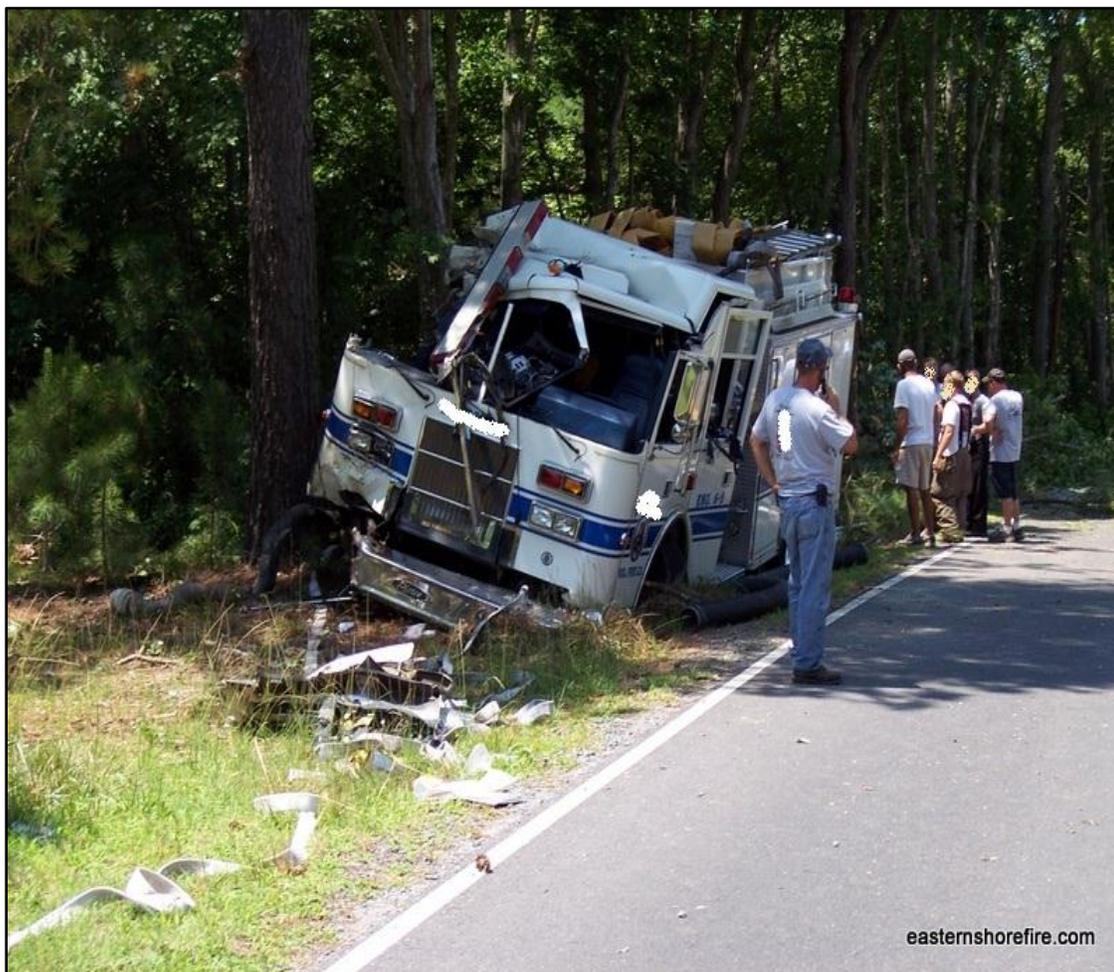
Photo 2. Engine 6-5's final position just off the roadway in the wooded area.
(Photo courtesy of easternshorefire.com.)

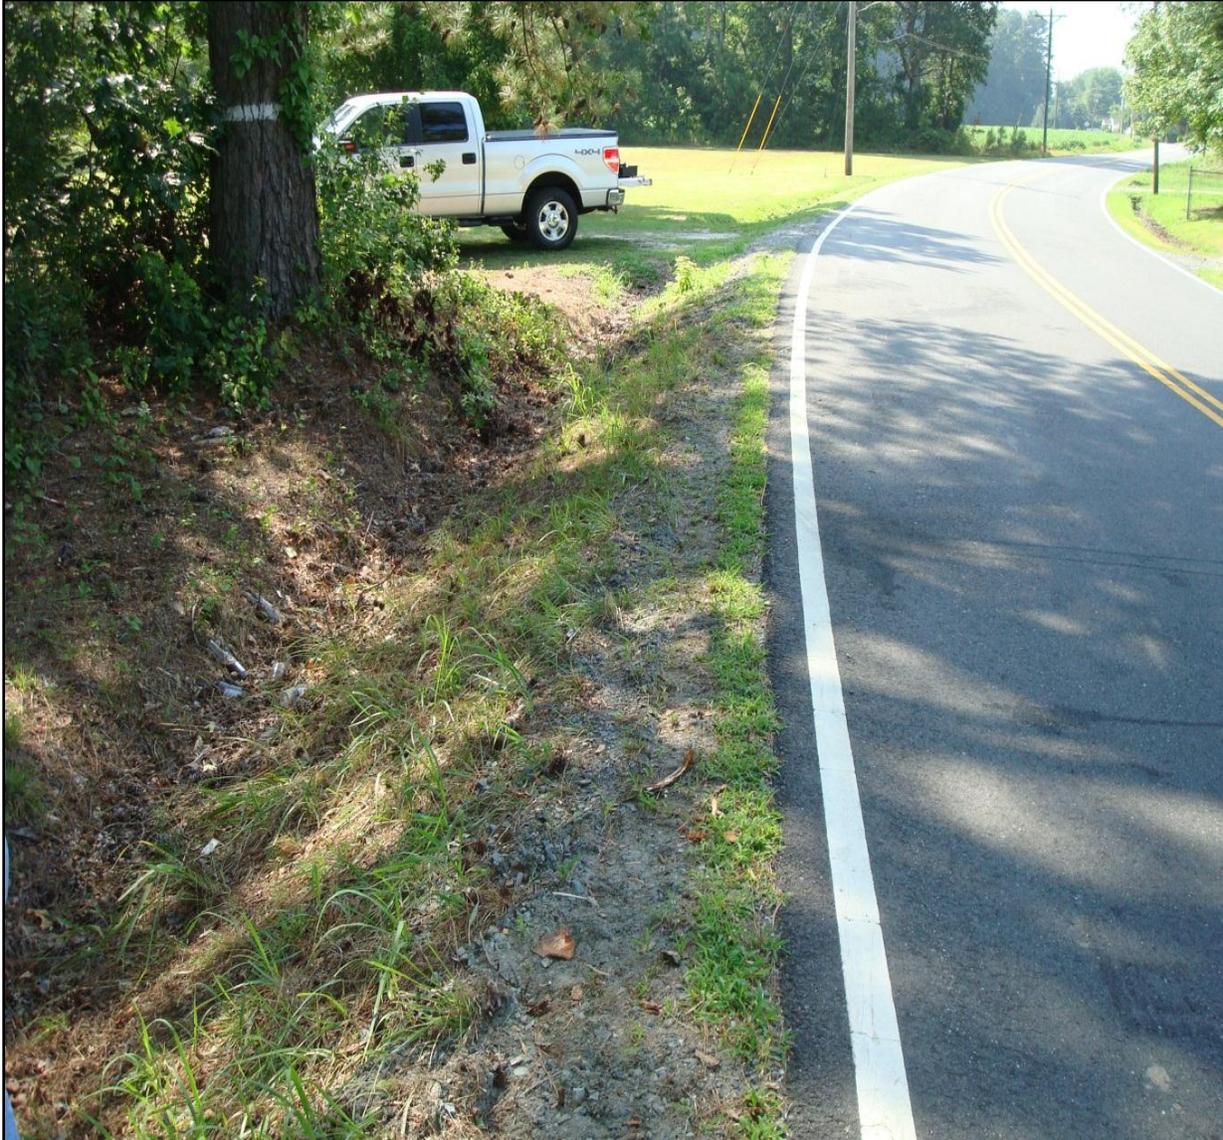
Engine 6-5 was traveling on a two-lane paved asphalt state highway with a posted speed limit of 45 mph. The incident occurred as the engine entered a slight left turn after exiting a right turn. While entering the turn, the right rear wheels of Engine 6-5 left the paved surface and the engine went into the ditch. There was a narrow soft shoulder and ditch at the point where Engine 6-5 left the roadway (see Photo 3). The roadway was narrow and had a minimal shoulder in the curve (see Photo 4). The roadways in the area were reported as dry by other emergency personnel and police. At the time of the

Photo 3. Curve where Engine 6-5 left the roadway. The ditch is visible just to the side of the pavement.
(Photo by NIOSH.)

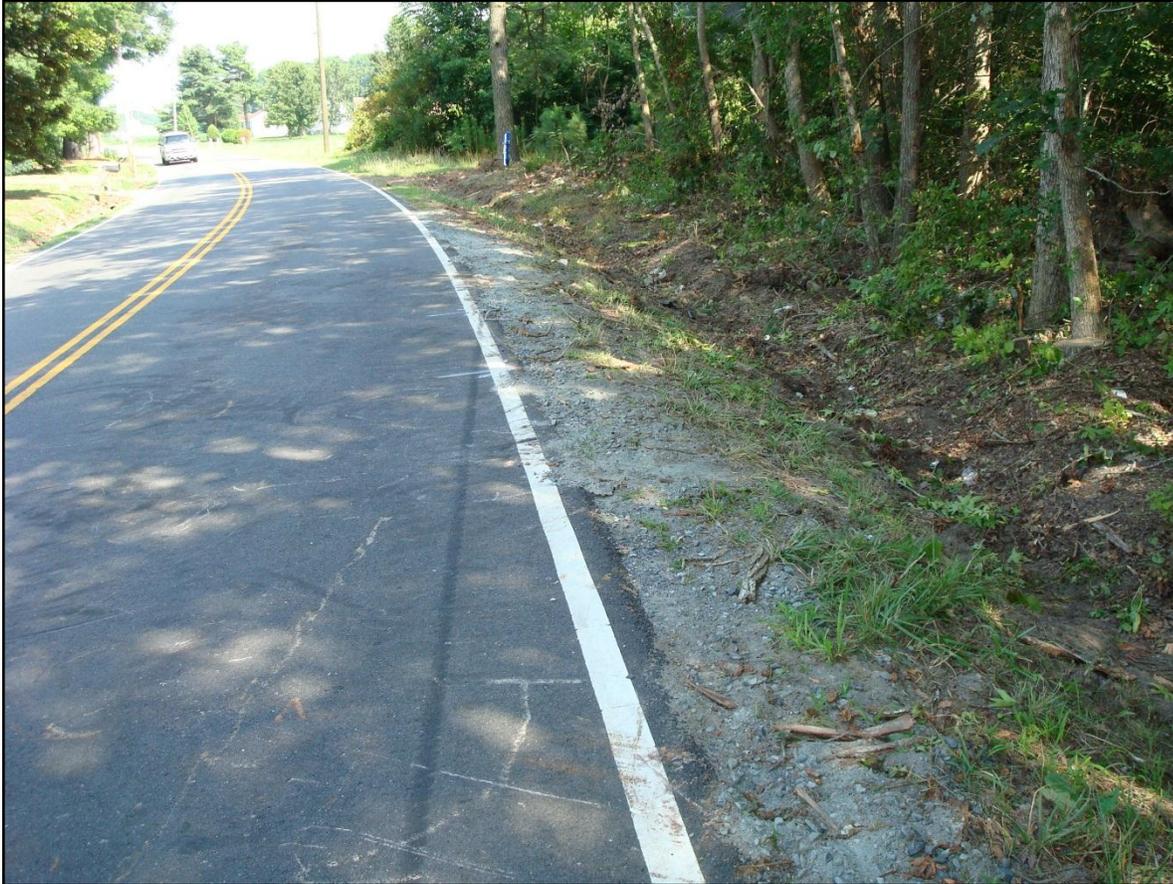
Photo 4. Crash scene after Engine 6-5 was removed. Yaw mark from left side dual wheels. Right side dual wheels were already off the roadway.
(Photo by NIOSH.)

In this incident, the driver of Engine 6-5 stated during interviews that his speed was approximately 35–40 mph and the road conditions were dry. The driver also stated that the truck had seemed sluggish and he had mentioned that to the victim (they had no other conversation during the response). After coming around the first right-hand curve, he started to enter the second left-hand curve and he described the rear end as being “picked up and moved over to the right.” The truck’s right wheels dropped off the pavement and traveled in the ditch and struck a utility pole and several trees. Engine 6-5 did have anti-lock brakes, and yaw marks on the roadway showed the point where Engine 6-5 left the pavement and entered the ditch (see Photo 4).

The state police crash report estimates the speed of Engine 6-5 to have been 55 miles per hour and notes failure to maintain proper control by the driver as a factor. The posted speed limit for the highway was 45 miles per hour. The roadway was narrow and had a minimal shoulder in the curve (see Photo 4). The state police crash reconstruction personnel examined the truck and could find no issues with the truck regarding braking or steering. There were no indications that anything was mechanically wrong with the truck. The truck was sent to the manufacturer’s refurbishment plant in Wisconsin for evaluation and possible repair.

Recommendation #1: Fire departments should ensure that fire department drivers/operators are trained in techniques for maintaining control of their vehicles at all times.
