Career Captain Sustains Injuries at a 2-1/2 Story Apartment Fire then Dies at Hospital – Illinois

A summary of a NIOSH fire fighter fatality investigation

September 24, 2013

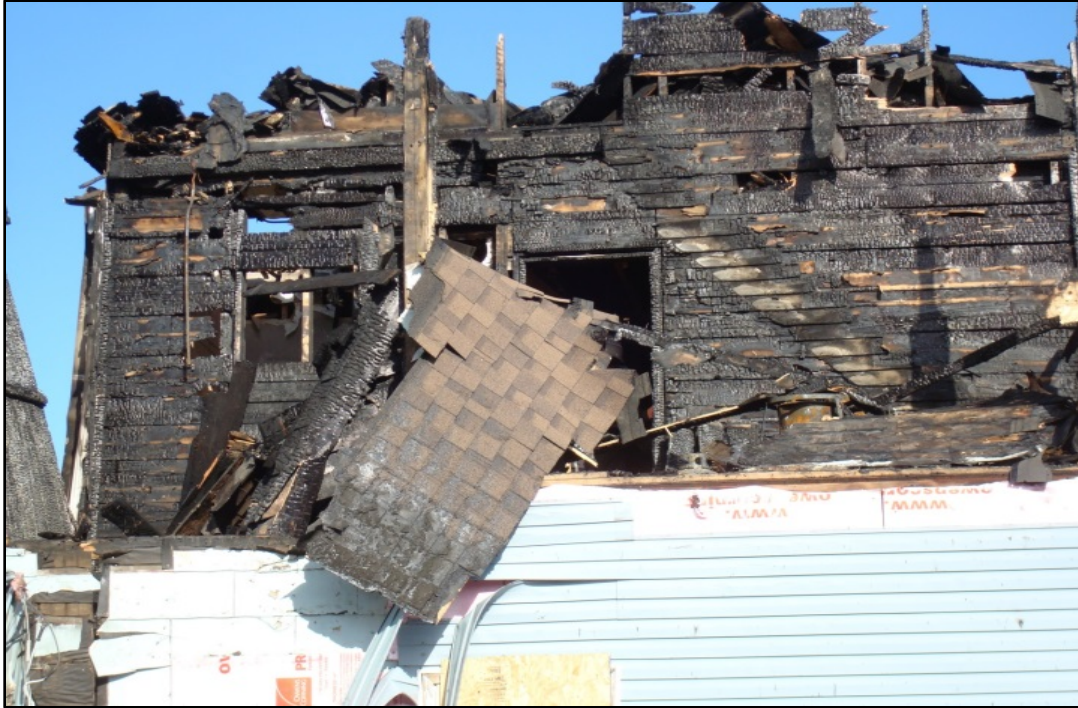
**Photo 4. Second floor doorway to covered porch, in which, the victim was operating behind
(NIOSH Photo)**
