Two Career Lieutenants Killed and Two Career Fire Fighters Injured Following a Flashover at an Assembly Hall Fire—Texas

Executive Summary

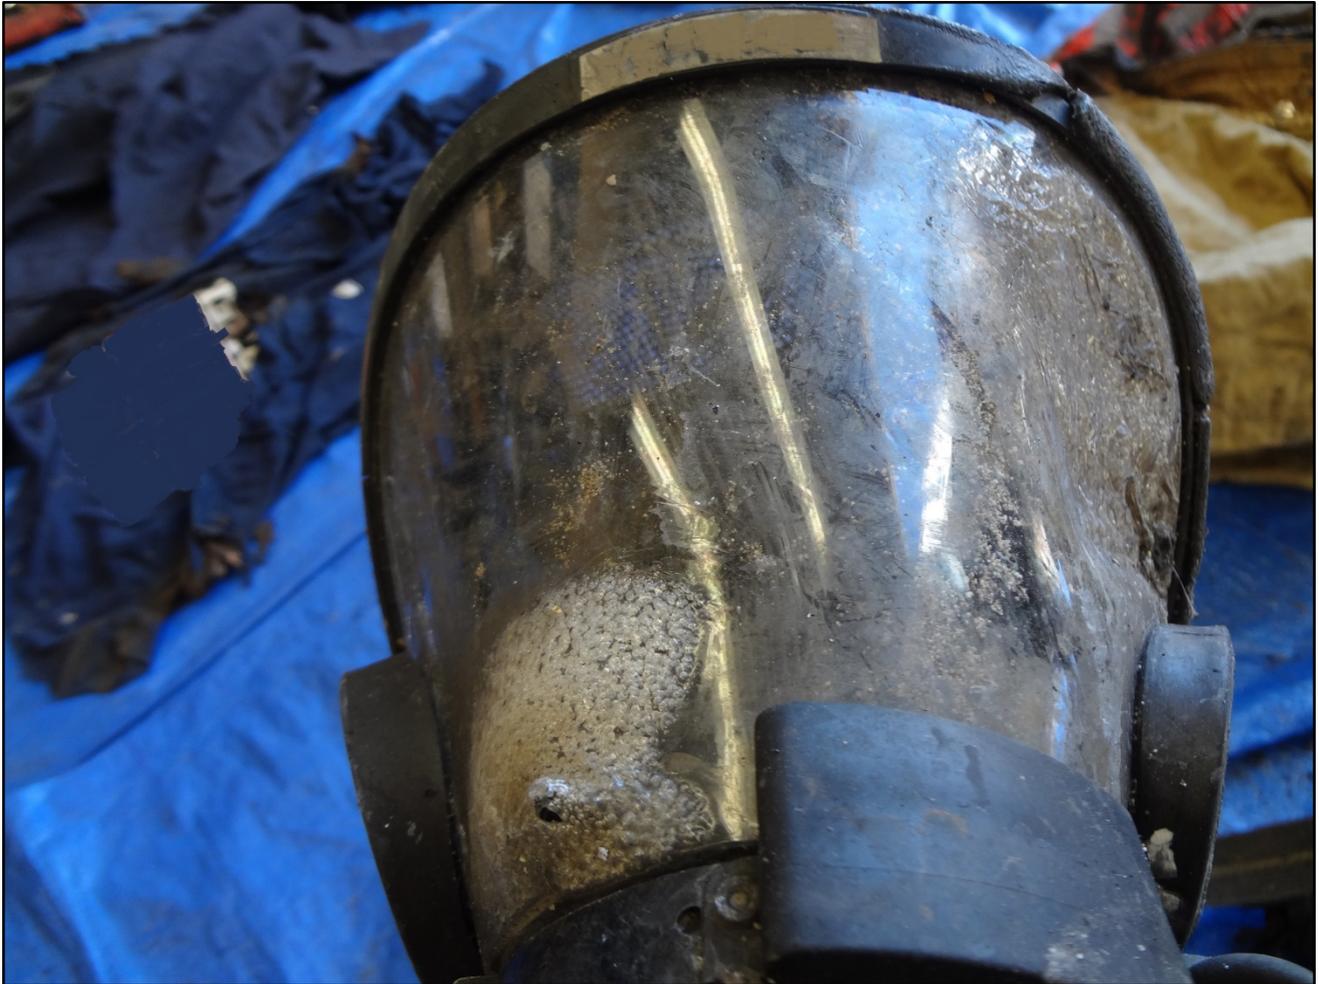
NIOSH NPPTL evaluated all four SCBAs to determine conformity to the NIOSH-approved configuration (see Appendix I). Information that could be retrieved from the four PASS device data loggers were also downloaded with assistance from the SCBA manufacturer. NIOSH investigators noted that all four facepieces showed signs of thermal degradation (see Photos 1-4).

Photo 1. Victim #1's facepiece showing thermal degradation.
(NIOSH photo.)

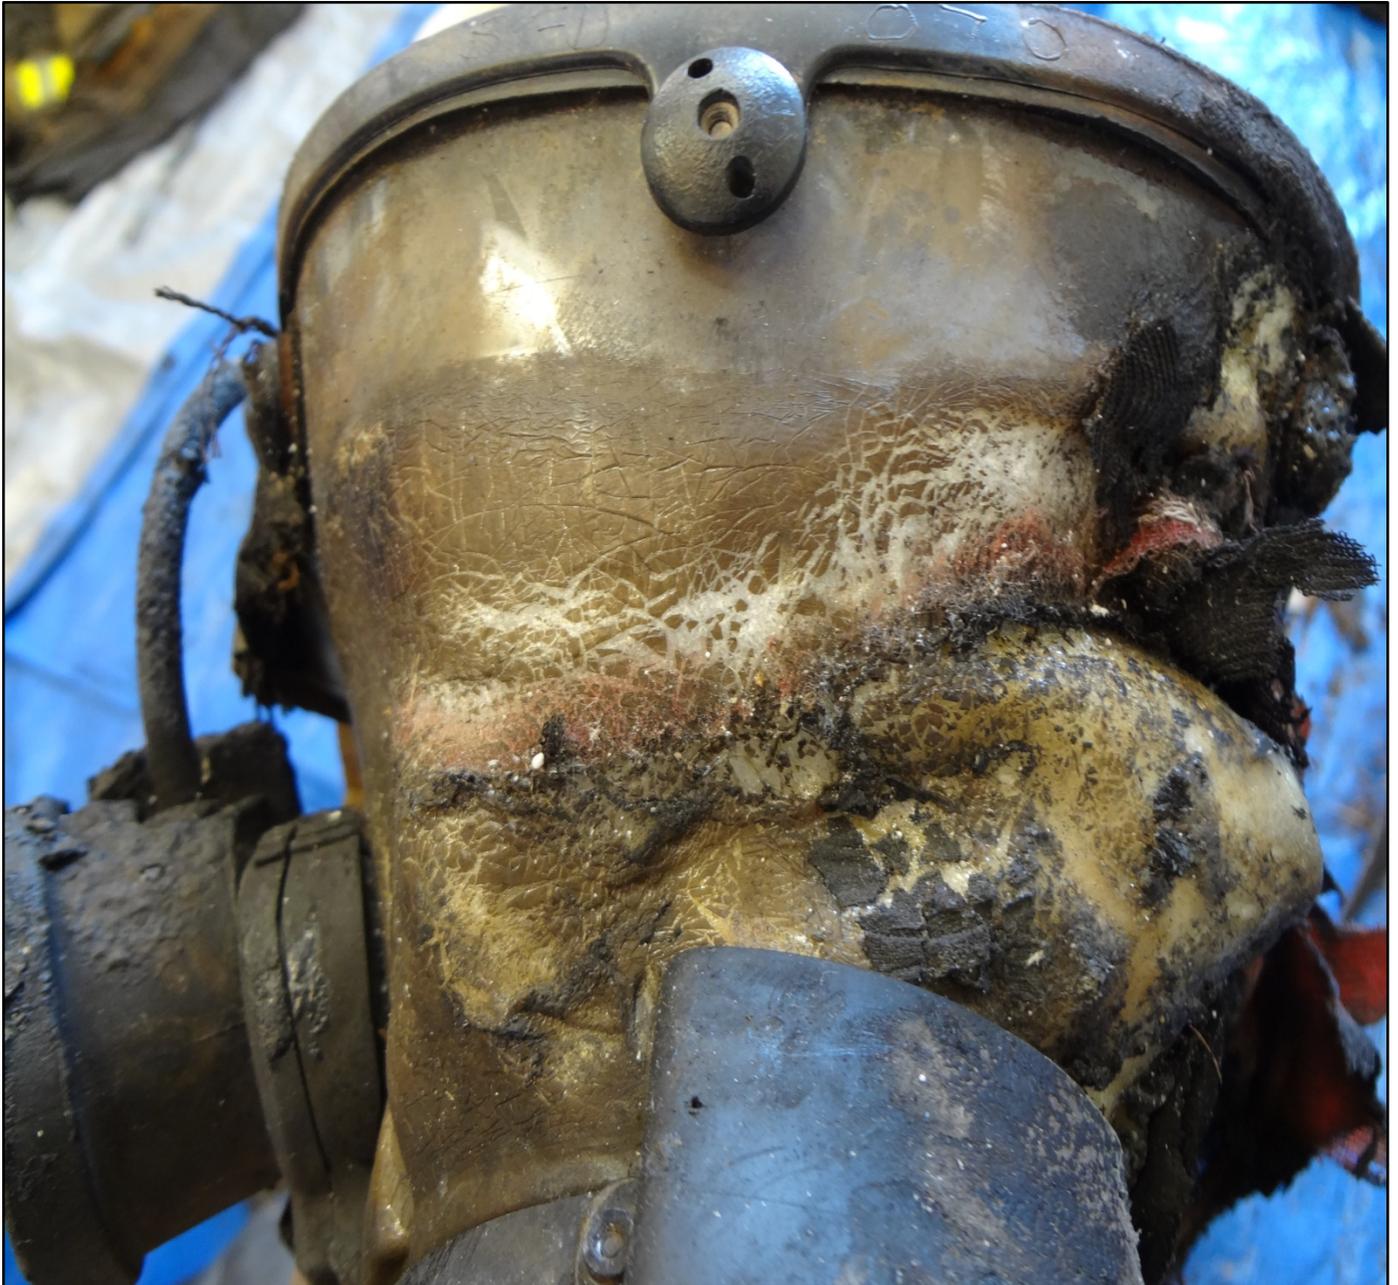
Photo 2. Victim #2's facepiece showing thermal degradation.
(NIOSH photo.)

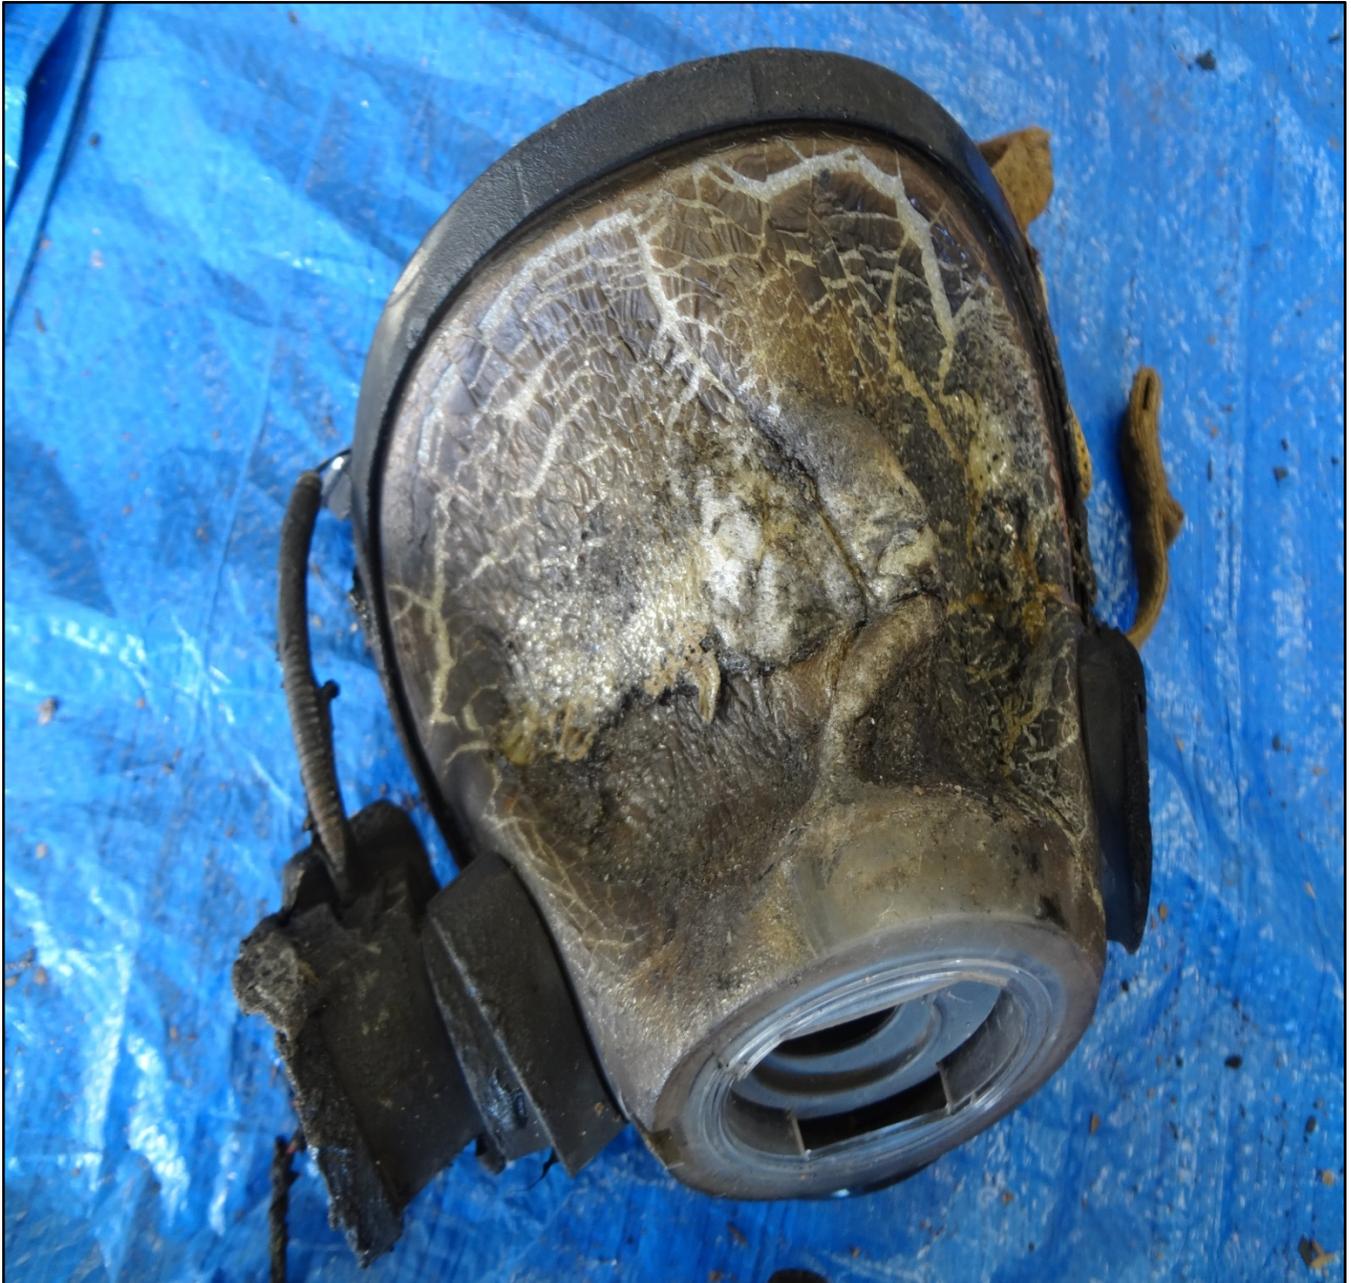
**Photo 3. FF1's facepiece showing thermal degradation.
(NIOSH photo).**

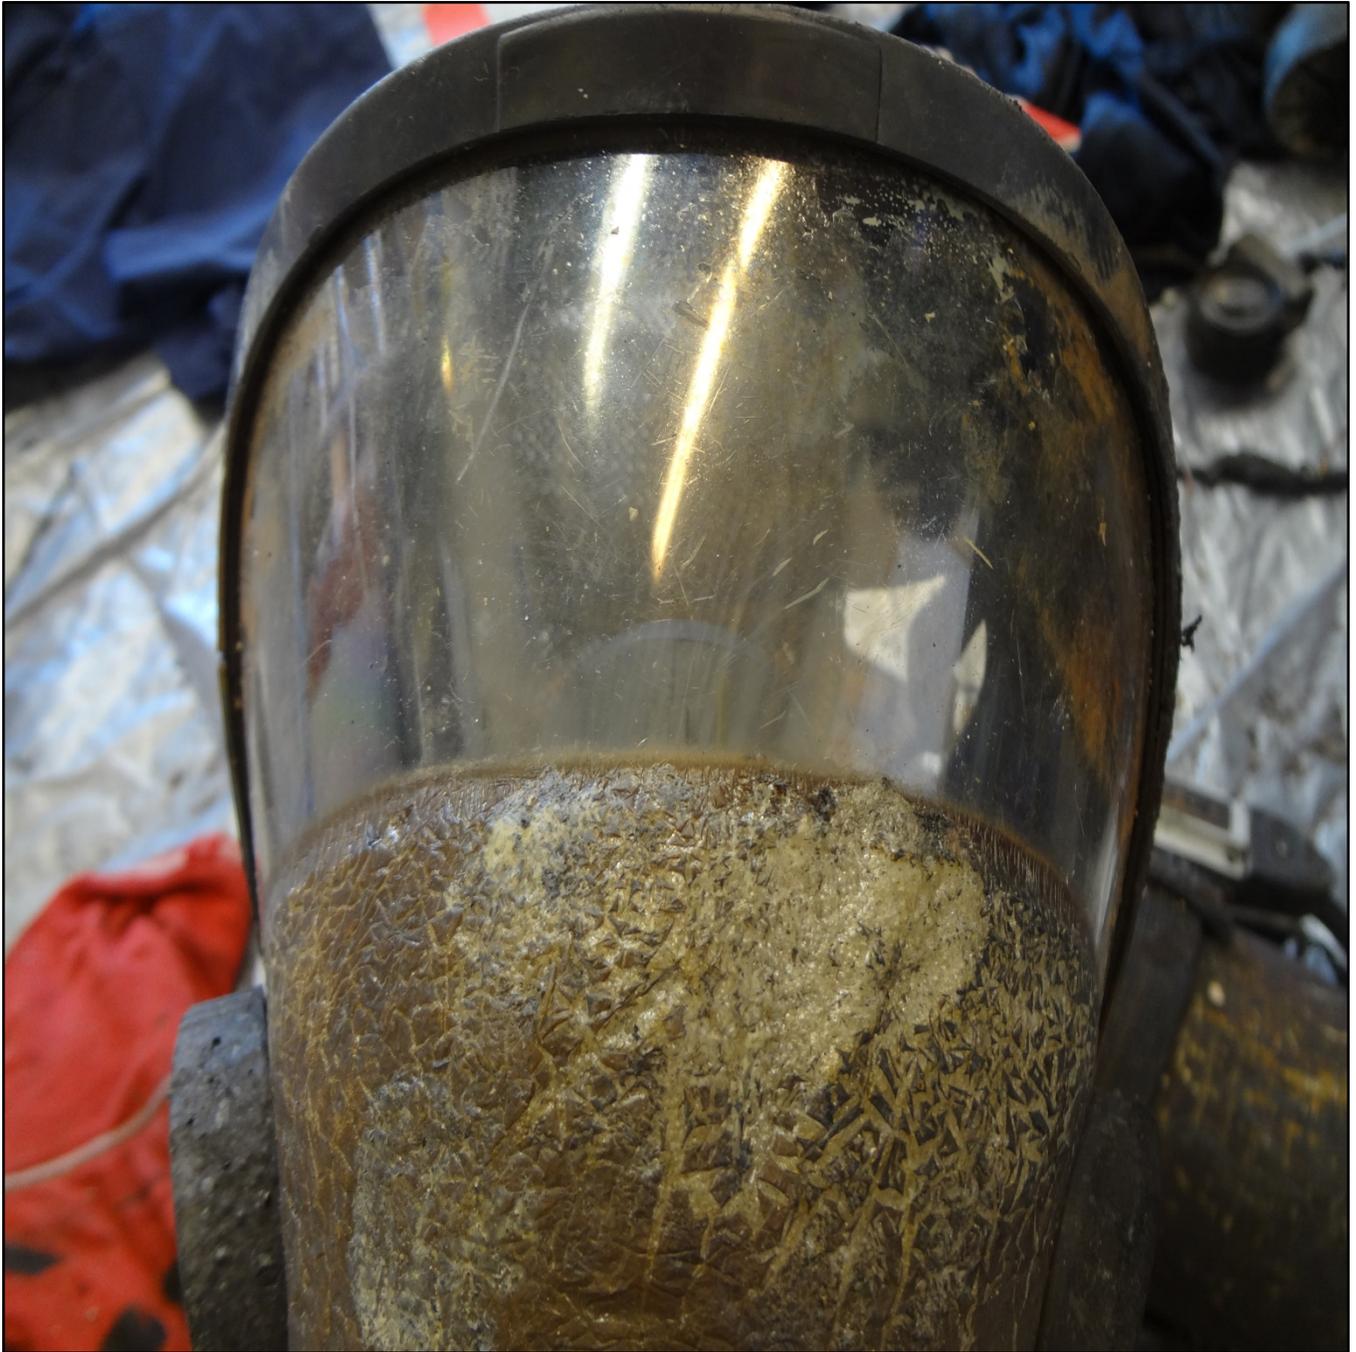
Photo 4. FF2's facepiece showing thermal degradation.
(NIOSH photo.)

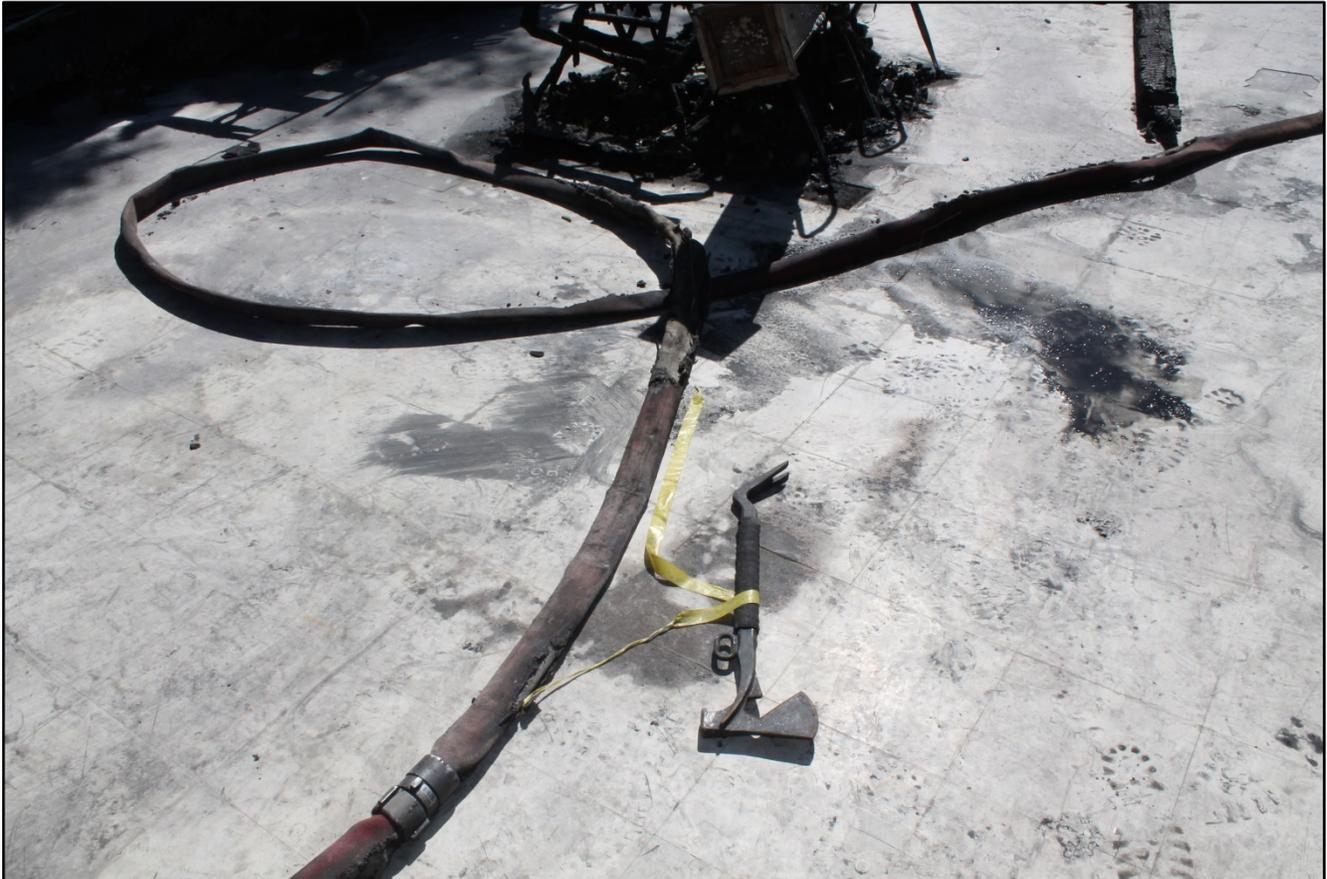
IC replied, "Follow the red hoseline out, follow the red hoseline out." Victim #1 advised, "Negative, command, I can't do it, cause I had stuff fall on the hoseline and I'm disoriented on it. Please send help." IC replied, "Follow the red hoseline out."

Photo 10. Close up of loop in hoseline. Photo taken after incident scene cleared of fire debris.
(Photo courtesy of state fire marshal.)

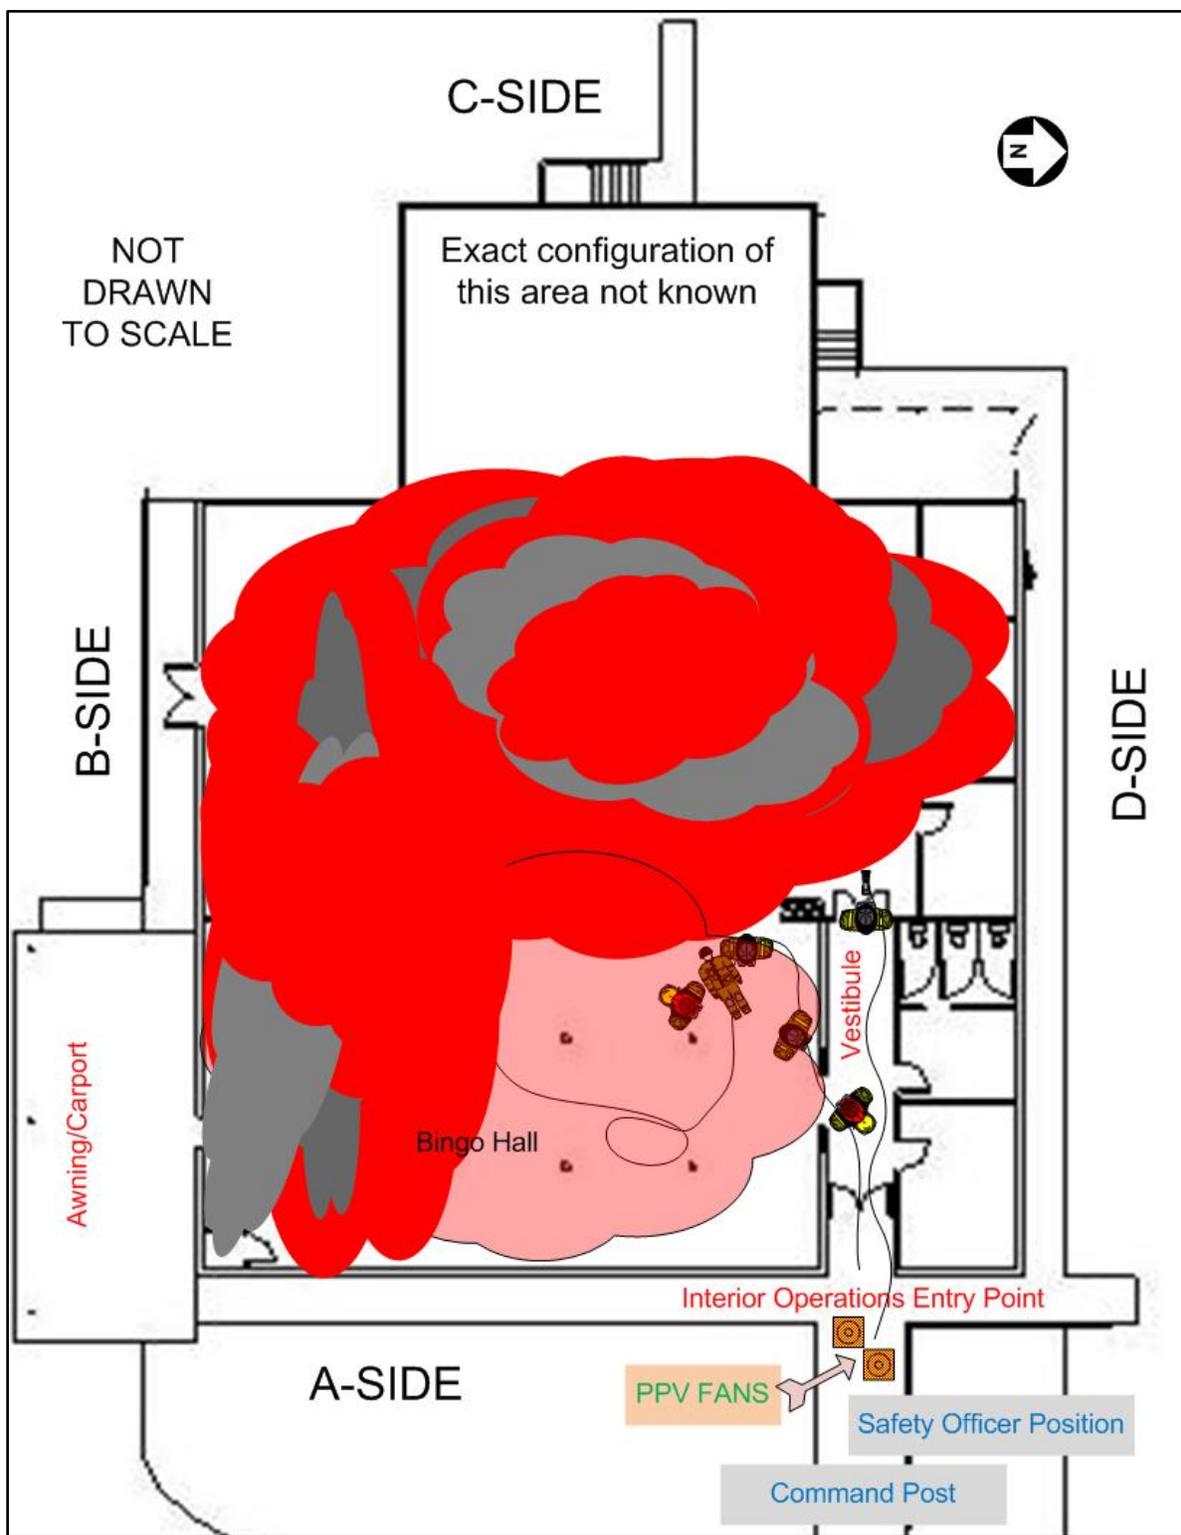
After positioning his nozzle man at the dance hall threshold the E2 officer briefly came off the yellow hoseline to look into the bingo hall again. He now observed what appeared to be fire fighters off to the right enveloped in fire and dragging Victim #1 (see Diagram 3). During the investigation, the E2 fire fighter reported to NIOSH that while advancing the hoseline past the bingo hall doorway, he heard the sound of a PASS alarm in the bingo hall and assumed his officer heard it too.

Diagram 3. Rendering of what was observed by E2 officer.
