Career Lieutenant Killed Following a Walkway Collapse While Working to Evacuate a University Student Housing Building—Missouri

A summary of a NIOSH fire fighter fatality investigation

January 26, 2015

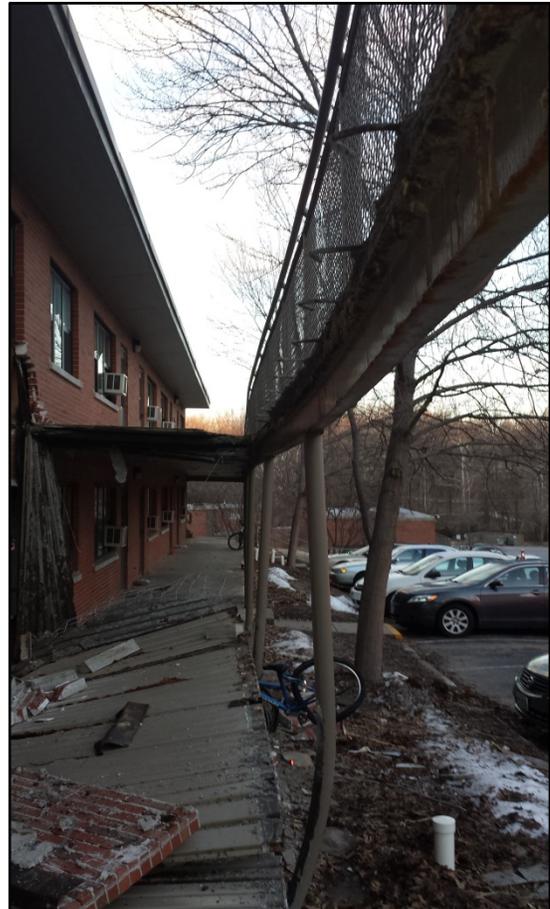
Collapse area.
(Photo courtesy of university contracted structural engineer.)

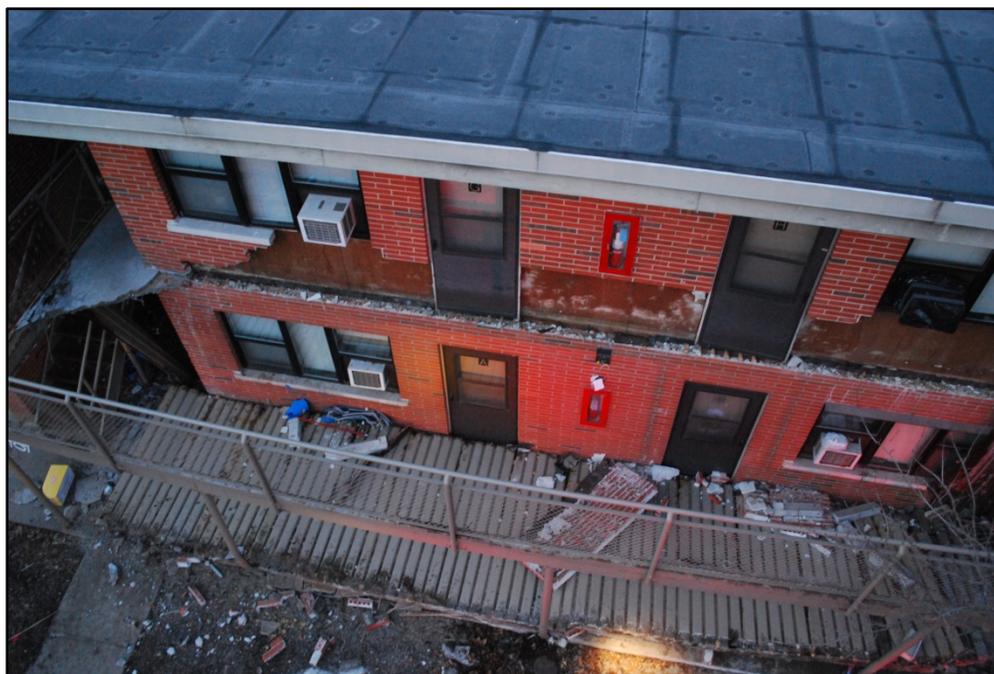
*Aerial view of collapse area.
(Photo courtesy of fire department.)*

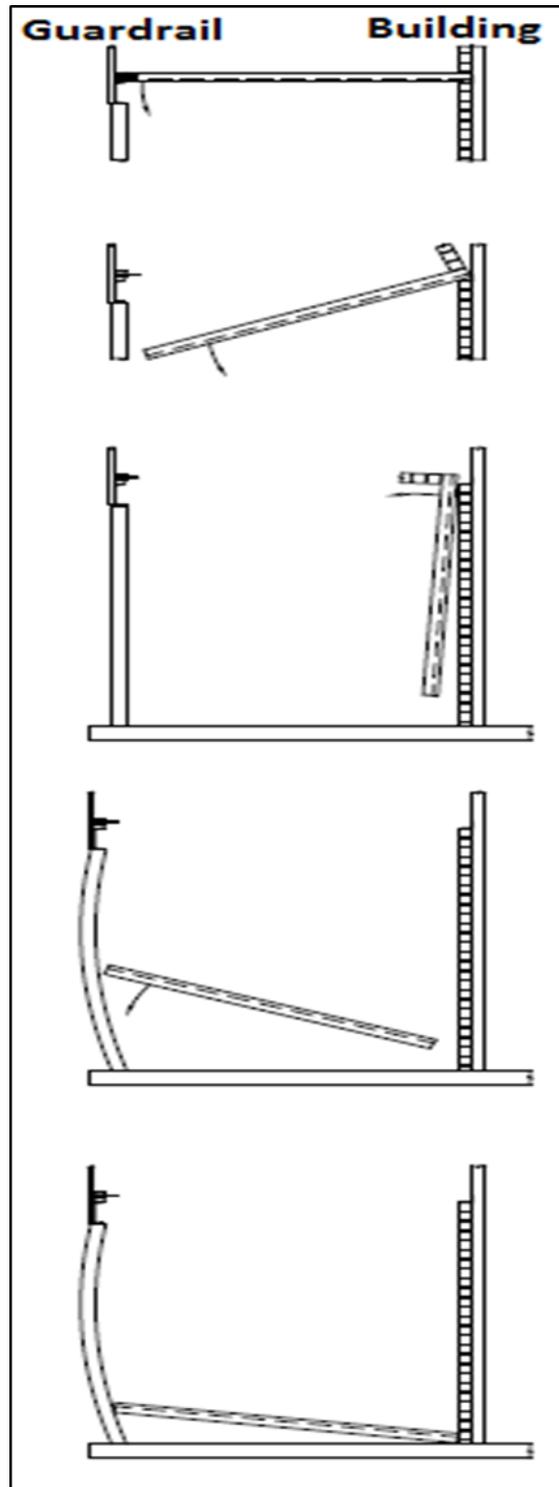
Figure 1. Schematic of how the walkway collapsed.
(Figure courtesy of university contracted structural engineering firm.)

As described above, all of these components were severely deteriorated, which made it very difficult to precisely determine what happened based solely on the observed debris. Additionally, surveillance video or reliable firsthand reports were not made available. However, the structural engineering firm was confident that the collapse was a result of a concrete shear failure along the outer edge. It was likely that water and chlorides, and expansion from freeze-thaw action, combined to deteriorate the concrete to the point where its shear strength could no longer support even the self-weight of the walkway. According to the structural engineering firm, the loud “bang” reported by the residents (see Investigation section) was probably the sound from the shear failure itself. The walkway then likely sagged but remained suspended due to membrane action of the slab supported at the ends and along the face of the building. Once the load surpassed the bond and tension strength of the mesh reinforcing, the slab broke free from the ends and the front edge dropped (see Figure 1).

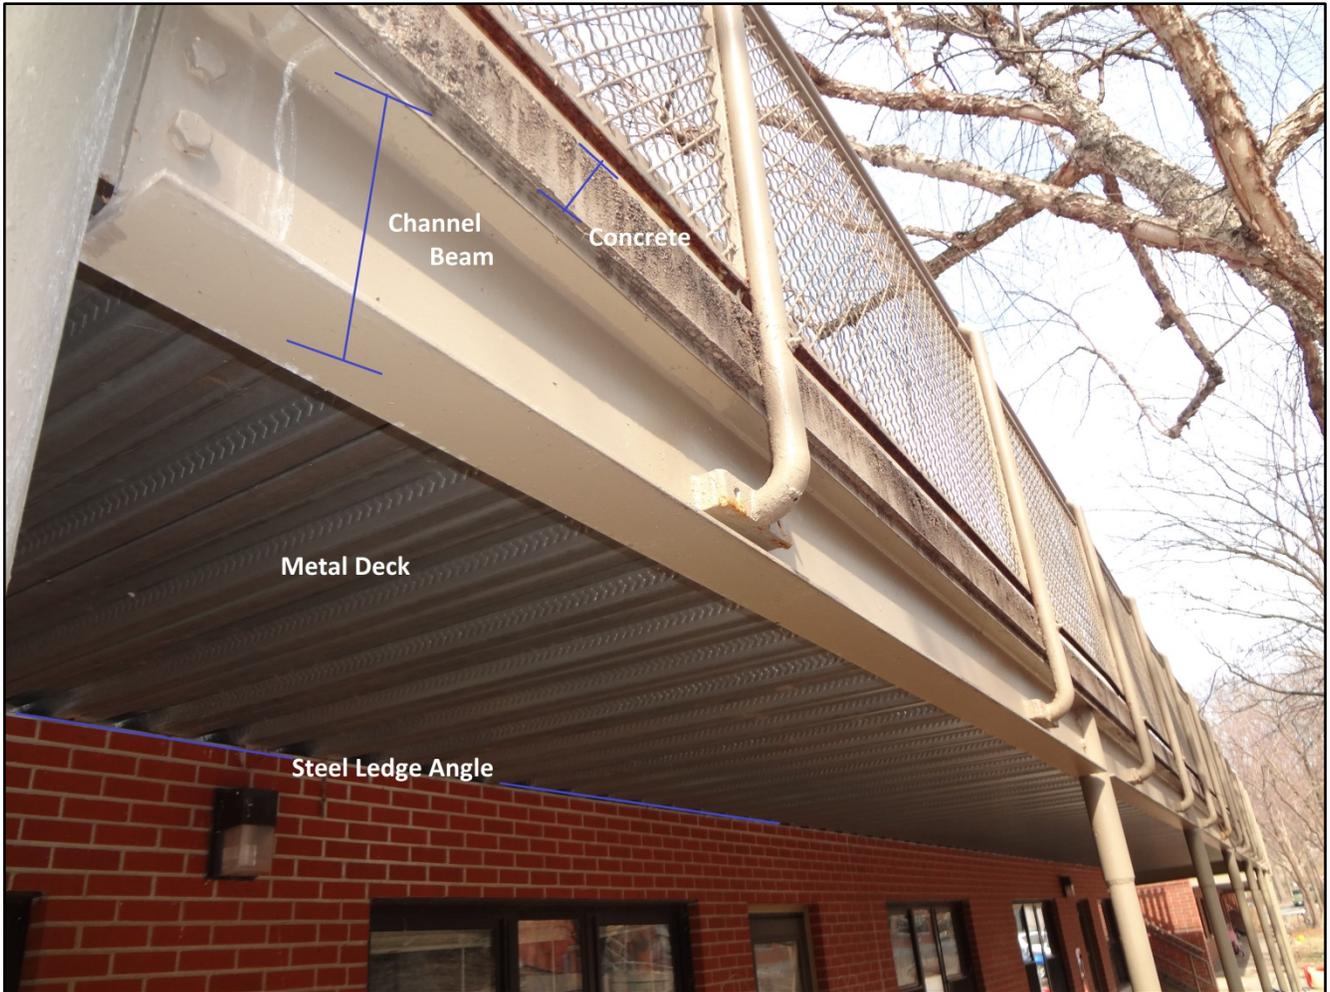
Photo 1. Walkway at another building within the same complex that had been repaired in 2004. (NIOSH photo.)

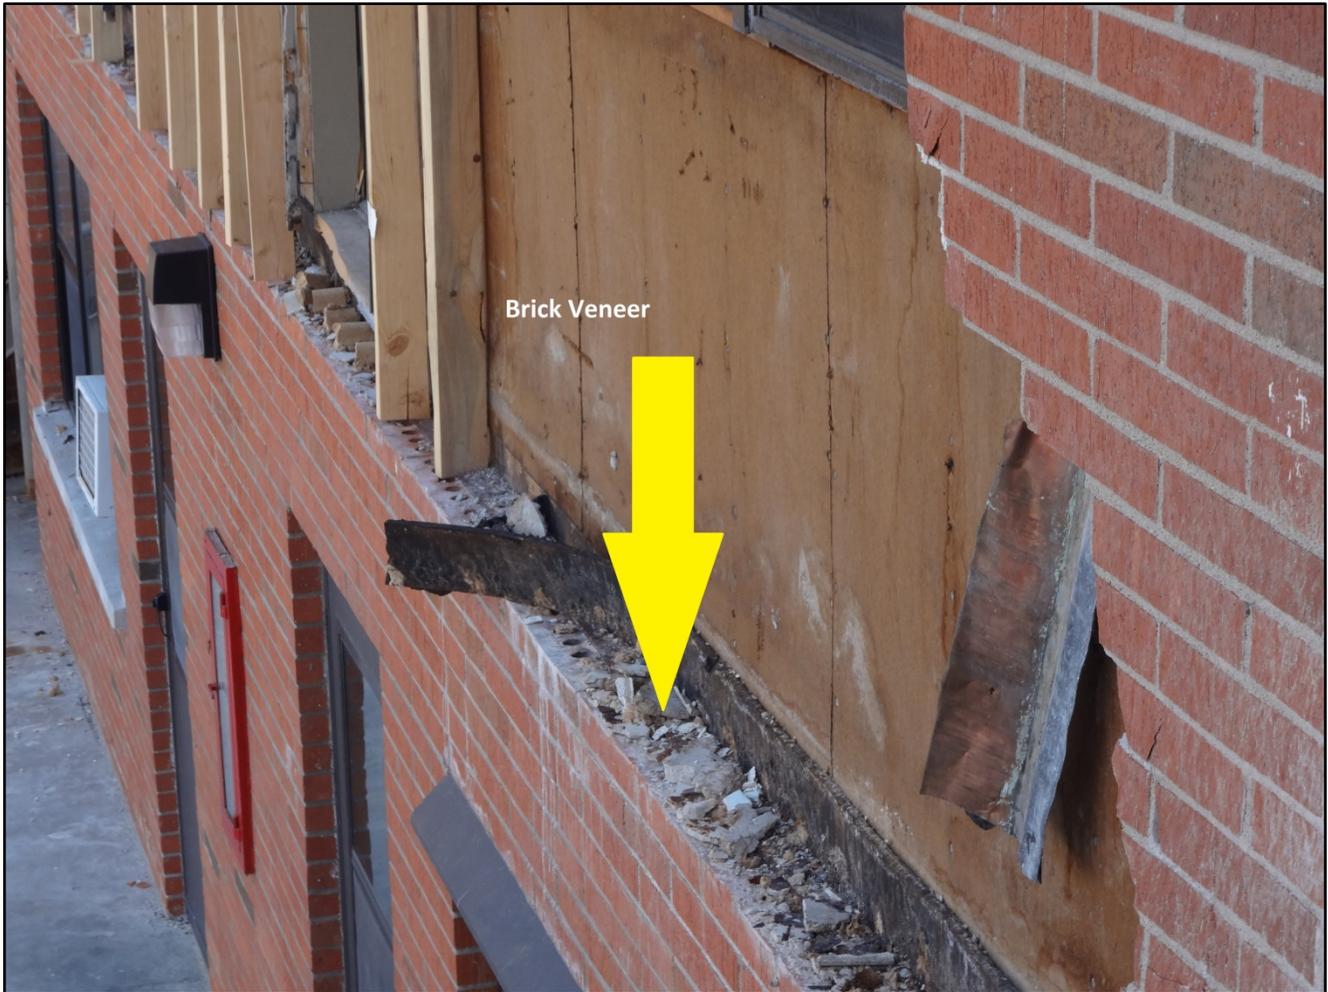
Photo 2. Top of brick veneer that supported the steel ledger at the inner edge (building side) of the walkway. Note how the collapse has pulled brick veneer above the walkway from the vertical wall, exposing the wood framing.
(NIOSH photo.)

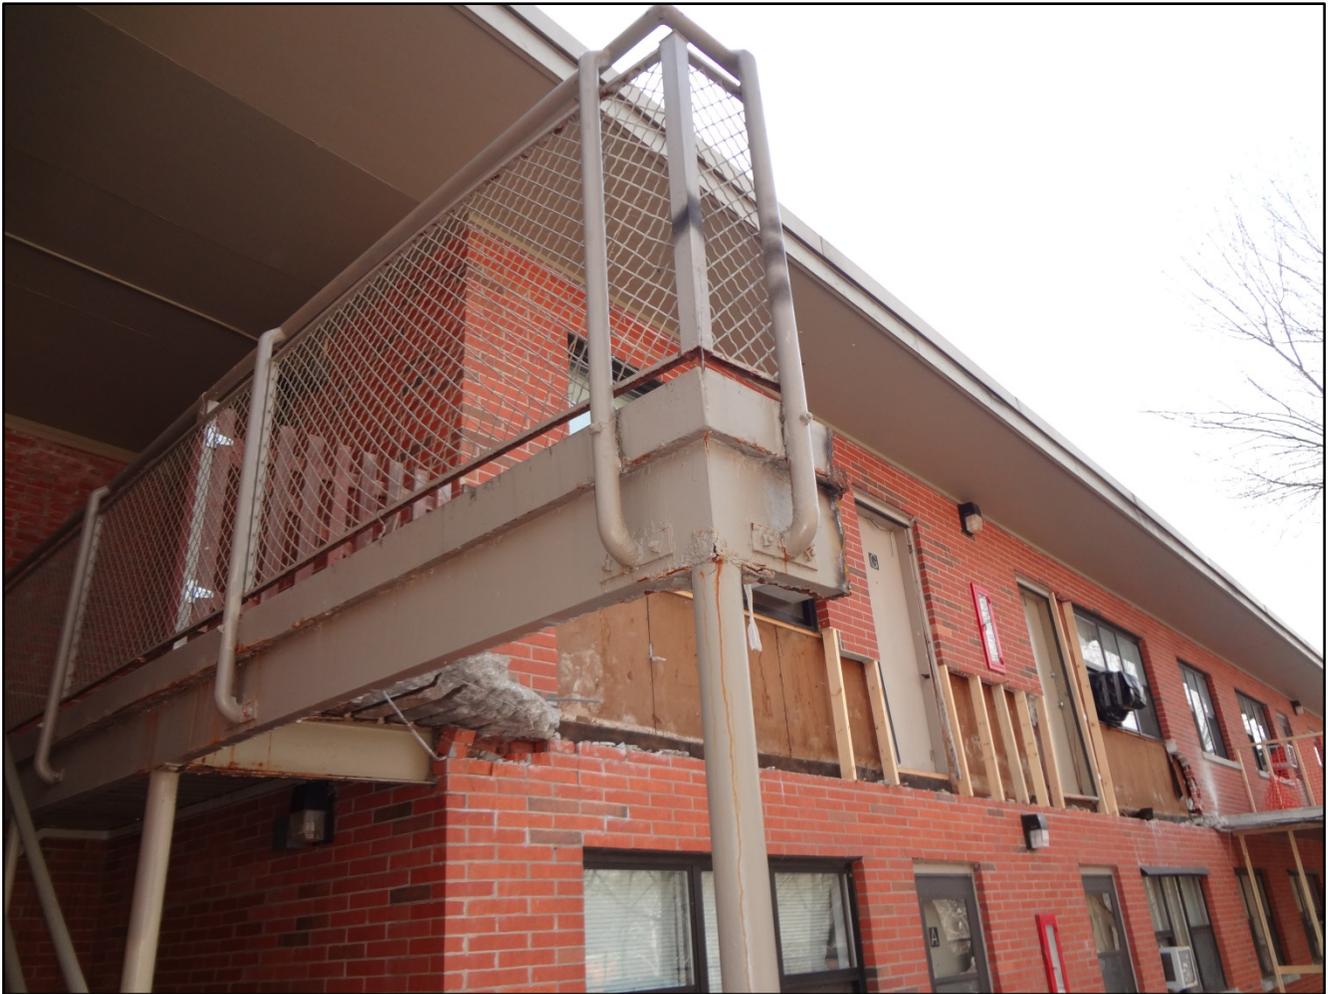
**Photo 3. Steel guardrail attached to channel with vertical posts.
(NIOSH photo.)**

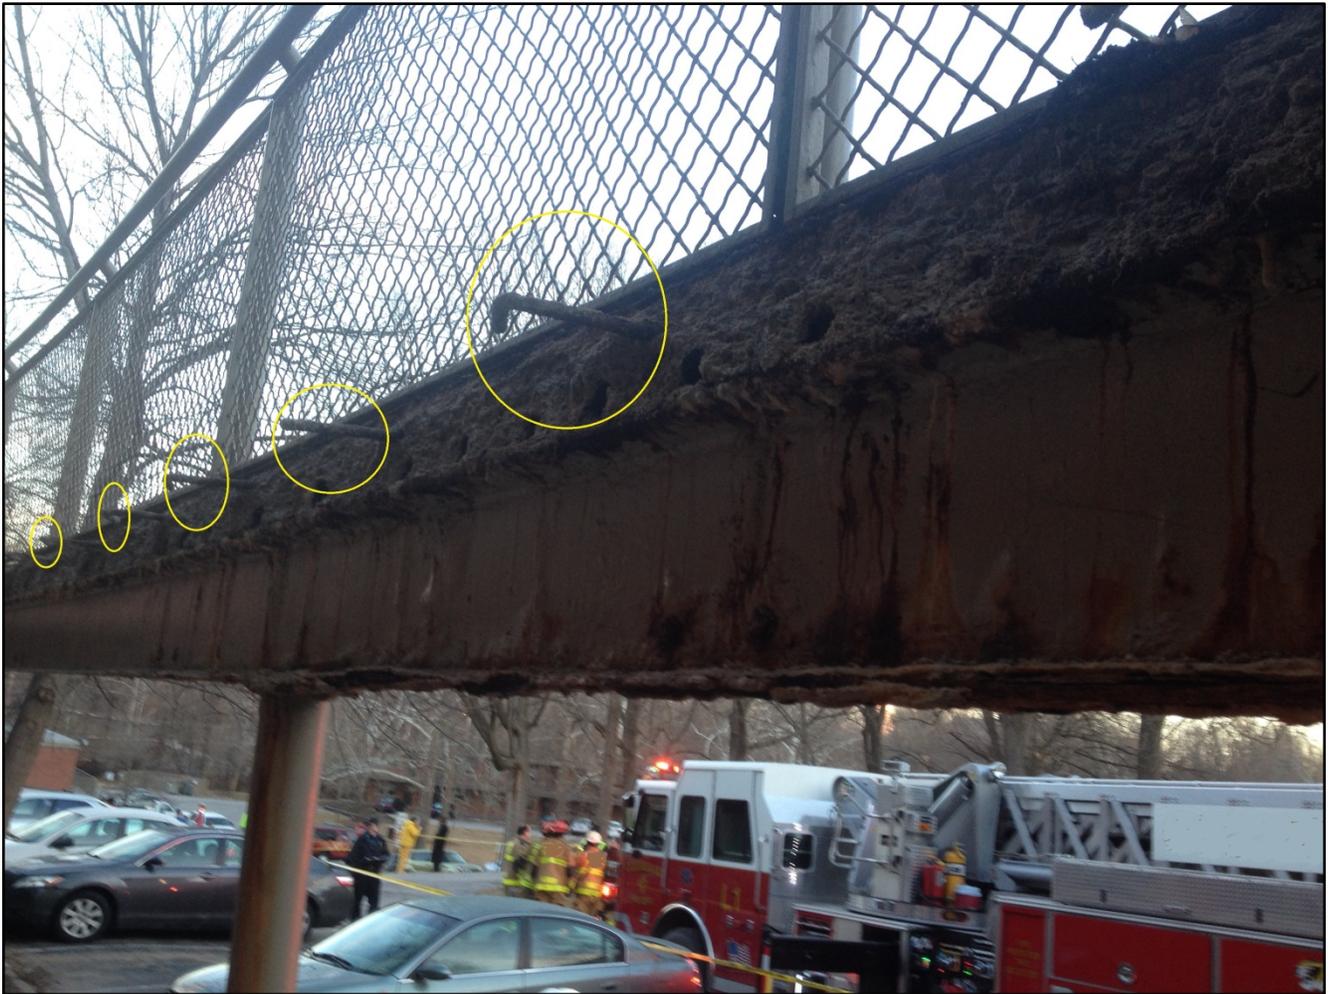
The elevated walkway framing consisted of a 1½-inch painted metal deck with 2½ inches of concrete (4 inches total), supported on a steel ledger angle attached to the building and a 9-inch painted steel channel beam along the outer edge (see Photo 1). The exact method of attachment of the steel deck had not been verified at the time of the report. Although the ledger angle was bolted to the building's wood framing, the walkway gravity loads were actually supported by the veneer brick below because the brick had been mortared tight to the underside of the horizontal leg of the ledger (see Photo 2). The outer 9-inch channel was supported by steel pipe columns spaced 12 feet on center. The edge of the walkway was protected by a steel guardrail with vertical posts that were attached to the face of the 9-inch channel and an angle that was embedded into the top edge of the concrete slab (see Photo 3). The top angle had ½-inch smooth "J" dowels spaced on approximately 2-foot centers that were cast into the 4-inch walkway slab (see Photo 4).

Photo 4. Spacing of dowels within walkway concrete slab.
(Photo courtesy of university contracted structural engineering firm.)

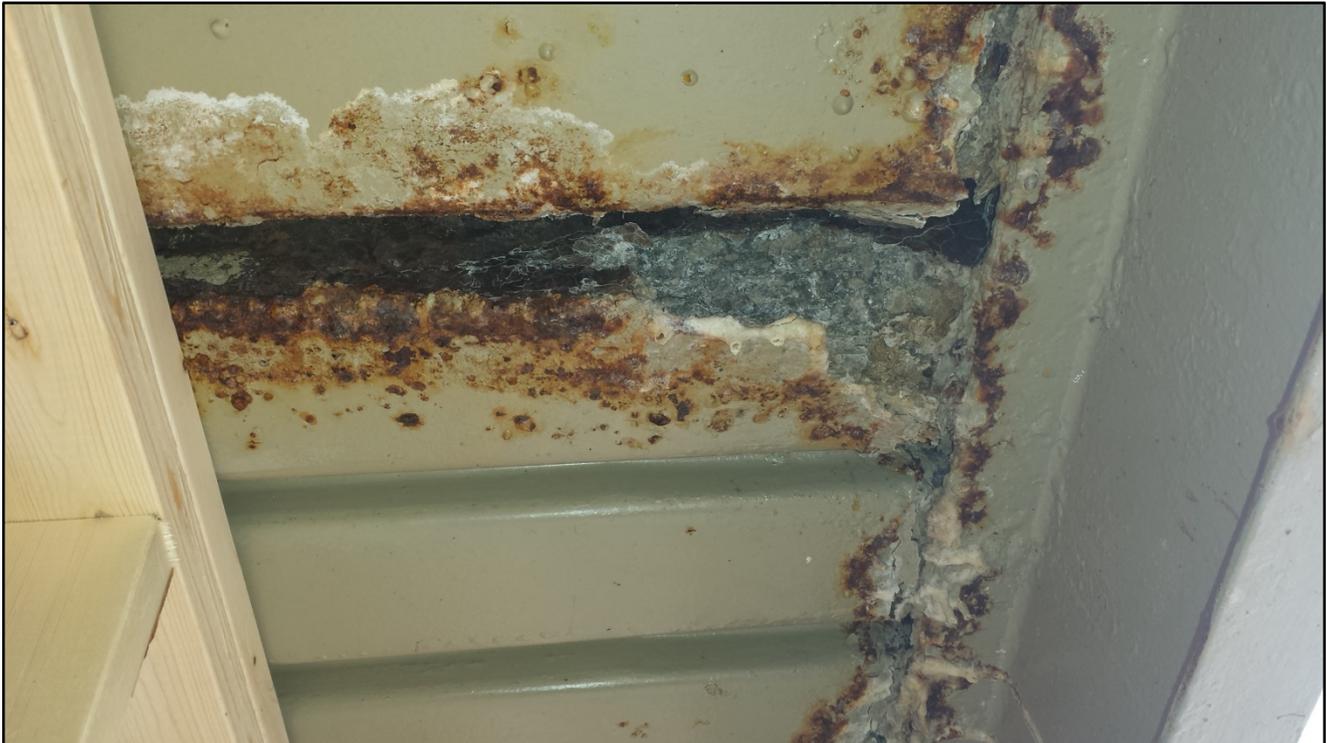
In general, the walkway support beams, metal deck, and concrete slab were all found to be significantly deteriorated (see Photo 5). The 9-inch channels and metal deck were heavily corroded, and portions of the concrete slab were delaminated and showed signs of severe weathering (see Photo 6). In addition to the deterioration at the outer edge, a few longitudinal cracks in the steel deck were observed that extended nearly the full width of the walkway (see Photo 7).

Photo 5. Deterioration of underside of metal deck with concrete showing.
(Photo courtesy university contracted structural engineering firm.)

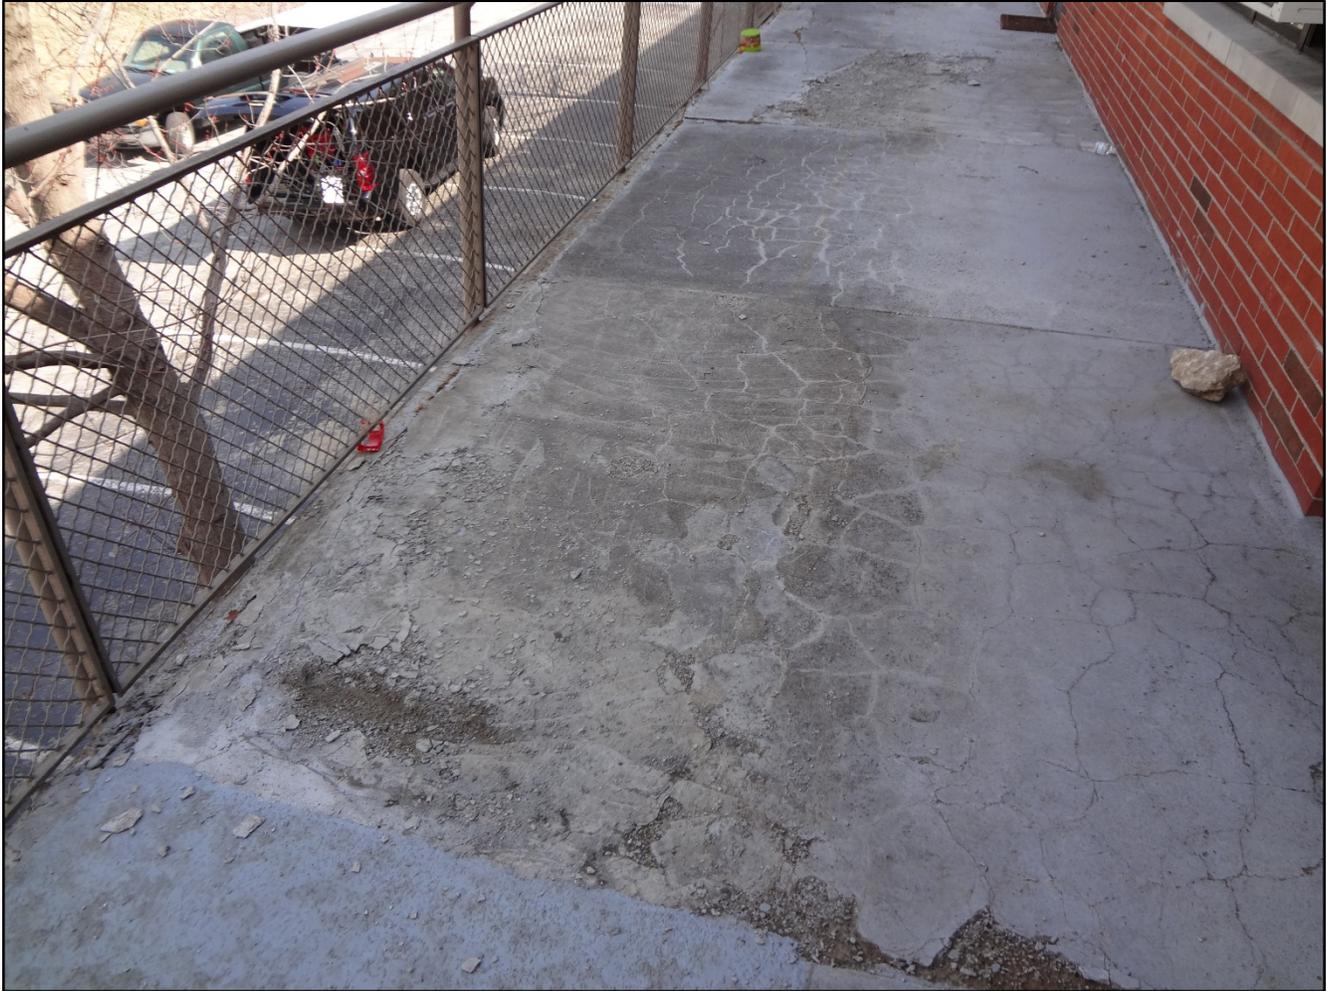
**Photo 6. Delamination of the remaining section of walkway. The concrete walkway was approximately 90 inches wide.
(NIOSH photo.)**

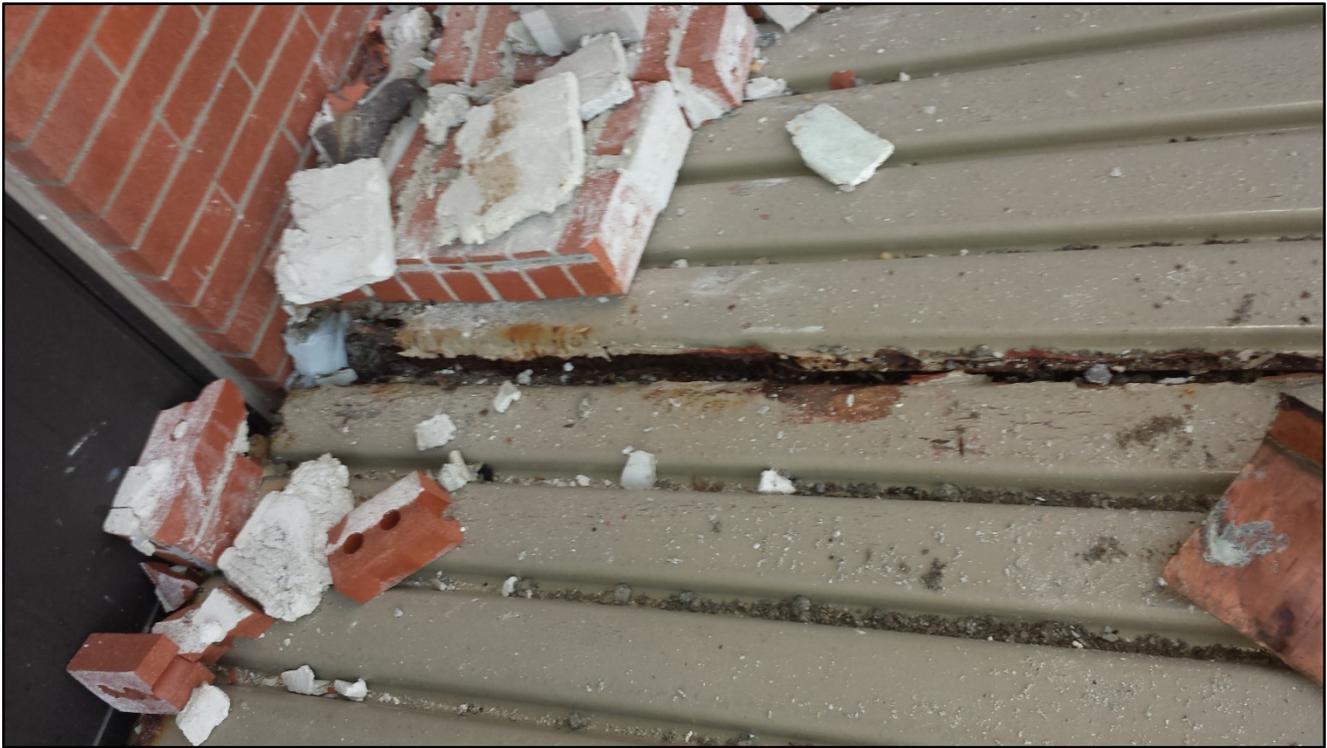
Photo 7. Longitudinal corrosion of the metal deck.
(Photo courtesy of university contracted structural engineering firm.)

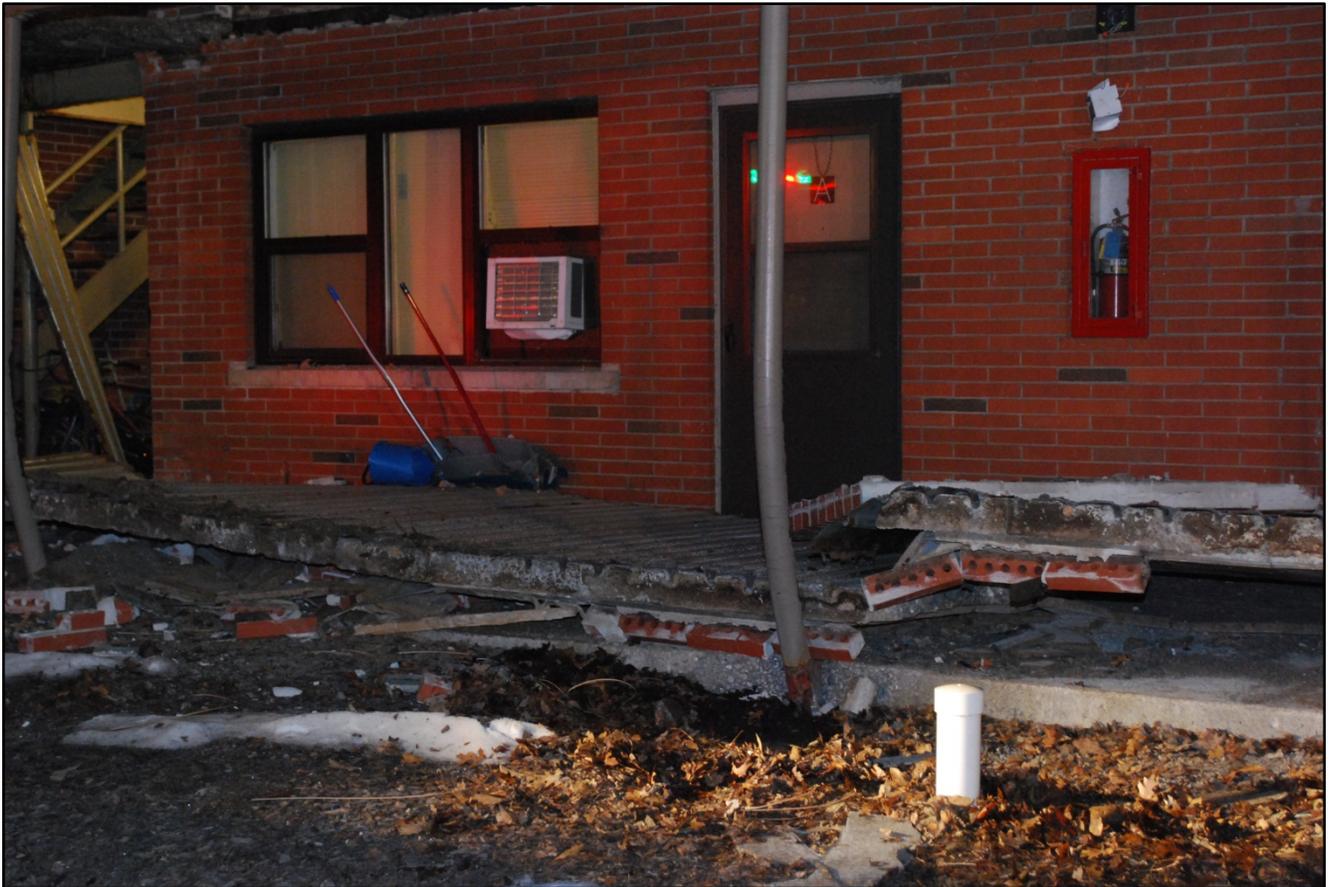
The structural engineering firm’s report stated the final resting geometry of the walkway deck after the collapse was mostly upside down (see Photo 8). This allowed for a very thorough observation of the steel deck but precluded any meaningful evaluation of the top of the concrete slab. However, although there were some longitudinal discontinuities in the metal deck and concrete, the alignment of the framing seemed to show that the original failure did not occur somewhere in the middle of the span or at one of the ends, but rather at the front or back edge (see Photo 9). The final position, markings, and collateral damage also indicate that the front (or outside) edge was the first section to drop. Therefore, the structural engineer determined that the original failure occurred somewhere near, or within some component of, the outer structural system (see Figure 2).

**Photo 8. Resting position of the walkway after it collapsed to the patio below (approximately 8 to 9 feet). The collapsed section of walkway measured approximately 42 feet.
(Photo courtesy of university police department.)**

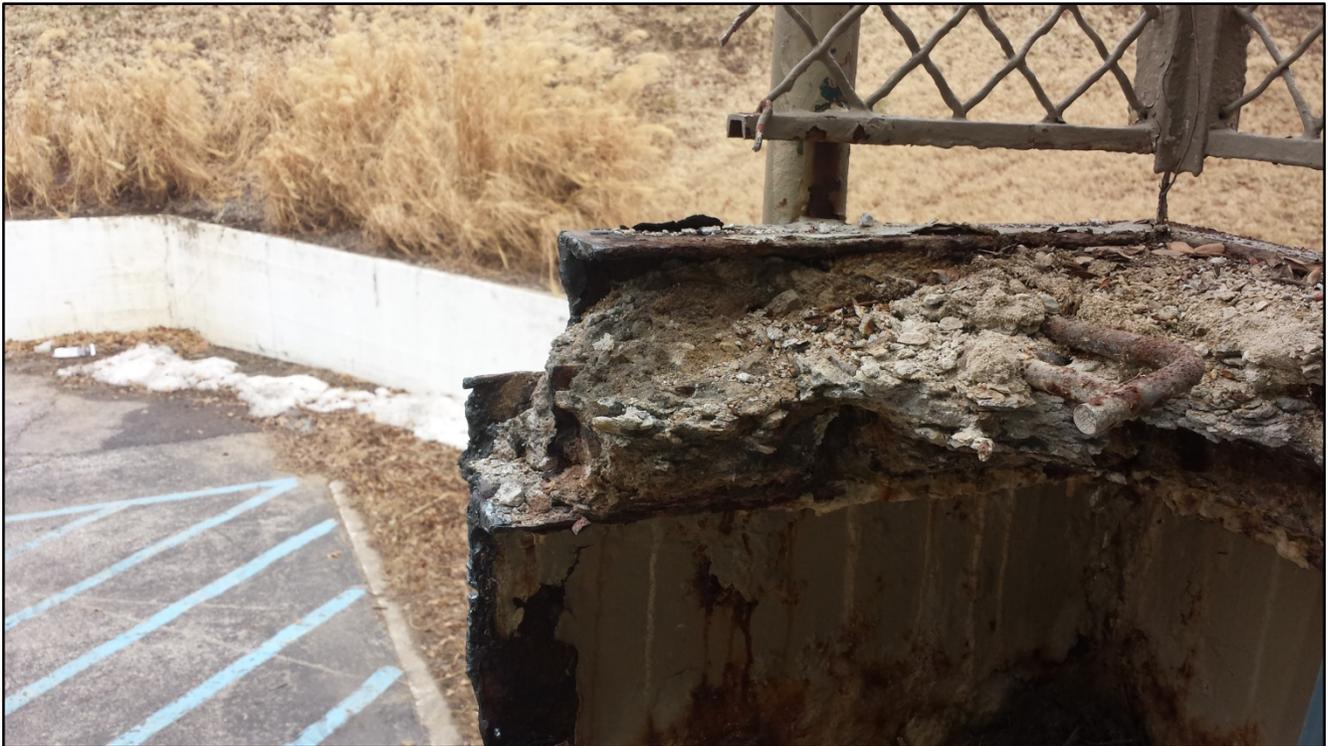
Photo 9. Potential area of failure.
(Photo courtesy of university contracted structural engineering firm.)

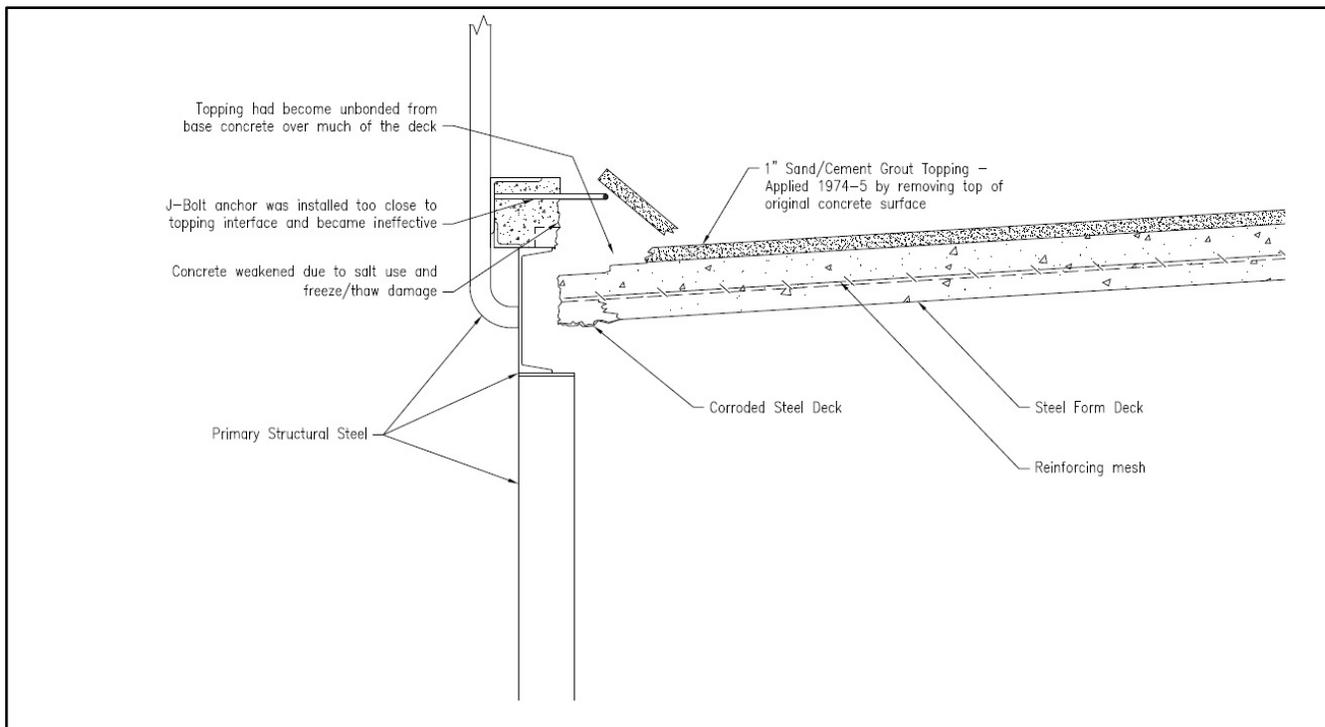
Figure 2. Schematic of walkway failure.
(Figure courtesy of university contracted structural engineering firm.)

The attachment of the metal deck to the channel provided lateral top-flange support of the edge beam, which helps to prevent localized buckling, rolling, and sweep. Evidence that the integrity of the metal deck had been compromised due to corrosion is prominent throughout the length of the remaining walkway. However, the channel remained in place and appeared to be mostly intact. Therefore, it appeared likely that the lack of lateral support of the edge beam was not a major contributing factor.
