Lieutenant and Fire Fighter Die and 13 Fire Fighters injured in a Wind-driven Fire in a Brownstone—Massachusetts

Executive Summary

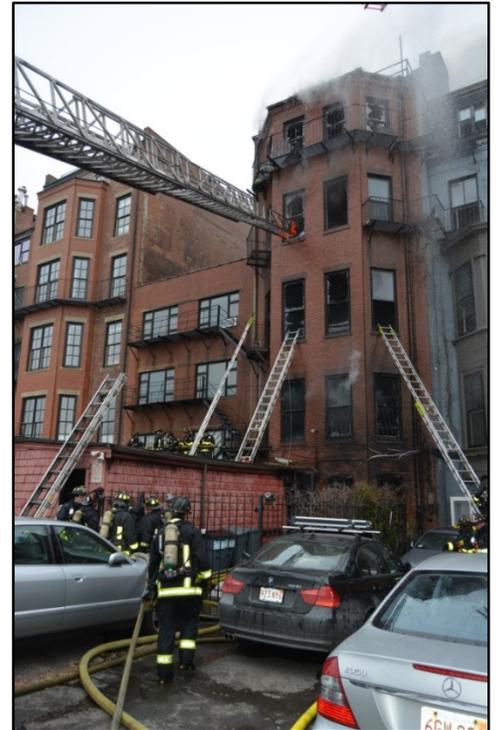
A view of fireground from Side Charlie. The fire started near the one-story shed (located against the fence) and extended into hallway on the basement of the structure.

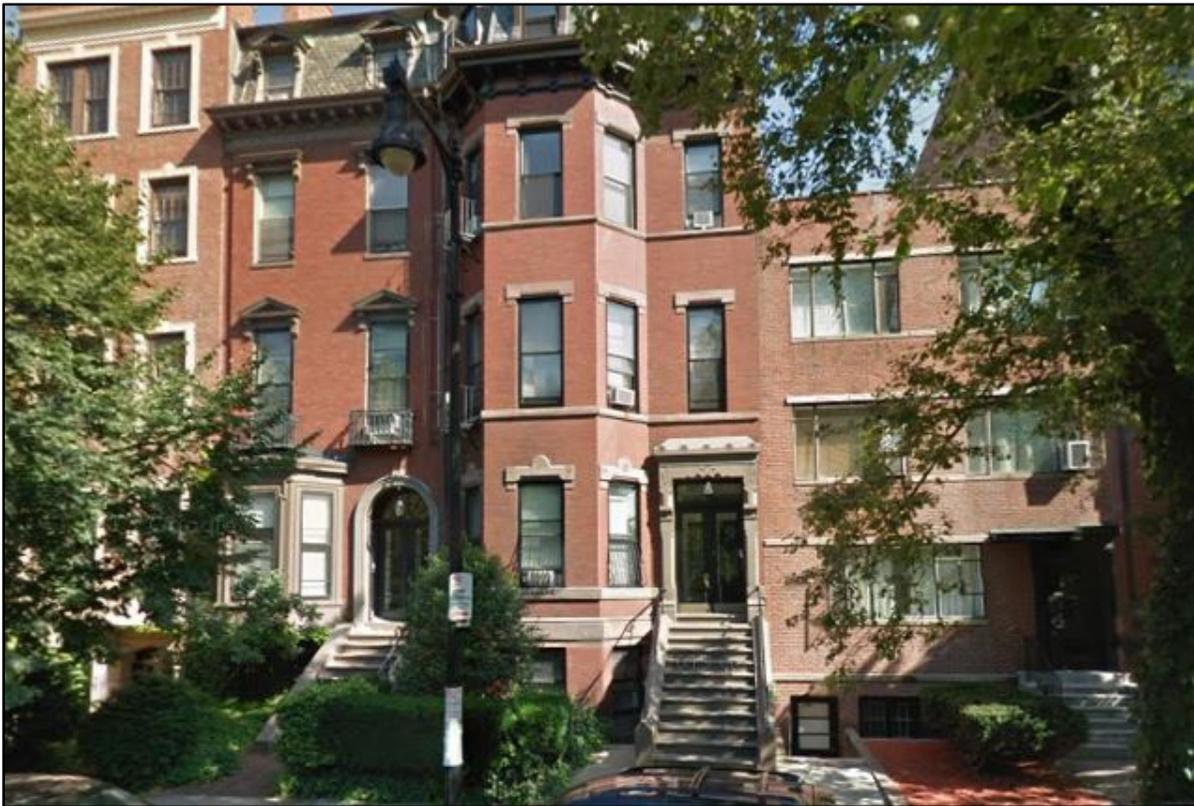
Photo 1. The fire building is the one with the bay windows from the basement to the fourth floor. The entrance to the basement apartment is under the steps.

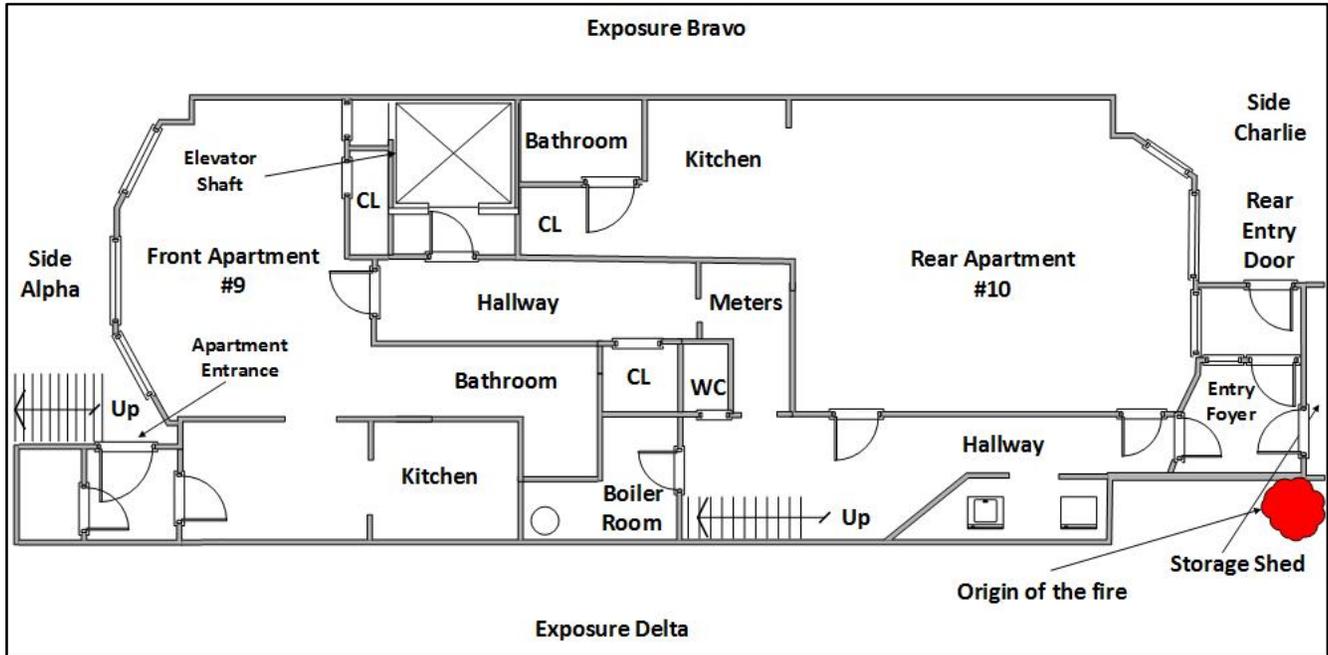
Diagram 1. The diagram of the basement of the fire building. The front apartment is #9 and the rear apartment is #10. The shed was attached to the structure on Side Charlie, behind the rear entrance doors for the rear apartment.

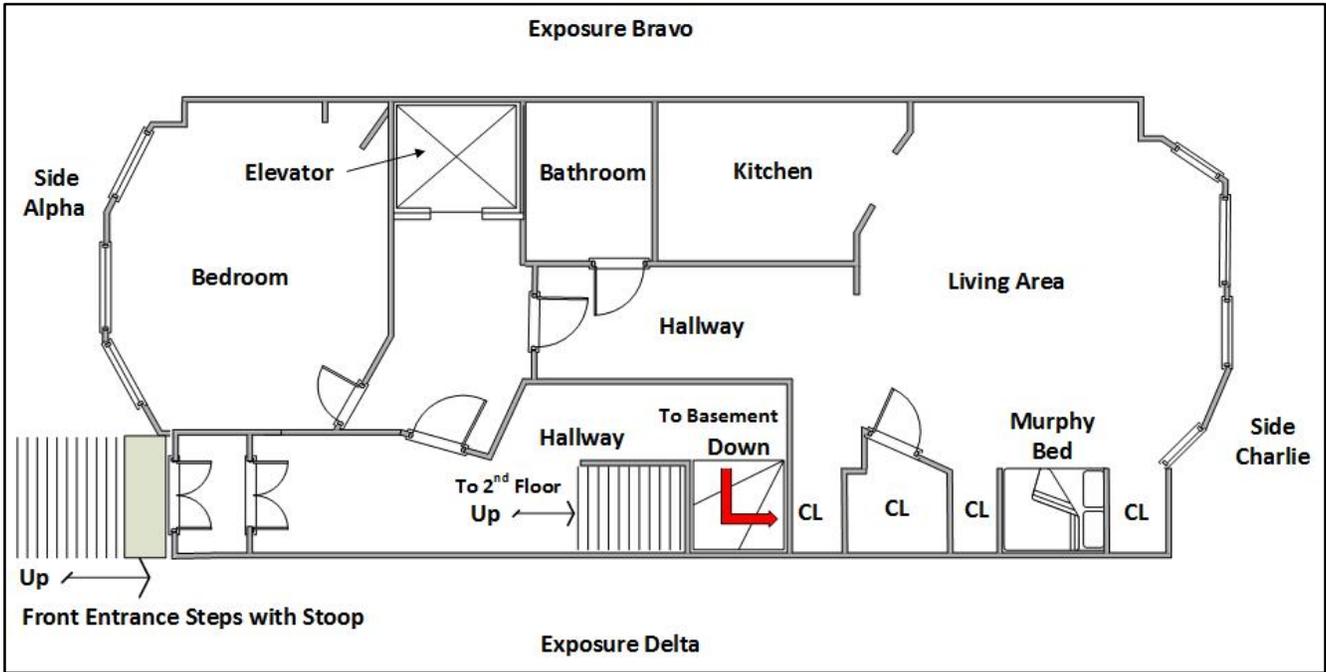
Diagram 2. The diagram of the first floor (Apartment #1) of the fire building. The stairs leading down to the basement are marked by the red arrow.

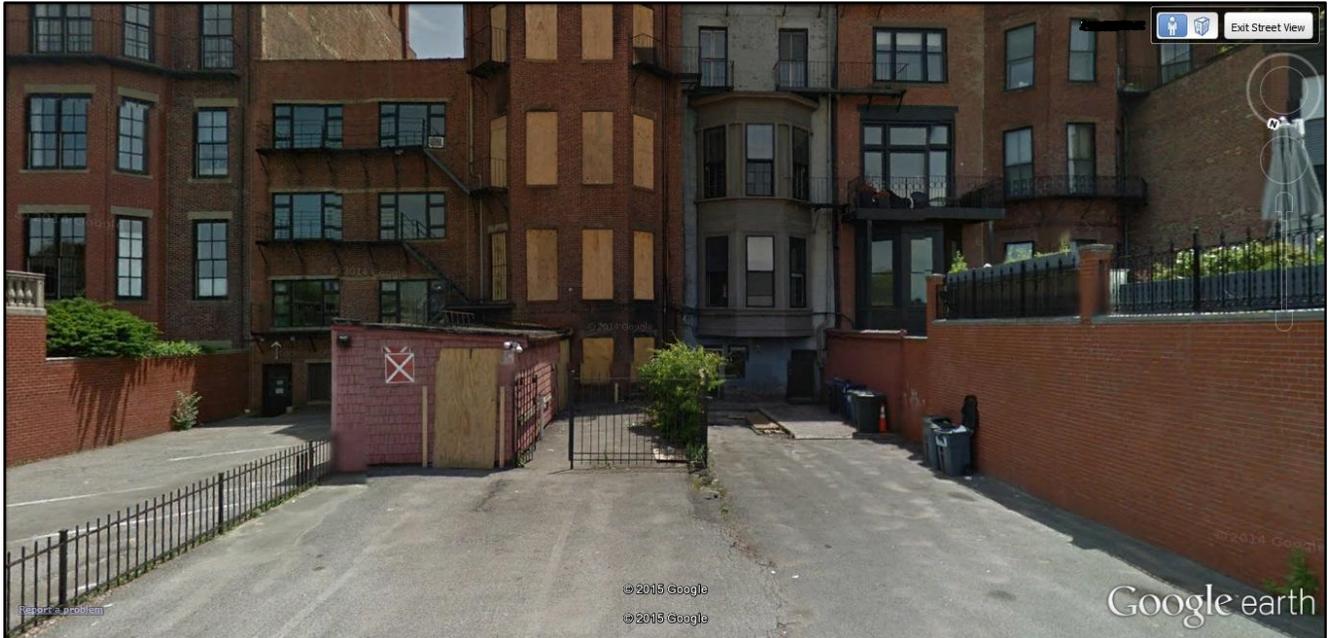
The fire started in a shed in the rear of the structure. The shed was attached to the building by the rear entrance. The shed served as the office, storage, and work facility for the property maintenance staff of the affected building (See **Photo 2**).

Photo 2. A view of Side Charlie and the location of the maintenance shed.
(*Photo source: Google Earth.*)

The fire was ruled accidental by the county's district attorney. According to fire investigators, employees from a welding company accidentally started a fire in the maintenance shed in the rear of the fire building. The welding company employees were installing pre-fabricated wrought-iron railings in the rear of the Delta Exposure building. It was the opinion of the Fire Investigation Unit that the area of origin of this fire was the rear of the fire building, outside the shed wall facing the rear Delta Exposure. The cause of the fire was a heat source too close to combustible material, with combustion accelerated by high winds.

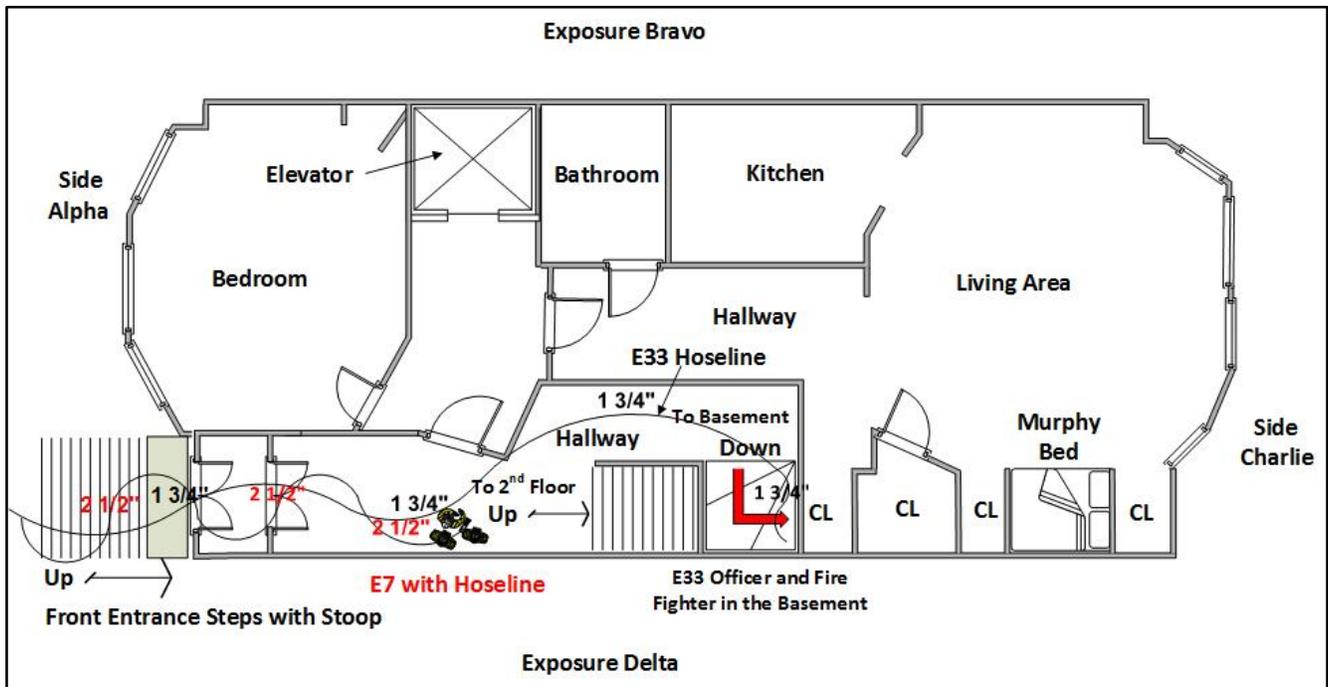
Diagram 4. The initial hoseline operations entering through the front door of the first floor.

Engine 33 has taken a 1¾-inch hoseline into the basement. Engine 7 is pulling a 2½-inch hoseline into the front hallway of the first floor, moving toward the basement steps. The time is approximately 1449 hours.

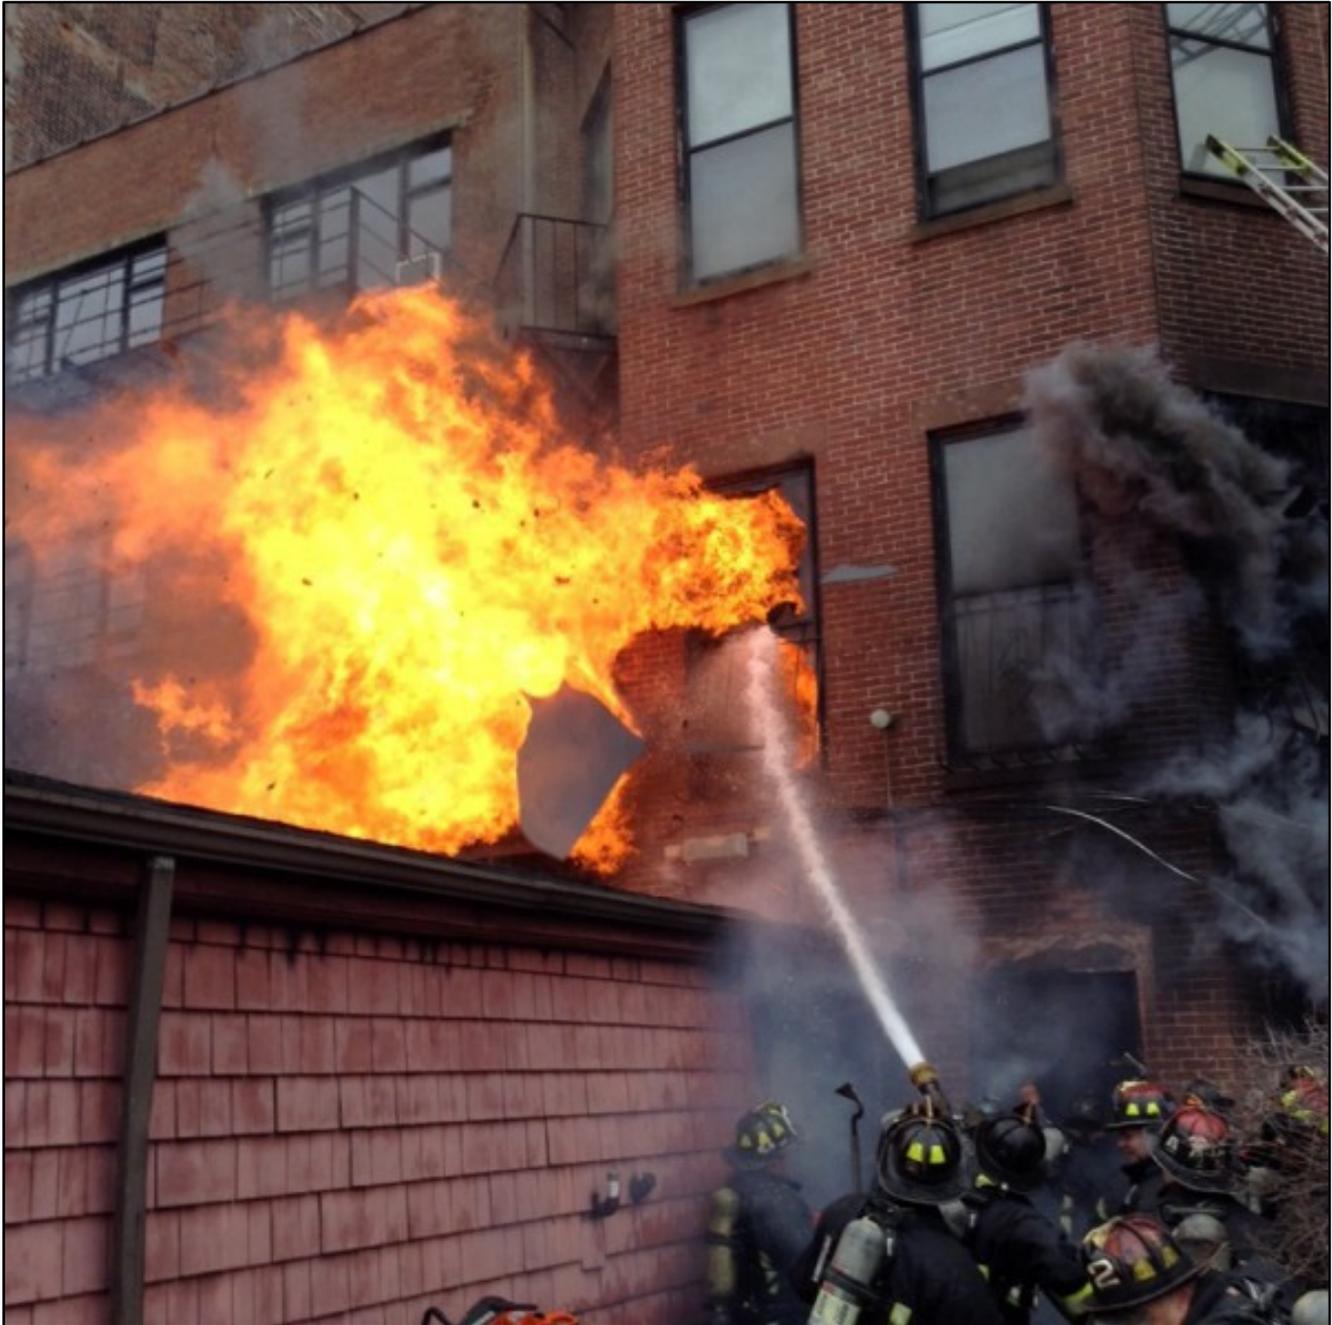
Photo 3. A rapid progression of fire conditions occurred on the first floor at approximately 1511 hours. Crews were operating on Side Charlie (upwind side) and making entry into the rear basement apartment via the windows. This photo shows the force of the rapid progression of fire conditions.

Due to the doors on Side Charlie being left open or failing, the interior door at the top of the basement stairs being left open, and the front doors on Side Alpha being left open by an occupant fleeing the fire, an unrestricted flow path was created from the basement to the first floor and floors above. The fire hose that Engine 33 deployed was impacted by the fire and heat generated by the flow path.

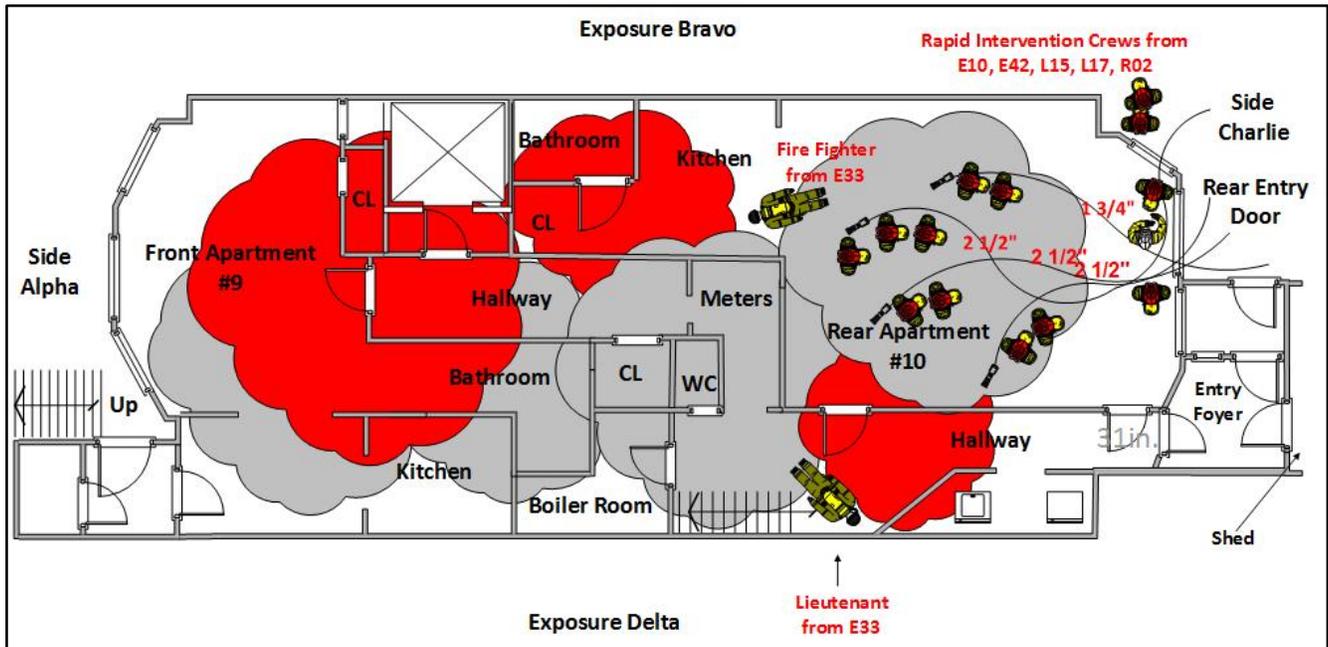
Diagram 6. Crews from Engine 10, Engine 42, Ladder 15, Ladder 17, and Rescue 2 are operating the rear basement apartment searching for the lieutenant and fire fighter from Engine 33. Rescue 2 finds the fire fighter from Engine 33 and removed him from the building. The time is 1519 hours. The lieutenant was not located until 1848 hours.

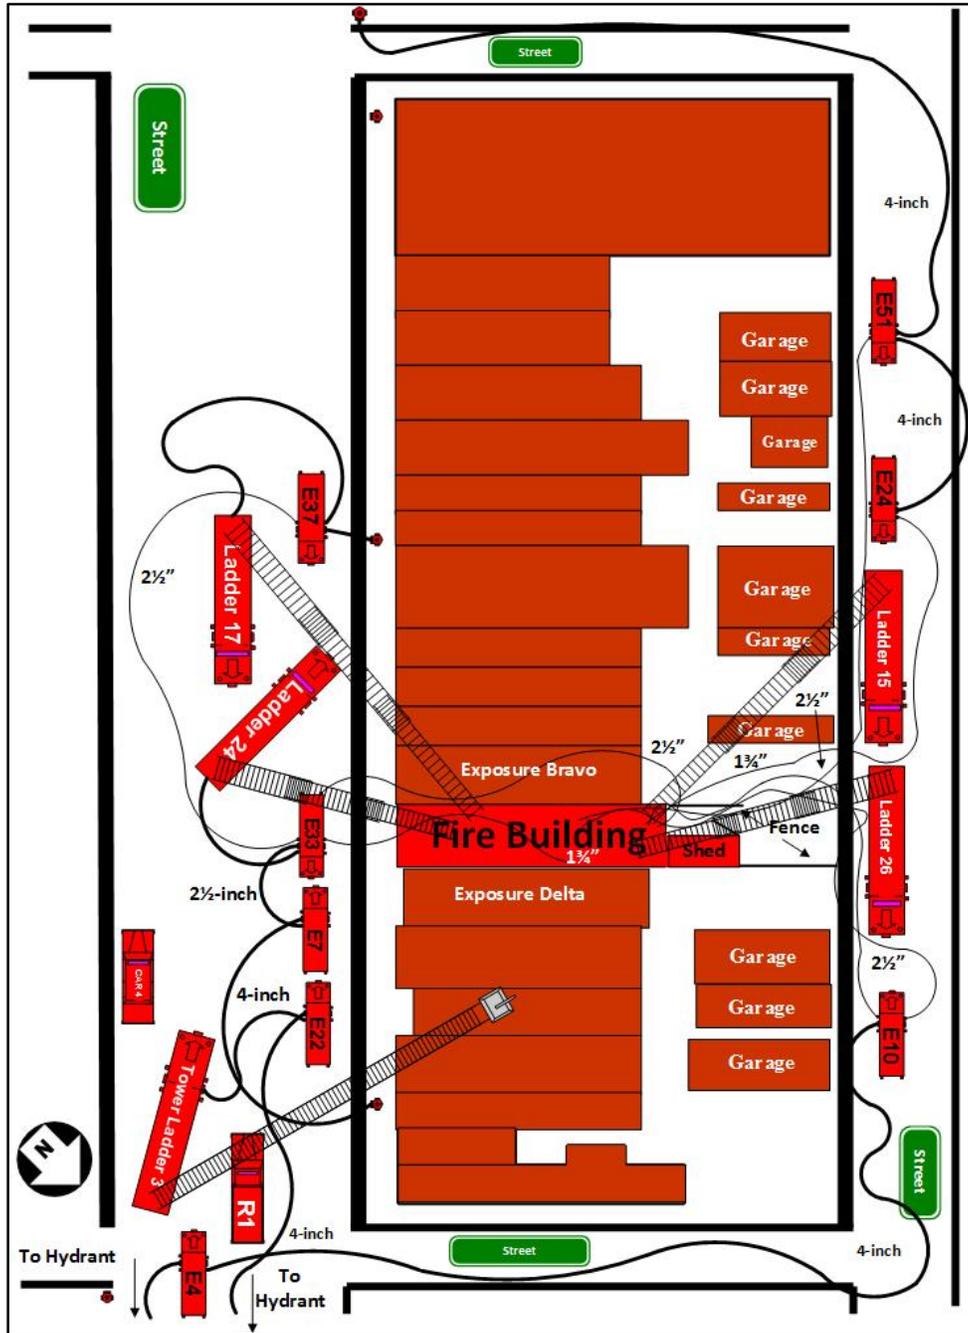
Diagram 7. Defensive operations. Ladder pipes, a tower ladder, and numerous deck guns plus hoselines are in operation. The time is approximately 1645 hours.

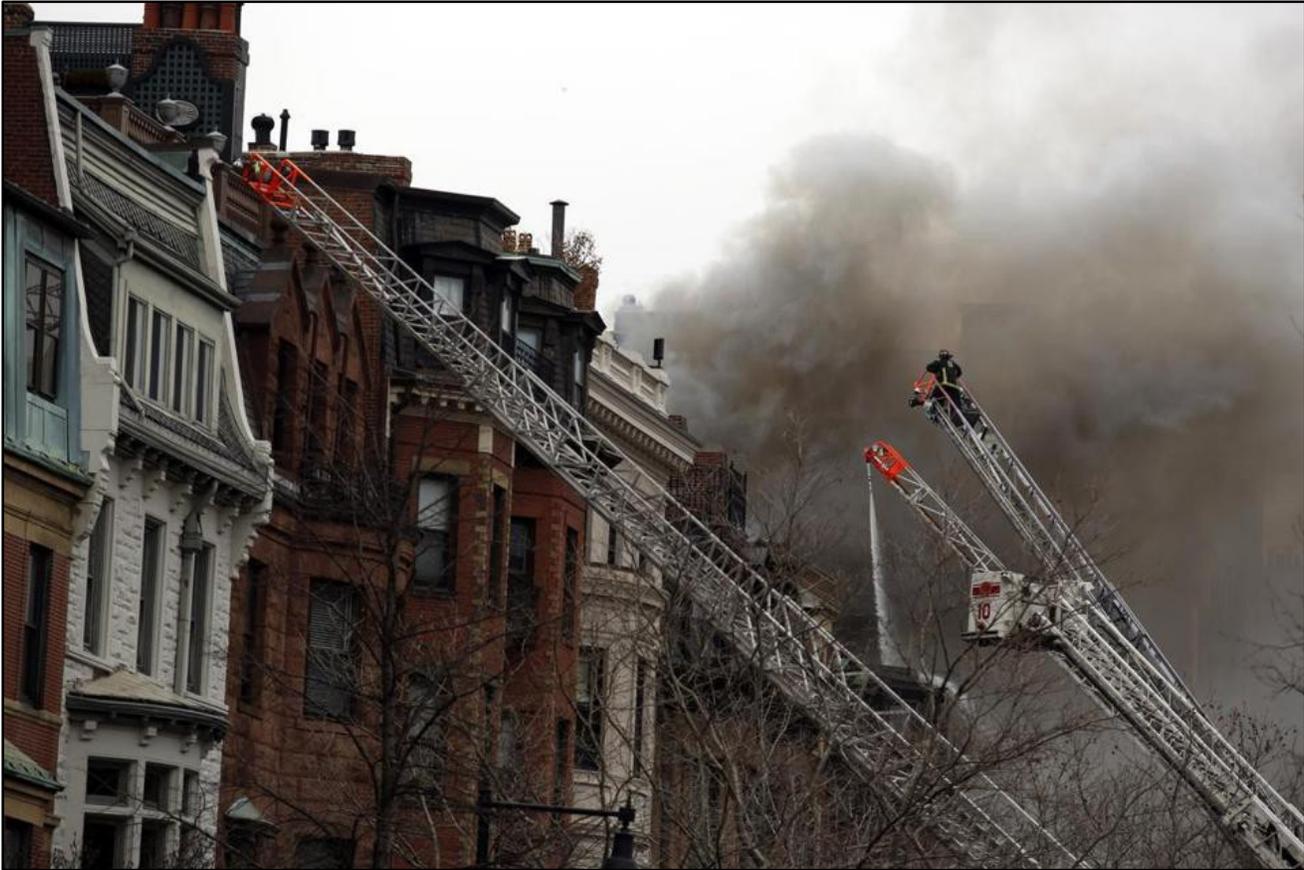
Photo 4. Defensive operations on Side Alpha of the fire building. Three ladder pipes, a tower ladder, numerous deck guns, and hoselines are in operation. The time is approximately 1615 hours.
(Photo courtesy of the fire department.)
