A summary of a NIOSH fire fighter fatality investigation

July 7, 2016

Career Fire Lieutenant Dies in Cluttered Apartment Fire on 19th Floor of High-rise Residential Apartment Building – New York

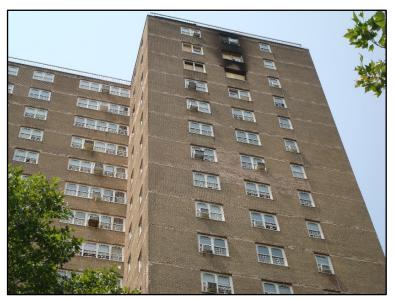
View of apartment building looking up from street level. Center window is room of origin. (NIOSH photo)

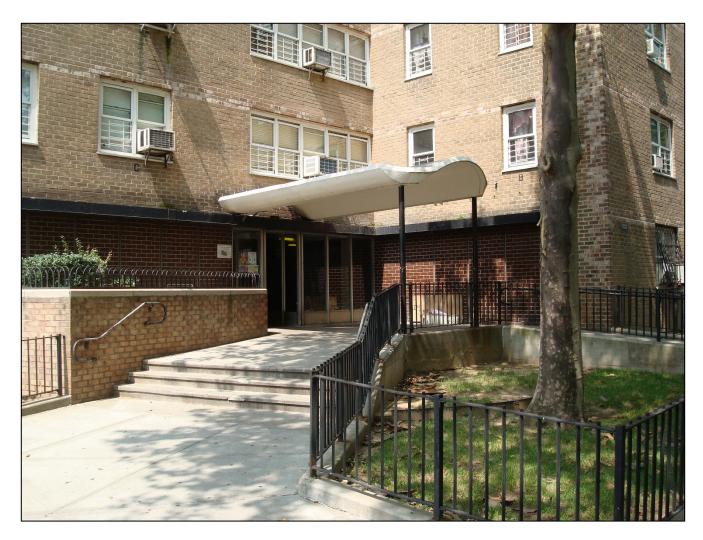
Photo 1. Entrance to main lobby. (NIOSH photo.)

As the crews walked through the courtyard to the lobby entrance, they looked up and observed fire in a window (see Photo 1 and Photo 2). The fire was not lapping out but it appeared like the window frame was on fire. Battalion Chief 35 arrived on scene and assumed incident command. BC35 radioed the dispatcher to confirm a working fire was in progress.

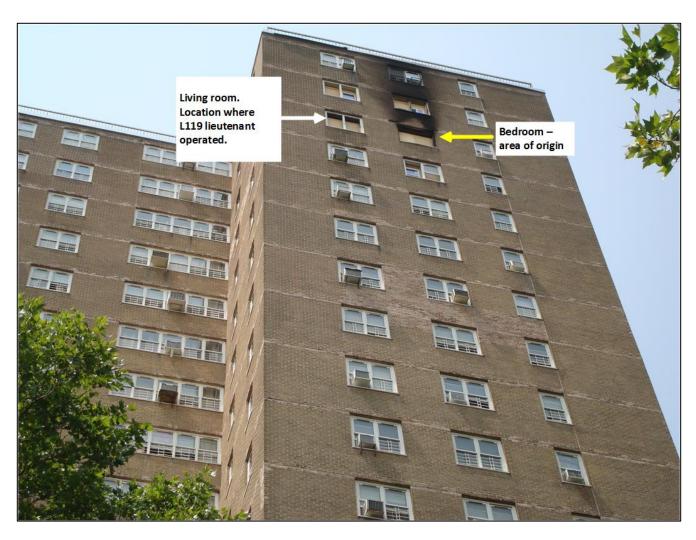
Photo 2. Outside view showing location of fire origin and location of living room where L119 Lieutenant operated. (NIOSH photo.)

At 2130 hours, the L119 lieutenant radioed a third Mayday and stated that he was getting burned bad which went unheard by almost all members at the scene. (*Note: This was the last contact with the L119 lieutenant. See Diagram 2 and Photo 2 for the location.*)

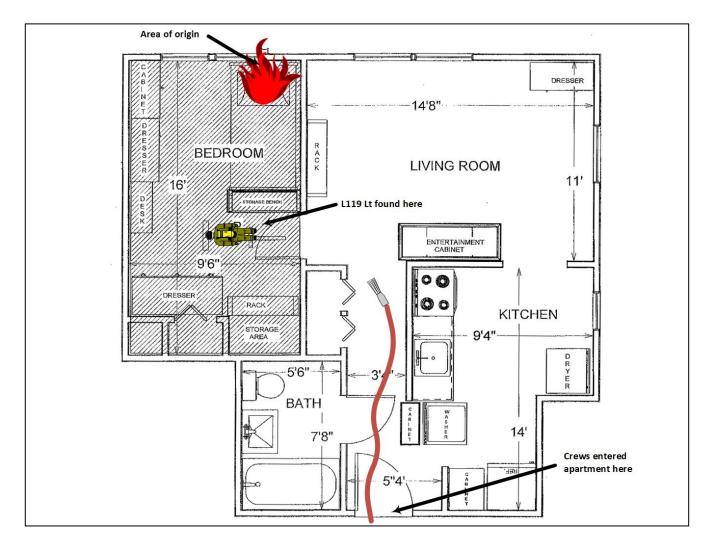
The L119 lieutenant was found at the foot of the bed just past the door swing. The bedroom door had to be removed from its hinges in order to move the L119 lieutenant. It was reported that his facepiece was off. Note: The L119 lieutenant's helmet was found in the living room and the L119 Can's helmet was found in the bedroom. It is believed that both the L119 lieutenant and the L119 Can had their helmets dislodged by the E211 hose stream and the L119 Can moved out of the apartment without a helmet as the heat in the hallway intensified while the L119 lieutenant donned the L119 Can's helmet and attempted to follow but was cut off by the rapidly deteriorating conditions. The L119 Can reported that he never entered the bedroom.

Diagram 2. Diagram shows attack hose placement and location where the L119 lieutenant was found. (Floorplan courtesy of fire department.)

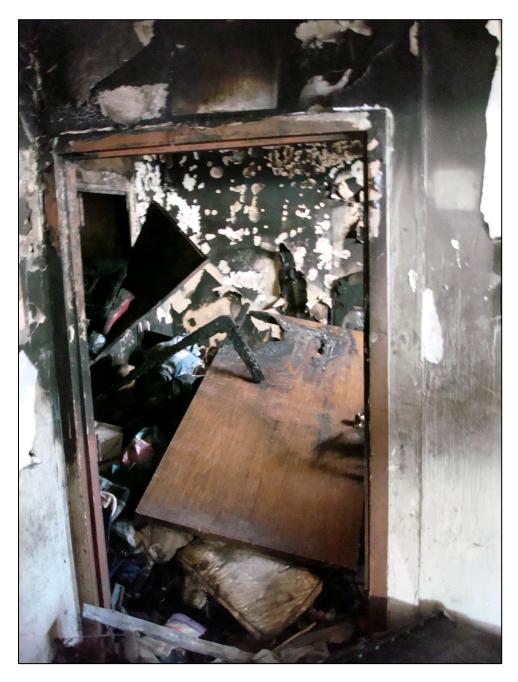
- Top of bedroom door burned through allowing fire to extend into living room and ignite fuel rich smoke (see Photo 3 and Photo 4)
- Engine 211 crew reported fire rolling across ceiling in apartment hallway

Photo 3. View is from living room looking into bedroom. Note that the door was removed during the recovery operation. (NIOSH photo.)

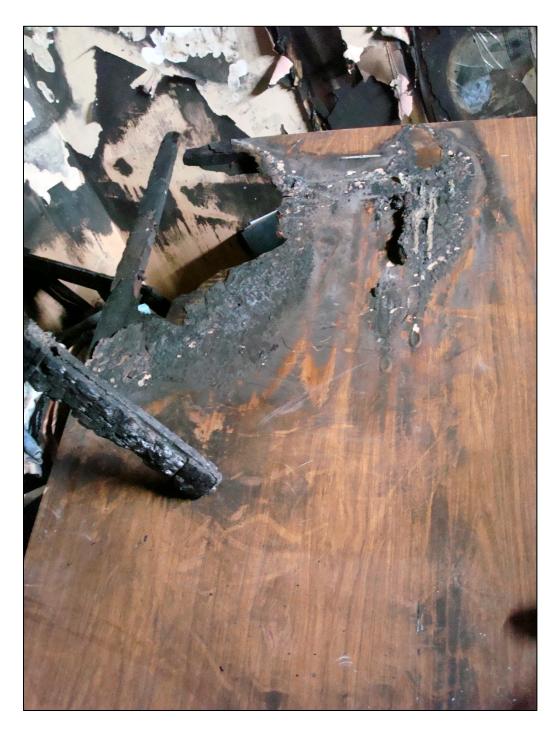
According to the fire department investigators, the fire was determined to have originated in the bedroom. The cause of the fire was determined to be an overheated extension cord connected to the window-mounted air conditioning unit. The extension cord ran between the wall and the bedframe and extended underneath the hoarded items accumulated in the bedroom.

Photo 4. Close-up view of bedroom door. Note the burn-through at top of door. It is believed that the door burned through allowing fire to extend from the bedroom. (NIOSH photo.)
