Career Fire Apparatus Operator Dies after Falling Down an Unsecured Elevator Shaft at a 5-Story Residential Structure – Ohio

Executive Summary

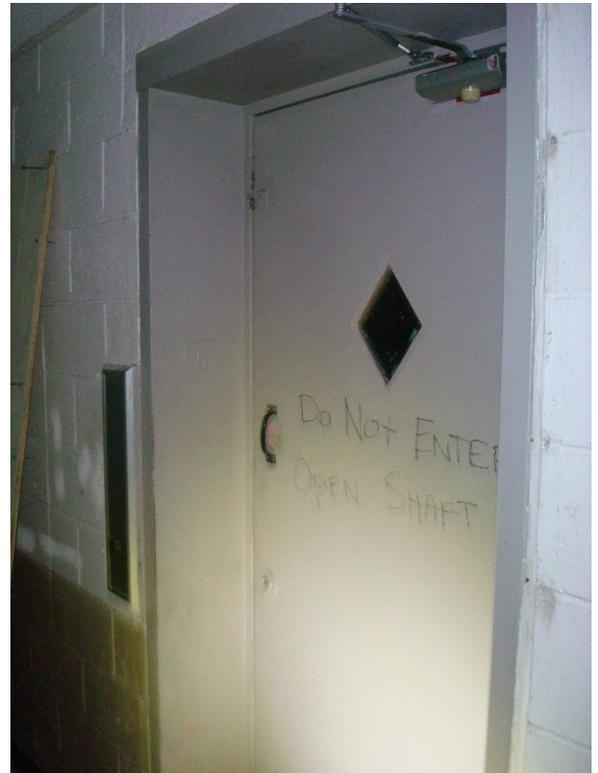
Fifth floor elevator hoistway door. Note warning written on door by Rescue 14 crew member while searching the fifth floor.
(Photo NIOSH)

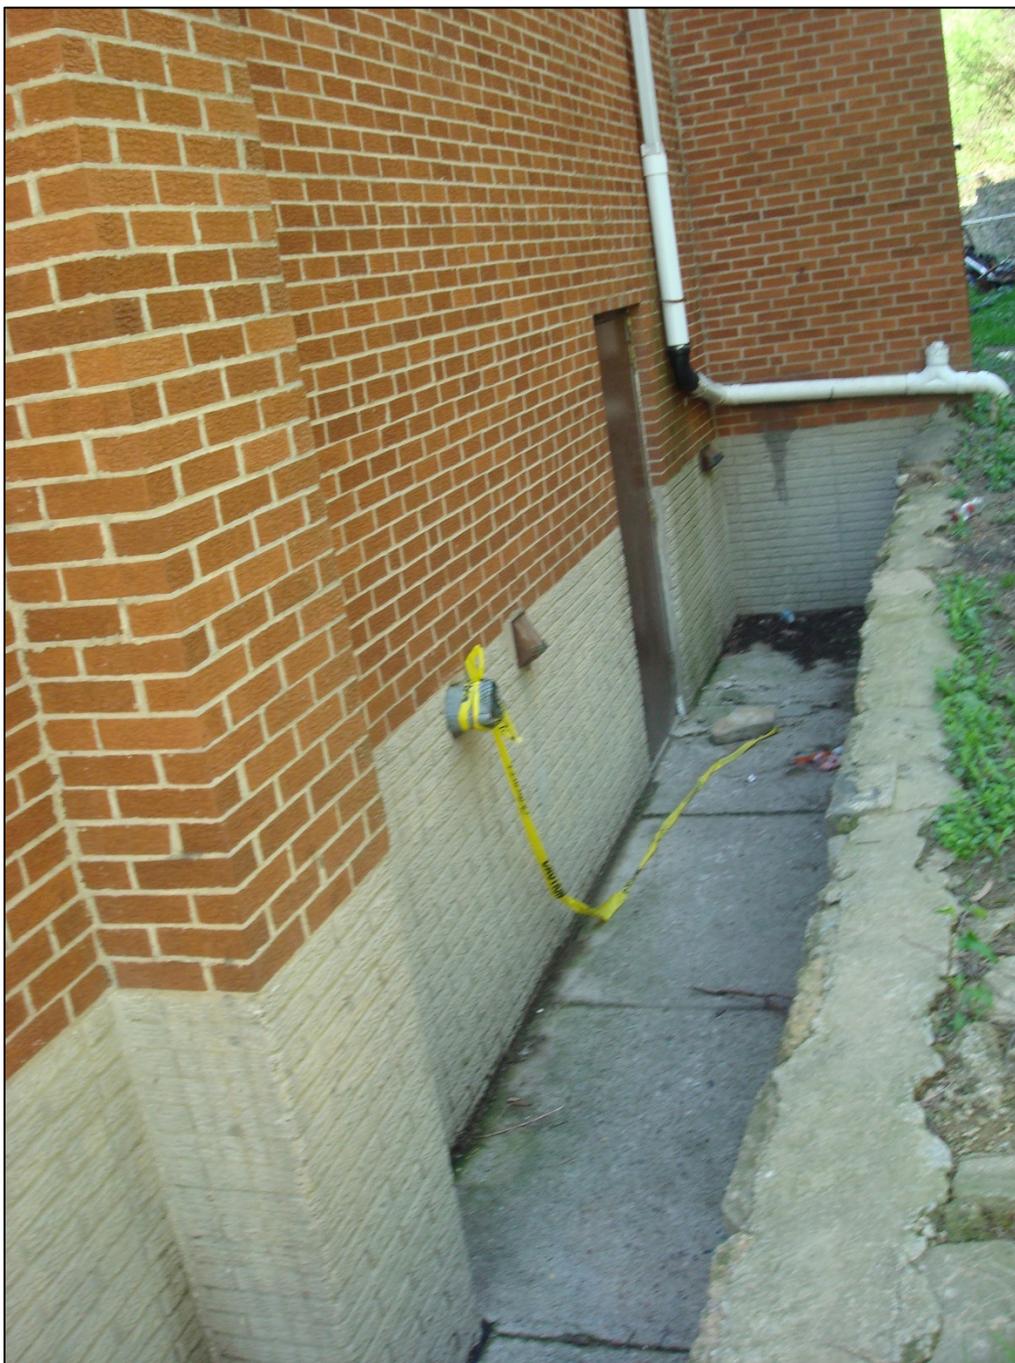
**Photo 5. Stairwell door on Side C near the C/D corner where the Engine 49 crew entered structure with initial attack hoseline. This door opens to the stairway landing between the first and second floors.
(NIOSH Photo.)**

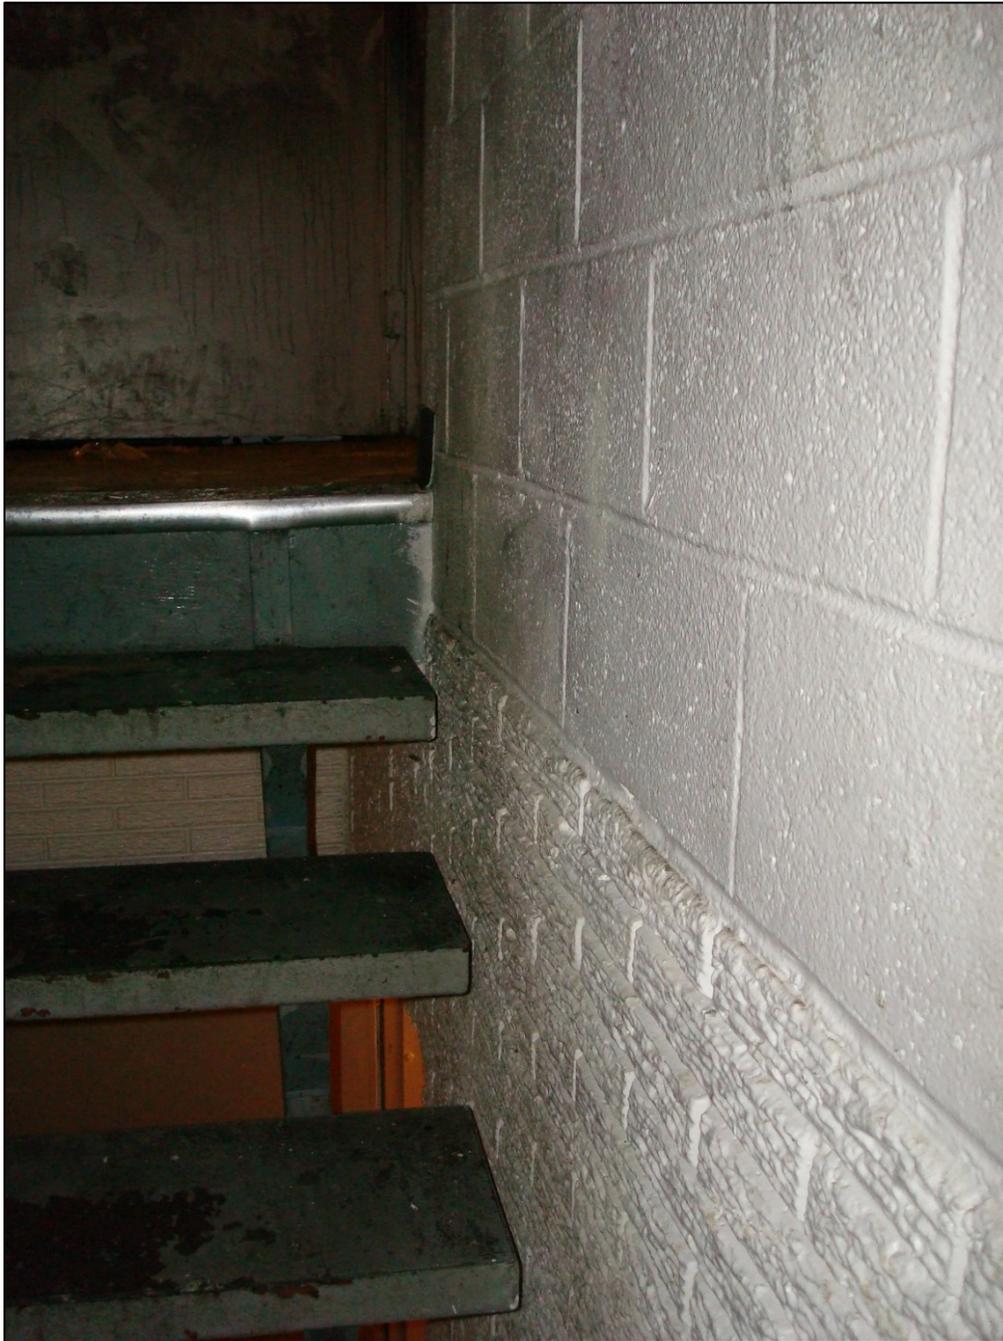
Photo 6. View of stairway between ground level and second floors where the Engine 49 hoseline snagged on stair treads. When the hoseline was charged, the hose became stuck preventing the hose from being advanced into the fire apartment. Note clearance between stair tread and wall where the hose became stuck.

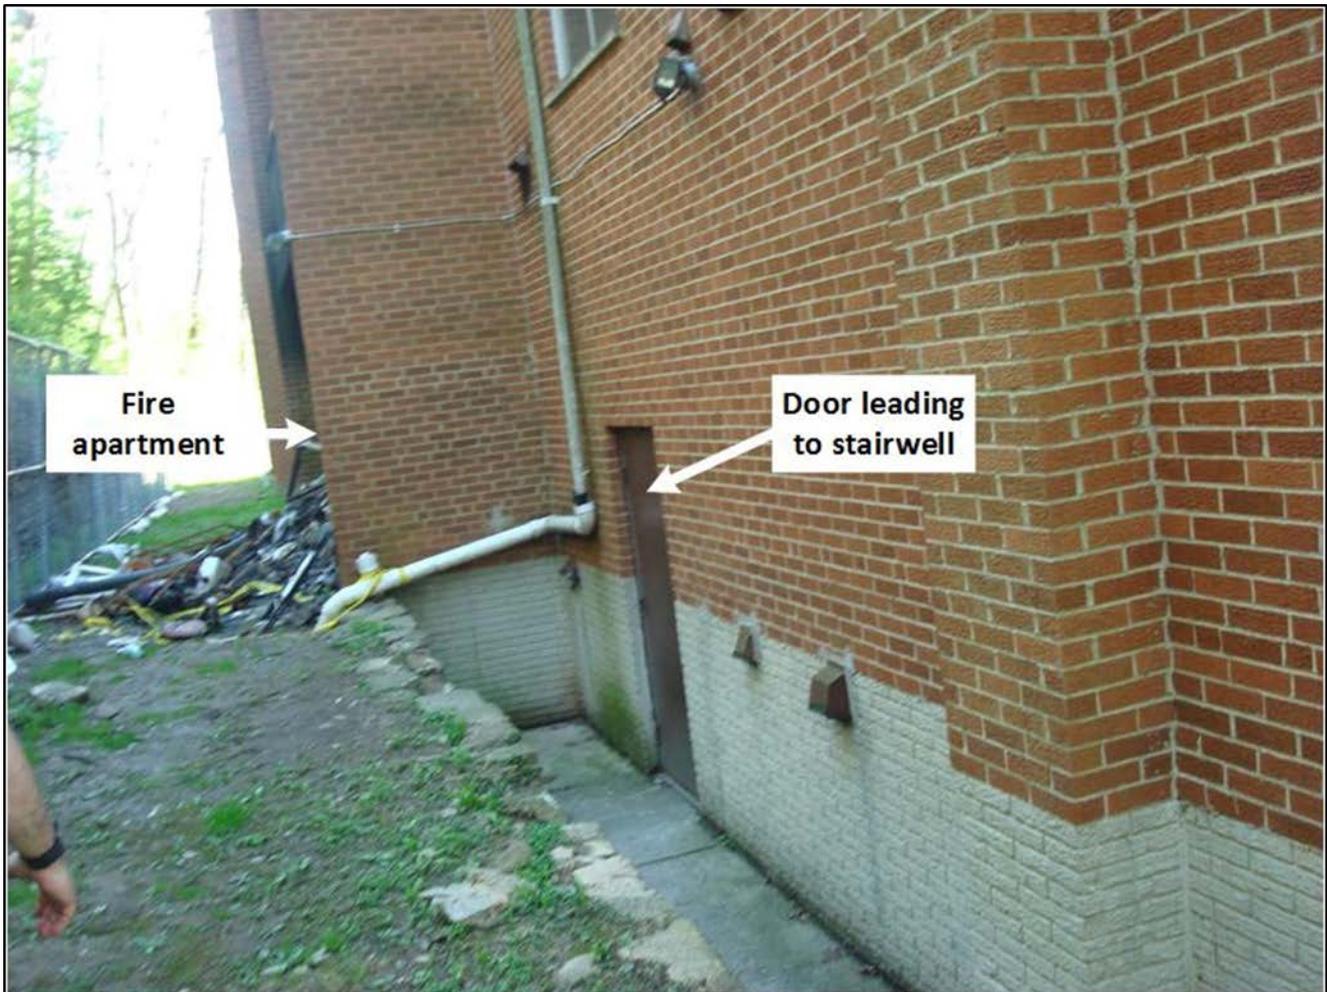
Photo 7. View of apartment building, Side C, looking from Side B toward Side D. The fire apartment is indicated. Note that the two Side C apartments on the second floor have ground level patios. The exterior door accesses the B/C stairwell at the landing between the first and second floors.

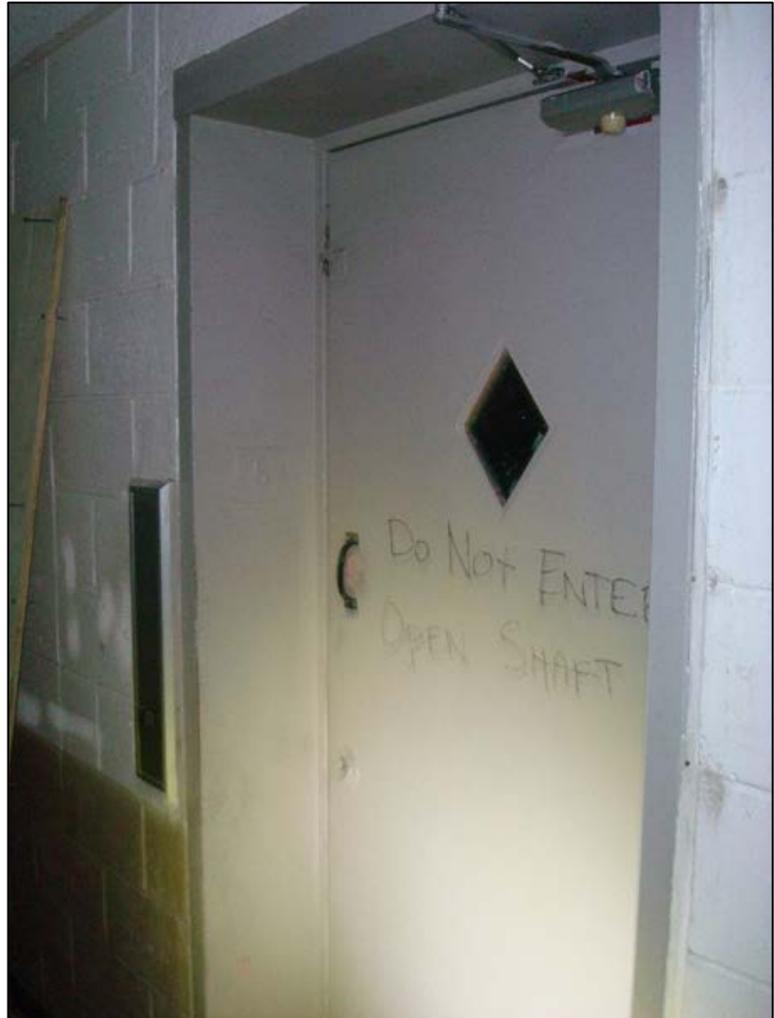
The Heavy Rescue 14 FAO fell down the elevator shaft at approximately 0612 hours and became lodged in the narrow void between the rear of the elevator car and elevator shaft wall. At approximately 0613 hours, the electronic incident command accountability system recorded the Heavy Rescue 14 FAO's PASS device motion alarm activating.

Photo 8. Fifth floor elevator hoistway door. Note warning written on door by Rescue 14 crew member while searching the fifth floor.
(Photo NIOSH)

In this incident, the Heavy Rescue 14 fire fighter 2 recognized the unlocked elevator hoistway door and open elevator shaft as a hazard. He reported this information to the Heavy Rescue 14 OIC and Heavy Rescue 14 fire fighter 1. The Heavy Rescue 14 fire fighter 2 wrote **“Do Not Enter Open Shaft”** on the elevator hoistway door with a permanent marker. The Heavy Rescue 14 crew reported this information to the Search and Rescue Operations Chief (District Chief 3) and other fire fighters

who were on the fifth floor at the time but this information was never reported to incident command or the shift safety officer. The Heavy Rescue 14 FAO was unaccounted for during this time. A radio transmission to Command advising Command of the open shaft hazard could potentially have alerted the Heavy Rescue 14 FAO. This information could have allowed the incident commander and/or the shift safety officer to take action to prevent exposure to this hazard by establishing a hazard control zone restricting access to the elevator hoistway door. Shortly after the Heavy Rescue 14 crew discovered the unlocked elevator hoistway door and notified other fire fighters of what they encountered on the fifth floor, the unaccounted for Heavy Rescue 14 FAO fell down the elevator shaft.

- *Consider ways to block open shafts and other fall hazards.*

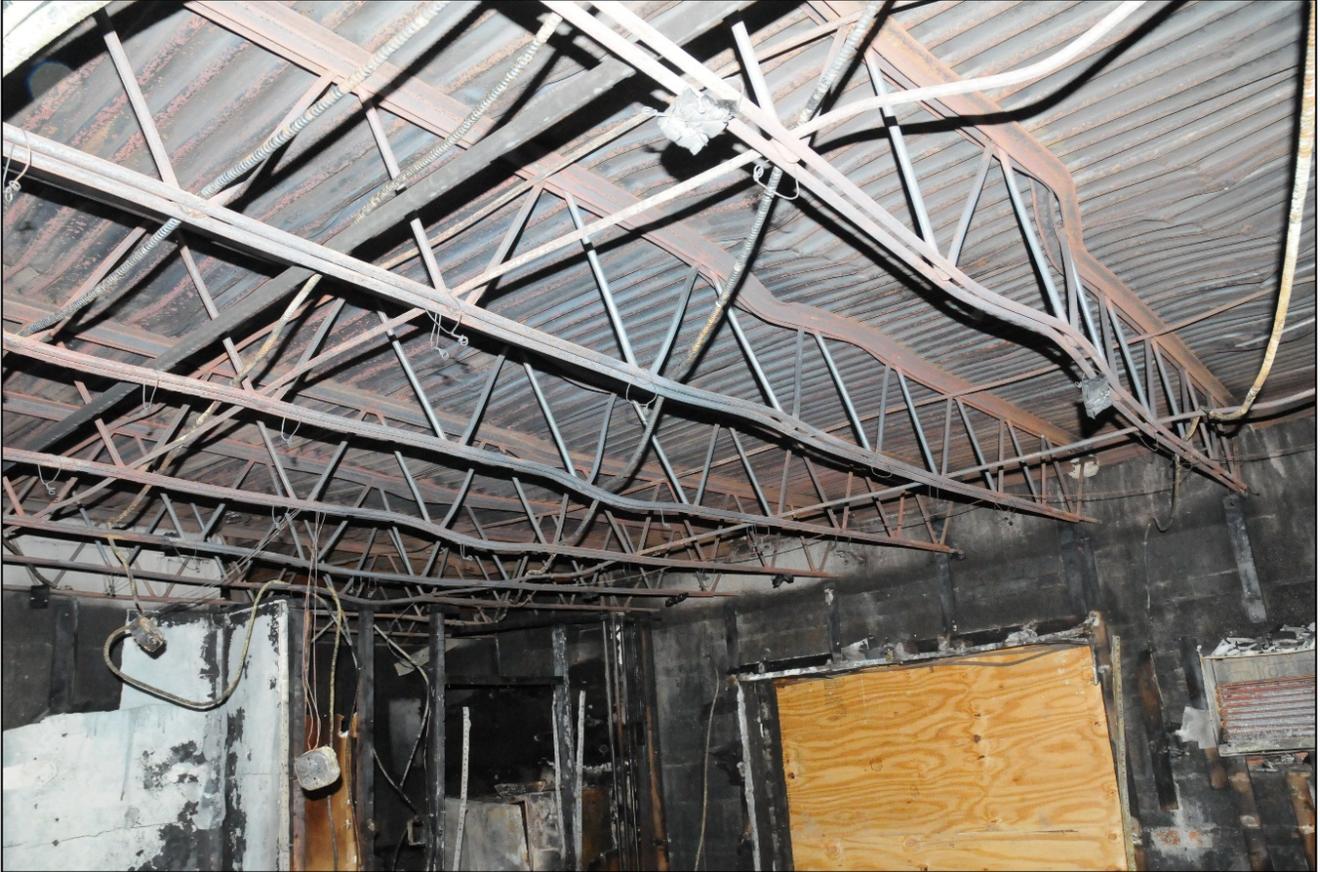
Fire investigators determined that the origin and cause of this fire was accidental, caused by unattended cooking materials left on the stove. The fire originated on the second floor in Apartment 27 which was located on Side C and was caused by unattended cooking materials left on the stove at left rear (B/C corner) of the apartment (see Photo 9).

Photo 9. Interior of second floor apartment where fire originated. View is looking toward Side C. Plywood covers the opening where sliding glass doors opened to the ground level patio. The fire originated in the kitchen located on the left side of the photo. Note fire damaged metal bar joists indicating intensity of the fire.
(NIOSH photo.)
