## Two Fire Fighters Die and Two Fire Fighters are Injured at Multi-occupancy Fire with Structural Collapse—Missouri

### Executive Summary

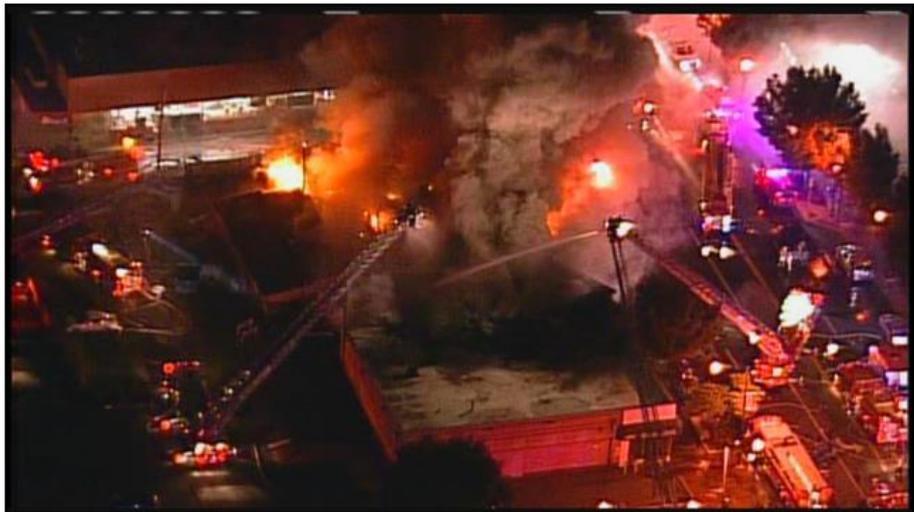
**An aerial view of the structure fire after the collapse of the wall on Side Delta. The street on the right side of the photograph is Side Alpha.**

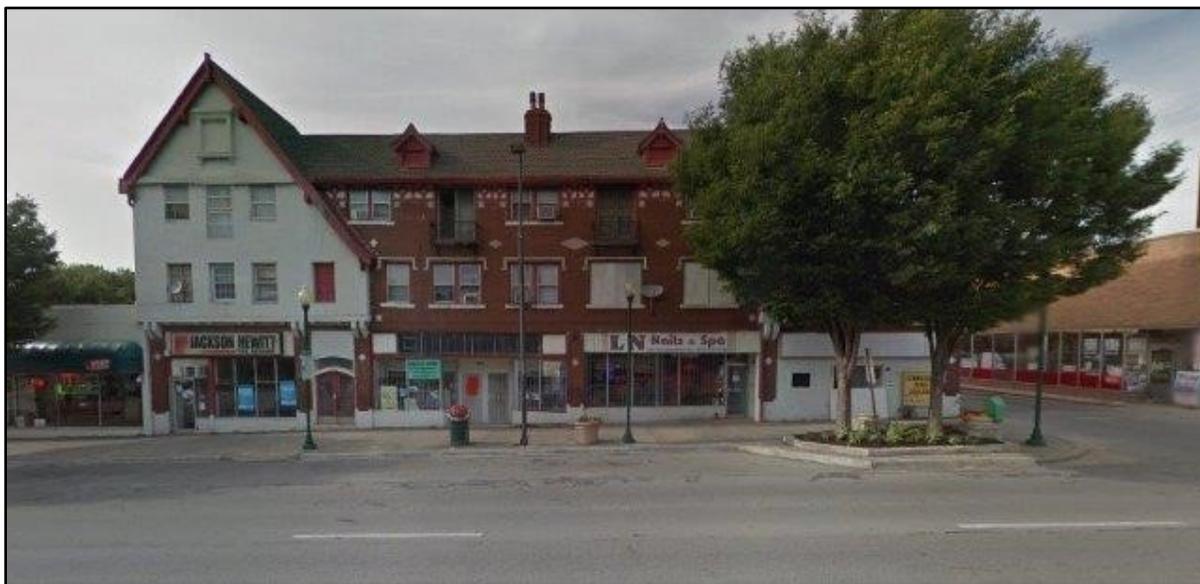
feet. Eight apartments were located on the 2<sup>nd</sup> floor and eight apartments were located on the 3<sup>rd</sup> floor. This structure did not contain a sprinkler system or a centrally monitored fire alarm system. Several of the apartments on the 2<sup>nd</sup> floor and 3<sup>rd</sup> floor contained single-station smoke detectors (**See Photo 1 and Diagram 2**).

**Photo 1. Side Alpha of the structure. The loan business on the Side Alpha/Bravo corner is only one-story. The alley on Side Delta is where the collapse occurred between the fire building and the grocery store.**  
*(Google Earth Street View.)*

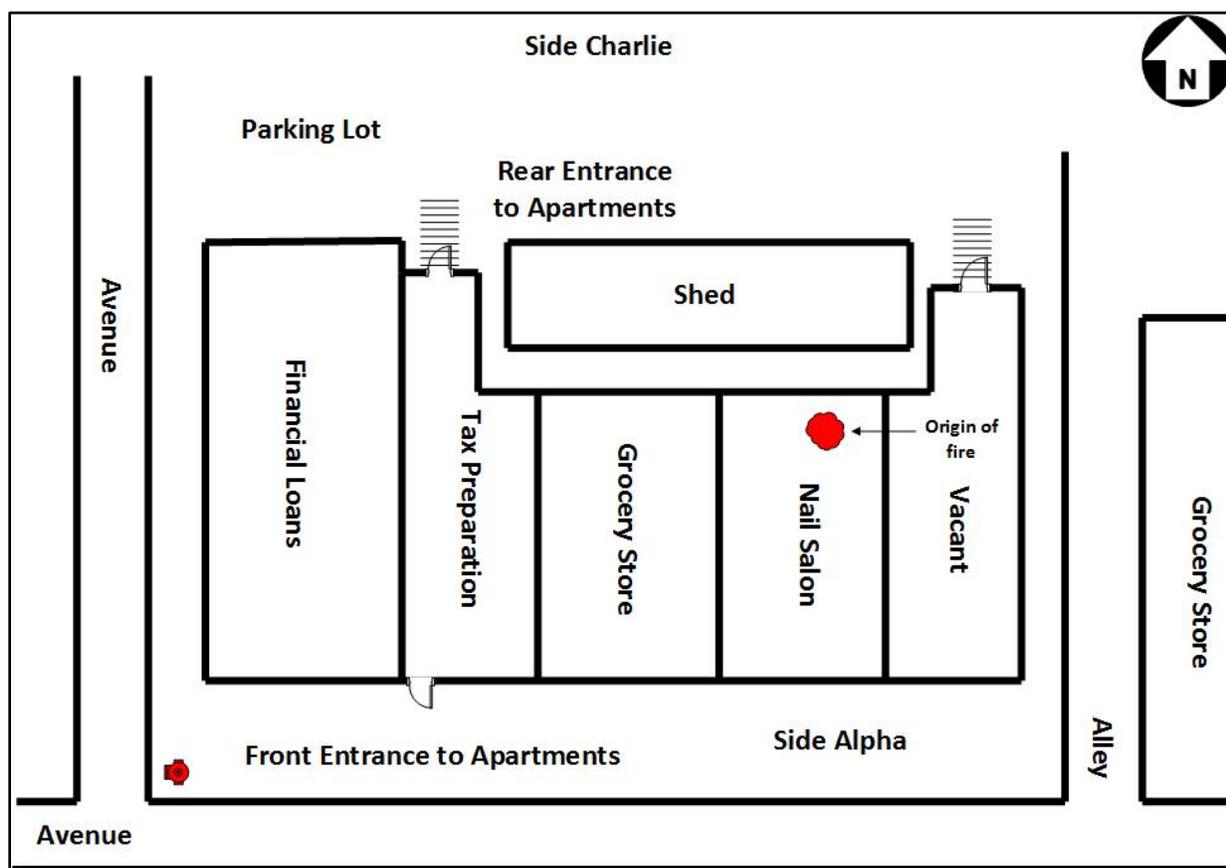
**Diagram 2. The site plan for the fire building. The financial loan business was a one-story occupancy. The apartments on the 2<sup>nd</sup> and 3<sup>rd</sup> floors extended from tax preparation business to the vacant occupancy.**

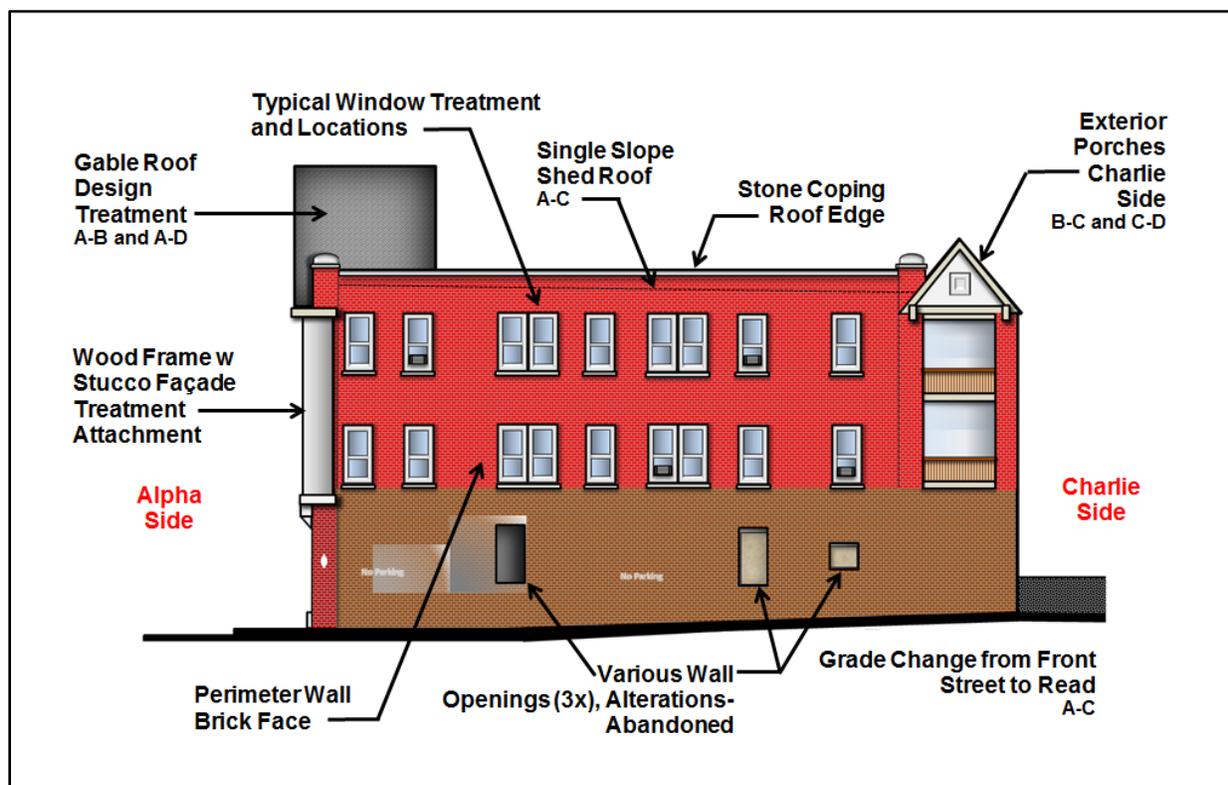
- **Side Delta.** This wall was constructed masonry bearing wall with hollow clay block wall unreinforced masonry construction with full-face brick veneer construction. There were no entrances to the building from this side of the structure. There were several apartment window openings and 3 openings to the unoccupied occupancy on the 1<sup>st</sup> floor. The facade had extensive window treatments and openings on the upper floor apartments (See Diagram 5).

**Diagram 5. Side Delta Elevations and Masonry Perimeter Wall Features**  
(Graphic courtesy of *Buildingsonfire.com* / C.J. Naum.)

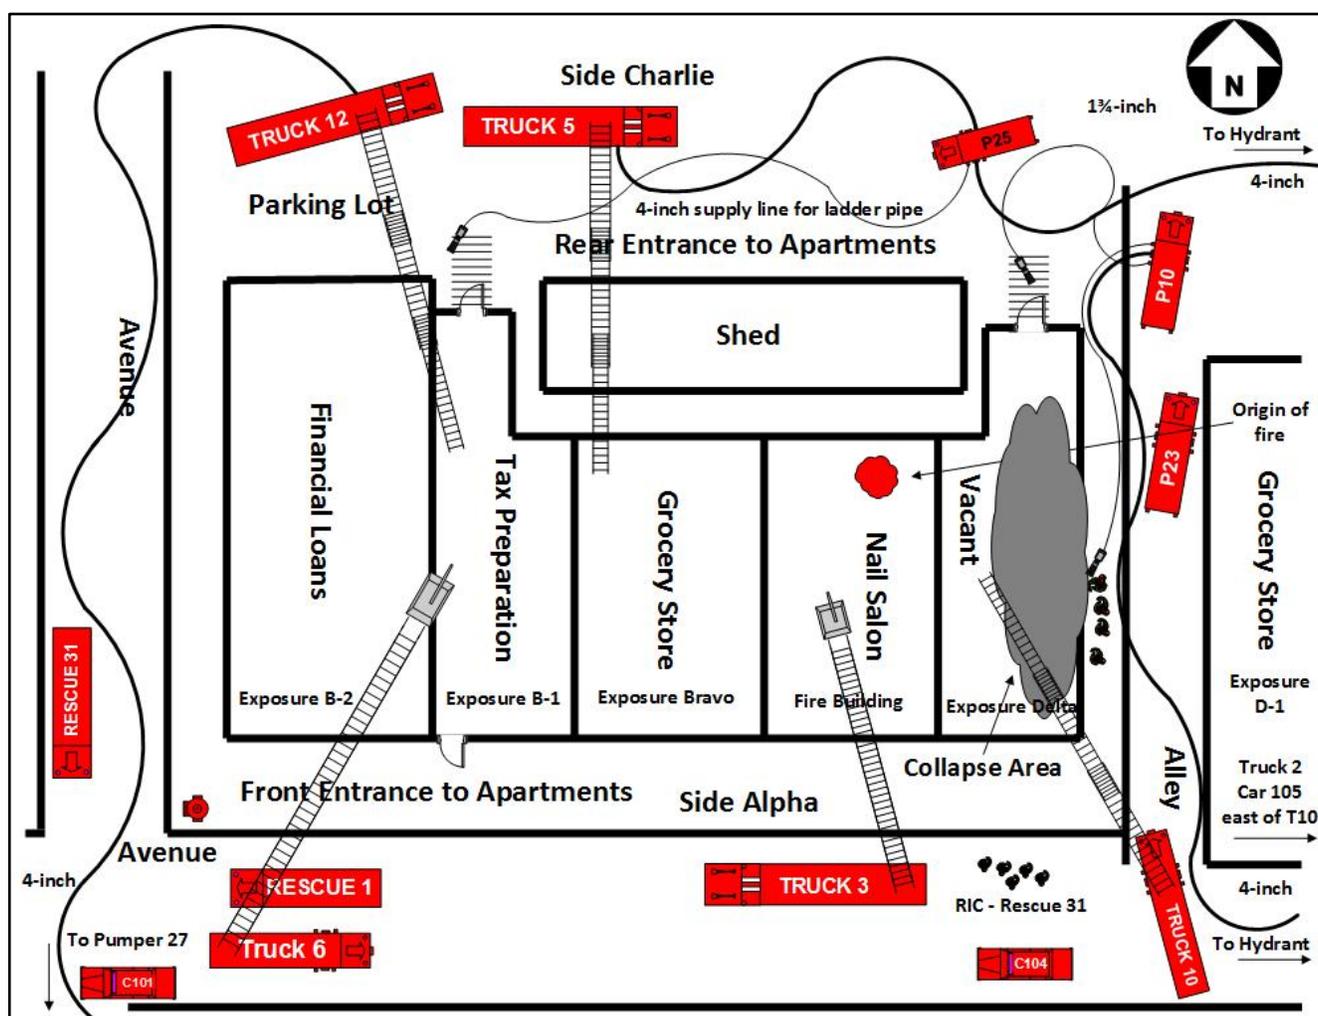
At approximately 2005 hours, crews operating on Side Alpha witnessed an interior collapse. The district safety officer from Car 104 witnessed a collapse on Side Charlie when the balcony and walls of the 2<sup>nd</sup> floor apartment collapsed. Then the wall on Side Delta collapsed into the alley, trapping four fire fighters. The trapped fire fighters were from Pumper 10, Truck 2, and Pumper 23 (See **Diagram 7** and **Photo 3**).

**Diagram 7. The location of the fire fighters from Pumper 23, Pumper 10, and Truck 2 on Side Delta when the structural collapse occurred at 2006 hours. The crew from Truck 2 parked on the avenue east of Truck 10**

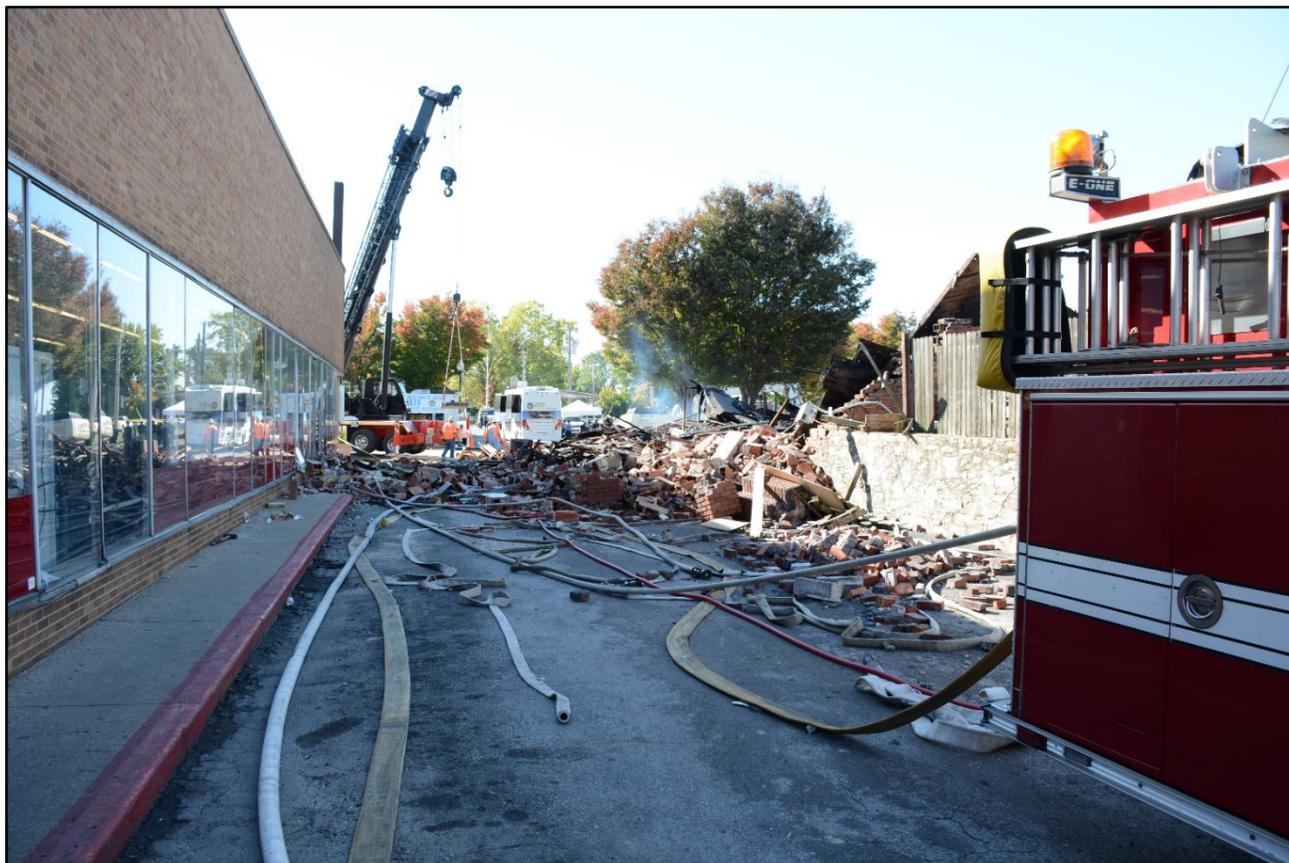
**Photo 3. Side Delta (east alley) where the collapse occurred, trapping the fire fighters from Pumper 23, Pumper 10, and Truck 2. Pumper 23 has been moved from its original location behind Pumper 10. This picture was taken the morning of October 13, 2015.**  
*(Photo courtesy of the Bureau of Alcohol, Tobacco, Firearms and Explosives.)*

At the time of the collapse, which was approximately 2006 hours, two fire fighters from Pumper 23, two fire fighters from Pumper 10, and one fire fighter from Truck 2 were operating in the alley on Side Delta. The tactical decision to place resources within the collapse zone was communicated over the radio by the Side Delta division supervisor. This message was not confirmed by the Incident Commander. The task consisted of stretching and directing a hose line from the corner of the Side Delta of the structure and to place a hose stream into two openings that were showing aggressive fire. The crews on Side Delta reported that fire was impinging upon a pumper that was spotted in the alley.

***Recommendation #1: Fire departments should ensure that when a collapse zone is established, the collapse zone is properly managed and enforced by the division supervisor and/or assistant safety officer. Command should also consider designating exclusion zone(s) or no-entry zones as needed due to dangerous or hazardous conditions.***

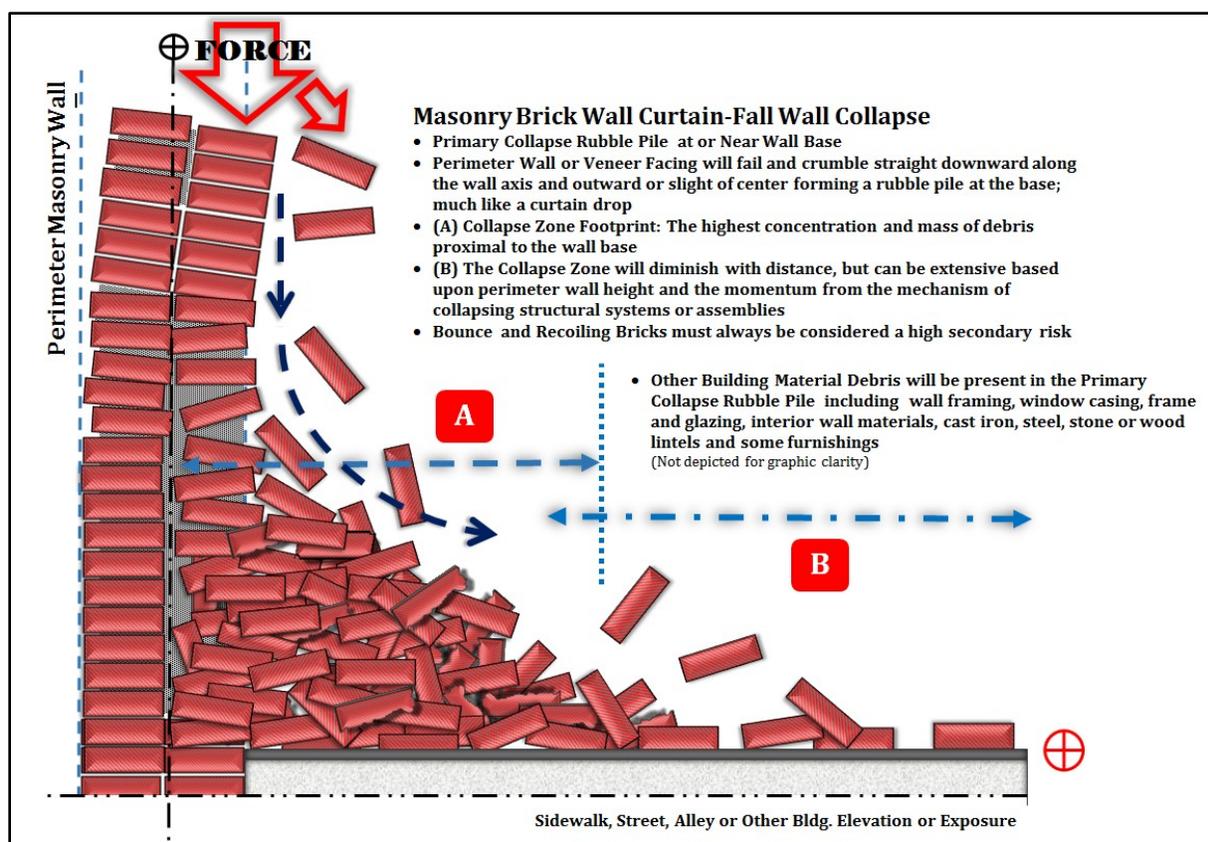
(550°C), the remaining strength of the steel component is approximately 50% of the value at ambient temperature [NFPA 1997; SFPE 1995]. Steel beams will elongate and soften when exposed to temperatures at 1000°F (538°C) at a rate of 9.5 inches per 100 linear feet. This also equates to a 0.06% to 0.07% elongation for each increase in 100°F (38°C). Structural steel failure and collapse will typically occur at 1300°F (704°C) [SFPE 1995] (See Diagram 8).

**Diagram 8. Typical masonry wall curtain-fall collapse characteristics of a masonry brick curtain-fall collapse zone**  
(Graphic courtesy of *Buildingsonfire.com* | C.J. Naum.)
