F2016-09

Career Captain Drowns After Running Out of Air During Technical Rescue SCUBA Dive— North Carolina

LINE OF DUTY DEATH REPORT VISUAL EXTENSION

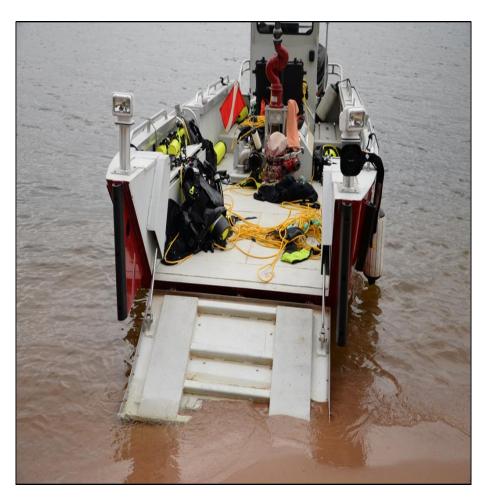
Dive boat from fire department 4, from which Diver 4 was diving. It was not his department's boat. (Photo courtesy of mutual aid fire department.)

- Fire department dive teams should ensure vessels are properly equipped when used for supporting dive operations or consider other options.
- Standards-setting organizations should consider adopting a national consensus standard for public safety SCUBA divers that includes minimum initial and refresher training and a SCUBA equipment standard that includes minimum respirator performance.
- Fire departments should consider implementing a body recovery procedure to reduce the time dive teams spend at depth recovering a victim.

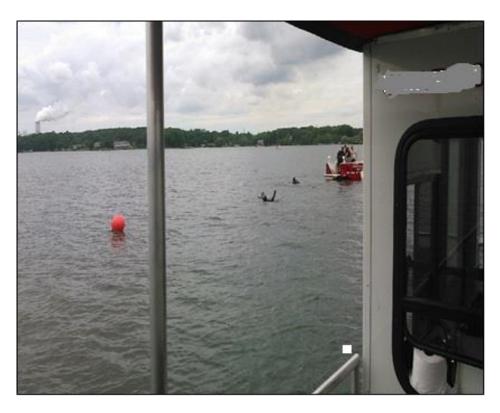
A career captain drowned after running out of air while searching for a civilian drowning victim during a technical rescue deep dive. Photo taken from Dive Boat 38 showing the bow of FD 4's dive boat and divers having to surface swim to the descent buoy. Photo taken before the drowning.

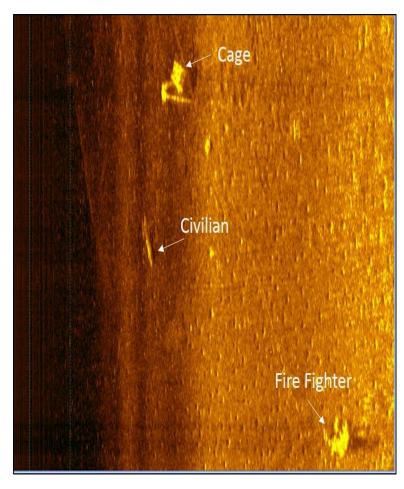
Sonar image showing the location of the cage (metal cage that the descent line is attached to), the civilian drowning victim's location, and the downed firefighter/diver.

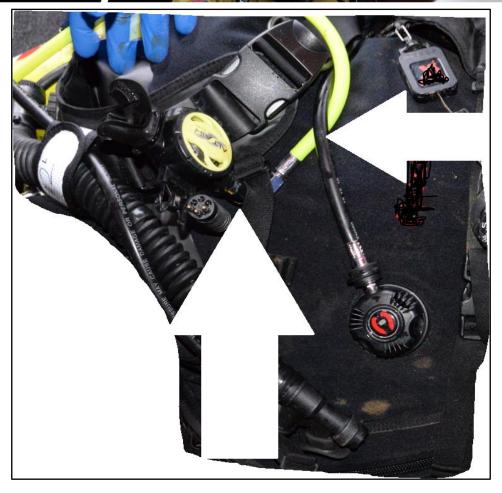
- Pre-dive safety check
- Air management
- Uncontrolled out-of-air emergency (not being able to use redundant air supply, redundant air regulator was routed under the air fill for the dry suit and also under the high chest strap for the BCD)
- Panic/rapid uncontrolled ascent while holding breath
- Training and experience
- SCUBA equipment issues affecting buoyancy control (dump valve was pinned open and unintentionally allowed air to escape)
- Lack of a safety officer trained in technical rescue SCUBA diving during the event.

The photo shows the orientation of Diver 4's redundant air regulator is routed under the air fill for the dry suit and also under the high chest strap for the BCD. Although the final location of the mouthpiece would have been close to the diver's head, it would have been difficult to deploy. Diver 3 reported during interviews that Diver 4 was struggling with his redundant air regulator. Divers should always have easy access to the redundant and alternate air regulator. (Photo courtesy of the mutual aid dive team. The photograph was altered by NIOSH to obscure manufacturer's name.)

- SCUBA manufacturers and standard-setting organizations for public safety divers should consider including HUD in all full-face SCUBA apparatus due to the frequent zero-visibility conditions and silt-out in low-light conditions.
- Fire departments should ensure that public safety divers are properly trained to recognize and have the repetitive skills training to control outof-air emergencies and be able to use their redundant air before anxiety leads to panic. Additionally, when dive teams mix full-facepiece regulators with stand-alone regulators from a pony system, the divers must be well-trained to accomplish the difficult removal and switch task.

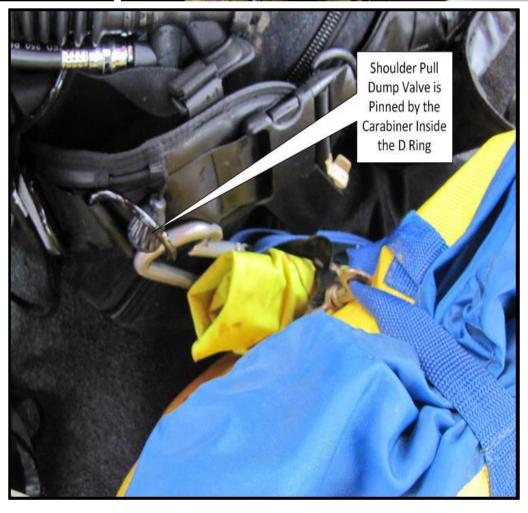
Close up photo taken when the victim was recovered showed his shoulder dump valve was possibly pinned "open" by the body bag carabiner inside the D ring. This could have made maintaining positive buoyancy difficult as any air pushed into the BCD may have escaped here.
