Volunteer Fire Fighter Struck and Killed by Tanker Backing into the Bay of the Fire Station—Pennsylvania

Executive Summary

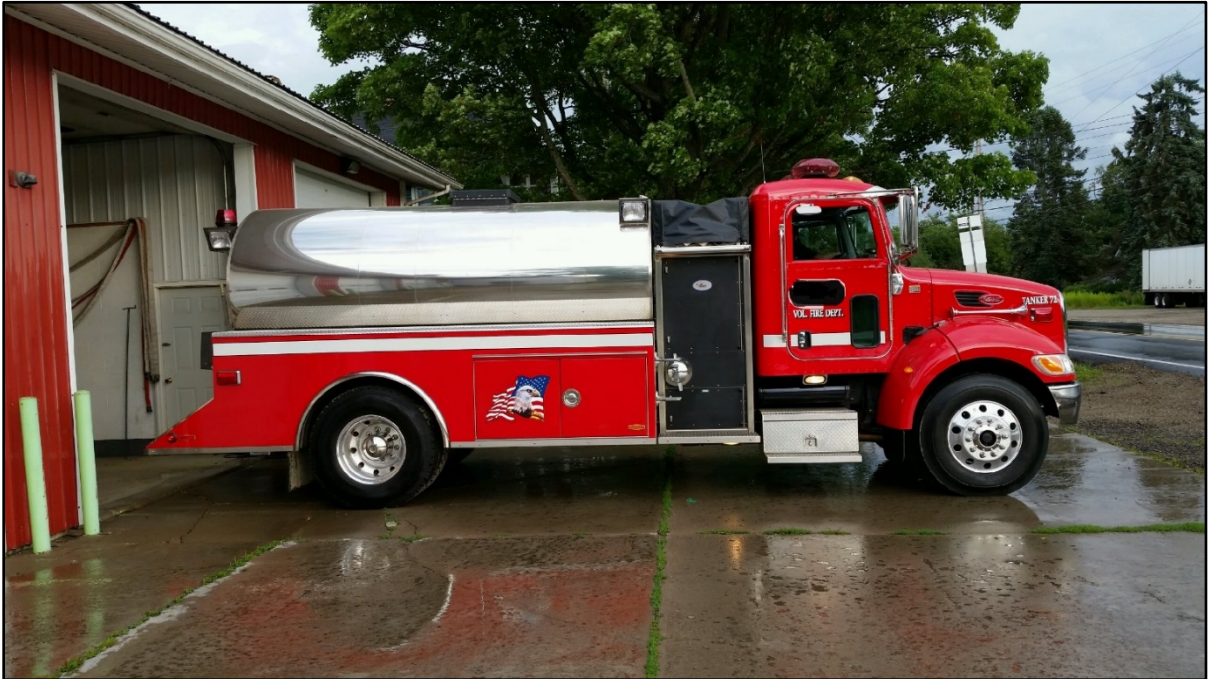
Tanker involved in incident. (NIOSH photo)

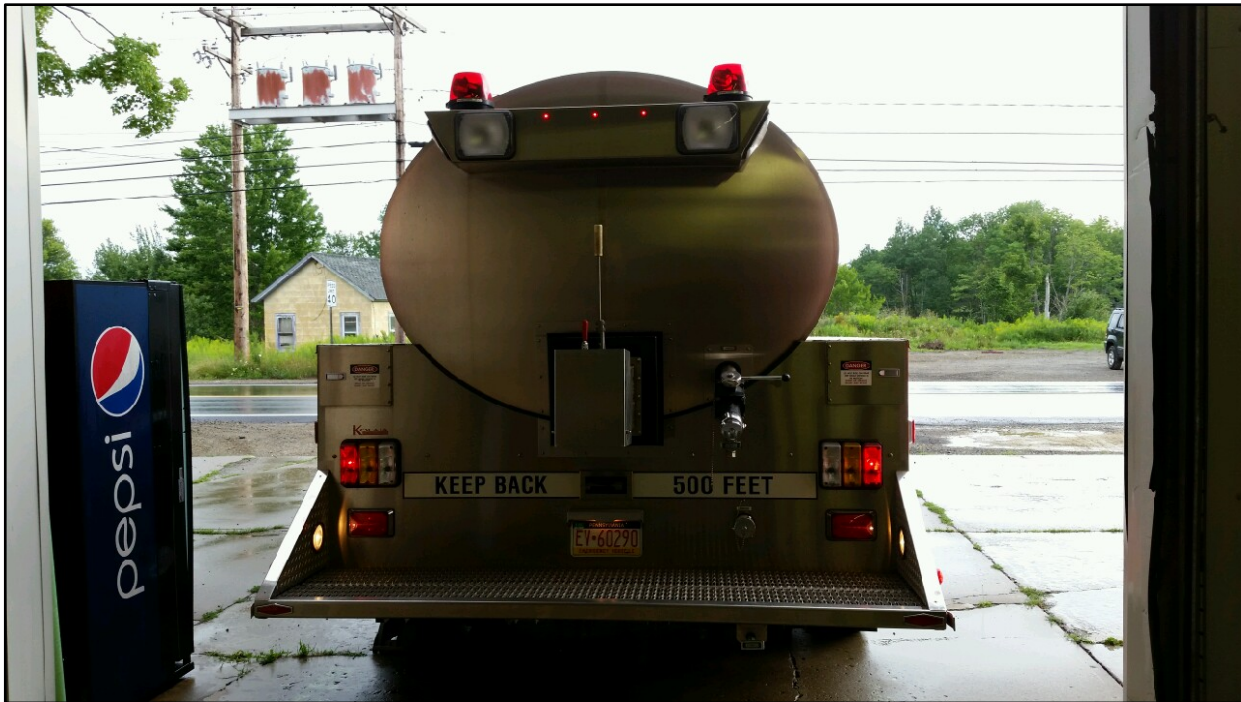
Photo 1. Rear of Tanker 72.
(NIOSH photo)

The incident involved a Peterbilt 2008 model Tanker. The vehicle was equipped with a 500-gallon tank. The truck was not equipped with an audible backup alarm that automatically sounds when the truck is put into reverse (see Photos 1 and 2).

Discussion: Modern technology has provided motor vehicles with a variety of electronic devices that can assist in safe backing, parking, and general maneuvering. These technologies can be added to fire apparatus to aid in improving fire fighter and fire apparatus safety. Fire apparatus are currently being equipped with additional mirrors, cameras, and apparatus-mounted sensing devices to aid in backing maneuvers. Additional mirrors mounted and angled so that blind spots are reduced or eliminated can assist the driver while backing. A rear-view camera mounted on the rear of the apparatus provides a view of the blind area directly behind the vehicle on a video monitor in the cab. Radar or sonar sensing systems designed as backing aids provide an alarm in the cab when an individual or other obstacle is detected at the rear of an apparatus. A combination of a camera and a sensor system may offer the best protection, especially on a congested fireground or at a motor vehicle incident [IFSTA 2013]. Even though these technological devices may provide an additional measure of safety, they do not substitute for visible spotters. NFPA 1901 Annex D and NFPA 1906 Annex D both contain guidelines to assist fire departments and authorities having jurisdiction with the determination of how to properly equip older fire apparatus with safety equipment to assist drivers during backing operations [NFPA 2016a,b; USFA 2003].

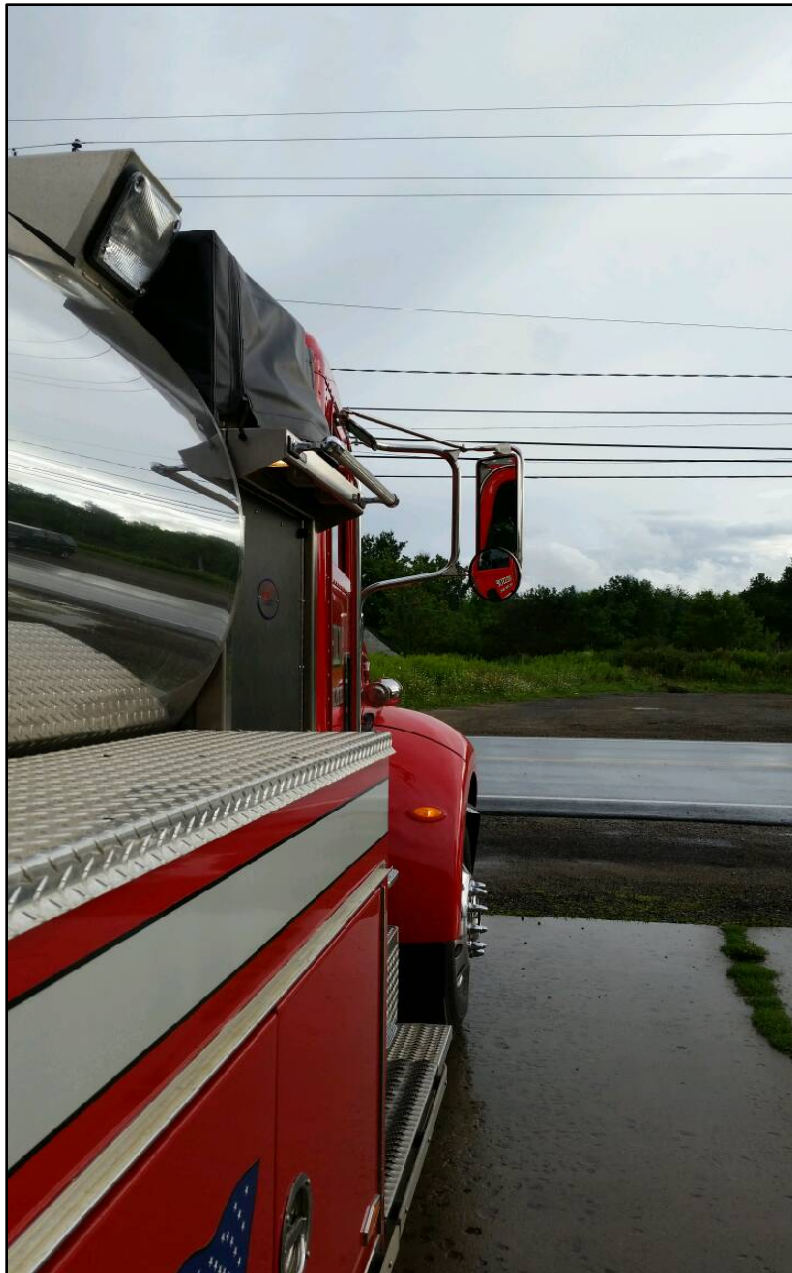
Photo 2. Photo of the passenger side mirror on Tanker 72. Photo shows the narrow field of view that the right-side mirror provides.
(NIOSH photo)

In this incident, the driver was attempting to back into the third bay when the fire fighter walked toward the rear of the backing tanker. It is believed the fire fighter did this to get the driver's attention and direct him to another bay. The driver saw the fire fighter in his right side mirror. According to his statement, as he continued backing, he looked in his left mirror and then back to the right again but did not see the fire fighter. The driver had decades of experience driving fire apparatus and had driven this apparatus since its acquisition in 2008.

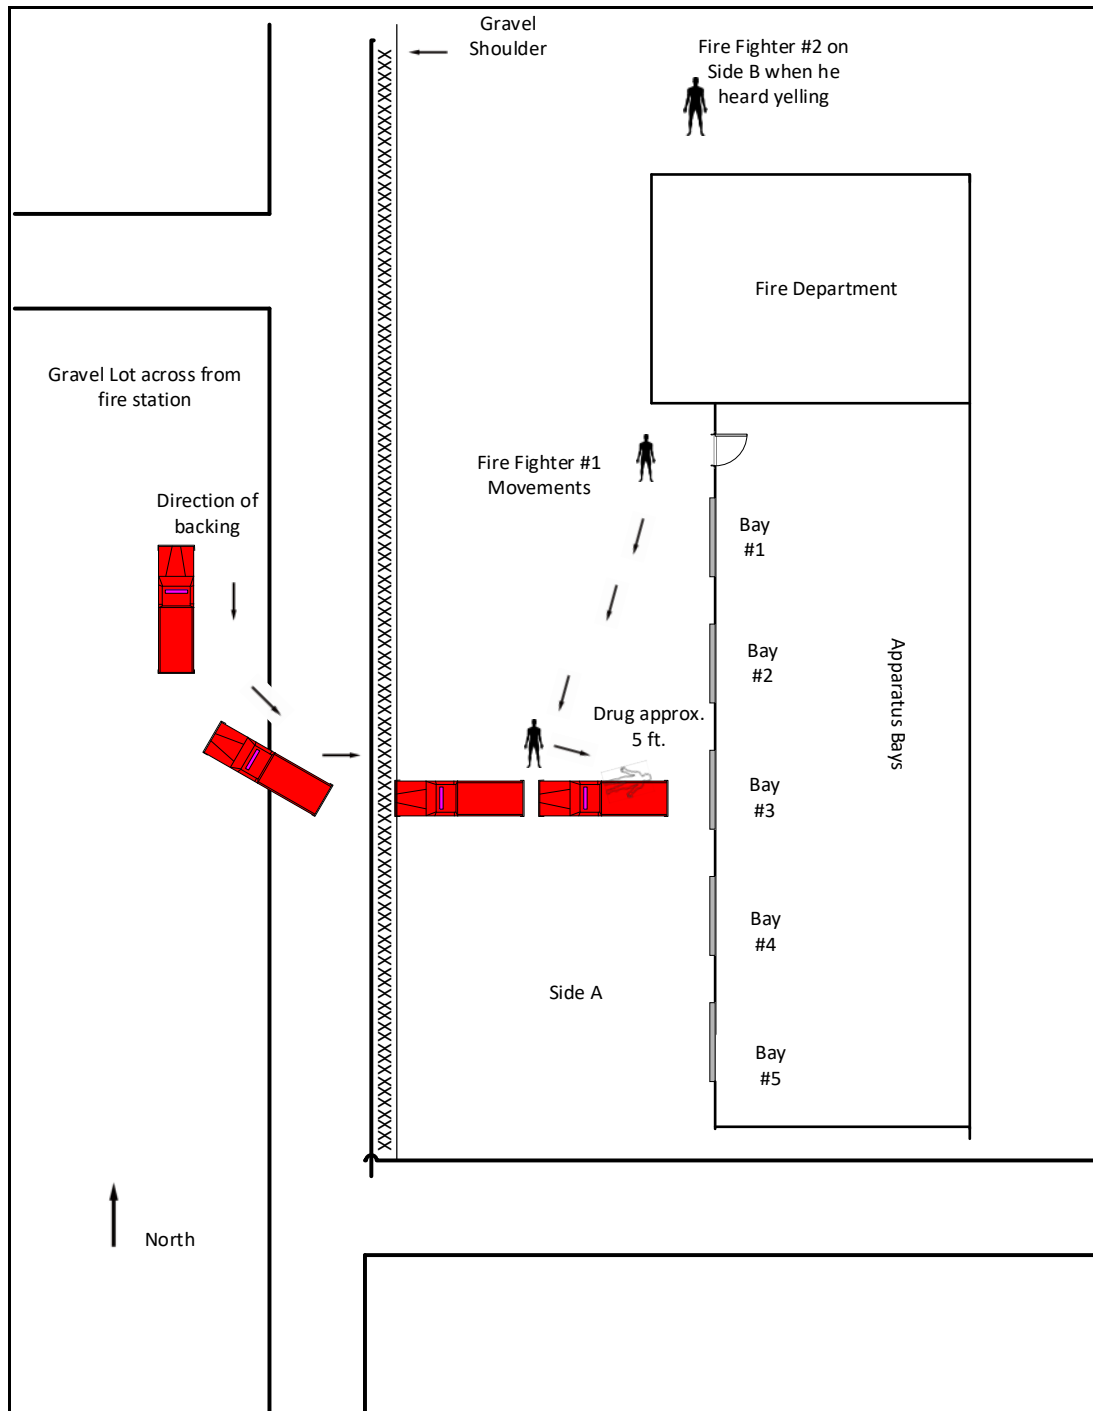
- **1130 Hours.** Fire department dispatched three apparatus, including a tanker, to help slow and coordinate traffic.
- **1138 Hours.** Tanker 72 arrived at their designated location.
- **1335 Hours.** Tanker 72 arrived back at the fire department.
- **1337 Hours.** Tanker 72 was backing toward Bay 3 of the fire station. Approximately 30 feet away, a fire fighter went to assist, presumably to redirect tanker to Bay 2, and was backed over.

issues, and that the driver had impaired hearing according to his statement in the state police report, which may have played a role in the incident. At approximately 1337 hours, a second fire fighter was around Side B of the station, heard the fire fighter yelling the driver's name, and walked around to Side A to see why he was yelling. The second fire fighter noticed that the tanker's rear right wheels were on the fire fighter's left leg and the fire fighter was horizontal on the parking pad of the fire station. The second fire fighter ran to the driver's door to get the driver's attention to stop. When the driver stopped the tanker, it had completely ran over the fire fighter's left half of his body (see Diagram). The second fire fighter immediately called 911. The ambulance arrived in minutes but the fire fighter had no pulse and was pronounced dead at the scene.

Diagram. Route of the tanker backing up and travel of fire fighter impacted by tanker.
