## Career Lieutenant Killed in Building Collapse While Fighting Row House Fire—Pennsylvania

### Executive Summary

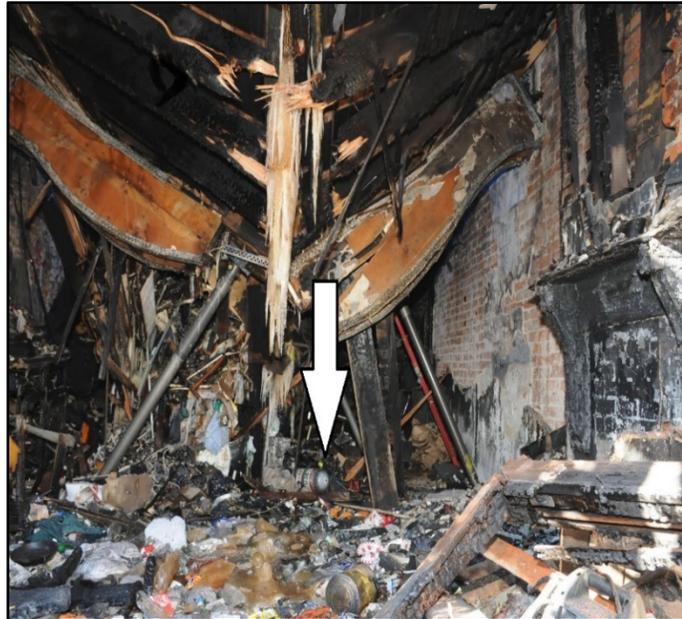
*The Lieutenant was killed in a V-shape collapse while fighting a row house fire. Arrow points to victim's SCBA and the approximate area where the victim was trapped.*

pinned down by the second-floor joists and was unable to escape. Rescue crews worked continuously for approximately 60 minutes in extremely dangerous conditions to extricate the lieutenant. He died of positional asphyxia with superheated gas and smoke inhalation (see cover Photo).

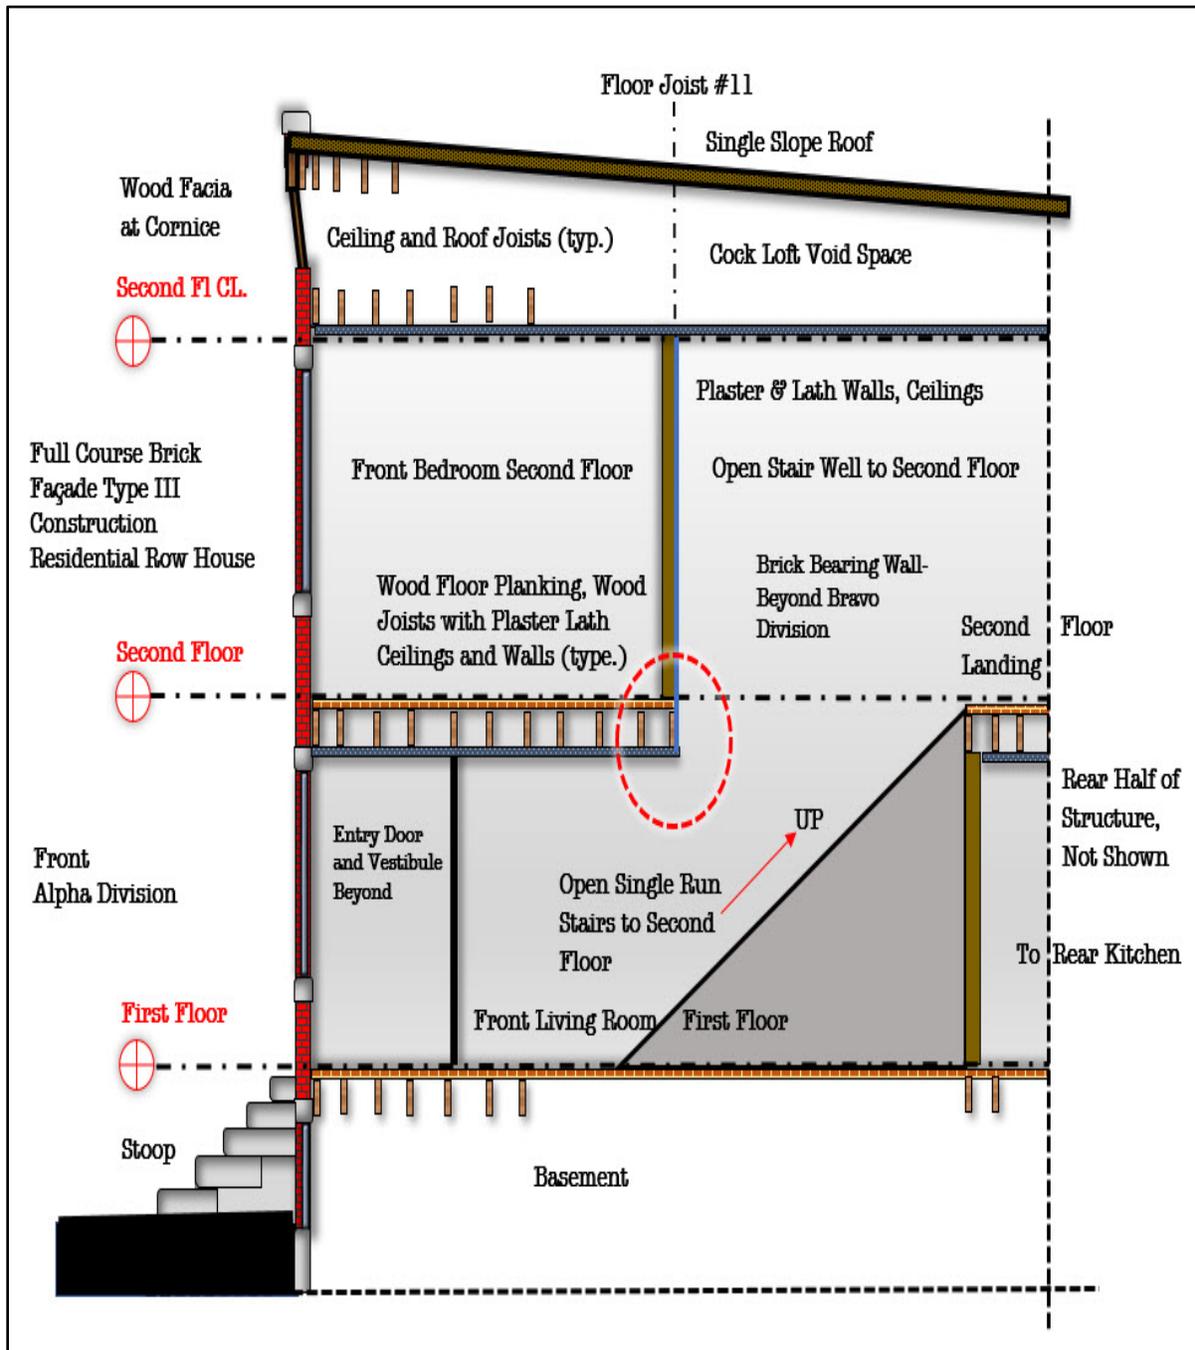
Diagram 3. Cross-Section of Row house. Red dotted circle indicates where second floor joists framed up to the stairwell opening  
(Graphic Courtesy of Buildingsonfire.com | C.J. Naum)

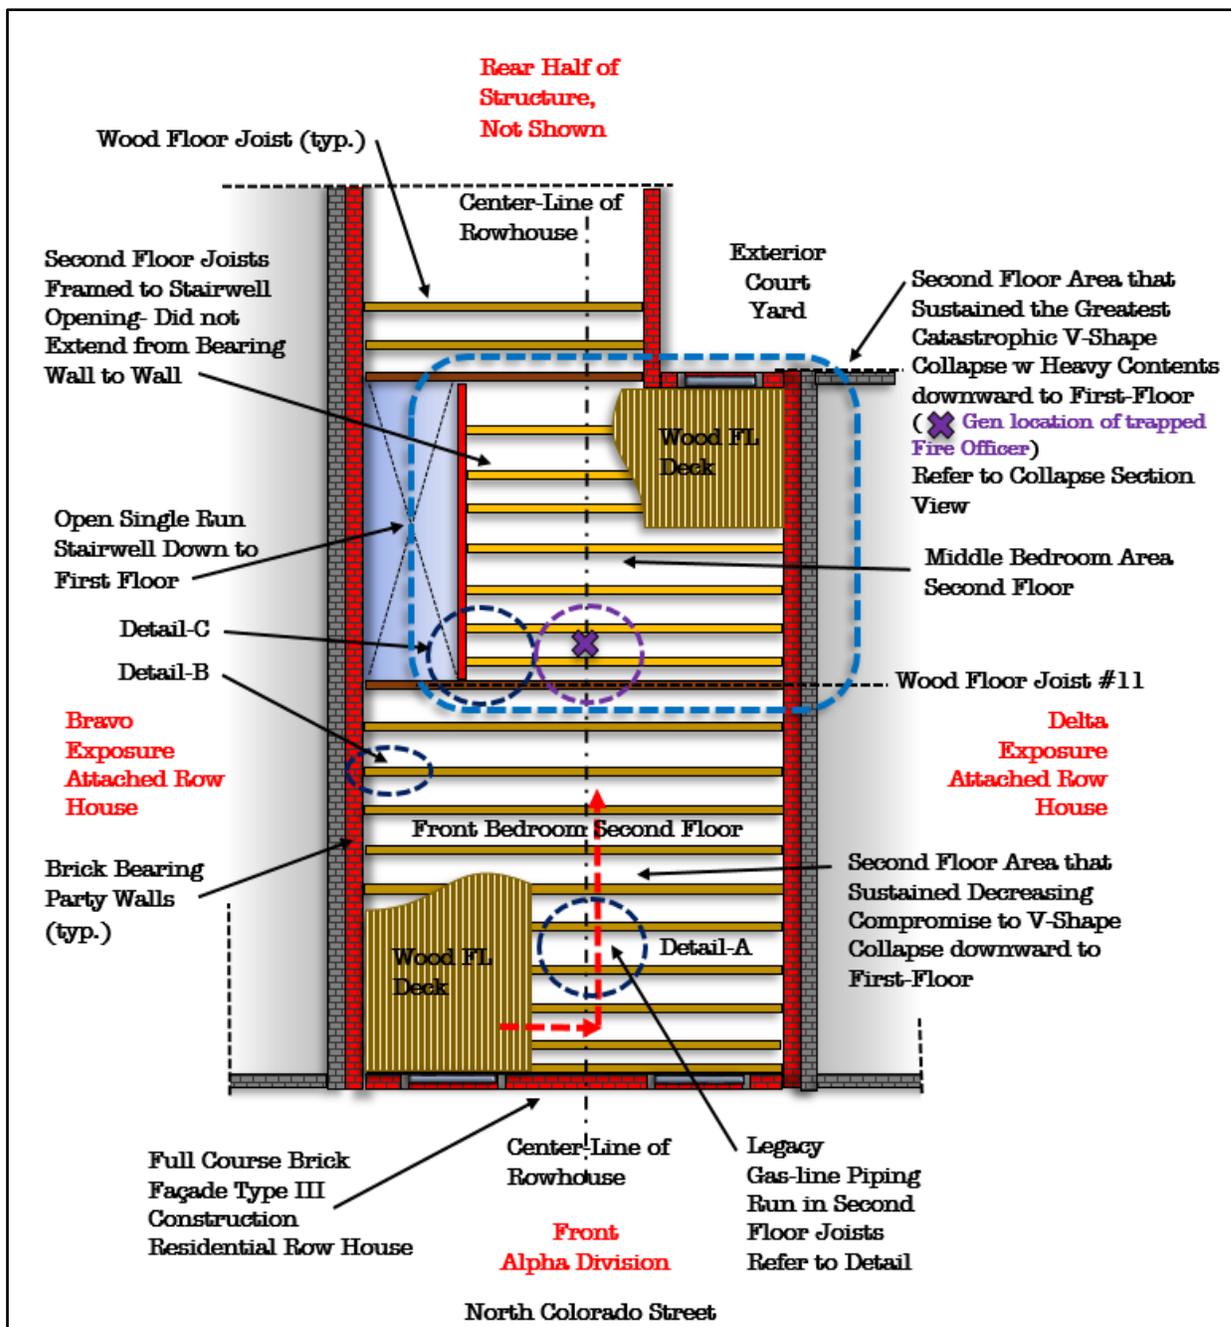
Diagram 4. Row house Floor Joist Plan-Second Floor. Detail A indicates gas piping run in joists. Detail B indicates second floor joists extend from bearing wall to bearing wall. Detail C indicates joists terminating at stairwell opening.  
 (Graphic Courtesy of Buildingsonfire.com / C.J. Naum)

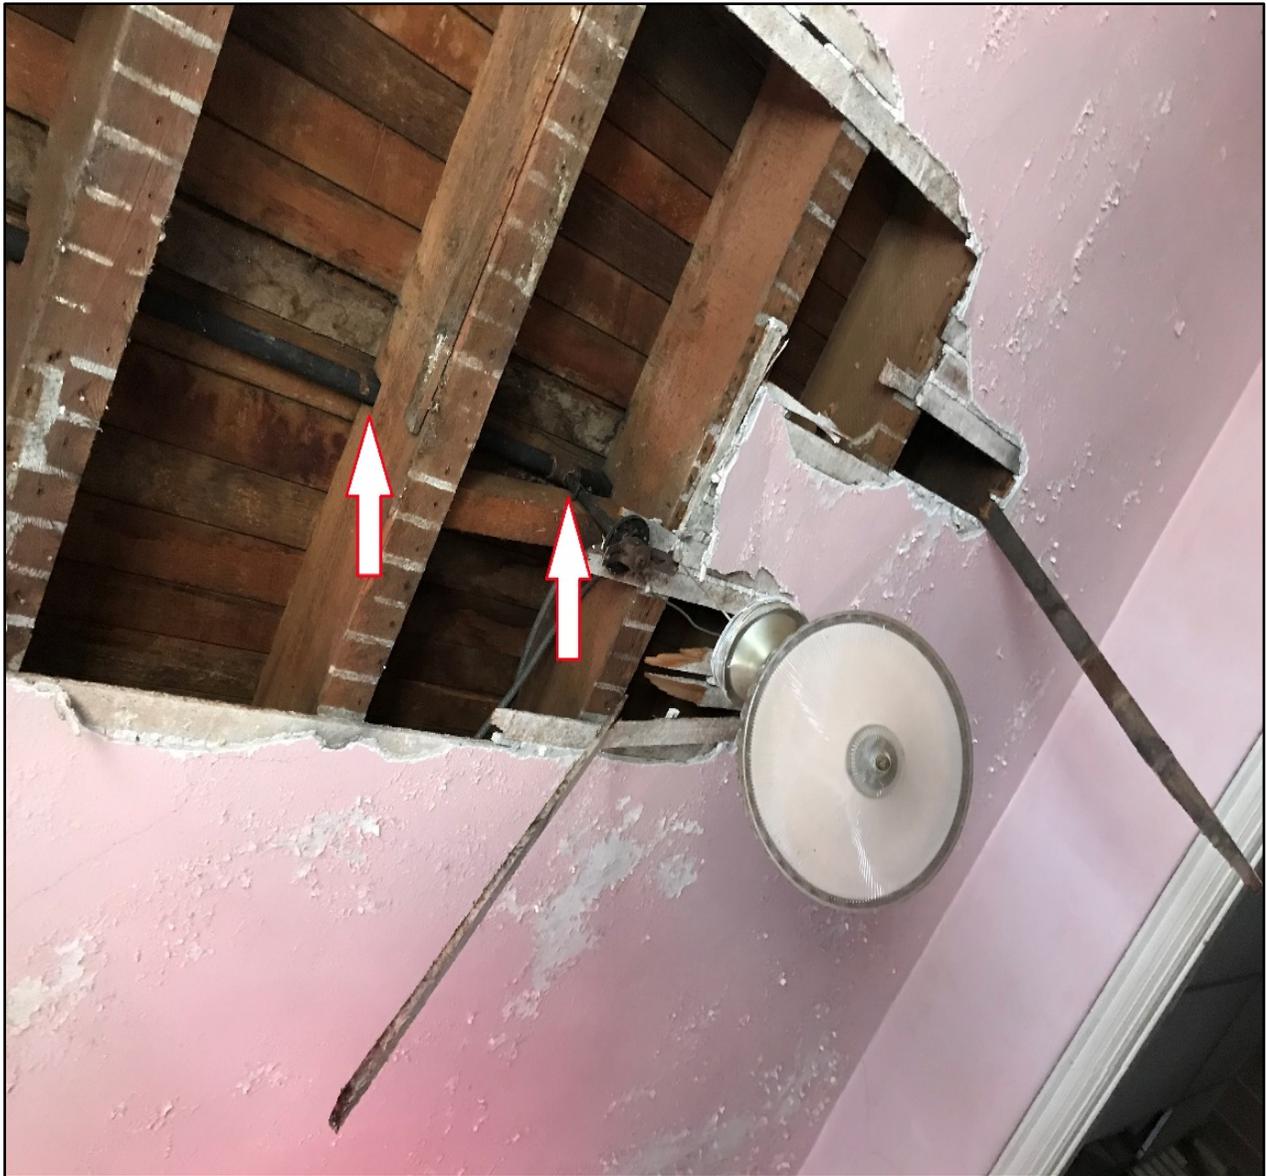
*Photo 2. Exposure row house exemplar photo showing the floor joists cut to allow for gas pipe and the gas pipe drop for the light fixture. Electric light fixtures were attached to these pipes in later years.*

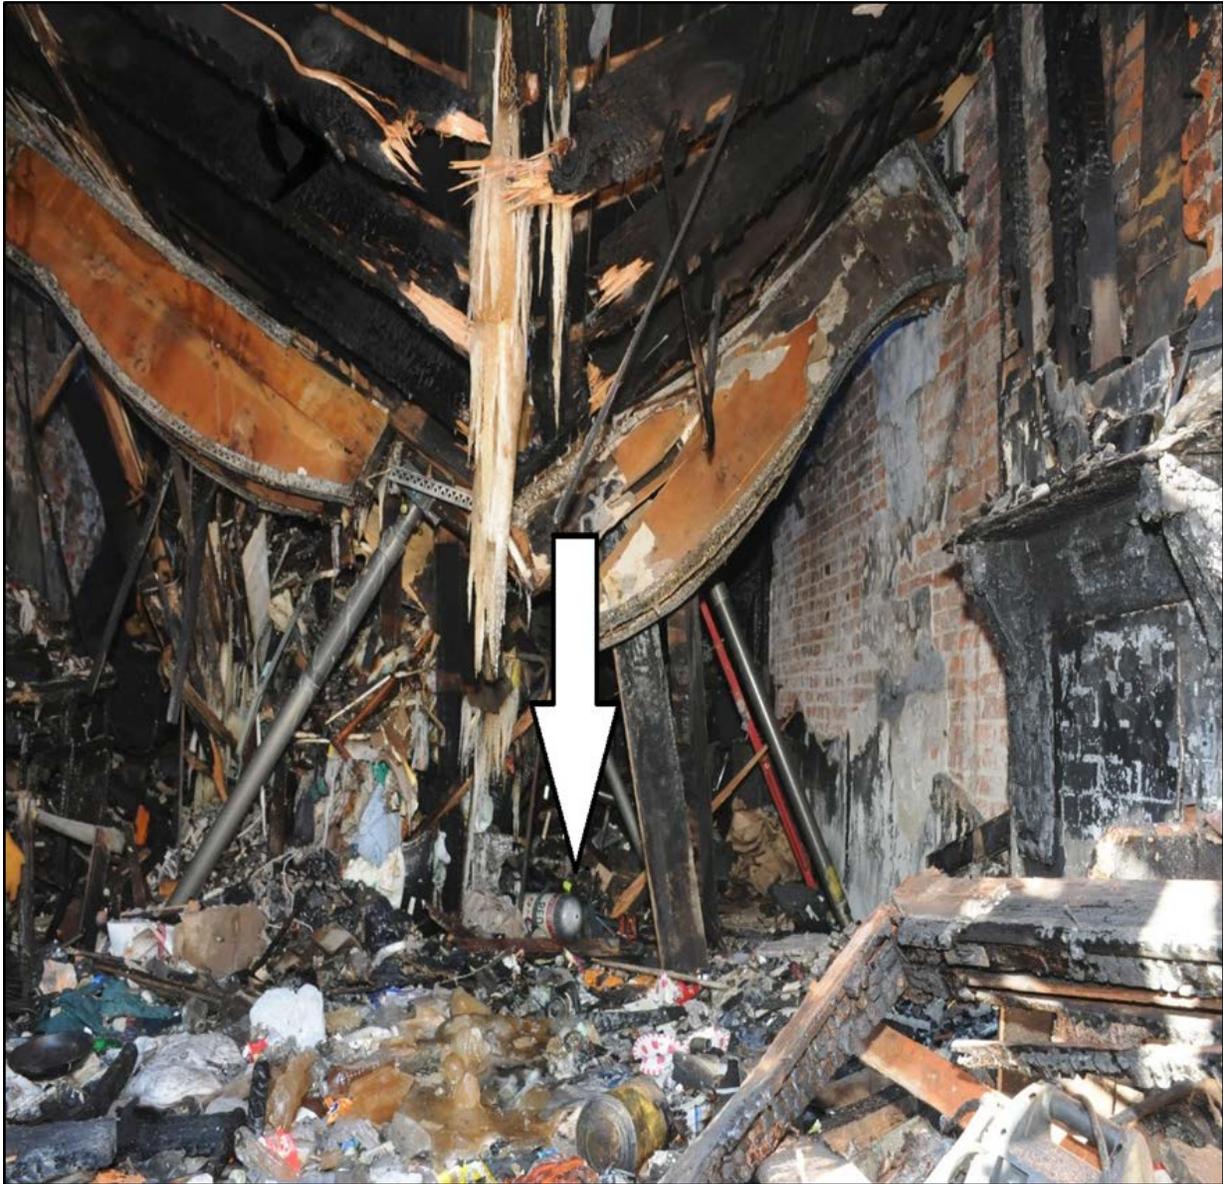
*Photo 7. Arrow indicating victim's SCBA and approximate location where Engine-45's Lieutenant was located and extricated by Fire Department RIT crews.  
(Photo courtesy of the Fire Department)*

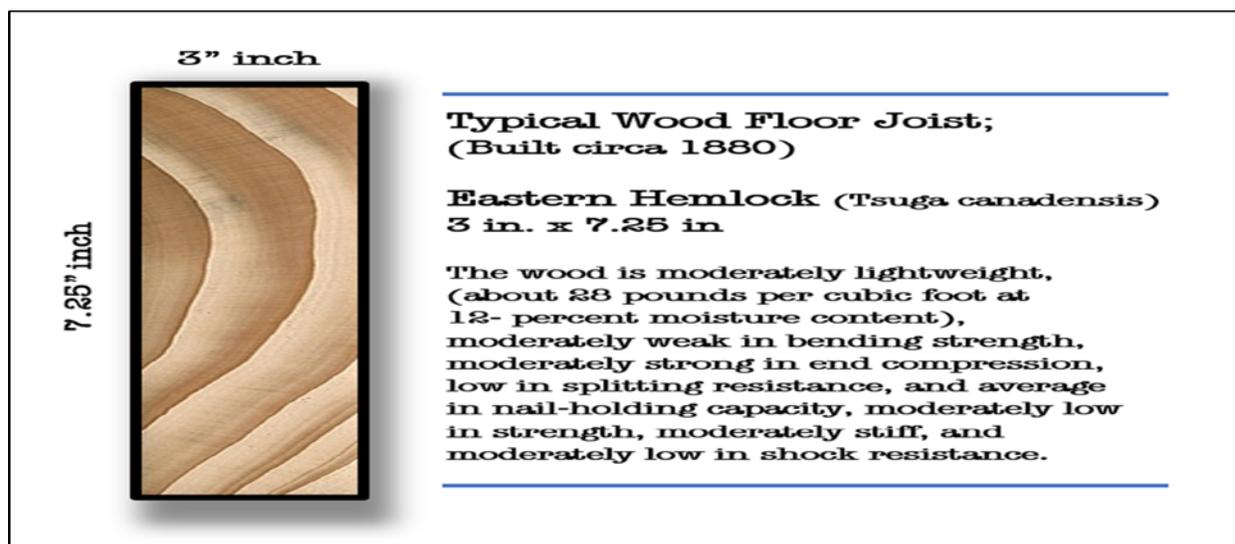
**Diagram 9. Typical Wood Floor Joist. Uniqueness and variances for this row house included, possible degraded load carrying capacity of the existing wood floor joists due to age, creep, the effects of loss of moisture content or cyclical exposure to environment elements [Naum 2019]. (Graphic Courtesy of Buildingsonfire.com / C.J. Naum)**

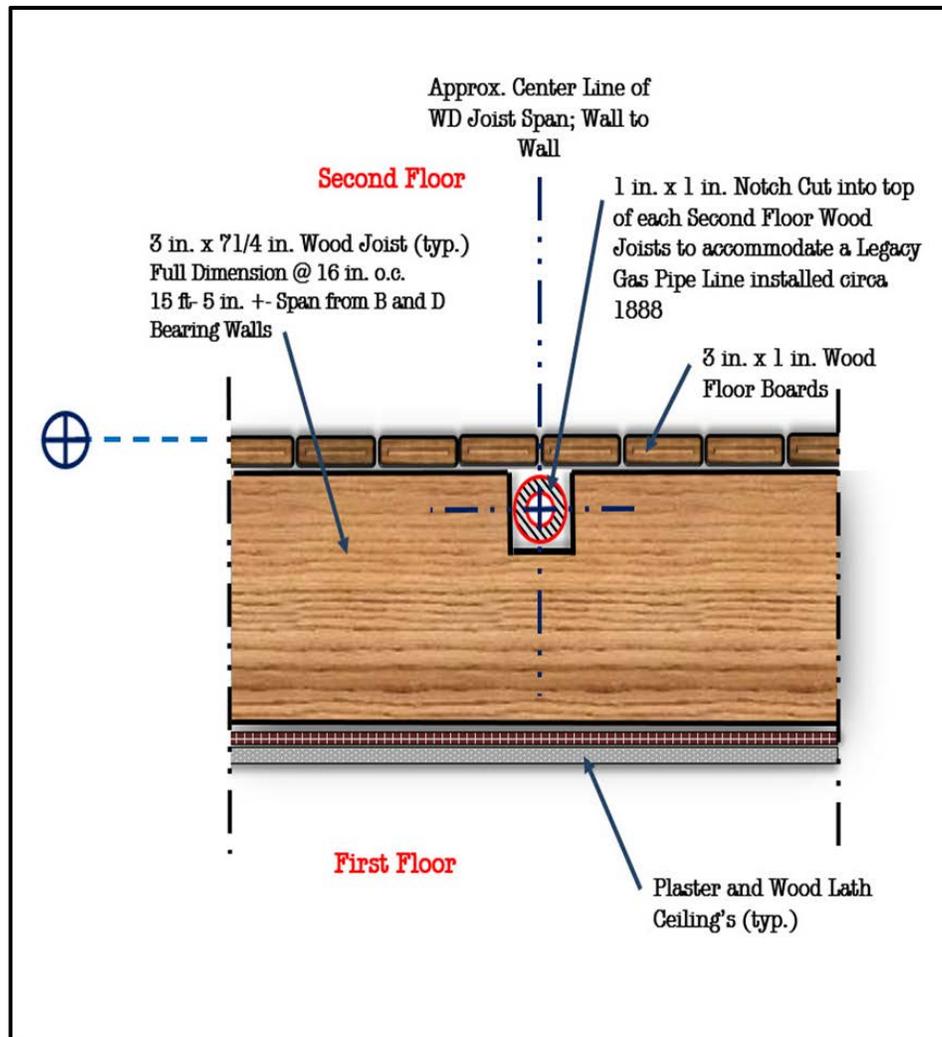
*Diagram 10. Gas-line & Notch. The inherent legacy notching of the existing wood floor joists was a primary contributor to create an existing floor system that was highly susceptible and prone to be affected by an interior compartment or structural fire or affected by existing or in the addition of live or dead loads [Naum 2019].*

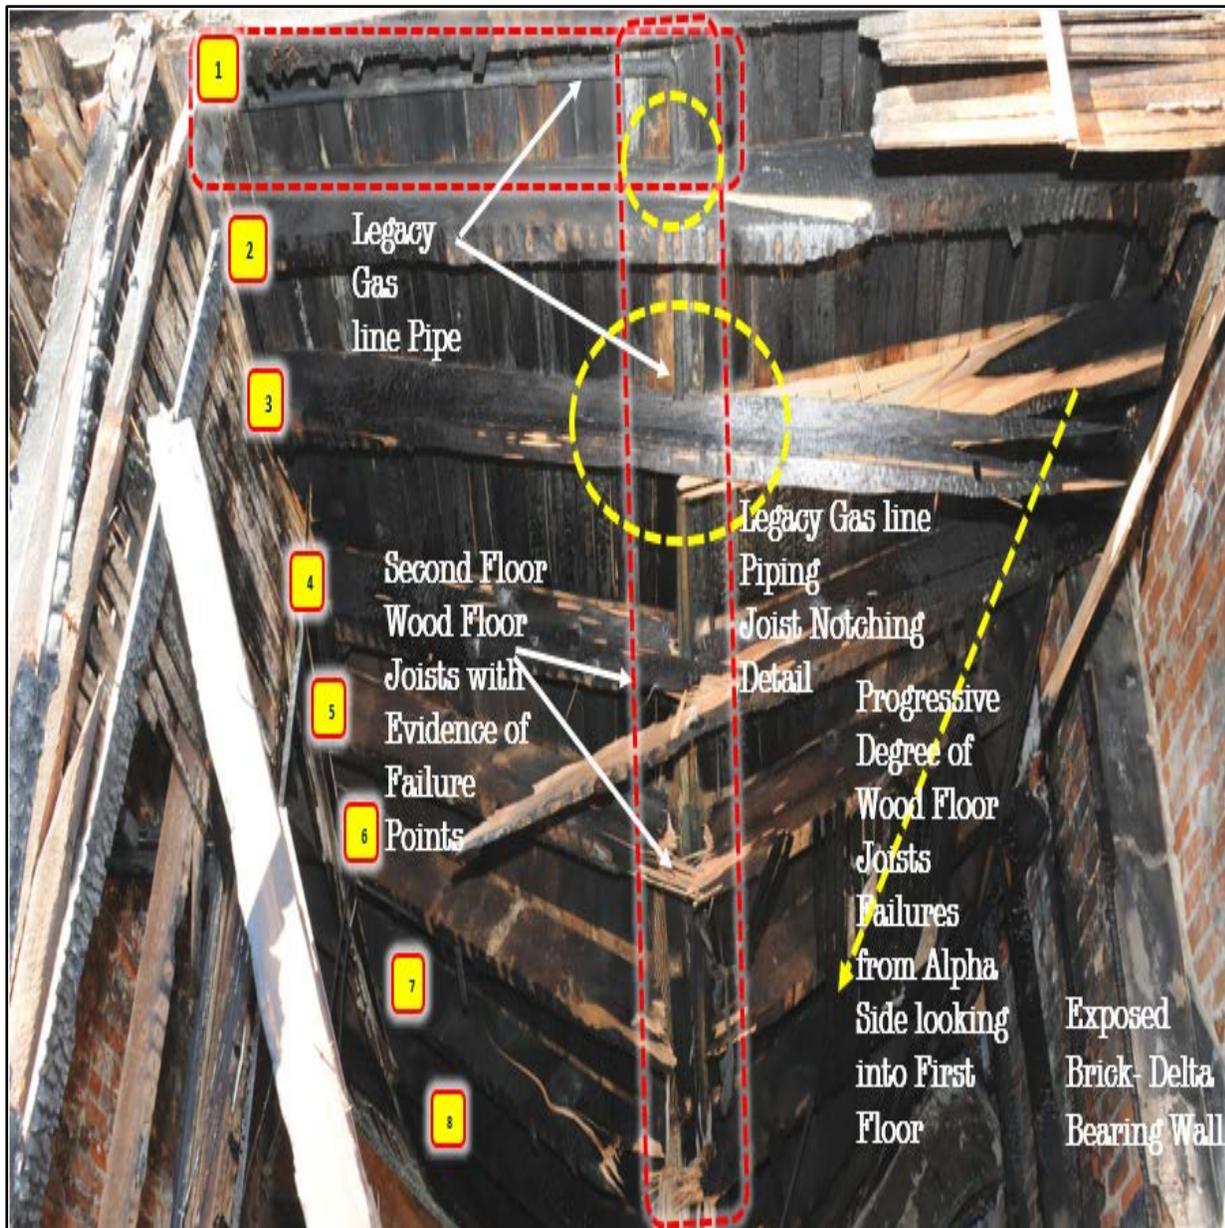
*Diagram 11. Joists numbered from side Alpha toward side Charlie detailing the joist breaking points along the notched cut out for the gas pipe installation.*

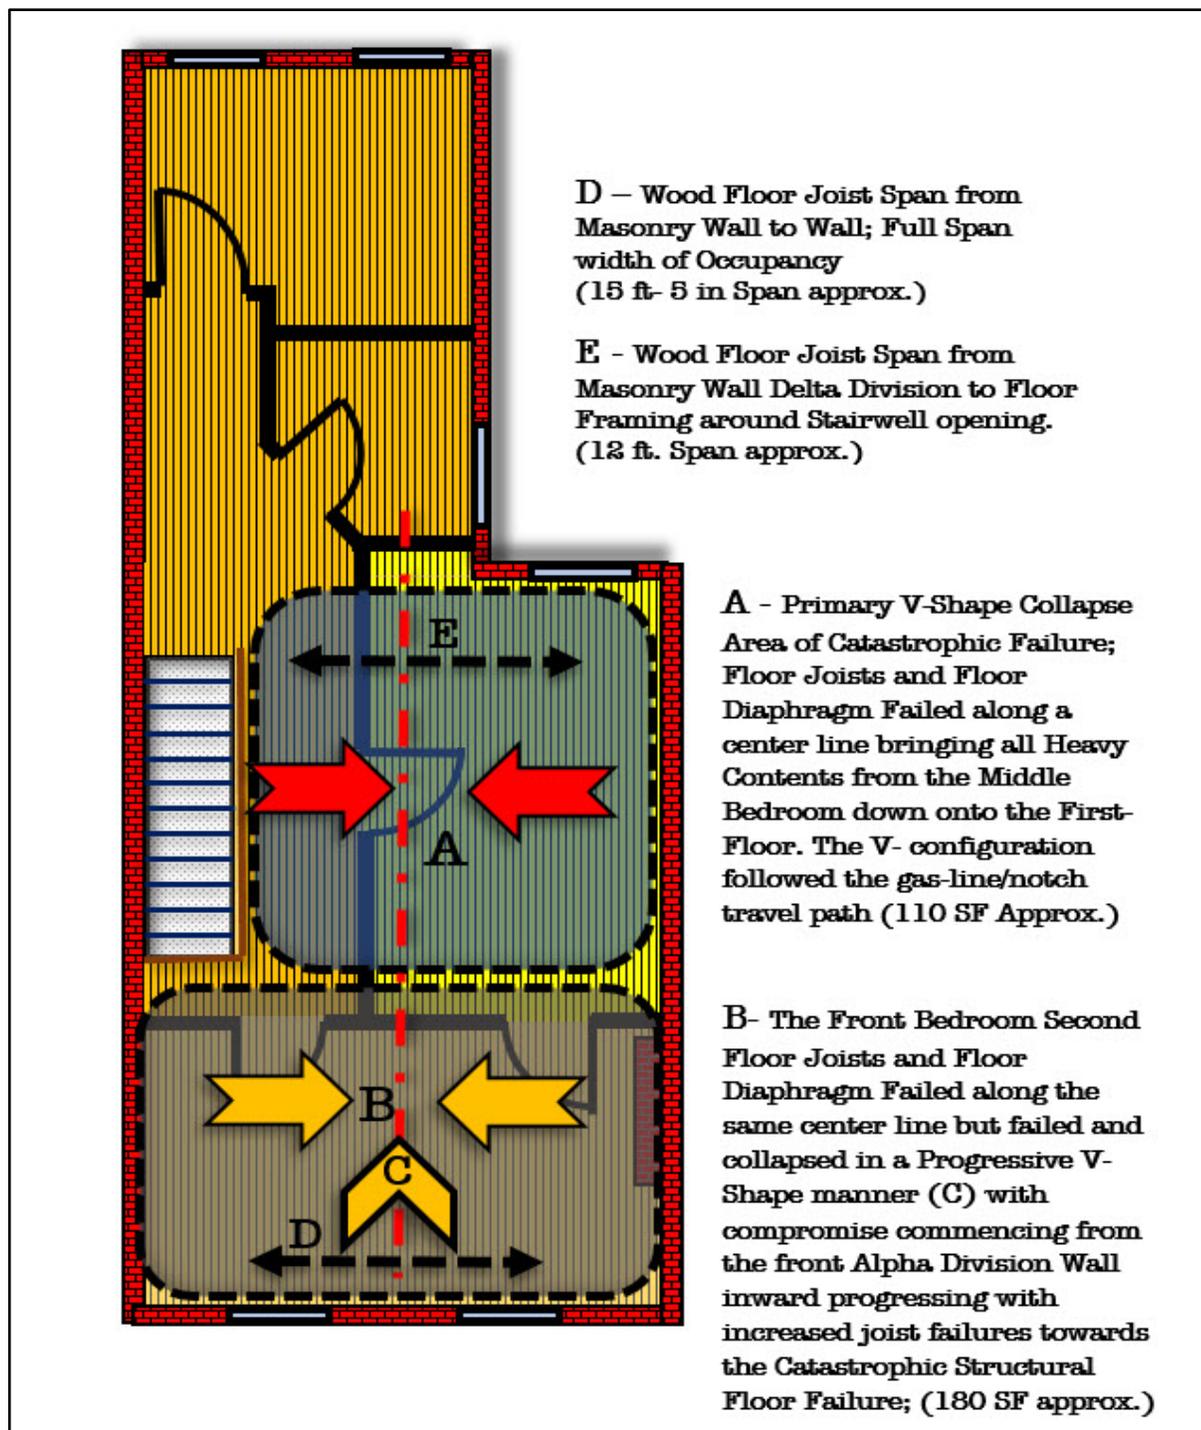
Appendix 2 Diagram 6. Second Floor Collapse Areas. Photo: Analysis Diagram Courtesy of Buildingsonfire.com | C.J. Naum

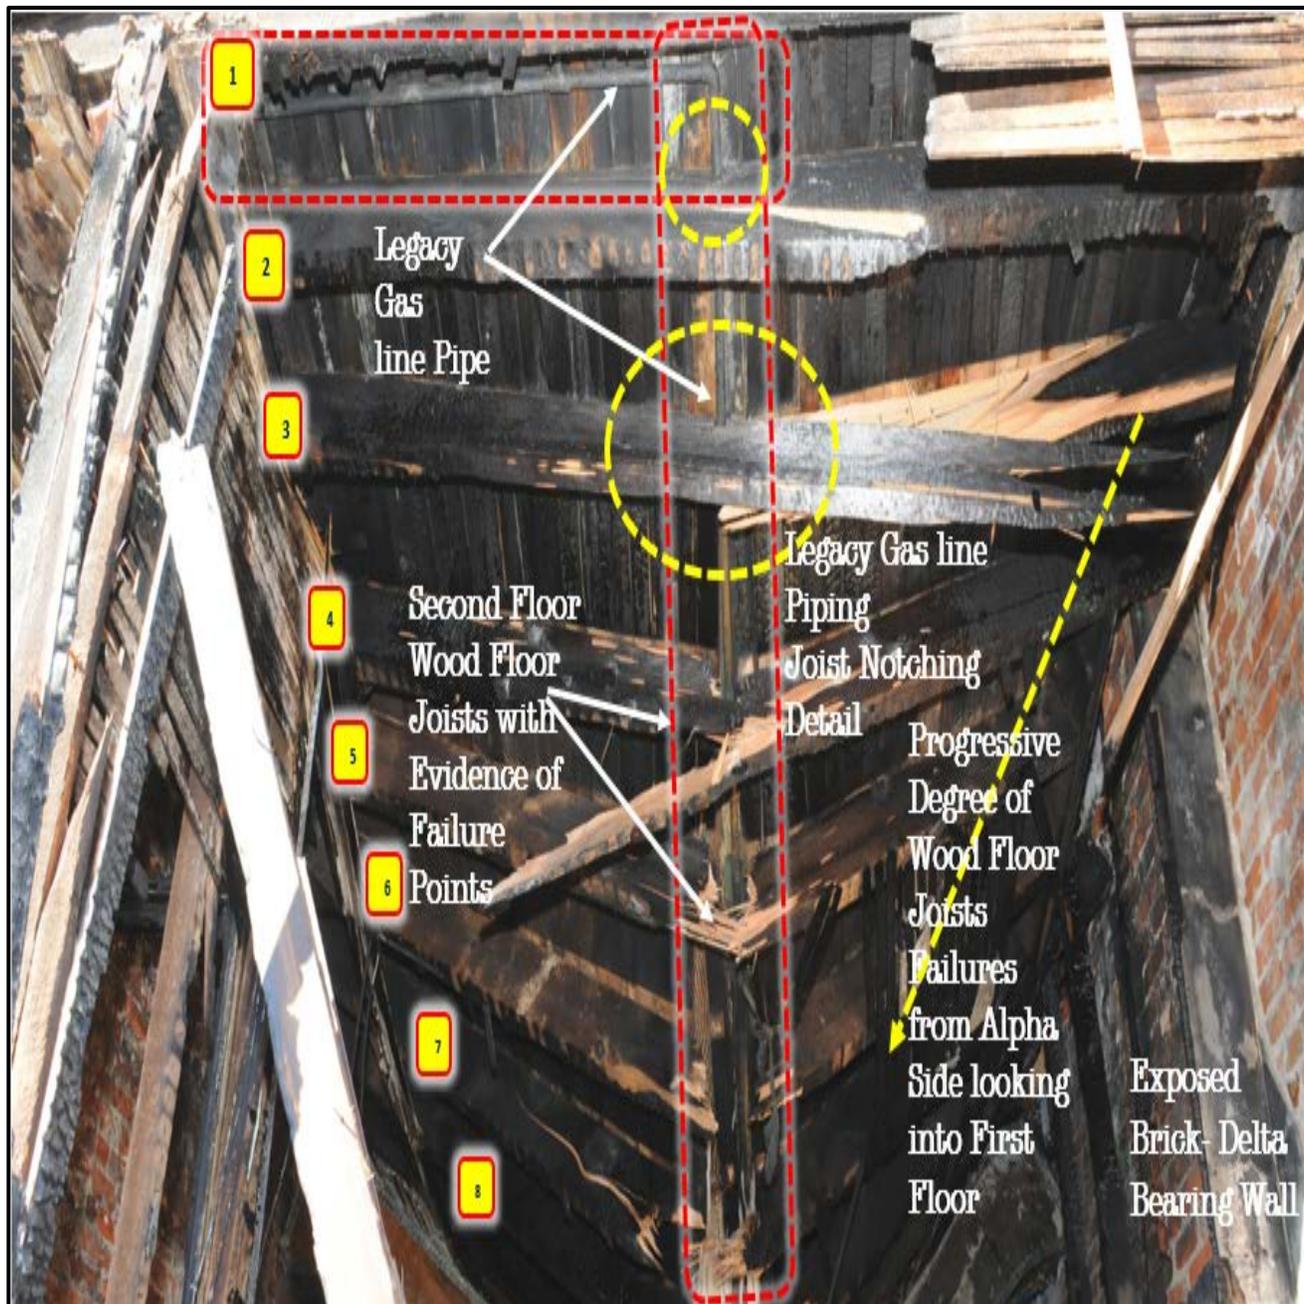
**Appendix 2 Diagram 10. Second Floor Collapse of Floor Joists Details of Failures, looking inward from the Alpha Division.** Photo Courtesy of Fire Department. Analysis Diagram Courtesy of Buildingsonfire.com | C.J. Naum

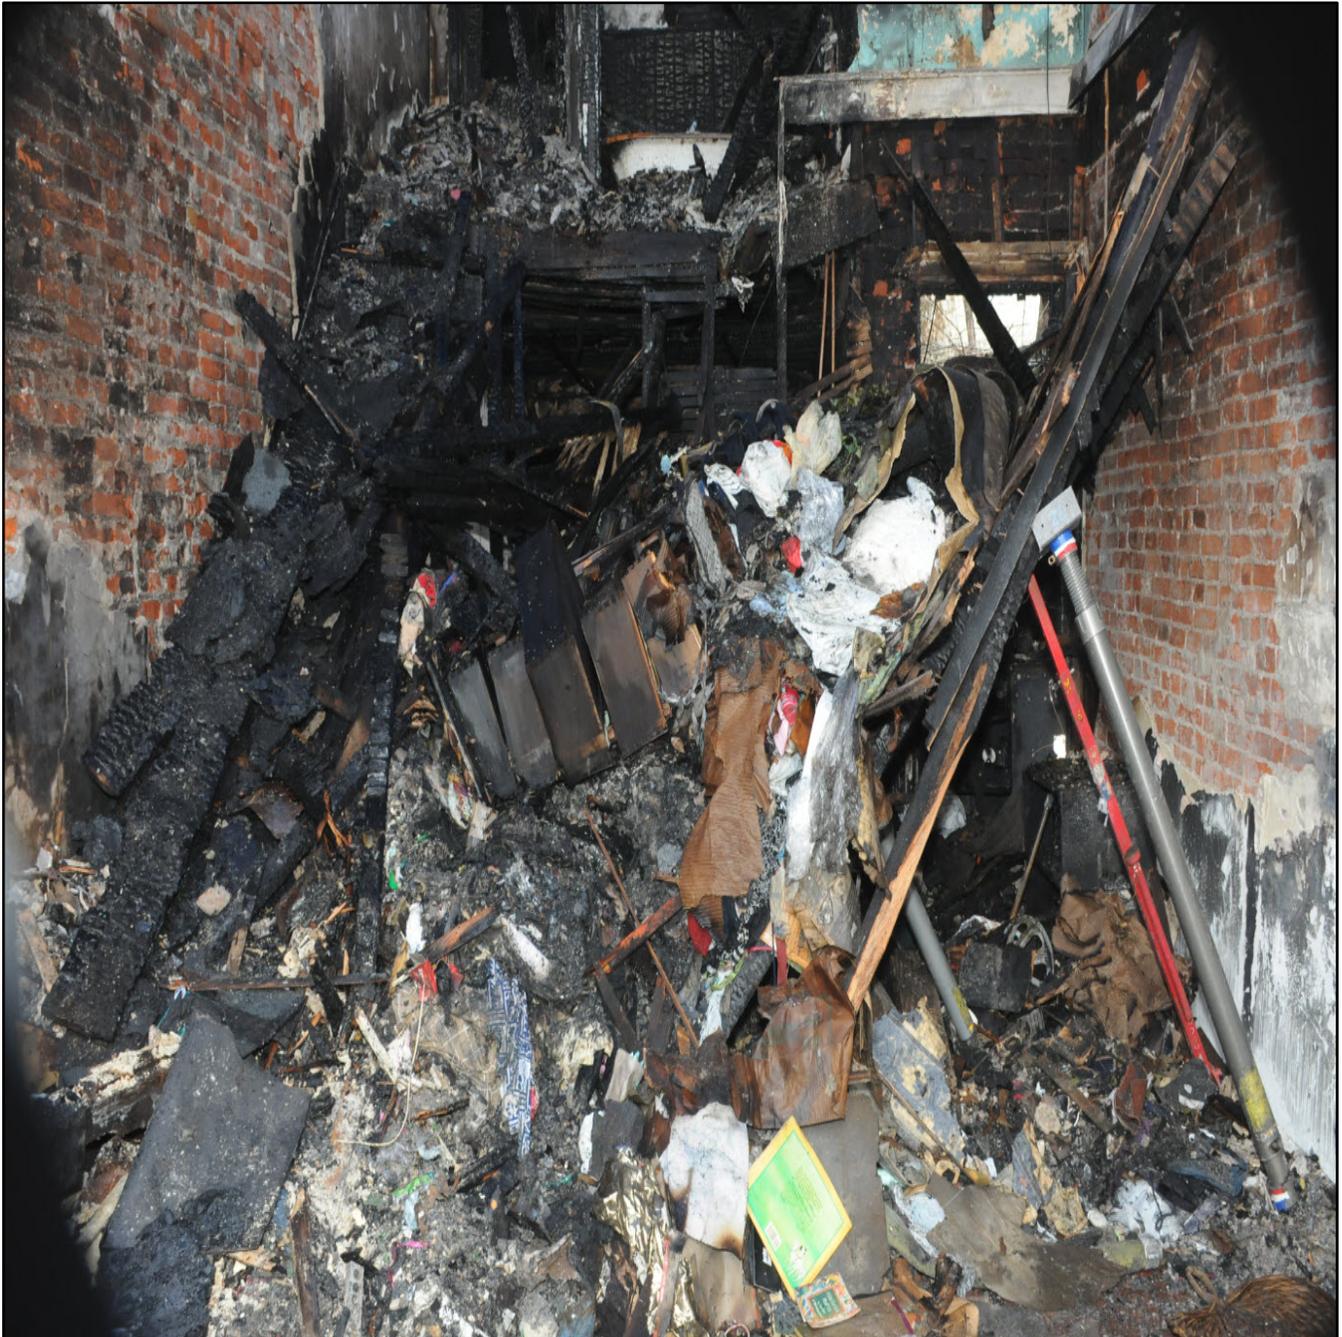
**Appendix 2 Photo 5. Front First Floor Looking inward to Collapse Zone 1<sup>st</sup> Floor.** Photo Courtesy of Fire Department. Hoarding, Heavy Content and Clutter from Second Floor Rooms into the V-Shaped Floor Collapse. Photo Courtesy of Fire Department.

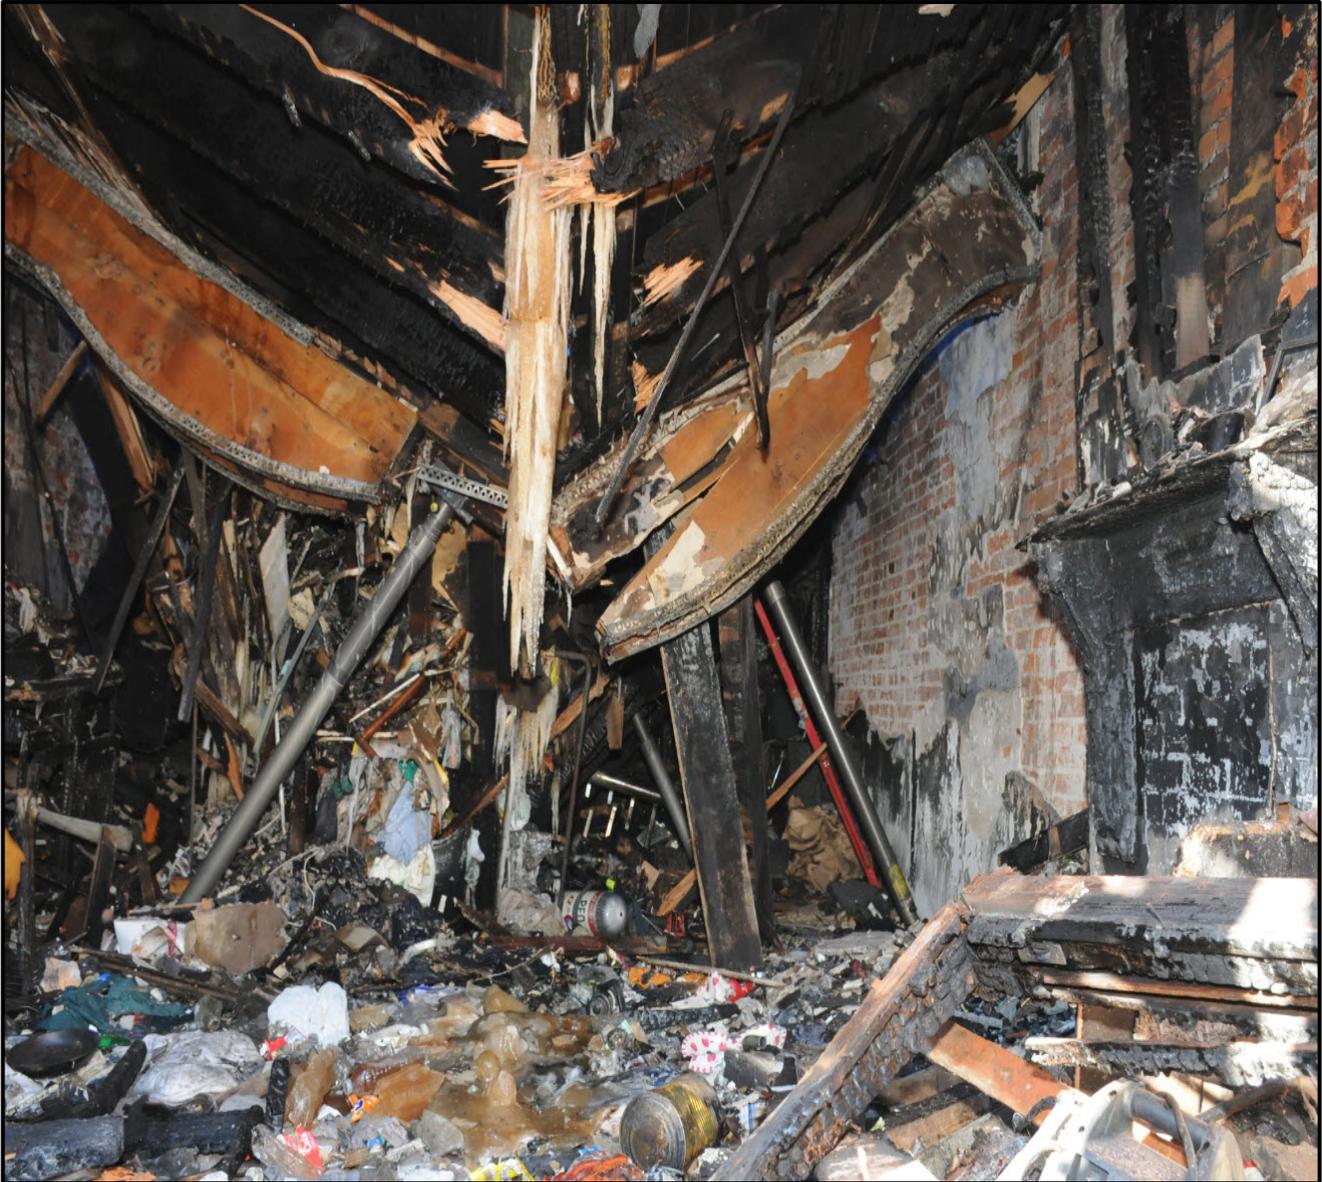
**Appendix 2 Photo 6. Front First Floor Looking inward to Collapse Zone and Second Floor Debris Heavy Content.** Photo Courtesy of Fire Department. Foreground: Compromised front 2<sup>nd</sup> Floor Bedroom joists V-pattern. Background: Beyond the decorative wood “beam” is the catastrophic full V-pattern collapse of the Center 2<sup>nd</sup> Floor Bedroom

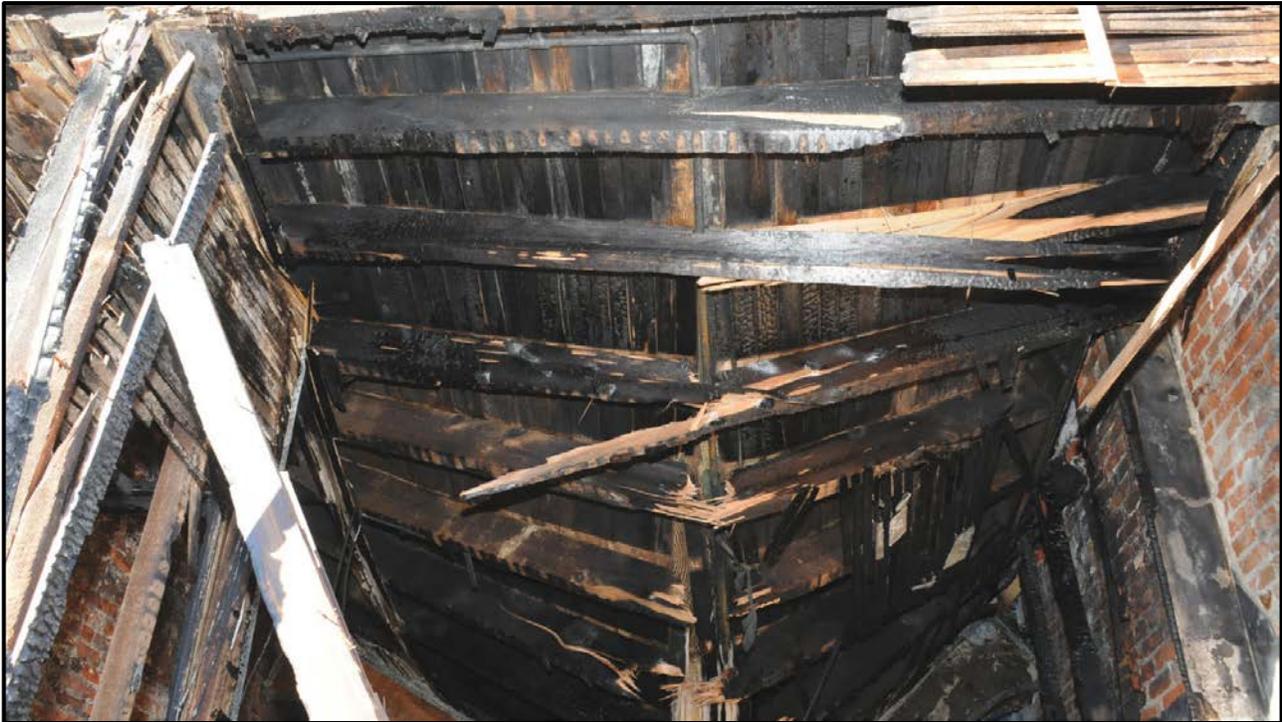
**Appendix 2 Photo 7. Front First Floor Looking inward to Collapse Zone and Second Floor Debris Heavy Content.** Photo Courtesy of Fire Department.

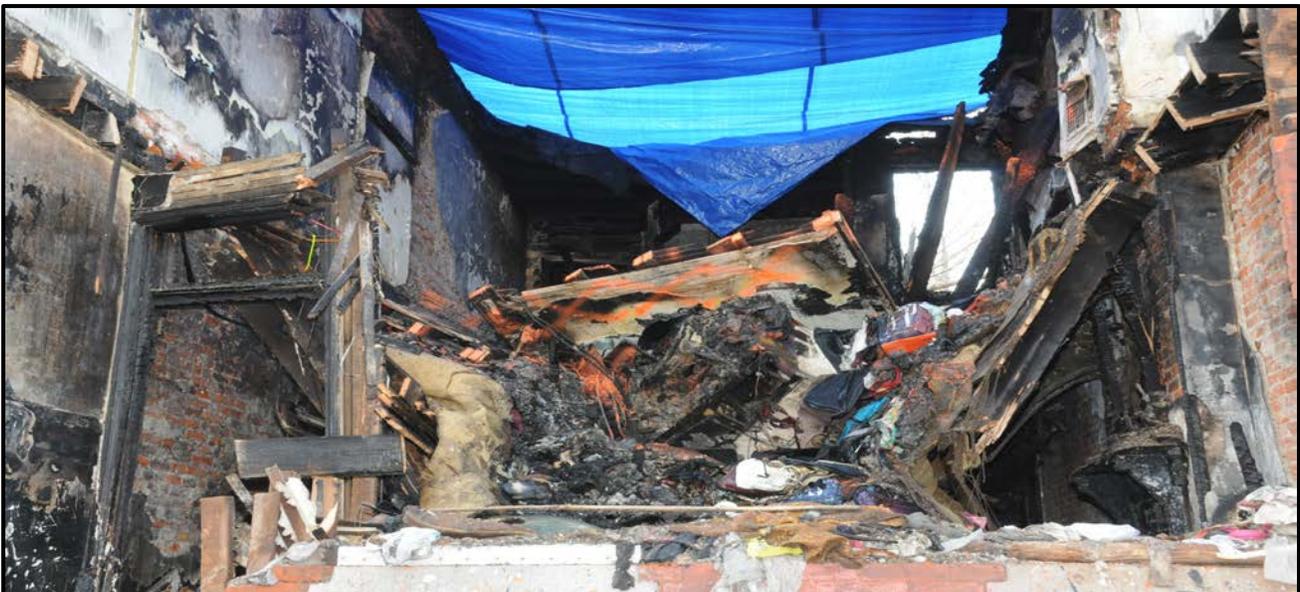
**Appendix 2 Photo 8. Second Floor Collapse of Floor Joists.** Photo Courtesy of Fire Department.

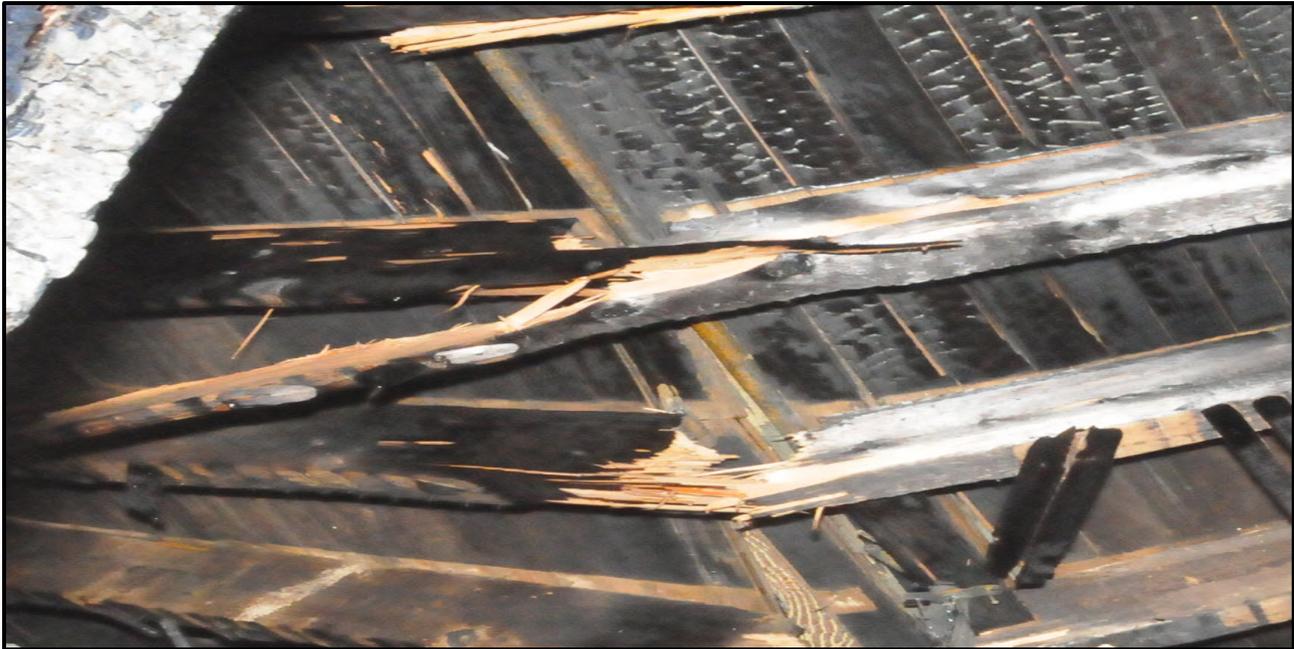
**Appendix 2 Photo 9. Second Floor Collapse of Floor Joists.** Photo Courtesy of Fire Department .

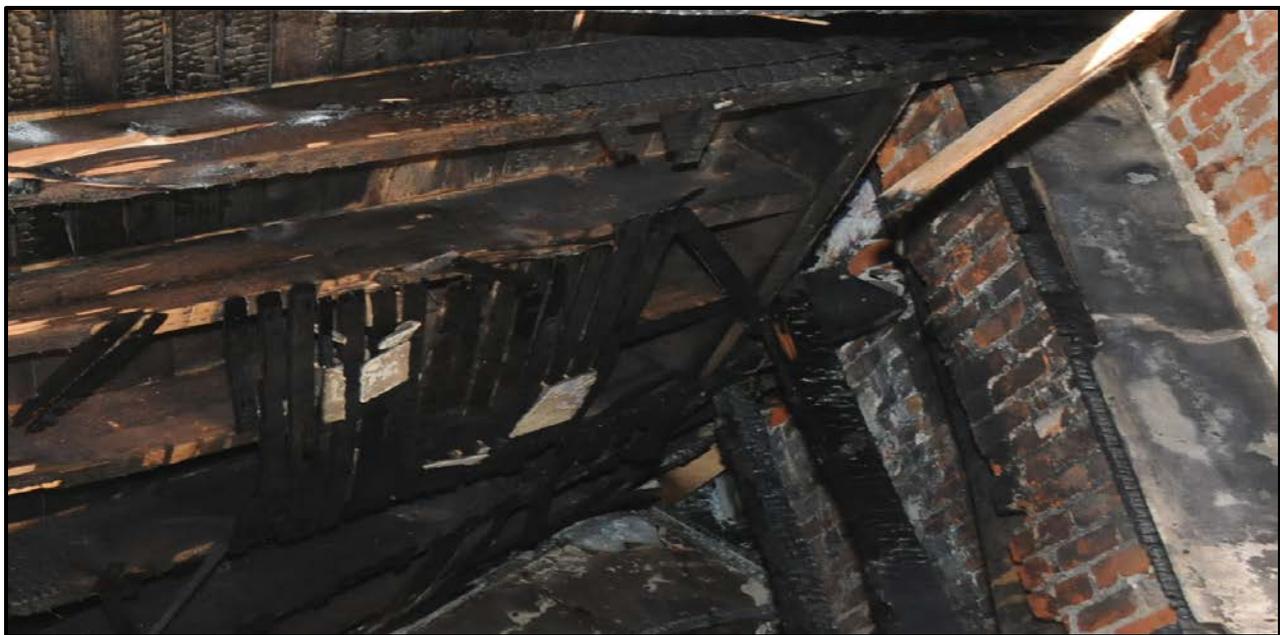
**Appendix 2 Photo 10. Second Floor Collapse of Floor Joists at Fireplace.** Photo Courtesy of Fire Department.

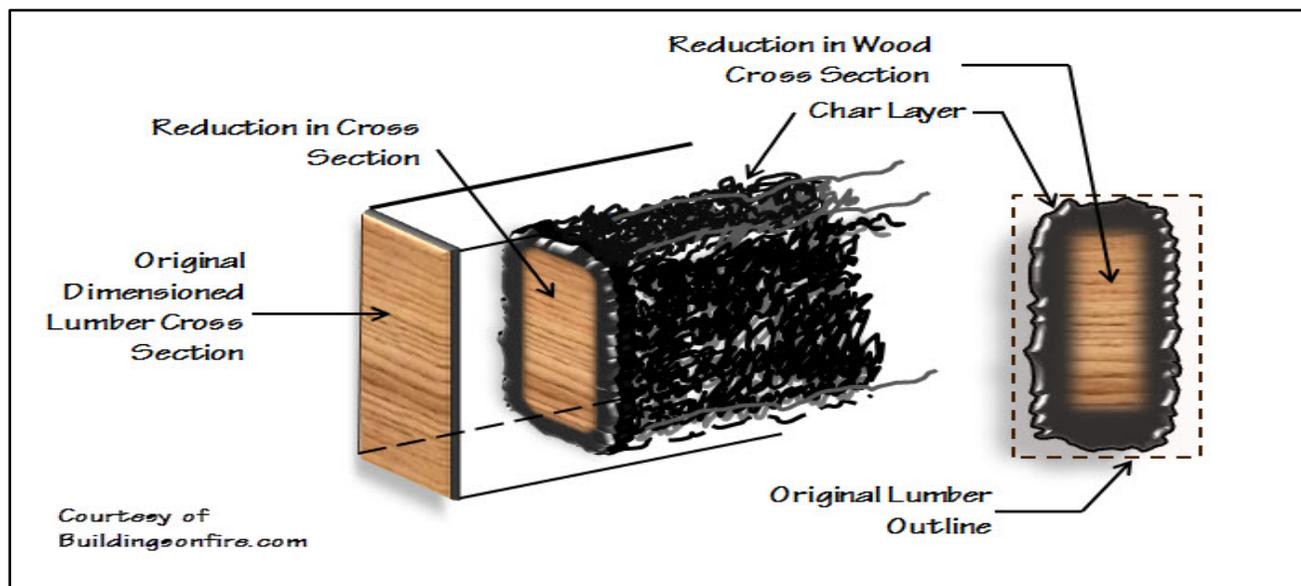
**Appendix 2 Diagram 12. Charring Effect on Wood Floor Joist Component and Cross Section** Graphic Courtesy of Buildingsonfire.com | C.J. Naum
