LINE OF DUTY DEATH REPORT

2018-12 • 7/1/2021

One Firefighter Dies and Another Injured in Natural Gas Line Explosion— Wisconsin

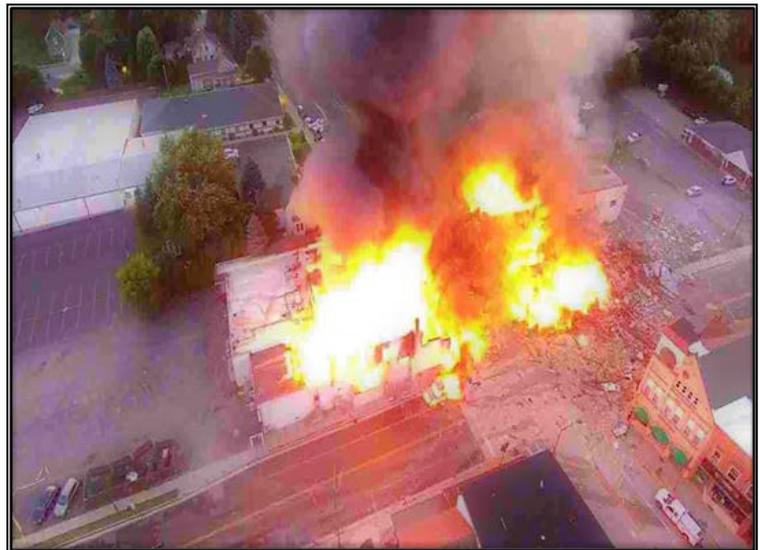
Site of Natural Gas Explosion
(Fire Department Photo)

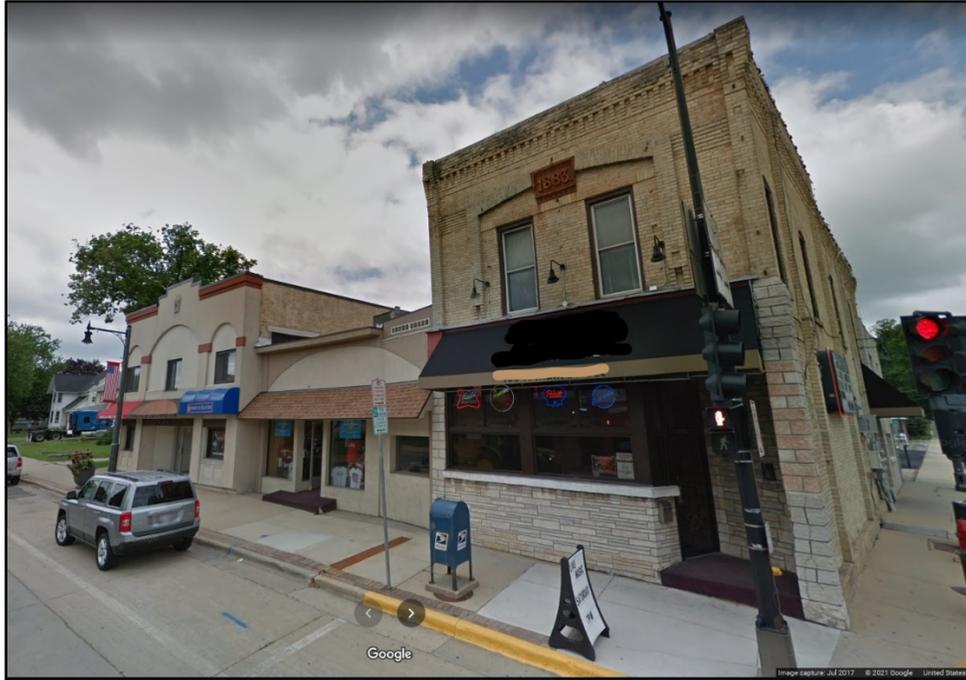
**Photo 1. Side Alpha of Pub prior to explosion.
(Photo from Google Maps)**

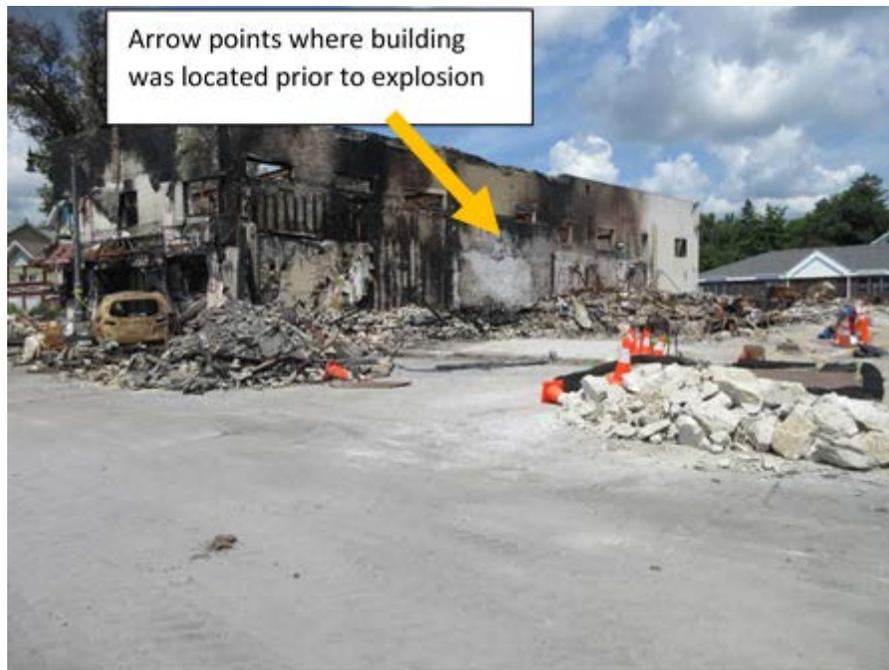
**Photo 2. Site of explosion. Note the building/origin of the explosion was destroyed during the
blast
(NIOSH Photo)**

A 5-inch gas main was punctured by a sub-contractor during unpermitted underground boring to locate underground utilities, causing natural gas to collect in the sewers and basements of the surrounding buildings. An unknown ignition source caused the trapped gas to ignite and explode in the building while the firefighters were exiting.

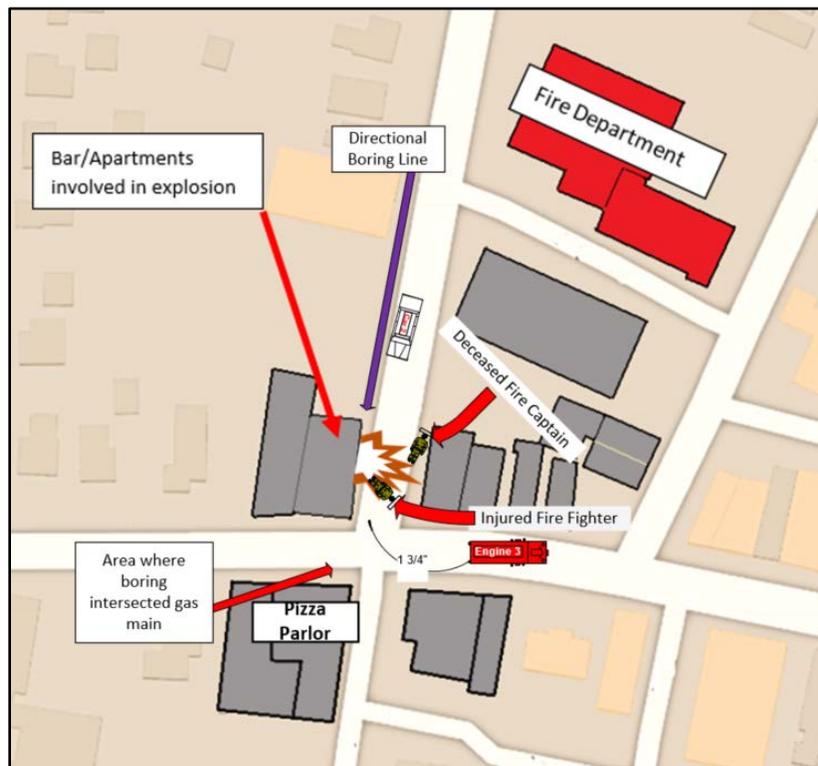
The initial report of gas odor came from a pizza parlor at the intersection of two city roads approximately 1 block down from where underground boring was taking place. The area is a main street in a historic city, consisting of older, multi-story brick buildings which housed restaurants and businesses on the first floor, and many with apartments or additional business offices on the upper floors. To the northwest side of the intersection, there was a bar/pub (explosion site). Across the street to the east is a multipurpose building that houses a confection restaurant and apartments. To the southeast of the intersection is a building shared by the Department of Corrections and a Mexican restaurant. To the west on the other side of the street was the pizza parlor (see Diagram). Given the time of day, the restaurants in the area were full of patrons during the “dinner rush.”

Diagram. Overview of intersection where explosion occurred. Depicts site of explosion, area where boring line pierced gas main, and the direction of the boring line
