LINE OF DUTY DEATH REPORT

F2019-19 • September 14, 2020

While Maneuvering Outside His Apparatus, Firefighter Falls into Roadway and Is Struck and Killed by a Delivery Van – Texas

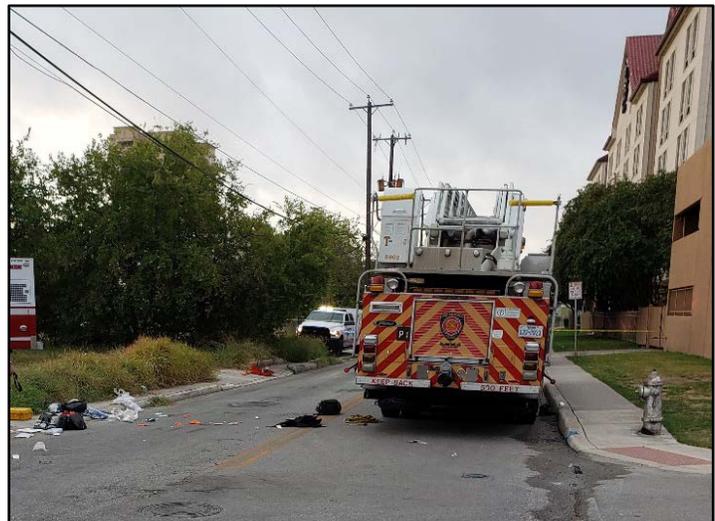
Aerial Platform 1 parked in the southbound lane of a two-way street. The firefighter-paramedic was struck in the northbound lane.

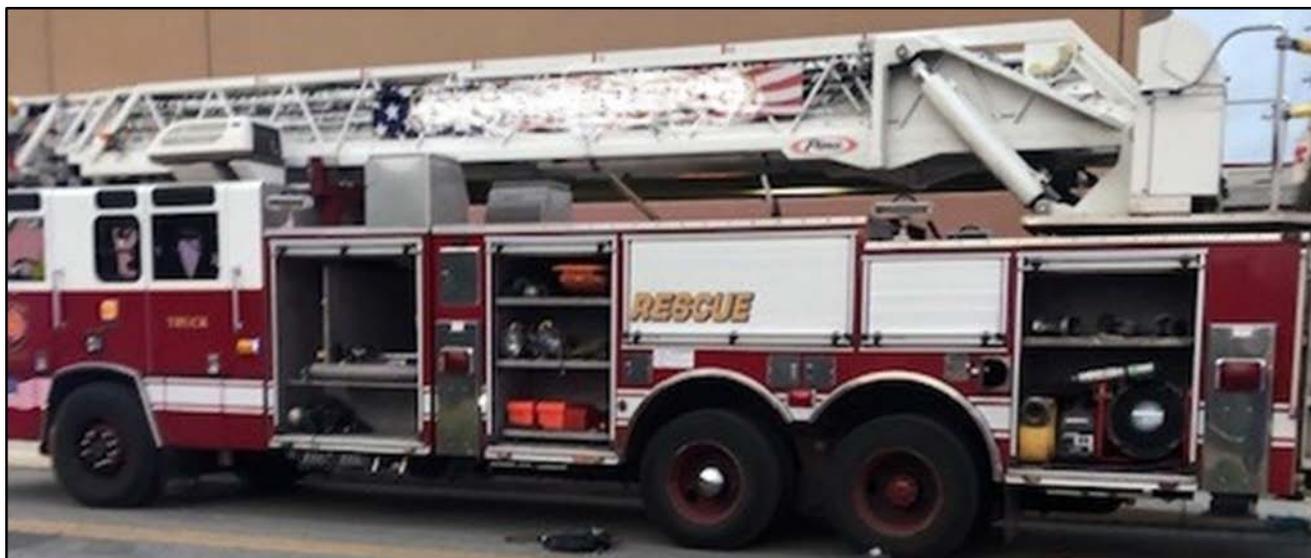
Photo 1. Replacement aerial platform.
(Photo courtesy of the fire department.)

The replacement apparatus was not in compliance with section 14.1.6 which states: “all driving and crew compartment doors shall have at least 96 in² (62,000 mm²) of retroreflective material affixed to the inside of each door” [NFPA 2003], or the most recent 2016 edition which states in section 14.1.5: “Any door of the apparatus designed to allow persons to enter or exit the apparatus shall have at least 96 in² (62,000 mm²) of retroreflective material affixed to the inside of the door” [NFPA 2016].

Recommendation 9: #Fire departments should consider installing retroreflective markings on the interior cab doors of all apparatuses.

In this incident, the replacement Aerial Platform 1 did not have high visibility chevrons or other markings on the inside or edges of the cab doors. Since the delivery van was approaching from the front of Aerial Platform 1, inside cab door markings would not have been visible from the northbound direction. Nonetheless, this recommendation would help to reduce the risk of future stuck-by incidents when firefighters are exiting from their cab in traffic.

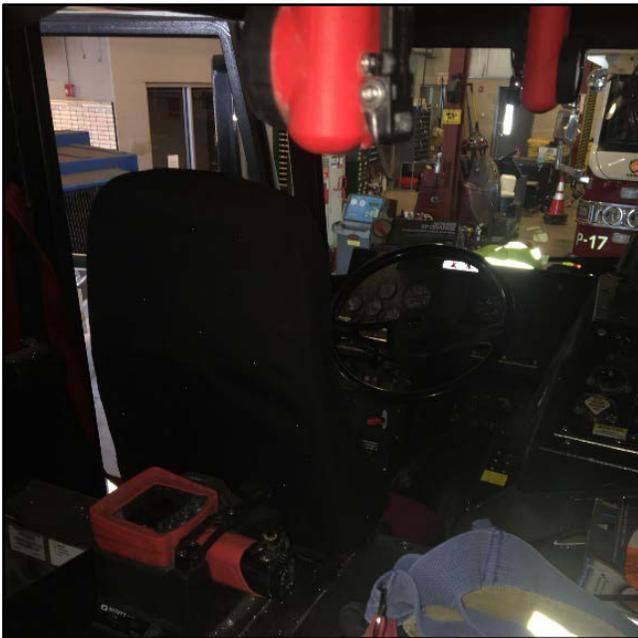
Although the replacement unit was the same make and model, it had some differences. The most important relevant to this incident was a different location for the TIC’s charging station. The Aerial Platform normally assigned to Station 1 (the one they had been using for the past several months) had the TIC’s charging station mounted on the console behind the engineer’s seat (see Photo 2). The replacement Aerial Platform had the TIC’s charging station bolted onto the floor behind the officer’s seat (see Photo 3).

Photo 2. Station 1’s usual Aerial Platform. Location of the TIC and its charger bolted to the console behind the engineer’s chair.
(Photo courtesy of the fire department.)

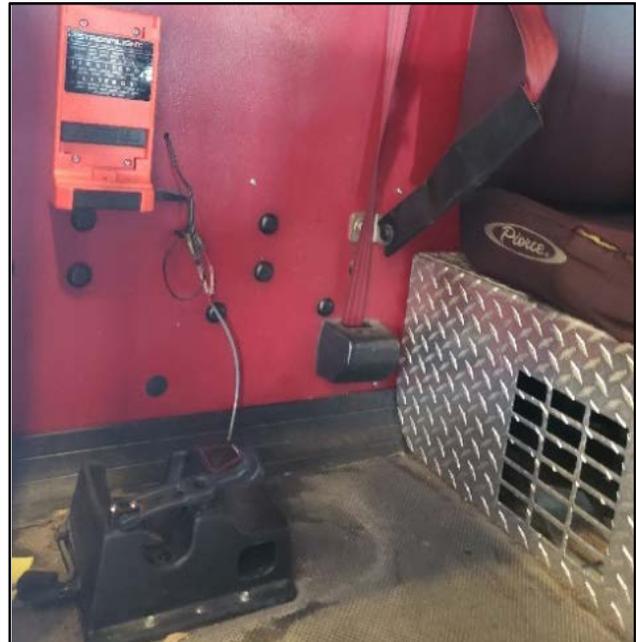
Photo 3. Aerial Platform 1 replacement apparatus. TIC charger bolted on the floor behind the officer’s seat.
(Photo courtesy of the fire department.)

In this incident, the Aerial Platform apparatus Station 1 had been using over the past several months had its TIC's charging station mounted on the console behind the engineer's seat. On Oct. 13, 2019, Aerial Platform 1 was scheduled for maintenance and replaced by an apparatus of the same make and model. However, the replacement Aerial Platform had its TIC charging station bolted onto the floor behind the officer's seat. **Perhaps**, if the firefighter-paramedic had known of this location, he would have remained on the side of the apparatus that was opposite from moving traffic.

Recommendation #8: Fire departments should ensure firefighters familiarize themselves with equipment locations when a replacement apparatus is being used.

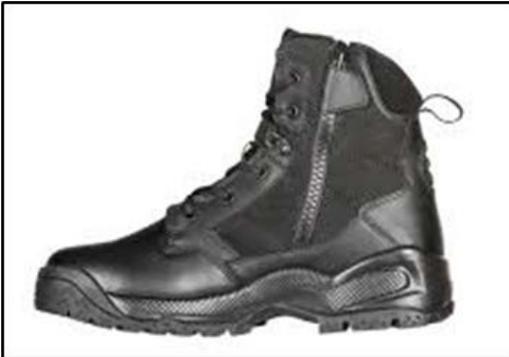
Photo 4. Similar tactical zippered station boot worn by the firefighter-paramedic. (Photo courtesy of manufacturer.)

Some firefighters leave the side zipper open to facilitate boot removal when responding to a fire emergency requiring the use of bunker boots. According to his crew members, the firefighter-paramedic frequently kept his boots in the unzipped position. During this incident, the firefighter-paramedic's turnout pants, coat, and bunker boots were in the rear cab of the apparatus covering the TIC charging in its docking station located on the floor of the rear seat behind the officer (see Photo 5).

In this incident, the firefighter-paramedic was stuck and dragged, and his boots ended up a significant distance from his final position. This finding suggests his boots may have been unzipped before impact. If his boots were unzipped, it may have initiated his slip/trip and backwards fall into the southbound lane. However, all of this is conjecture. Although there is no evidence that following this recommendation would have prevented this fatality, ensuring all staff lace-up or zip-up their station boots during work hours is a reasonable preventative action.

Recommendation #6: To reduce the risk of slips, trips, or falls, fire departments should encourage firefighters to lace-up or zip-up their station boots.

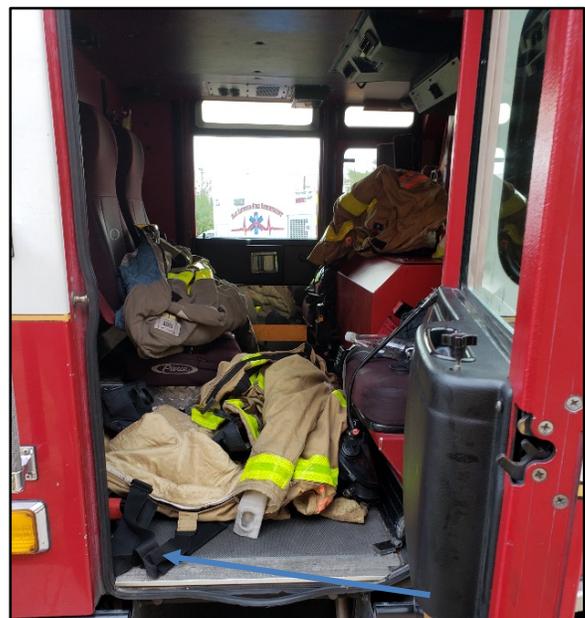
Photo 5. Replacement Aerial Platform 1 rear cab compartment at the incident. Note the firefighter-paramedic turnout gear covering the TIC and its charger. (Photo courtesy of TX SFMO.)

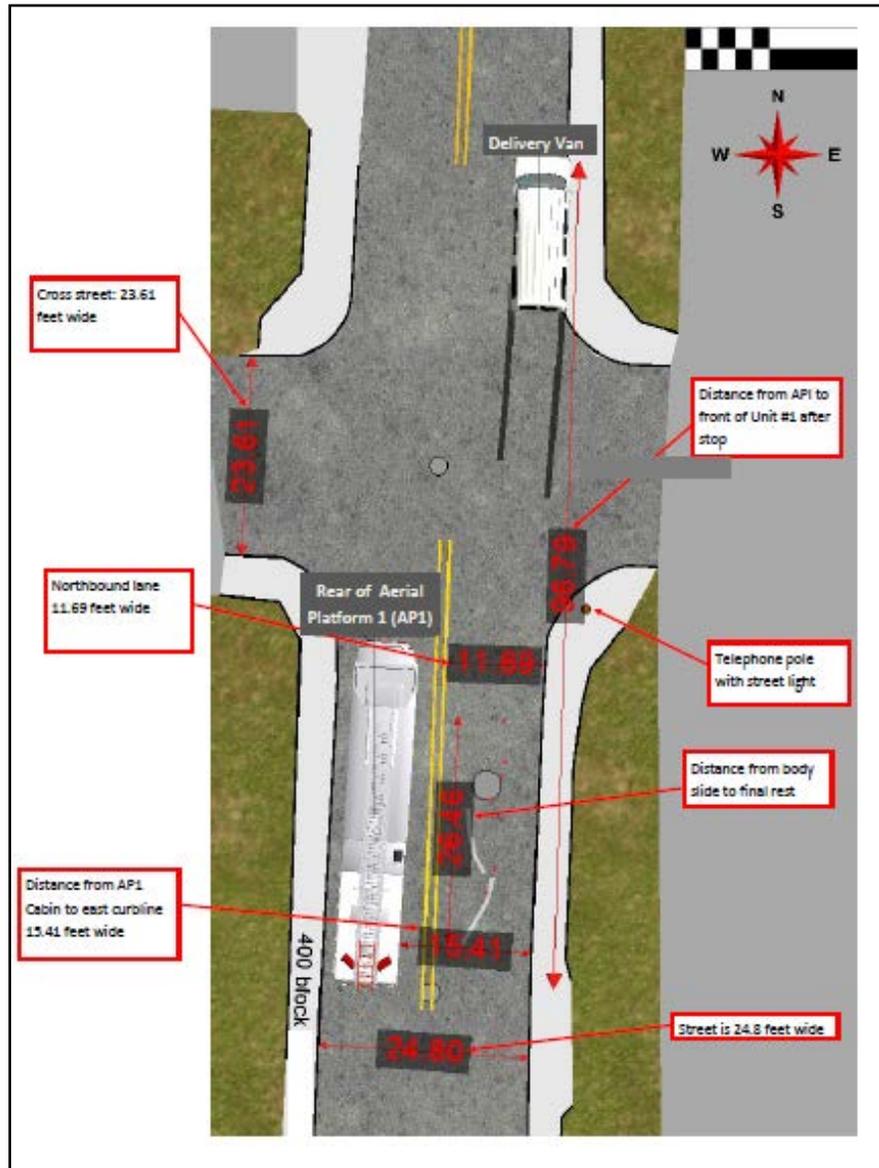
Just as the van reached the front end of Aerial Platform 1, the firefighter-paramedic fell backwards into the northbound lane perpendicular to the engineer's door. It is unclear if he was about to enter the cab or had just exited the cab. It is also unclear whether the firefighter-paramedic slipped or tripped. The delivery van struck the firefighter-paramedic, dragging him 26.5 feet before his body was released from the underside of the van (see Diagram 1). The firefighter-paramedic's left station boot was found under Aerial Platform 1's rear cab door, approximately 14 feet away from his final resting area. The right boot was found close to the telephone pole on the northbound right curb, approximately 18 feet

Diagram 1. Street widths and distances between the parked Aerial Platform 1 in the southbound lane and the stopped delivery van in the northbound lane. The firefighter-paramedic was dragged 26 feet under the delivery van before being released to the final resting location.
