## **F2020-11**

**Firefighter Killed by the Collapse  
of the Porch Roof at a Residential  
Structure Fire-Pennsylvania**

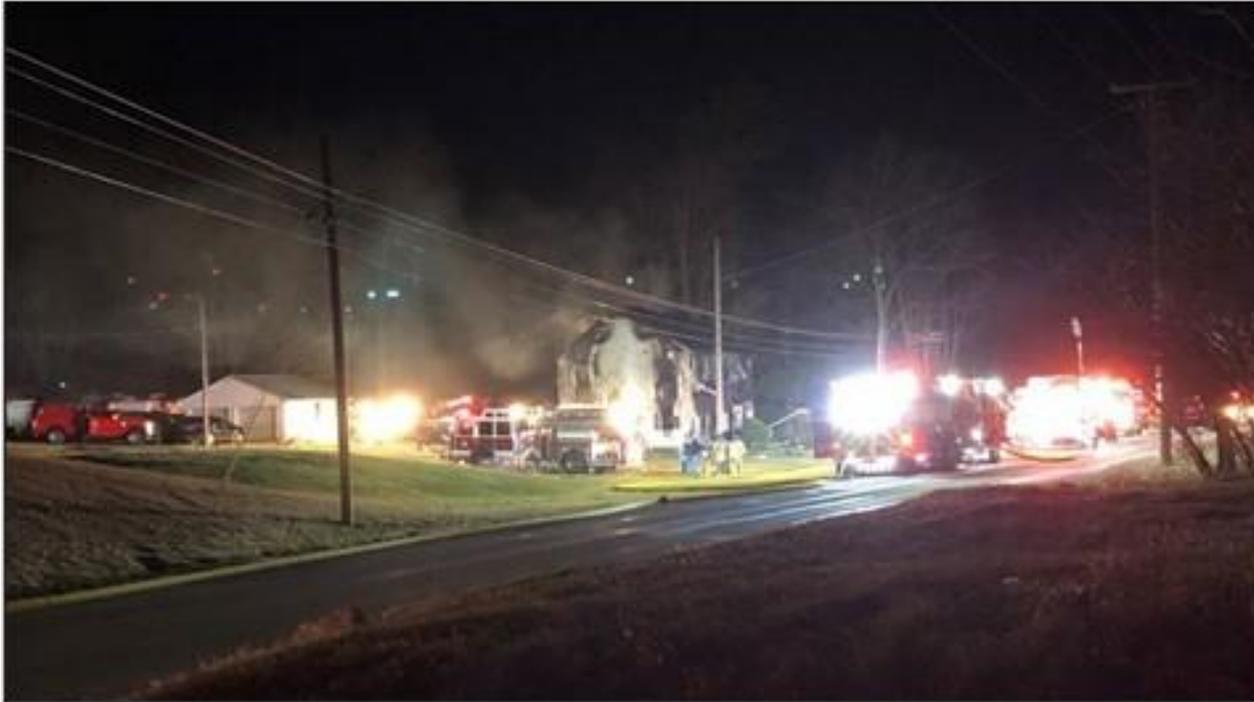
A firefighter from E336 was killed when the front porch roof collapsed on him while operating at this residential structure fire. Engine 336 is parked on Side Bravo and Command is located at the Side Bravo/Side Charlie corner in the red vehicle.  
(Photo courtesy of the fire department.)

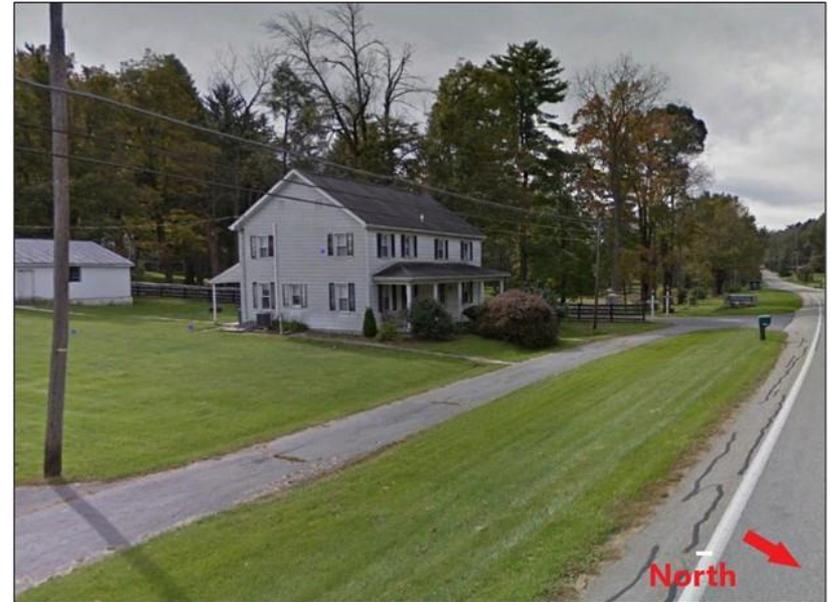
Side Alpha and Side Bravo of the house. The service line on Side Bravo burned through during the fire.  
(Photo from Google Maps)
