Supermarket Fire Claims the Life of Volunteer Fire Fighter - West Virginia

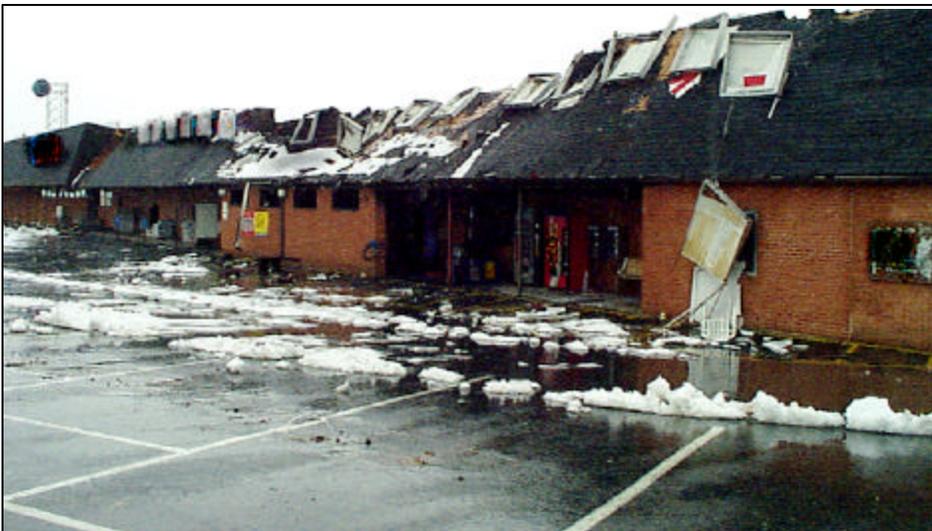
Figure. Supermarket where one firefighter lost his life.

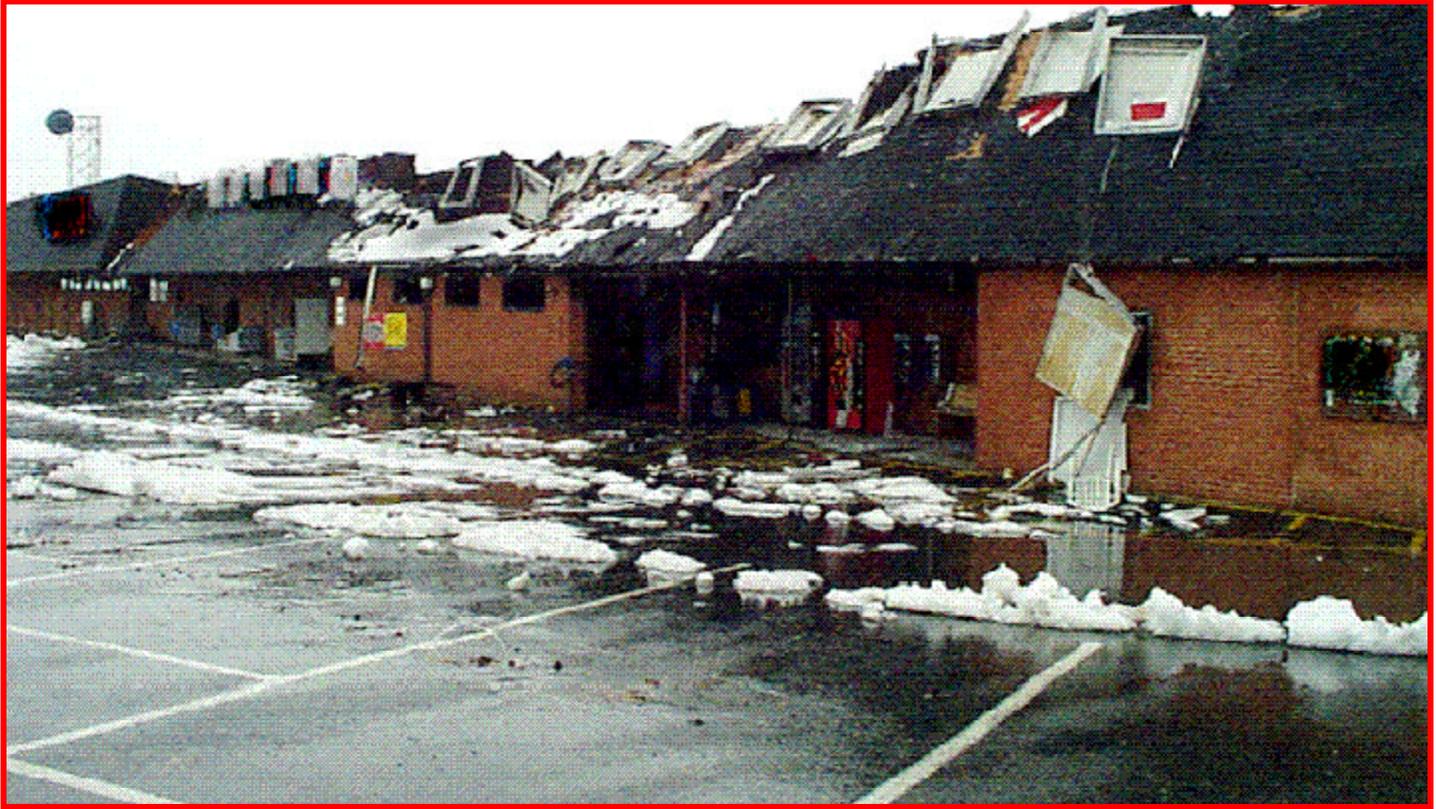
Figure. Supermarket where one fire fighter lost his life.
