A summary of a NIOSH fire fighter fatality investigation

Single-Family Dwelling Fire Claims the Lives of Two Volunteer Fire Fighters--Ohio

Fatality Assessment and Control Evaluation
Investigative Report #98F-06

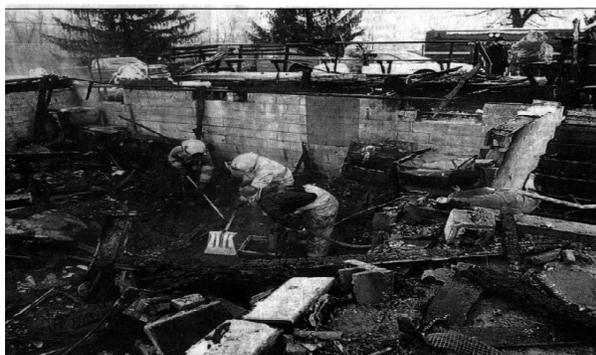
Figure: Basement where fatalities occurred.

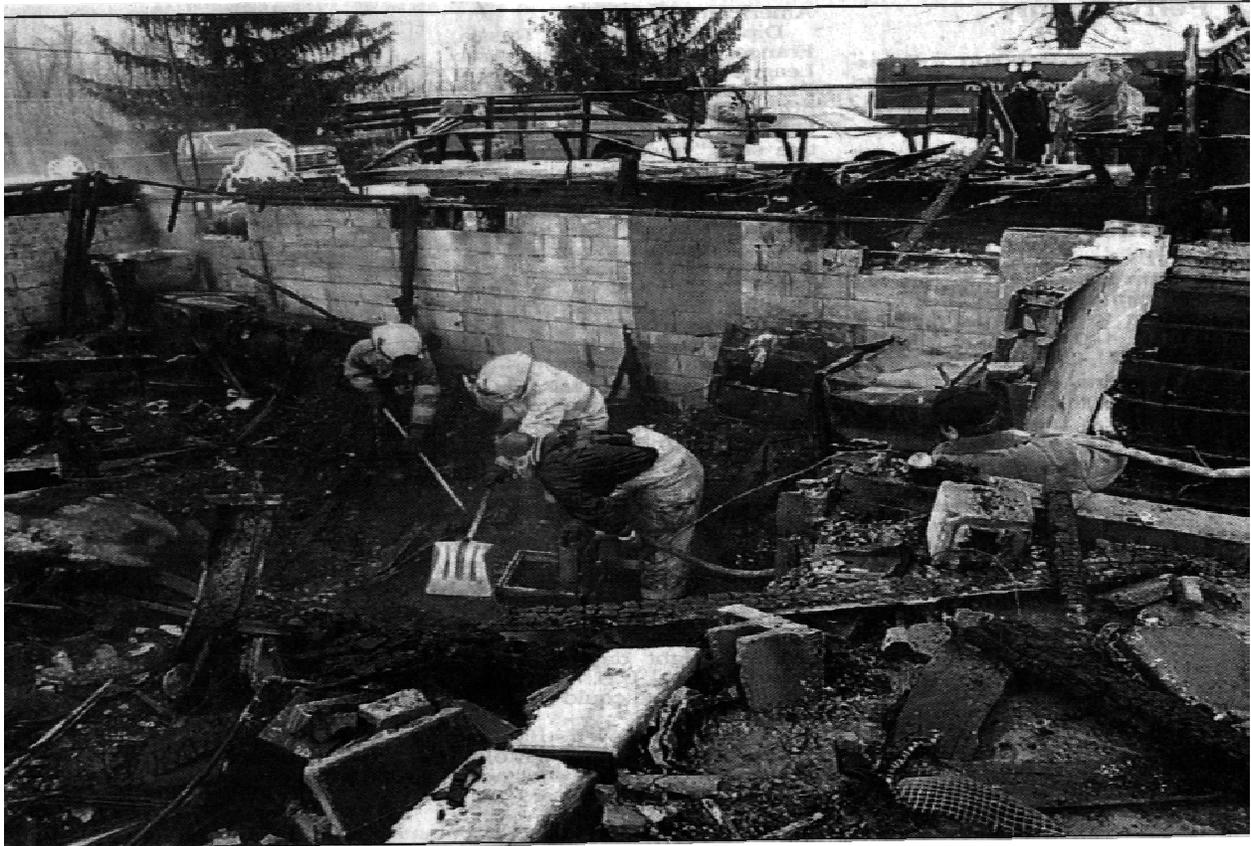
Figure: Basement where fatalities occurred.

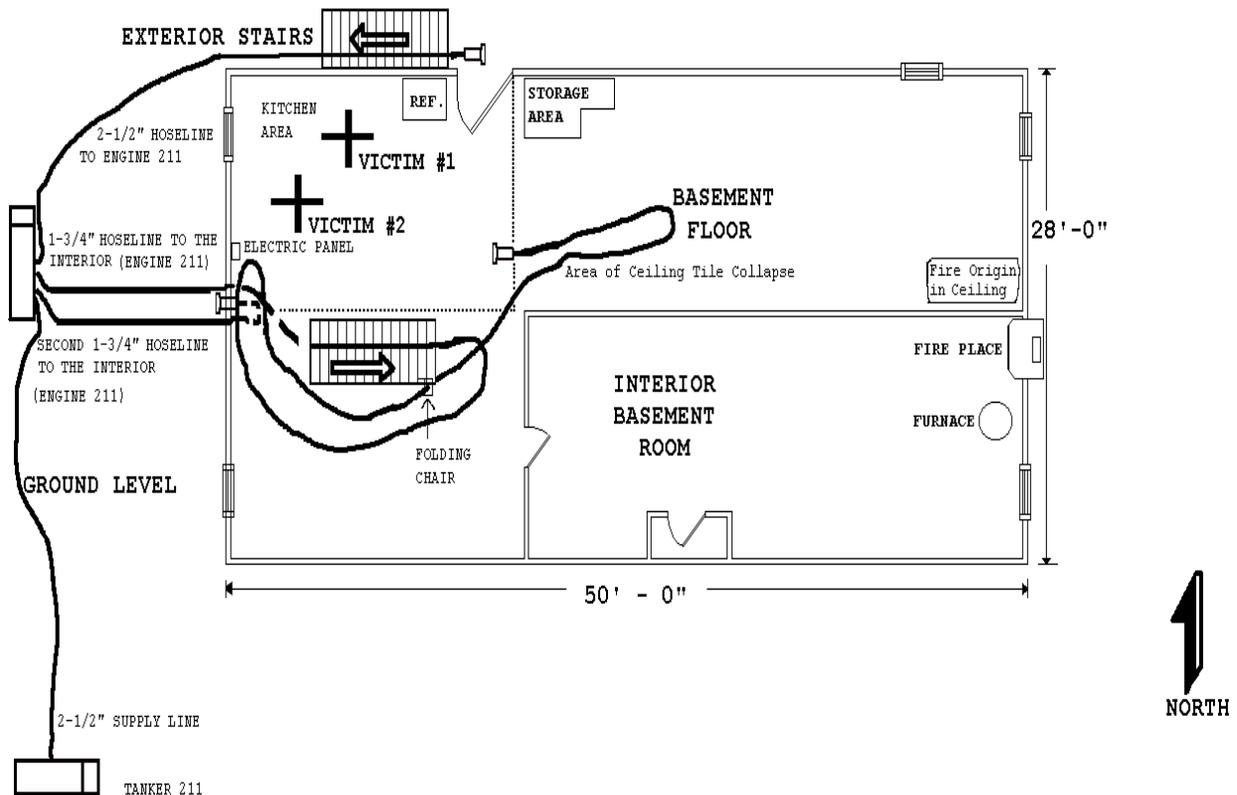
**Figure. Fire Dwelling
Basement Floor Plan
FACE 98F06**

One-story, 20-year old single-family dwelling with full basement measuring 28' x 50'. Wood-frame construction with shingle roof and hardboard siding. Three smoke detectors present-none operable.
