Commercial Structure Fire Claims the Life of One Fire Fighter—California

On March 8, 1998, one male fire fighter, the Captain on Engine 57 (the victim), died while trying to exit a commercial structure after his egress was cut off by the wooden trussed roof that collapsed. Task Force 66 was the first on scene and reported light smoke showing from a one-story commercial building. A ventilation team from Truck 66 proceeded to the roof of the building and commenced roof ventilation. Forcible entry into the building required about 7 ½ to 9 ½ minutes from arrival on scene to force open the two metal security doors in the front. While fire companies waited for the security doors to be opened, fire conditions changed dramatically on the roof. Fire was coming from the ventilation holes opened by the ventilation crew. As soon as the security doors were opened, three engine crews (Engine 66, Engine 57, and Engine 46) advanced hand lines through the front door in an attempt to determine the origin of the fire. Approximately 15 feet inside the front door, the fire fighters encountered heavy smoke with near zero visibility conditions. The engine crews advanced their hose lines approximately 30

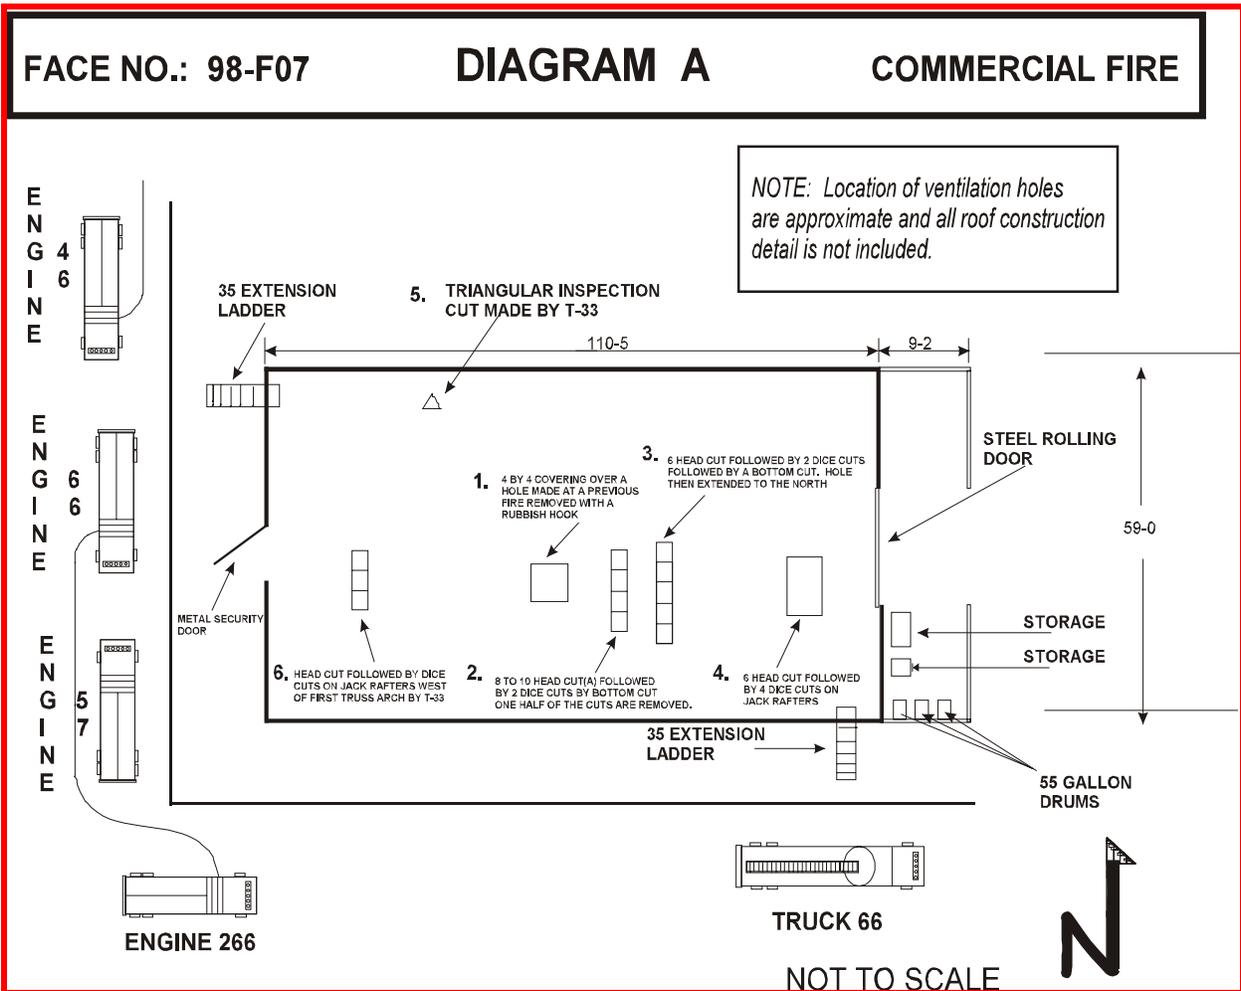
As Truck 66's ventilation team approached the center of the roof, they saw fire coming from a vent. The ventilation team opened an initial hole, approximately 4 feet by 4 feet, but was driven back by heavy fire and heat (see diagram A). By 0226 hours, members of Truck 66 were on the roof and reported the fire was somewhat heavy near the center ventilation hole. Even though flames were showing through the roof, they stated the roof still felt solid. Due to changing conditions, Battalion 13 requested two additional task forces at approximately 0226 hours, and Operations Control Division (OCD) dispatched Division II and Battalion 3 to the scene (the aforementioned units were delayed due to equipment failure at the OCD).

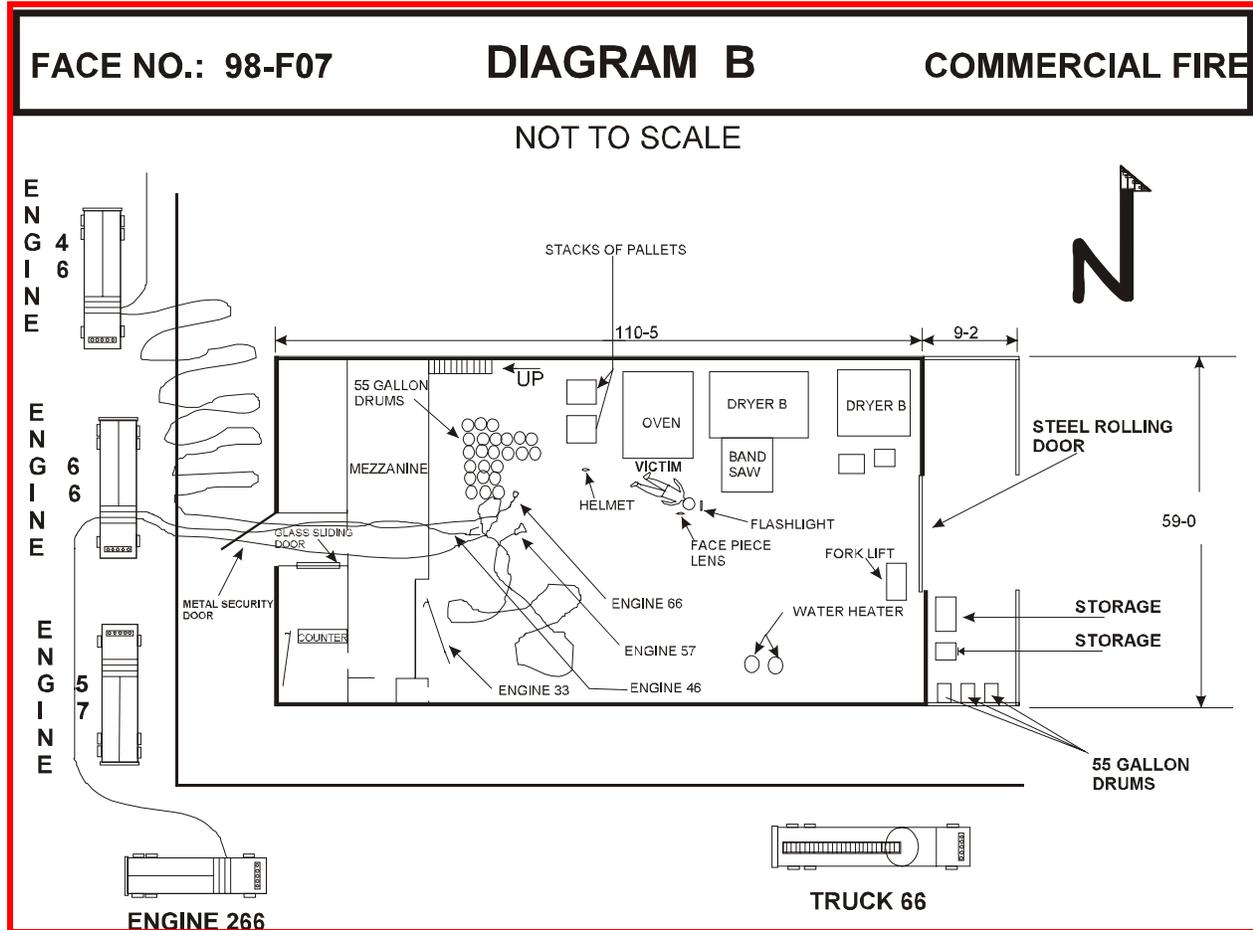
Fire fighters from Engine 66 and Engine 46 advanced their hose lines 30 to 40 feet inside the building but found no fire (see diagram B). As Engine 57's inside members advanced into the structure, their Engineer stayed in the hall area and helped advance the hose line. Engine 33's inside members advanced beyond the office area into the manufacturing area, and they raised their pike poles to touch the ceiling or roof. The pike poles proved ineffective since the fire fighters were beyond the mezzanine area which was 6 to 13 feet above the office area. Interior fire fighters reported they could hear the saws on the roof and knew that ventilation was taking place, but the heat and smoke level was intensifying as they advanced into the structure.
