## **Sudden Floor Collapse Claims the Lives of Two Fire Fighters and Four Are Hospitalized with Serious Burns in a Five-Alarm Fire--New York**

# Fatality Assessment and Control Evaluation Investigative Report #98F-17

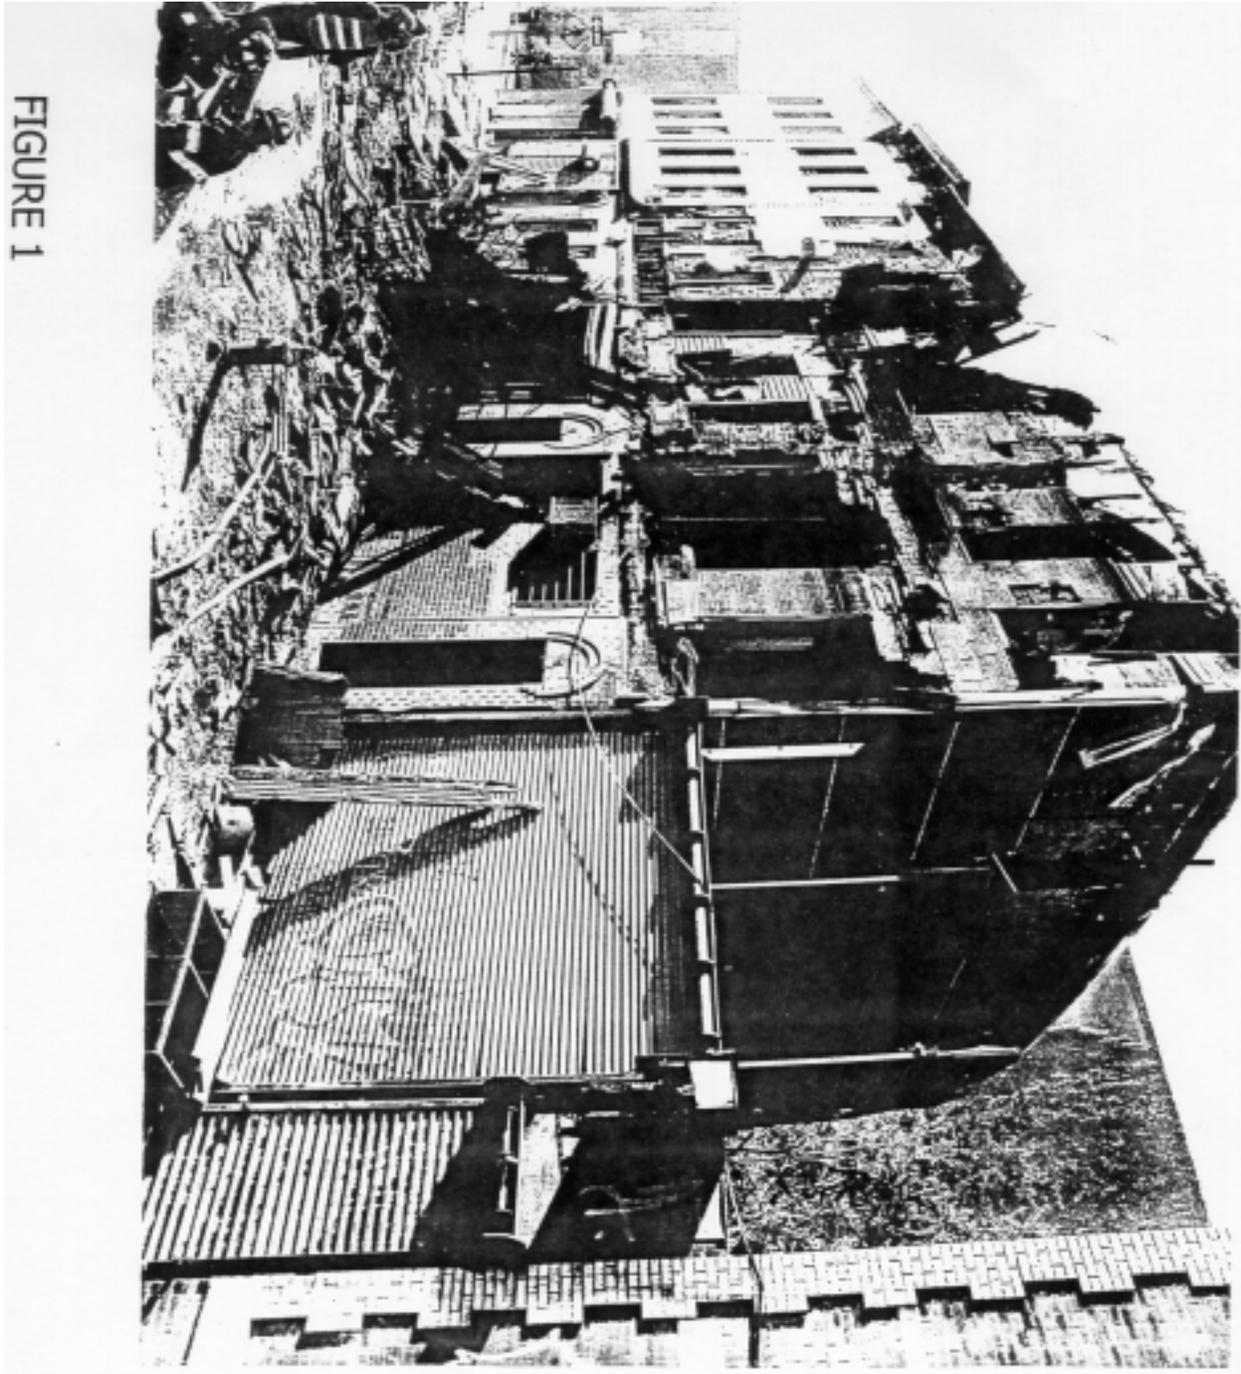
FIGURE 1

On June 5, 1998, at 2022 hours a call came into the Dispatch Center reporting a boiler room fire at a residential/commercial complex. The structure was one of five attached, three-story, wood-frame residential/commercial units (see Figure 1). Engine 332 (Lieutenant [Victim #2] and four fire fighters), Engine 231 (Lieutenant and four fire fighters), Engine 290 (Lieutenant and five fire fighters), Ladder 175 (Captain and five fire fighters), and Battalion 44 responded. Engine 332 was the first unit to arrive at 2025 hours, and reported a 1075 (working fire). Engine 332 and Engine 231 made hydrant connections close to the building and stretched hand lines to the front (see Figure 2). Fire fighters from Ladder 175 (Captain and five fire fighters) reported in at 2026 hours, and fire fighters from Engine 231 reported in at 2027

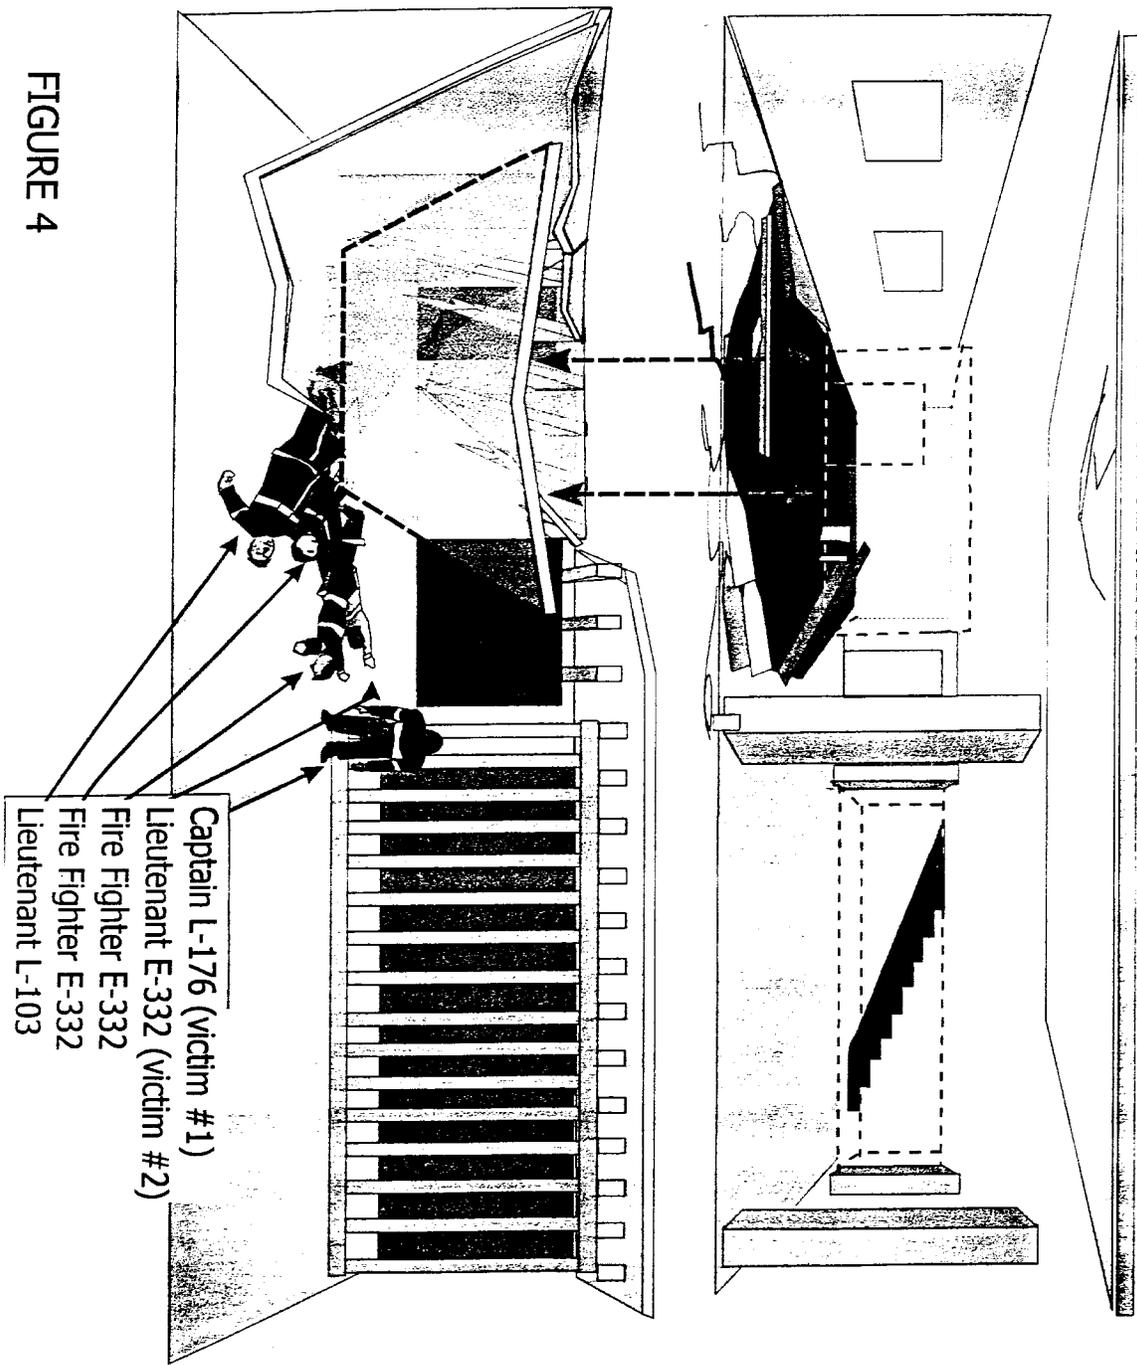
**FIGURE 4**

At 2035 hours there was a major change in conditions, fire was now escalating in the front of the building. It is believed that at 2035 hours, when a major change in conditions occurred, the rear area of the second floor (kitchen and bedroom area) collapsed, trapping five fire fighters (see Figure 4) (the Captain on Ladder 176 [Victim #1], the Lieutenant on 332 [Victim #2] and two fire fighters on Engine 332, and the Lieutenant on Ladder 103). The collapsed section allowed the fire to vent freely up through the floor and out the front and back of the building, with flames leaping to the roof line.

- Captain L-176 (victim #1)
- Lieutenant E-332 (victim #2)
- Fire Fighter E-332
- Fire Fighter E-332
- Lieutenant L-103
