Vacant Dwelling Fire Injures Two Fire Fighters-Virginia

Fatality Assessment and Control Evaluation
Investigative Report #98F-18

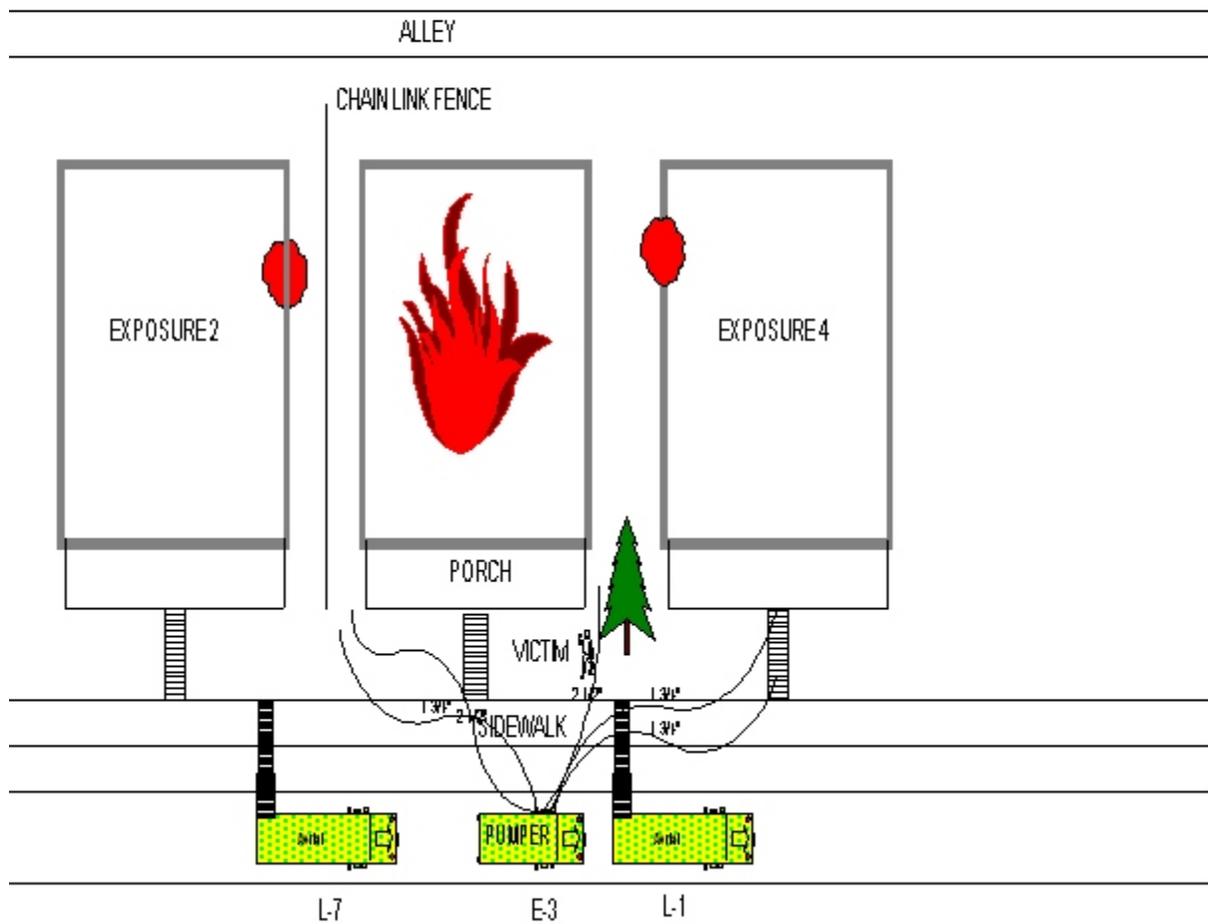
Figure. Fire Incident Scene

FACE 98F-18
Top View
