Volunteer Fire Fighter Killed During Wildland Fire-Texas

Fatality Assessment and Control Evaluation Investigative Report #98F-19

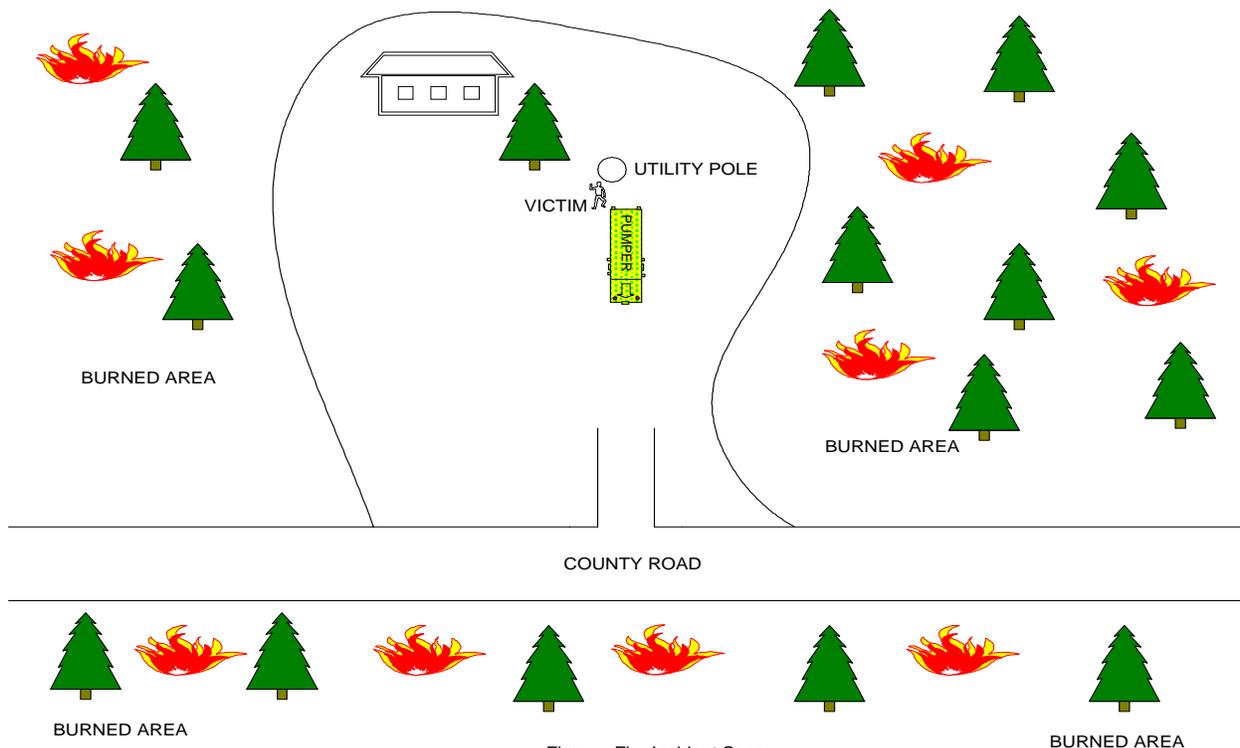
Figure. Fire Incident Scene
FACE 98F-19
Top View

On August 1, 1998, one male volunteer fire fighter died following an apparatus incident in which his right leg was crushed between the pumper on which he was riding and a utility pole (see figure). He was part of a mutual-aid response group that was fighting a 500-acre wildland fire that threatened 13 dwellings and additional outbuildings such as barns and sheds. The fire was also burning beside an interstate highway and was creating a dangerous smoke condition. The engine on which the victim was riding was going from house to house and extinguishing the wildland fire as it approached each dwelling and outbuilding. At the scene of the incident, the fire nearby had been extinguished. After loading the 1½-inch handline onto the hose bed, the victim was standing on the tailboard holding down the hose as the engine backed up in preparation for turning around. As the engine neared the utility pole, the victim tried to warn the driver/operator about the utility pole and apparently slipped off the tailboard. His right leg was crushed between the tailboard and the utility pole and was traumatically amputated at the knee. The victim was treated at the scene and went into cardiac arrest. Resuscitation efforts were begun and the victim was transported to the local hospital by ambulance. Resuscitation efforts were continued at the hospital where he was later pronounced dead. NIOSH investigators concluded that, to minimize the chances of similar occurrences, fire departments should:

proceeded to the fourth house. Engine 602 was placed to the left of the fourth house. The victim removed the hose and began extinguishing the approaching fire. Upon completion, he again loaded the hose onto the hosebed and stood on the tailboard while the pumper was being turned around. While the driver/operator was backing up the pumper, he saw a tree in the reflection of the right-side mirror and attempted to avoid hitting it. In the attempt to avoid the tree, the back of the pumper struck a utility pole and the victim yelled for the driver to move the pumper forward. Upon moving the pumper forward, the driver/operator looked in the right mirror again and noticed the victim fall to the ground near the right rear corner of the pumper. The driver/operator stopped the pumper and went to where the victim was lying. The victim related to the driver/operator that he had tried to warn him about the utility pole. The driver/operator thought that the victim had received a broken leg and radioed to dispatch to request an ambulance at 1548 hours. Medic 6, a paramedic ambulance, was dispatched at 1548 hours and was enroute to the scene at 1549 hours. During this time, the fire had doubled back toward the pumper and the victim. Two other fire fighters operating nearby came over and began fire extinguishment in the area immediately around the pumper. A fire fighter retrieved a knife from his personal vehicle and cut the victim's bunker pants off the injured limb. The right leg had been amputated at knee level and the victim was losing blood. The bunker pants and boots had absorbed some blood and it was not readily ascertained how much blood was lost. Upon seeing the extent of the injuries, a tourniquet was applied to the victim's right leg. The IC, who was an Emergency Medical Technician-Intermediate, came to the scene and assessed the victim's condition. The IC began two IVs on
