Commercial Building Fire Claims the Lives of Two Volunteer Fire Fighters - Mississippi

SUMMARY

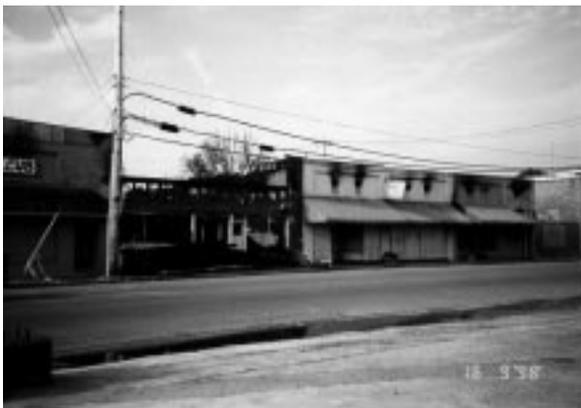
Figure 1. Building where Two Fatalities Occurred.

On August 29, 1998, at 0056 hours Central Standard Time, a volunteer fire department was dispatched to a fire at a commercial building which consisted of five separate stores (see Figure 1). The volunteer fire department responded with two vehicles and a total of 11 fire fighters. Three fire fighters arrived on Engine 12, and Victim #1 arrived shortly thereafter with Engine 9. The seven remaining fire fighters arrived in privately owned vehicles.

The site of the incident was a one-story, commercial building with a brick front exterior and concrete block sides and back. The building consisted of five individual stores with common walls. The roof of the store where the fire occurred was about 30 feet wide, consisted of 2-inch x 10-inch wood joists, and was covered with plywood sheathing and asphalt material (tar). The back wall of the building had been extended several feet for an addition (the ceiling consisted of wooden roof trusses made of 2-inch x 4-inch wooden studs). A partial parapet wall located in the front of the building extended partially down each dividing wall on the store roofs. A drop ceiling was installed with 2-foot by 2-foot tin tiles which were nailed to 1-inch by 4-inch wood runners. The building also included a one-story, attached addition in the rear of the building which was being used for

storage. This storage room had been constructed of concrete block and had a wooden, pitched roof which was covered with asphalt roofing material. None of the stores, including the storage room, was equipped with smoke alarms or sprinkler systems.
