Oxygen Regulator Flash Severely Burns One Fire Fighter - Florida

SUMMARY

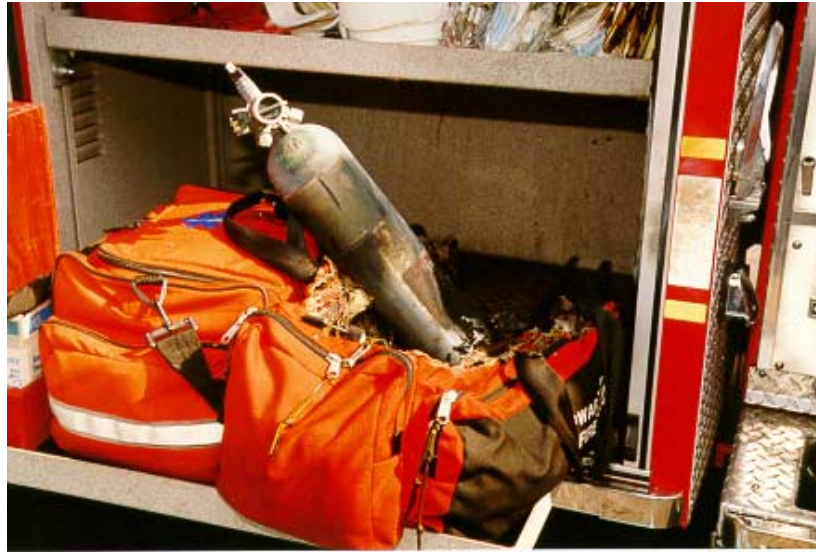
Photo 1: This photo depicts the airway bag which contained an aluminum cylinder filled with 99.7% pure oxygen, an aluminum regulator attached to the cylinder, and airway supplies.

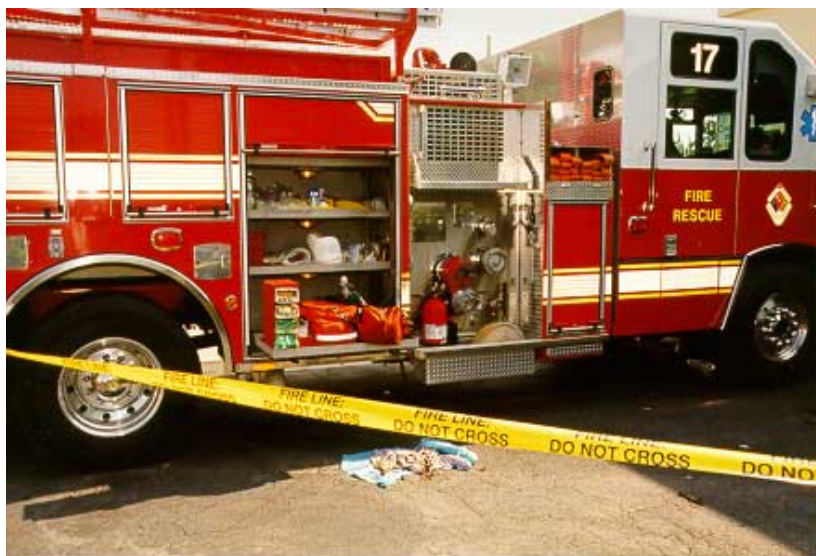
Photo 2: This photo depicts the incident scene where the victim was severely burned.

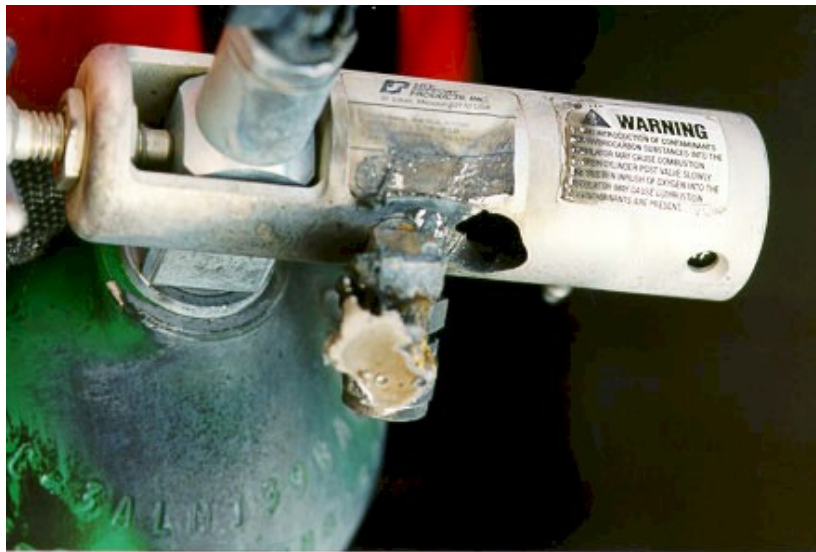
In addition to the replacement parts, the retrofit kit contained a warning sticker that was to be placed on each regulator as soon as it had been retrofitted (Photo 6). The sticker read: *WARNING: 1. The introduction of contaminates and hydrocarbon substances into the regulator may cause combustion; 2. Open the cylinder post valve slowly. The sudden inrush of oxygen into the regulator may cause combustion if contaminates are present.* The sticker served not only as a warning but also as an identifier to indicate regulators that had been retrofitted. A retrofit sticker had been placed on the regulator involved in this incident. After the incident, the fire department sent the cylinder and regulator involved in the incident to an independent testing laboratory for further testing.

Photo 6: This photo depicts the warning label that is placed on the retrofitted regulator. The sticker serves as a warning as well as an identifier that the regulator has been retrofitted.

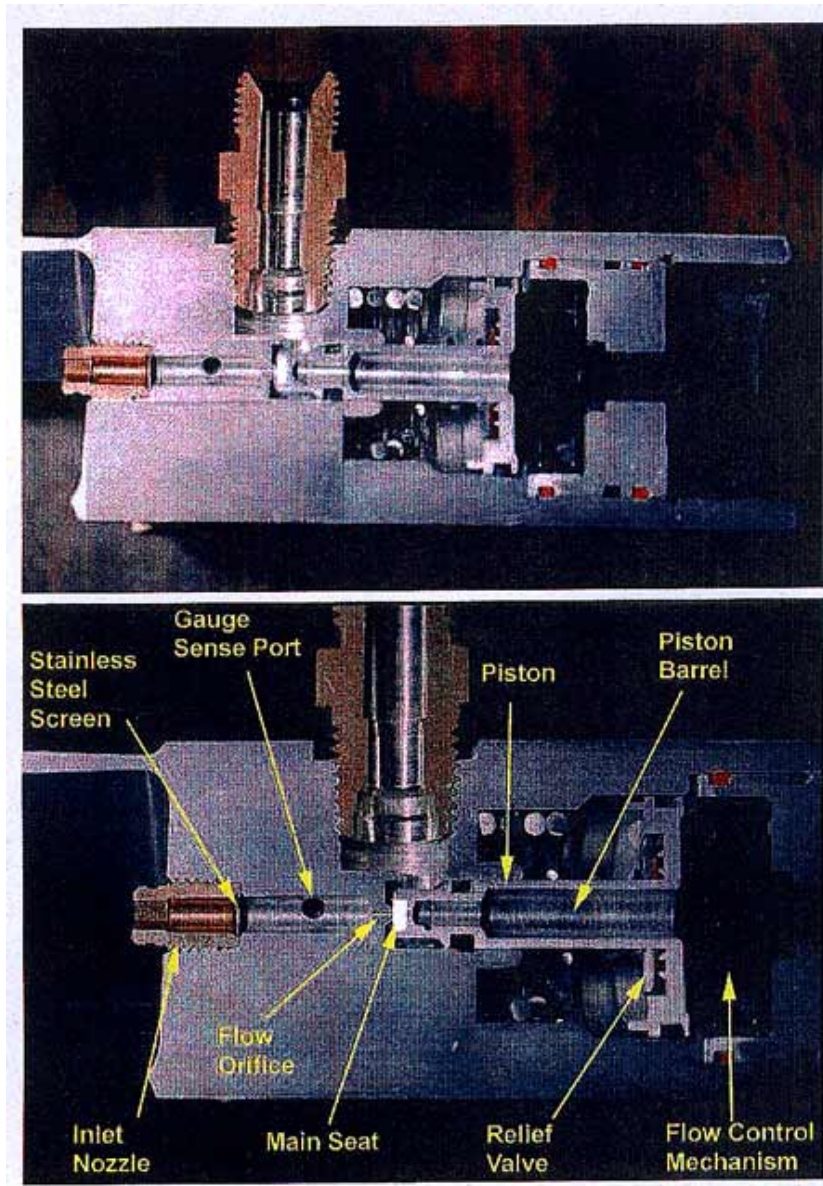
Diagram 1: Cut-away section from a regulator similar to the one that was involved in the incident.

In this incident, tests show that the particle traveled with the oxygen downstream (into the regulator) and ignited as it made contact with the bronze sintered-inlet filter (identified as a stainless steel screen on Diagram 1). Testing indicates that while bronze has been shown to resist ignition and sustained combustion at these pressures, the thin cross-section of the filter and the very close proximity to the aluminum body provides for a kindling path to the aluminum body for particle impact ignitions on the surface of the filter. While bronze is resistant to ignition, experience has shown that sintered filters can melt and break apart when exposed to a strong ignition mechanism like particle impact.

The two previous diagrams depict a close-up view of the internal regulating mechanism and oxygen flow path. The flow path and oxygen-wetted components are described below. The regulating piston is shown in a closed position with the main seat against the primary flow control orifice.

Both diagrams depict the same view; however, the bottom diagram illustrates the various parts of the regulator's interior. The oxygen flow enters the regulator from the oxygen cylinder valve at the inlet nozzle. A non-metallic gasket provides a seal between the CGA (Compressed Gas Association) 870 adapter on the cylinder valve and the regulator. The flow then passes through an inlet filter (a

stainless steel screen is shown here but the regulator involved in the incident is reported to have had a sintered bronze filter and is directed toward a flow orifice). The flow orifice and main seat provide the primary pressure regulation. Pressure upstream of this point (i.e., toward the cylinder valve) is nominally consistent with cylinder pressure. Pressure downstream is normally 50 psig or consistent with the set point of the regulator. The piston mechanism strokes to the right to allow flow to enter the piston barrel and left to hinder or stop flow when the pressure under the piston reaches the regulator's set point. Oxygen then flows into an orifice in the flow control mechanism and is delivered at the rate set by this mechanism.

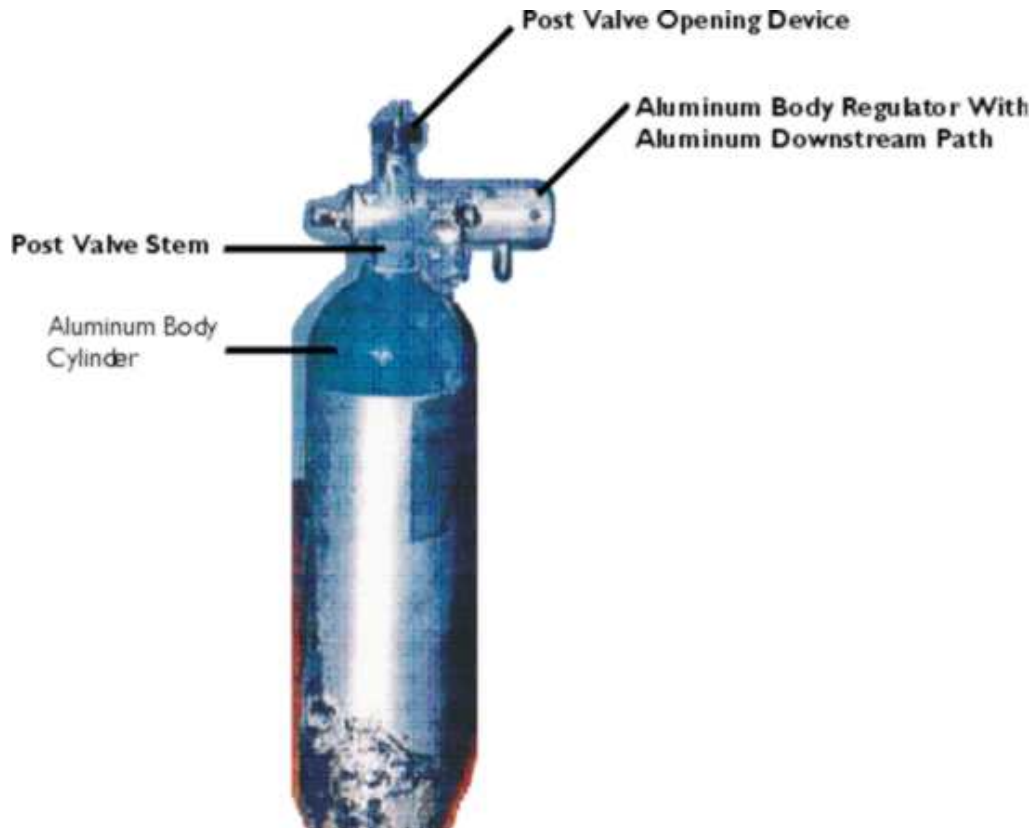
The cylinder has a post valve that closes off the oxygen opening and allows the regulator to attach (Diagram 2). When the post valve is screwed into the aluminum cylinder, there is a possibility that the two metals rubbing together (galling) could create metal particles that would remain enclosed in the cylinder body. Galling is a condition involving smearing and transfer of material from one surface to the other and particles could be introduced by metal-to-metal of seals rubbing which occurs when the post valve is opened and closed. The frictional heat of the galling could lead to ignition of the valve; or the particles generated by the galling could cause malfunction or ignition of another component within the regulator. Therefore, the design of the regulator's flow path should be resistant to ignition if particles should occur. Experts suggest the regulator flow path should be lined with brass, bronze, or a similar material which would resist particle ignition, and that using such a material would shield the particle ignition and provide the opportunity to burn out. Particulate migration from the cylinder can be minimized by the installation of a standoff tube (bayonette) at the inlet of the post valve.

Diagram 2: This diagram depicts the cylinder involved in the incident and the location of the post valve stem.
