Emergency Medical Technician Receives Serious Burns from an Oxygen Regulator Flash Fire-South Carolina

SUMMARY

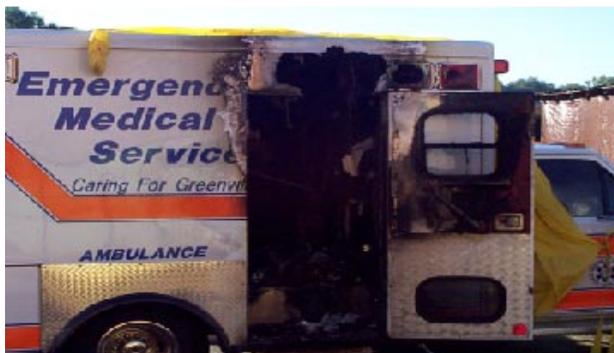
Incident scene

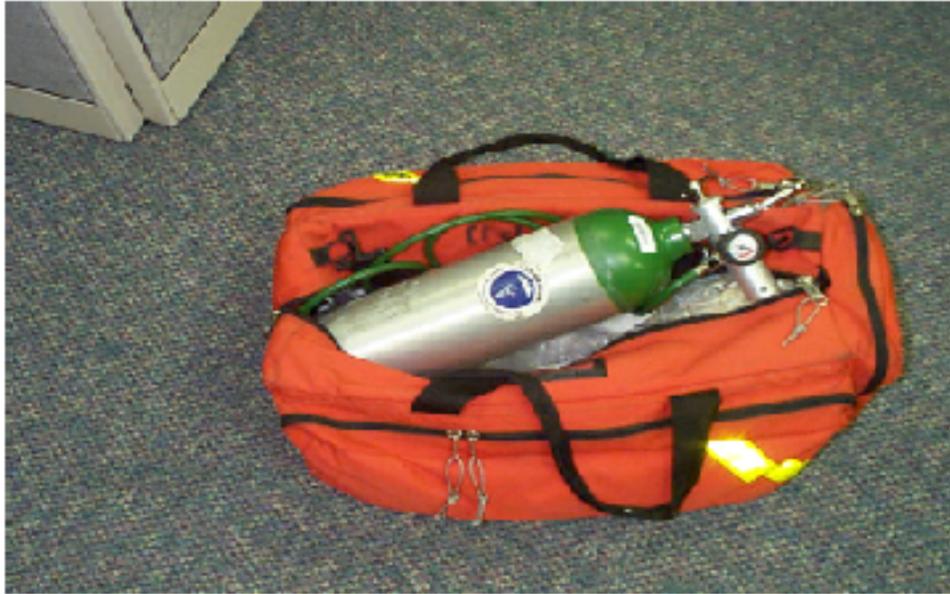
Photo 1: This photo depicts the Oxy-Caddy which is used to house the oxygen resuscitator when not in use. (Not actual Oxy-Caddy involved)

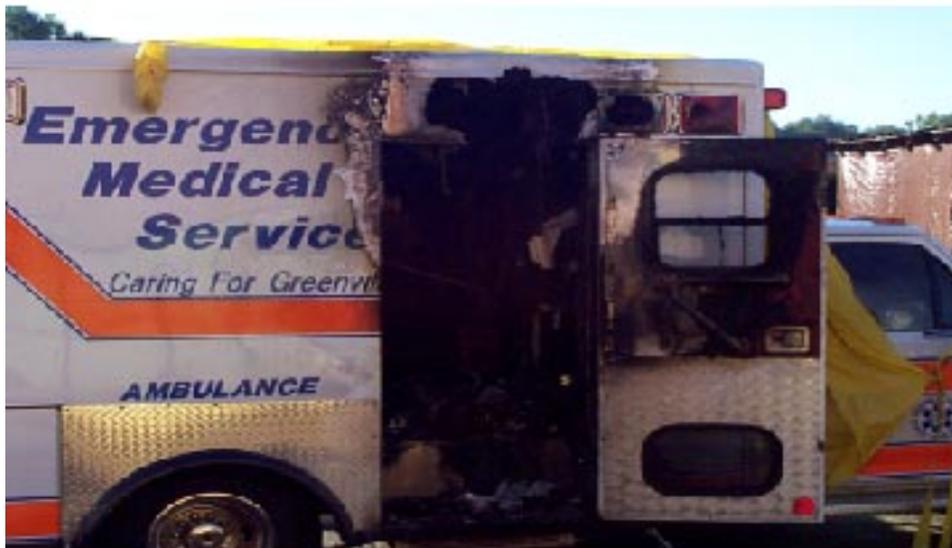
receive orders for morphine to treat the victim. The order was received and an IV line was started. She was also placed on an oxygen re-breather @ 15 liters per minute. The Corporal then gave the victim additional morphine as the EMTs wrapped her in burn blankets and loaded her onto the stretcher. She was then transported to the local hospital with burns to approximately 25 percent of her upper and lower extremities. The truck involved in the incident was declared a total loss and the estimated value was \$175,000 (see Photo 2).

Photo 2: This photo depicts the ambulance (truck) involved in the incident.

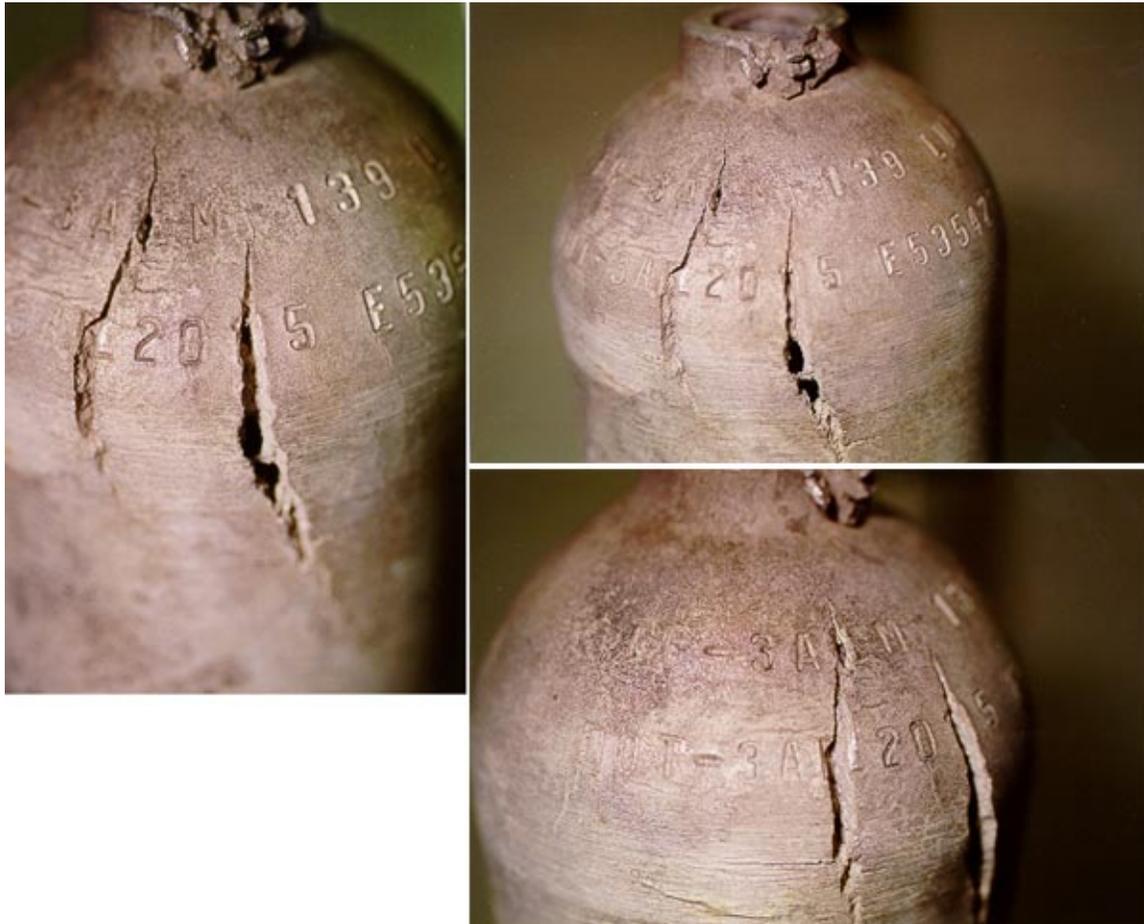
The regulator involved in the incident had a gauge guard placed on it to protect the pressure gauge from damage. The gauge guard (see Photo 5) was positioned on the regulator in a manner that blocked the relief vent holes (see Photo 6). Laboratory testing has shown that in past regulator fires the vent holes were usually the first exit of fire. In this incident the gauge guard blocked the vent holes, not letting the fire vent properly, causing the fire to burn back into the cylinder (blowback) and the cylinder to rupture (see Photo 3) which increased the severity of this incident.

Photo 3: These photos depict various views of the external wall of the fire-damaged oxygen cylinder. The cylinder was bulged from heat and internal pressure near the neck and had split, as shown, in an axial direction.

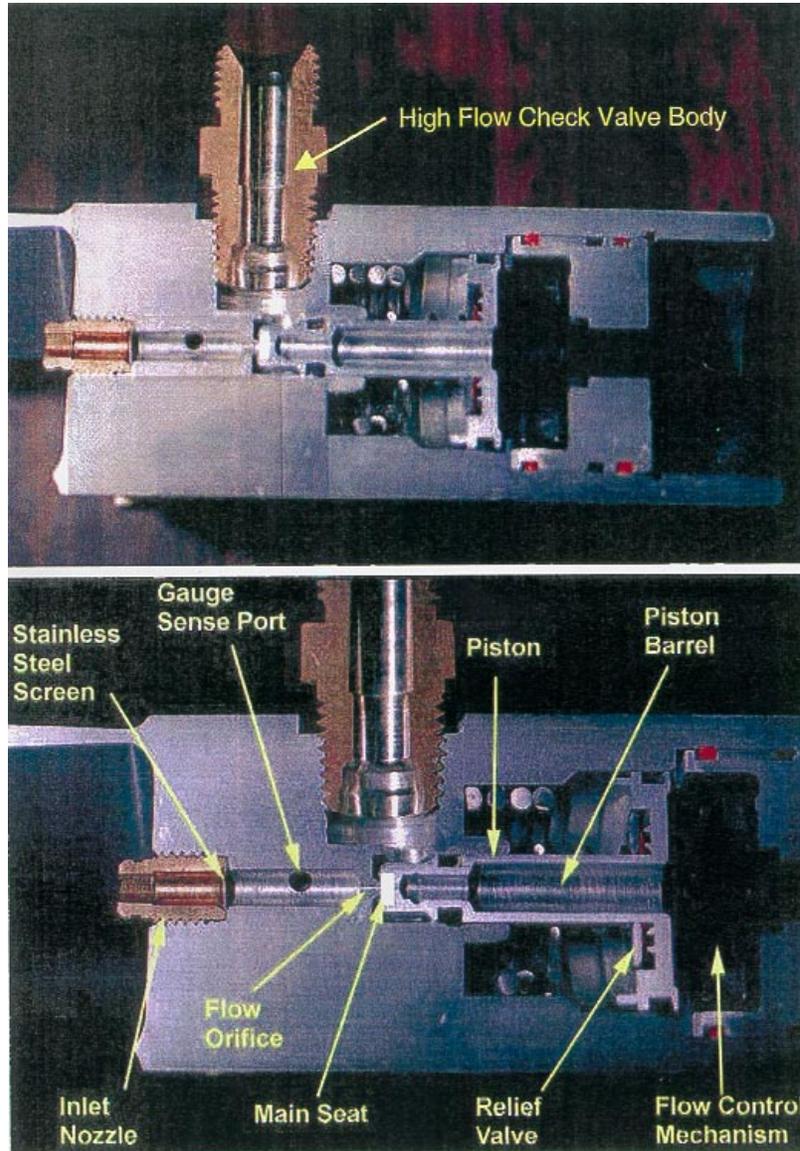
The manufacturer of the regulator had issued a recall notice prior to this incident stating the stainless steel screen located under the inlet nozzle (see Photo 4) should be replaced with a sintered-bronze inlet filter. The manufacturer would send the sintered-bronze inlet filter upon request. However, the EMS operation could not recall or show any record of having received this recall notice. The regulator involved was a full-bodied aluminum regulator with aluminum exposed to high-pressure oxygen. Additionally, laboratory testing has shown that the sintered-bronze filter was not completely effective in preventing fire flashes.¹⁵

Photo 4: This photo is an internal section view of a similar regulator involved in this incident. This view depicts the position of the stainless steel screen.

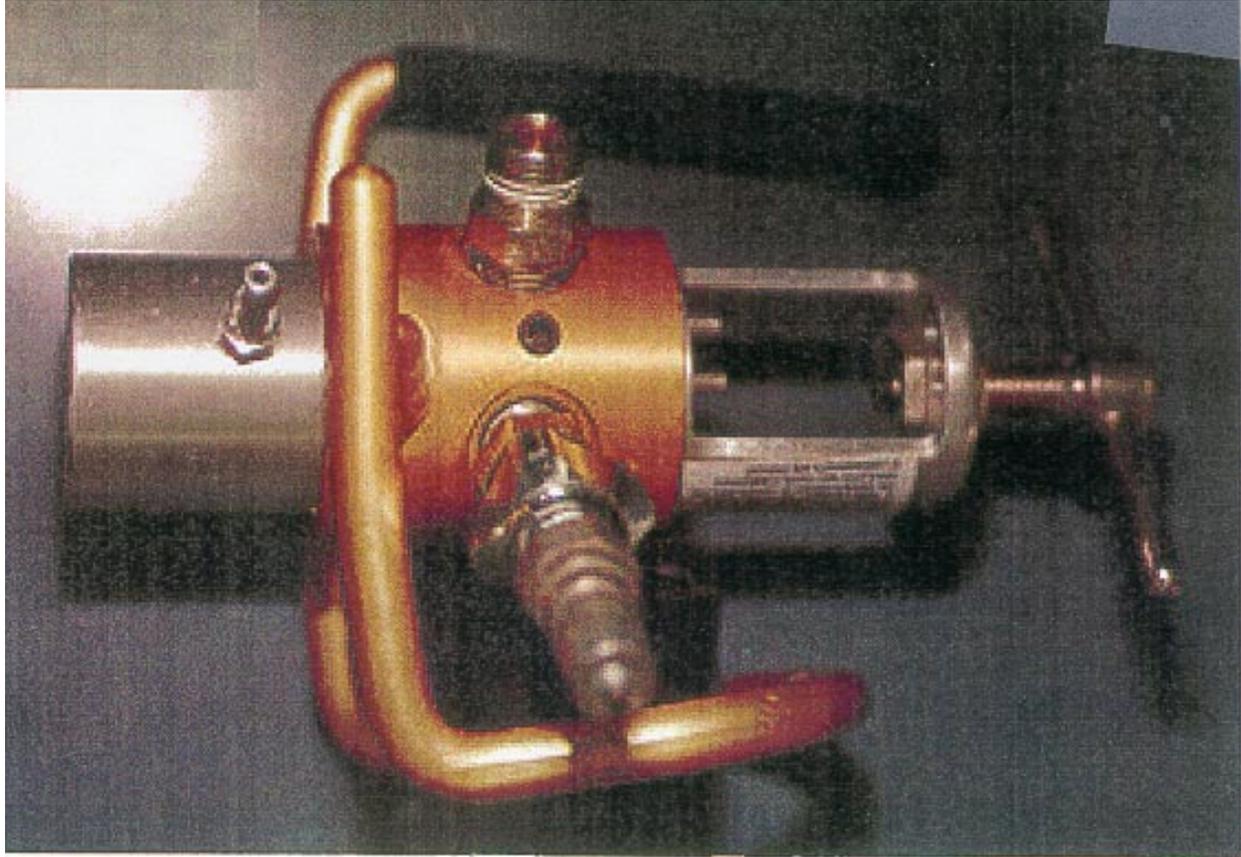
Photo 5: This photo depicts a similar regulator with a gauge guard blocking the vent ports.

Recommendation #5: Fire departments should ensure that any components added to the regulator, such as gauge guards, are installed so that they do not block the regulator vent holes.⁷

Discussion: Gauge guards can be installed on regulators to protect the gauge from being damaged. However, if any additional components (such as a gauge guard) are installed on the regulator, they should be supplied by the manufacturer and installed so as not to block the regulator vent holes. Covering of the vent holes could restrict the vents from

functioning properly and possibly cause a blowback condition if a fire would occur.

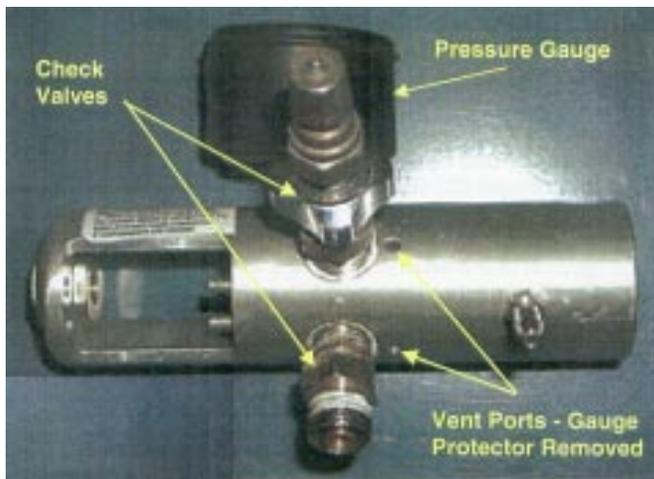
Photo 6: This photo depicts the vent ports located in the low pressure section of the regulator. In previous regulator fires, the fire usually exited the regulator through the vent ports.

Recommendation #8: Manufacturer's should ensure that they provide a warning pertaining not to occlude the vent ports on the regulator. ²

Discussion: Manufacturer's should provide a warning not to occlude the vent ports on oxygen regulators. If a fire would occur in a regulator, the vent ports would be a relief opening for the fire to properly vent. Blocking the ports could increase the combustion intensity and overpressure causing the fire to propagate towards the cylinder. In this incident, the vent ports were blocked by a gauge guard which protected the pressure gauge. When the fire occurred, the gauge guard blocked the fire vent path, causing a blowback condition. The fire then began burning into the cylinder, causing the cylinder to rupture. The fire became more intense and consumed most of the interior of the ambulance (truck) involved. The Emergency Medical Service stated that they received no warning which pertained to occluding the vent ports on the oxygen regulators.

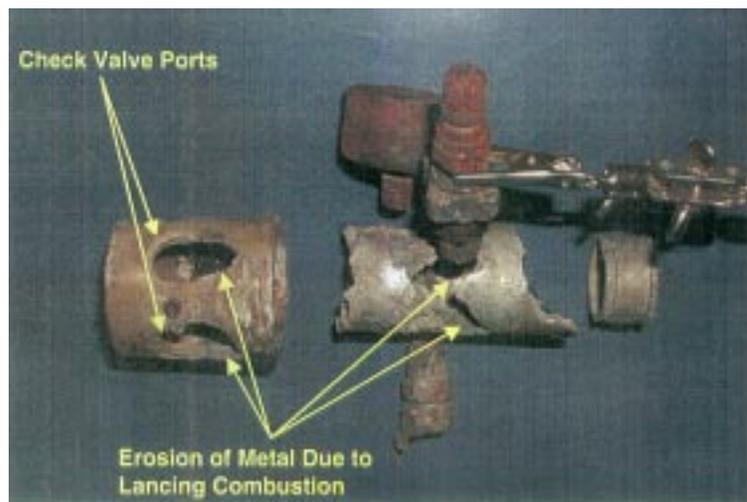
During the fire, the regulator broke off the cylinder and was found in several pieces (see Photo 7). The regulator and cylinder were sent by the EMS involved in this incident to an independent forensic testing laboratory to be evaluated. The results of that evaluation are summarized in the next section.

Photo 7: This photo depicts the remains of the regulator involved in the incident. The regulator was completely detached from the cylinder and discovered in several pieces as a result of the flash.
