Eight-Alarm Fire in a 27-Story High-Rise Apartment Building for the Elderly Nearly Claims the Life of One Fire Fighter—Missouri

Fatality Assessment and Control Evaluation Investigative Report #98F-26

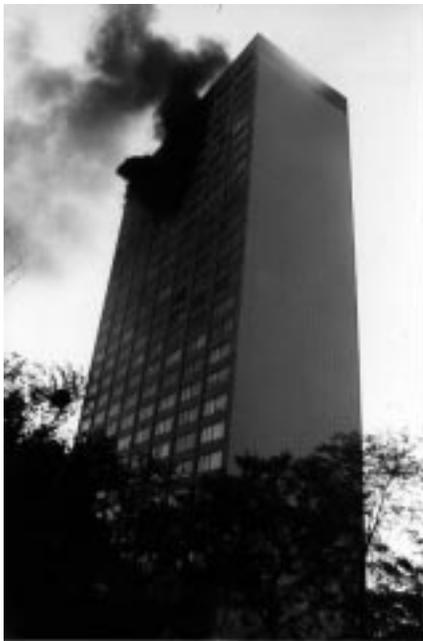
Incident Scene

On October 12, 1998, while attempting a rescue, two fire fighters became disoriented in a smoke charged hallway on the 21st floor of a high-rise apartment building, ran out of air, and one of the two fire fighters (Captain on Engine 17, the victim) came close to death in this incident. The fire started in the apartment of an elderly woman, and was reported as originating from an electrical cause or smoking in bed. The fire started shortly after 0900 hours, and the resident unsuccessfully attempted to extinguish the fire with glasses of water for a period of time. She then called the front desk, reported the fire and exited the apartment, leaving the door open, and took the elevator to the lobby. By the time the fire department arrived, the entire hallway on the 21st floor was fully charged with thick black smoke, and the fire had escalated, breaking out the apartment

windows and allowing the wind to blow the apartment door shut. Three oxygen bottles in the apartment, for the resident's use, accelerated the fire growth when they exploded. NIOSH investigators conclude that, to minimize the risk of similar occurrences, fire departments should:

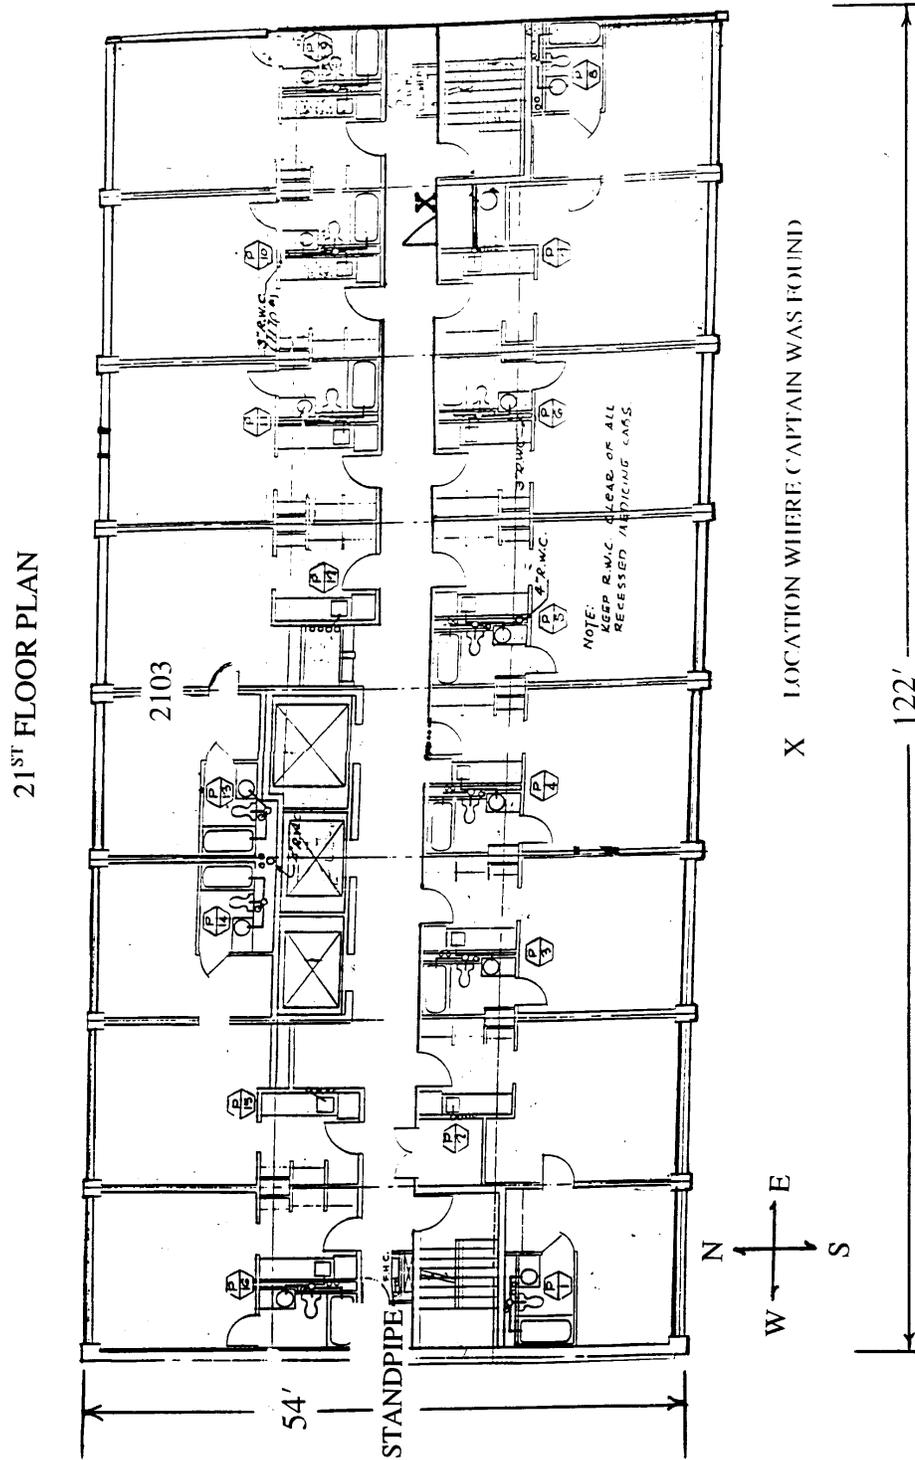
Floor Diagram

On October 12, 1998, at 0934 hours, the manager of A 27-story apartment complex (see floor diagram) for the elderly called the fire department to report a fire in apartment 2103. Note: From all the information obtained during this investigation, it is estimated the fire started around 0900 hours (**approximately 30 minutes before it was reported to the fire department**) in apartment 2103 as a result of an electrical short near the bed or from a burning cigarette. The elderly woman who lived in the apartment attempted unsuccessfully to extinguish the fire with glasses of water. It was reported that many bags of polyester clothing were stored in the bedroom, which could have intensified the fire and smoke conditions. In addition, the occupant was using supplemental oxygen, so there were three oxygen bottles in the apartment. When the occupant of the apartment was unsuccessful in extinguishing the fire, she called the front desk and reported the fire, exited the burning apartment, leaving her apartment door open, which charged the hallway with thick black smoke. The fire accelerated, breaking out the large windows, and the apartment door blew shut. One of the residents on the 21st floor stated he heard the fire alarm sounding at approximately 0910 hours and opened the door to his apartment but did not see any smoke or fire.

Upon arrival, the Captain and a fire fighter on Engine 29 took the elevator to the 19th floor with the hotel pack (two 50-foot lengths of 1 3/4 inch line) and then they took the west stairwell to the 21st floor (fire floor). Opening the door to the hallway on the 21st floor, which was charged with thick black smoke, they connected the 1 3/4-line to the standpipe located just to the left inside the door. The Captain on Engine 29 took the tip of the hoseline down the hallway on the 21st floor in search of the fire, and 2 fire fighters on Squad 2 followed the charged line; however, they could not locate the fire. The fire fighters on Squad 2 returned to the west stairwell, and the Captain (victim) and two fire fighters on Engine 17 went to the 19th and 20th floors, and observed no fire or smoke on these floors. They then took the west stairwell to the 21st floor and observed heavy smoke in the hallway of the 21st floor. The Captain on Squad 2 and several fire fighters went to the 22nd floor, connected a 1 3/4 inch line to the standpipe, and observed a light haze of smoke in the hallway. Heavy smoke was observed in the apartment directly above the involved apartment on the 21st floor because the flames leaping up from below were breaking the windows. All the residents

The Captain (victim) on Engine 17 decided to attempt a rescue although he knew he was low on air. A fire fighter on Squad 2 who was also low on air, stated he would go with him. Both fire fighters descended the steps to the 20th floor, walked down the hallway to the east stairwell landing, and ascended to the 21st floor. They turned on their SCBAs, opened the stairwell door and entered the smoke-laden hallway on the 21st floor, in an attempt to rescue the person who was reported to be hanging out of the window. Low on air and in a dark-hot-heavy smoke environment, both became disoriented, and they attempted to return to the door from which they had just entered. The fire fighter on Squad 2 stated he thought the Captain was right behind him; however, when he found the door and escaped into the landing of the stairwell, he discovered the Captain was not behind him. He pulled off his face piece, opened the door again and yelled for the Captain; however, there was no response from the Captain. The fire fighter stated he opened the door two or three times and yelled for the Captain, but he received no response.
