NIOSH
Fire Fighter Fatality Investigation
and Prevention Program

Two Volunteer Fire Fighters Were Killed and One Fire Fighter and One Civilian Were Injured During an Interior Fire Attack in an Auto Salvage Storage Building-North Carolina

Fatality Assessment and Control Evaluation
Investigative Report #98F-32

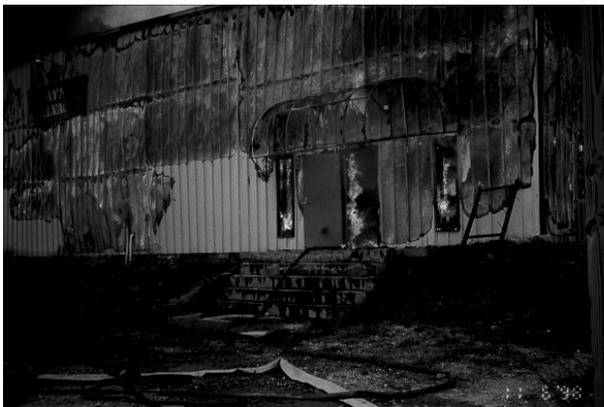
This photo depicts the front door of the burning structure where both victims entered to perform an interior fire attack

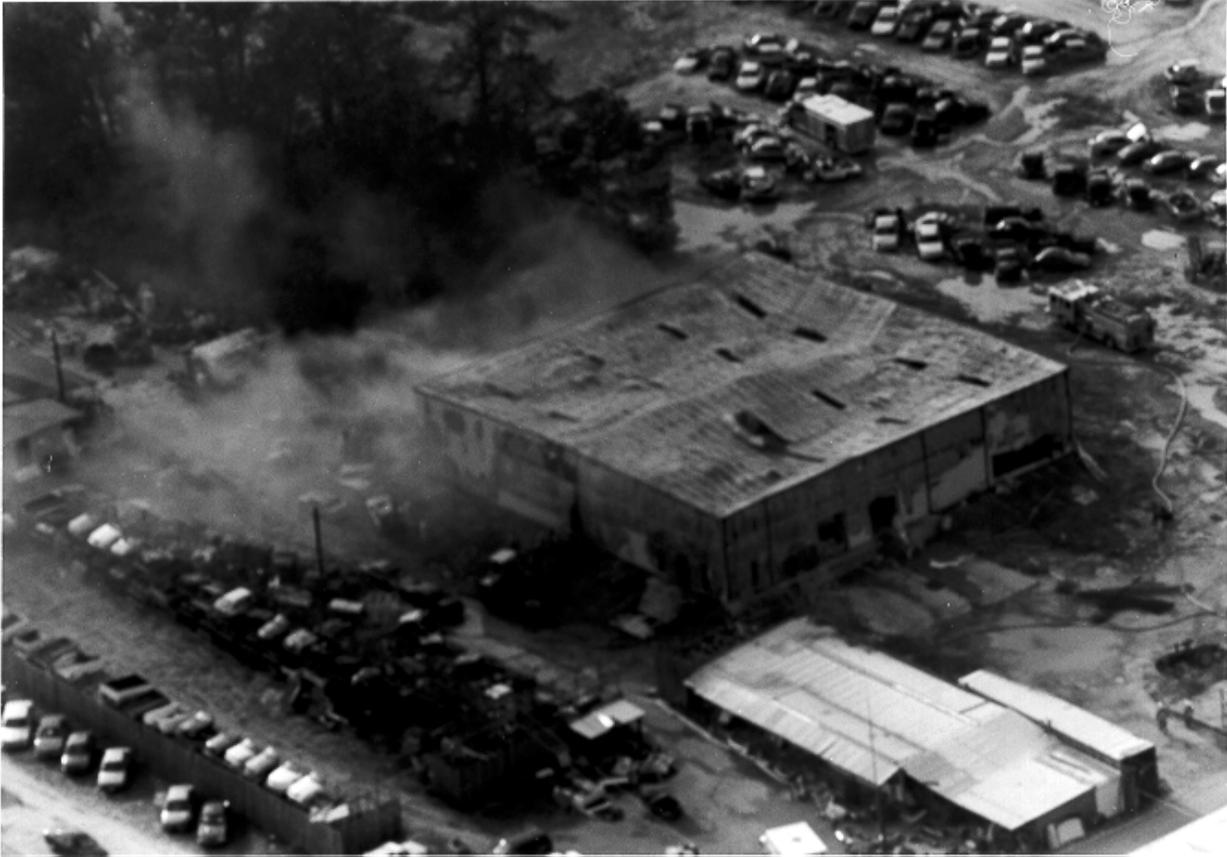
Photo 1: This photo depicts an aerial view of the burning structure

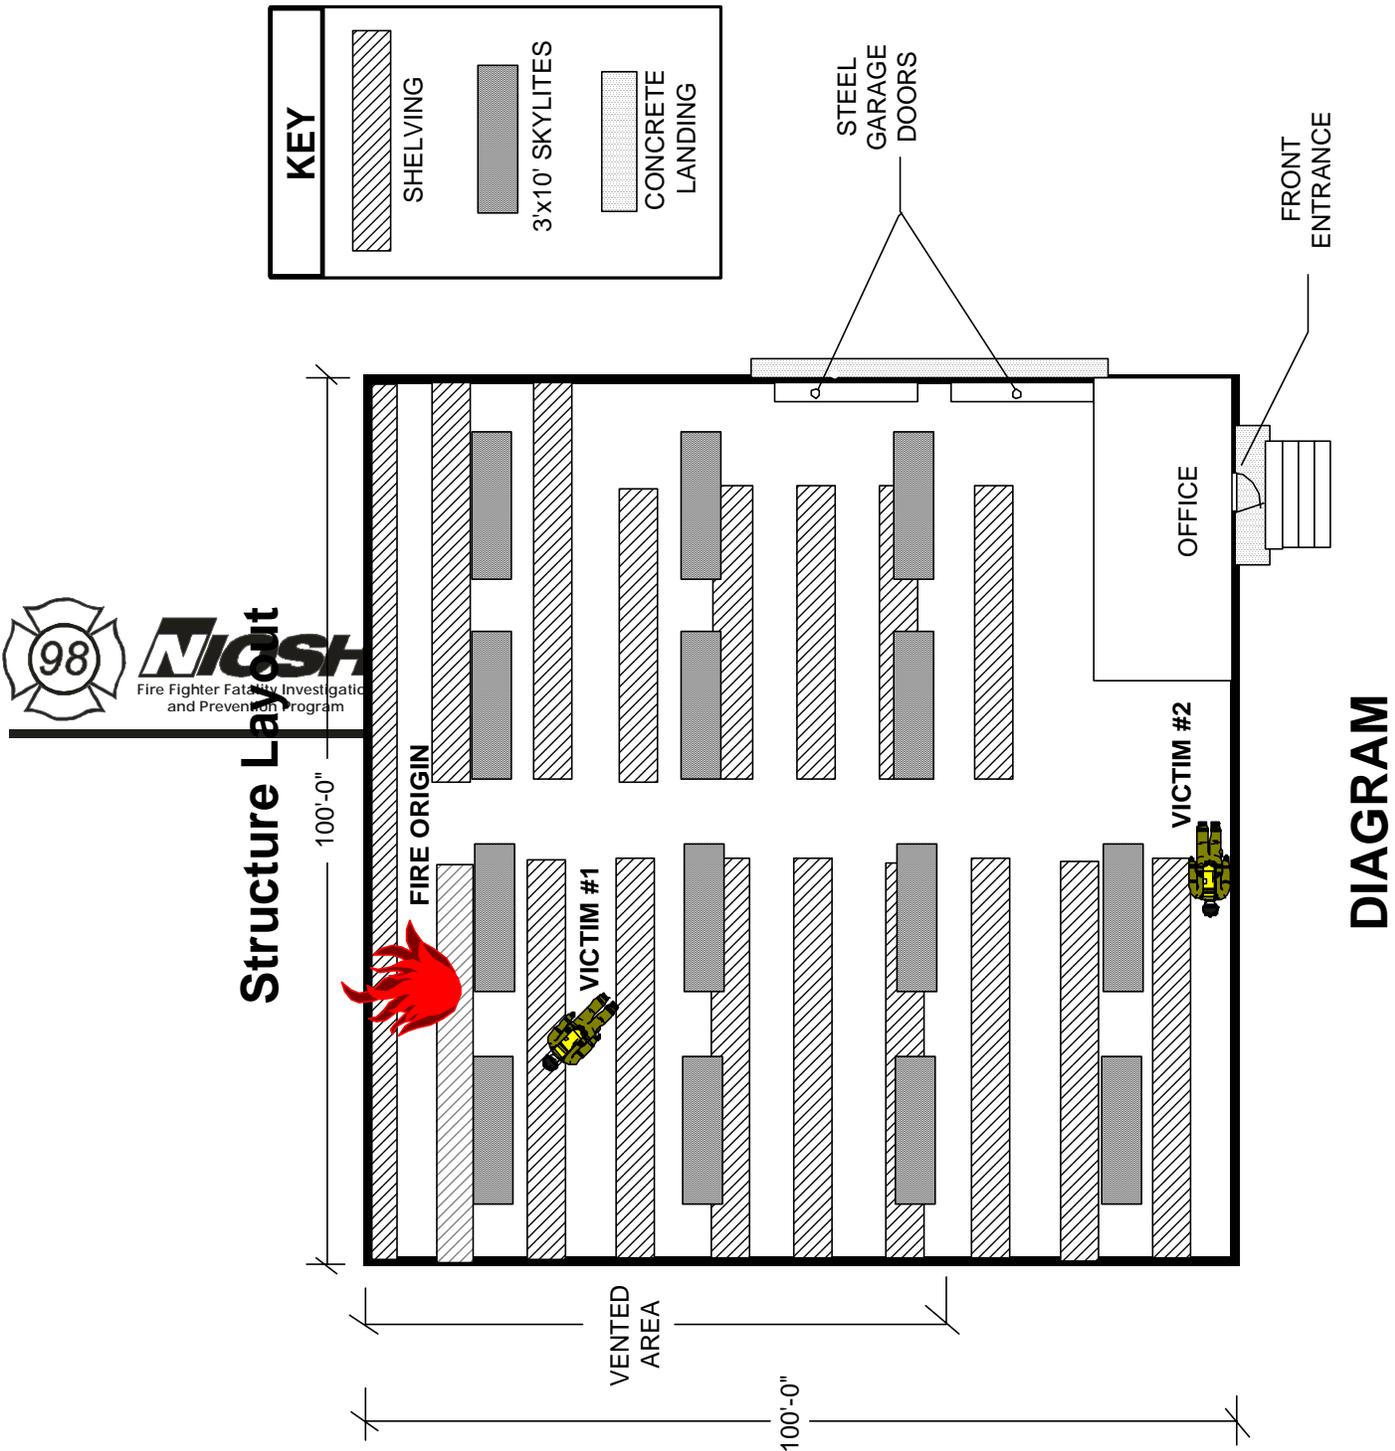
The Chief in Car 1 was the first to arrive on the scene at 1104 hours and reported light smoke emitting from the southwest corner of a storage building at an auto salvage yard. Upon arrival he assumed command and completed a size-up evaluation of the metal-pole storage building which measured 100 by 100 feet, with the height of the roof being 20 feet (Photo 1). After completing his initial size-up, he was approached by the owner of the structure who informed him of the approximate location of the fire's origin. The owner explained the structure was used to store metal hoods, light bulbs, radiators, oil pumps, fenders, and bumpers on the first level. The second level contained plastic, fiberglass, and rubber car components. The owner also described the layout of the structure as a grid of storage racks 6 feet wide standing approximately 18 feet high, with aisles ranging from 3 feet to 6 feet in width (see Diagram).

have been pinned or trapped by debris. Victim #1 was discovered lying in one of the storage racks near the rear of the structure, and Victim #2 was discovered in an aisle near the front (see Diagram). Victim #2 was recovered with a PASS device attached to his equipment, but it was in the off position. Victim #1 was known to have entered the structure without a PASS.
