**NIOSH**  
Fire Fighter Fatality Investigation  
and Prevention Program

## **Three Fire Fighters Die in a 10-Story High-Rise Apartment Building—New York**

## Fatality Assessment and Control Evaluation Investigative Report #99F-01

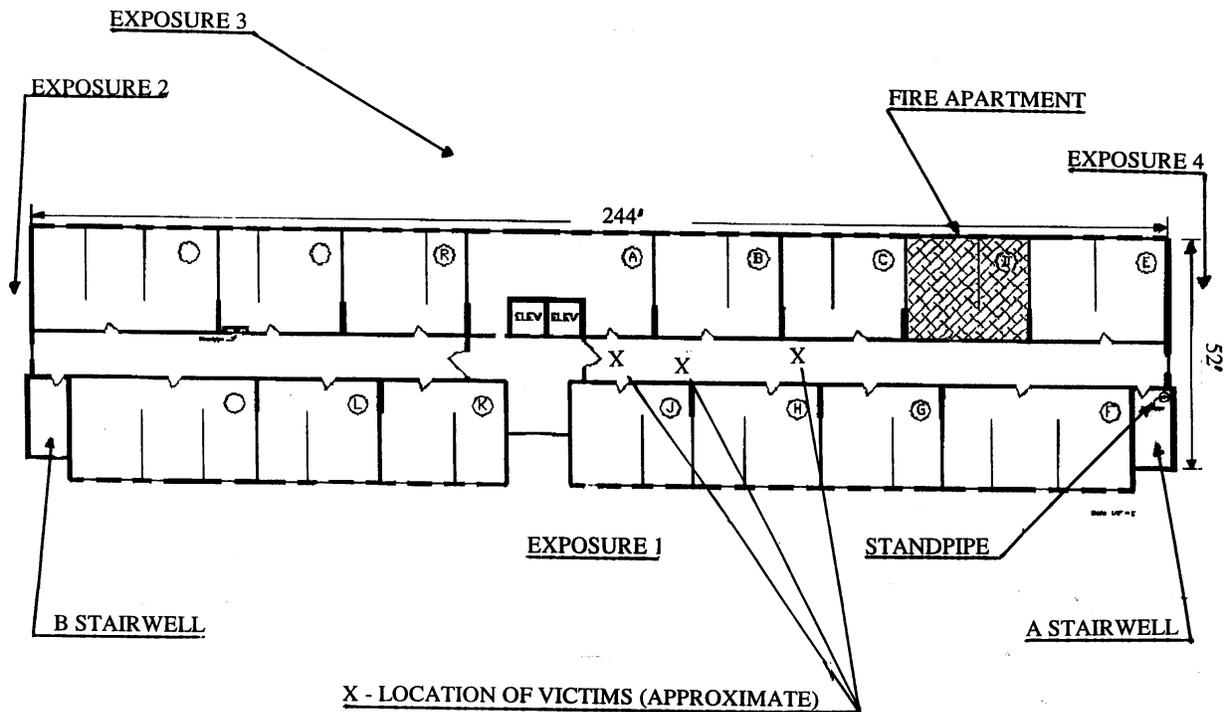
10<sup>th</sup> FLOOR DIAGRAM

During this same time period, the Lieutenant and 2 fire fighters (victims) from Ladder 170 entered the lobby with the Lieutenant, nozzleman, and controlman from Engine 290 and took the elevator to the ninth floor. Two fire fighters from Engine 290 took the B-stairway (see diagram) to the ninth floor where they met up with their Lieutenant and the victims. The victims along with the Lieutenant from Engine 290 took the B-stairs to the tenth floor, whereby, they entered the hallway on the tenth floor and observed only a light haze, and no fire. The four fire fighters from Engine 290 remained on the ninth floor, B-side landing, were flaking-out three,

At 0518 hours, the Captain on Squad 252 and a fire fighter on Rescue 2 were proceeding down the tenth floor hallway, from the B-side towards the fire doors, when they opened the doors (see diagram) and found a helmet just inside the doors, then they found Victim #3 (first victim to be removed from the tenth floor),
