NIOSH
Fire Fighter Fatality Investigation
and Prevention Program

A Summary of a NIOSH fire fighter fatality investigation

Three Fire Fighters Die in a 10-Story High-Rise Apartment Building—New York

Fatality Assessment and Control Evaluation Investigative Report #99F-01

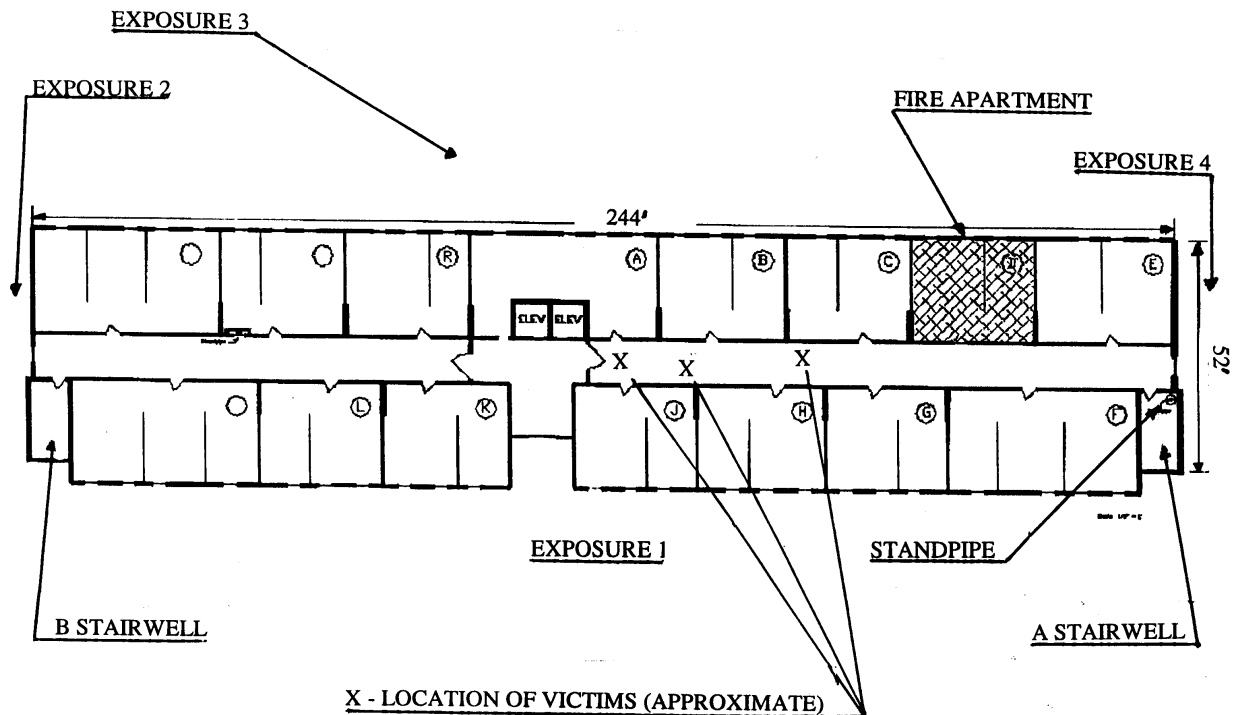
10th FLOOR DIAGRAM

During this same time period, the Lieutenant and 2 fire fighters (victims) from Ladder 170 entered the lobby with the Lieutenant, nozzleman, and controlman from Engine 290 and took the elevator to the ninth floor. Two fire fighters from Engine 290 took the B-stairway (see diagram) to the ninth floor where they met up with their Lieutenant and the victims. The victims along with the Lieutenant from Engine 290 took the B-stairs to the tenth floor, whereby, they entered the hallway on the tenth floor and observed only a light haze, and no fire. The four fire fighters from Engine 290 remained on the ninth floor, B-side landing, were flaking-out three,

At 0518 hours, the Captain on Squad 252 and a fire fighter on Rescue 2 were proceeding down the tenth floor hallway, from the B-side towards the fire doors, when they opened the doors (see diagram) and found a helmet just inside the doors, then they found Victim #3 (first victim to be removed from the tenth floor),
