NIOSH
Fire Fighter Fatality Investigation
and Prevention Program

March 27, 2000

Floor Collapse Claims the Life of One Fire Fighter and Injures Two-California

Fatality Assessment and Control Evaluation Investigative Report #99F-03

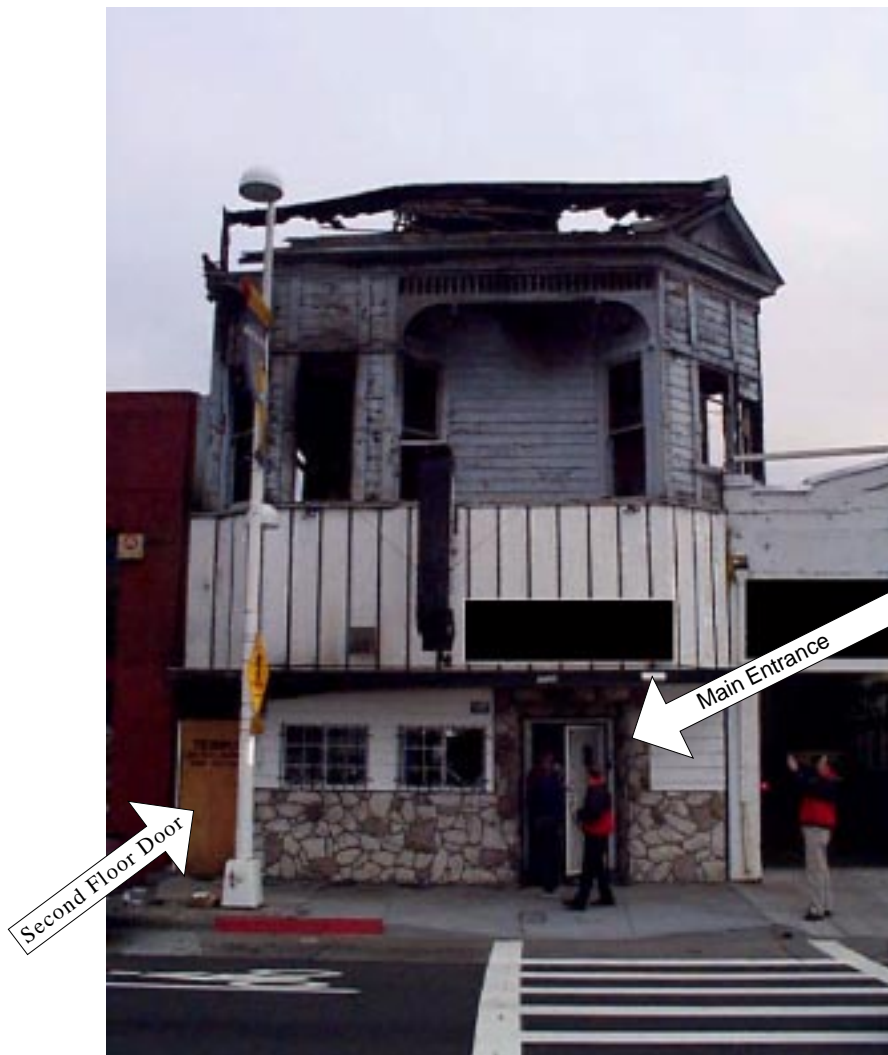
Photo

At 1046 hours, Truck 2574 was the first to arrive on the scene and reported heavy smoke was emitting from a two-story building (see Photo). Dispatch also made a report that they had received calls stating that civilians were trapped on the second-floor of the burning structure. Truck 2574 established Command and requested a second alarm. Battalion Chief 2512 arrived on the scene and assumed command. He immediately struck a third alarm and shortly after struck a fourth alarm because there were buildings adjoining the burning structure and he wanted to control the fire from spreading (see Photo). Engines 2550 and 2545 arrived on the scene shortly after. Engine 2550 hooked up a 2 ½ -inch line to a nearby hydrant and proceeded to the burning structure as Engine 2545 hooked up a 5-inch supply line to the hydrant. Engine 2550 and Engine 2545 pulled two 1½-inch attack lines and took position at exposure A (see Diagram). Engine 2548 arrived on the scene and set up in the rear of the structure at exposure C and side D, while Truck 2574 placed their aerial ladder to exposure C. Engine 2548's original assignment was to act as the Rapid Intervention Team (RIT), but as they arrived at 1051 hours, they requested to set up in the rear due to the amount of apparatus already in the front. At 1052 hours, Battalion Chief-2514 arrived and was assigned to be in charge of Outside Operations. He immediately proceeded to side D and then to exposure A, to complete a size up of the structure.

The Captain from Engine 2545 and a fire fighter from Engine 2555 entered the secondary front door, which lead to the second-floor (see Photo). As the two proceeded up the steps with the Captain on the nozzle, the steps collapsed, and the Captain and fire fighter retreated and exited the structure. The Captain reported to the IC that there was heavy fire near the stairs and that they could not access the second-floor. The Captain ordered a fire fighter from Engine 2545 to retrieve an axe and break loose the steps so they could proceed under them to the rear of the structure. After the steps were knocked out, the Captain and two fire fighters from Engine 2545 and a fire fighter from Engine 2555 entered the area applying water and proceeded toward the rear of the structure approximately 35-feet where they encountered a gas furnace. The furnace was blocking the fire fighters path to the rear of the structure, so they decided to remove the furnace and drag it to

Photo: This photo depicts the two-story tax payers building (commercial occupancy on the first-floor and living quarters on the second).

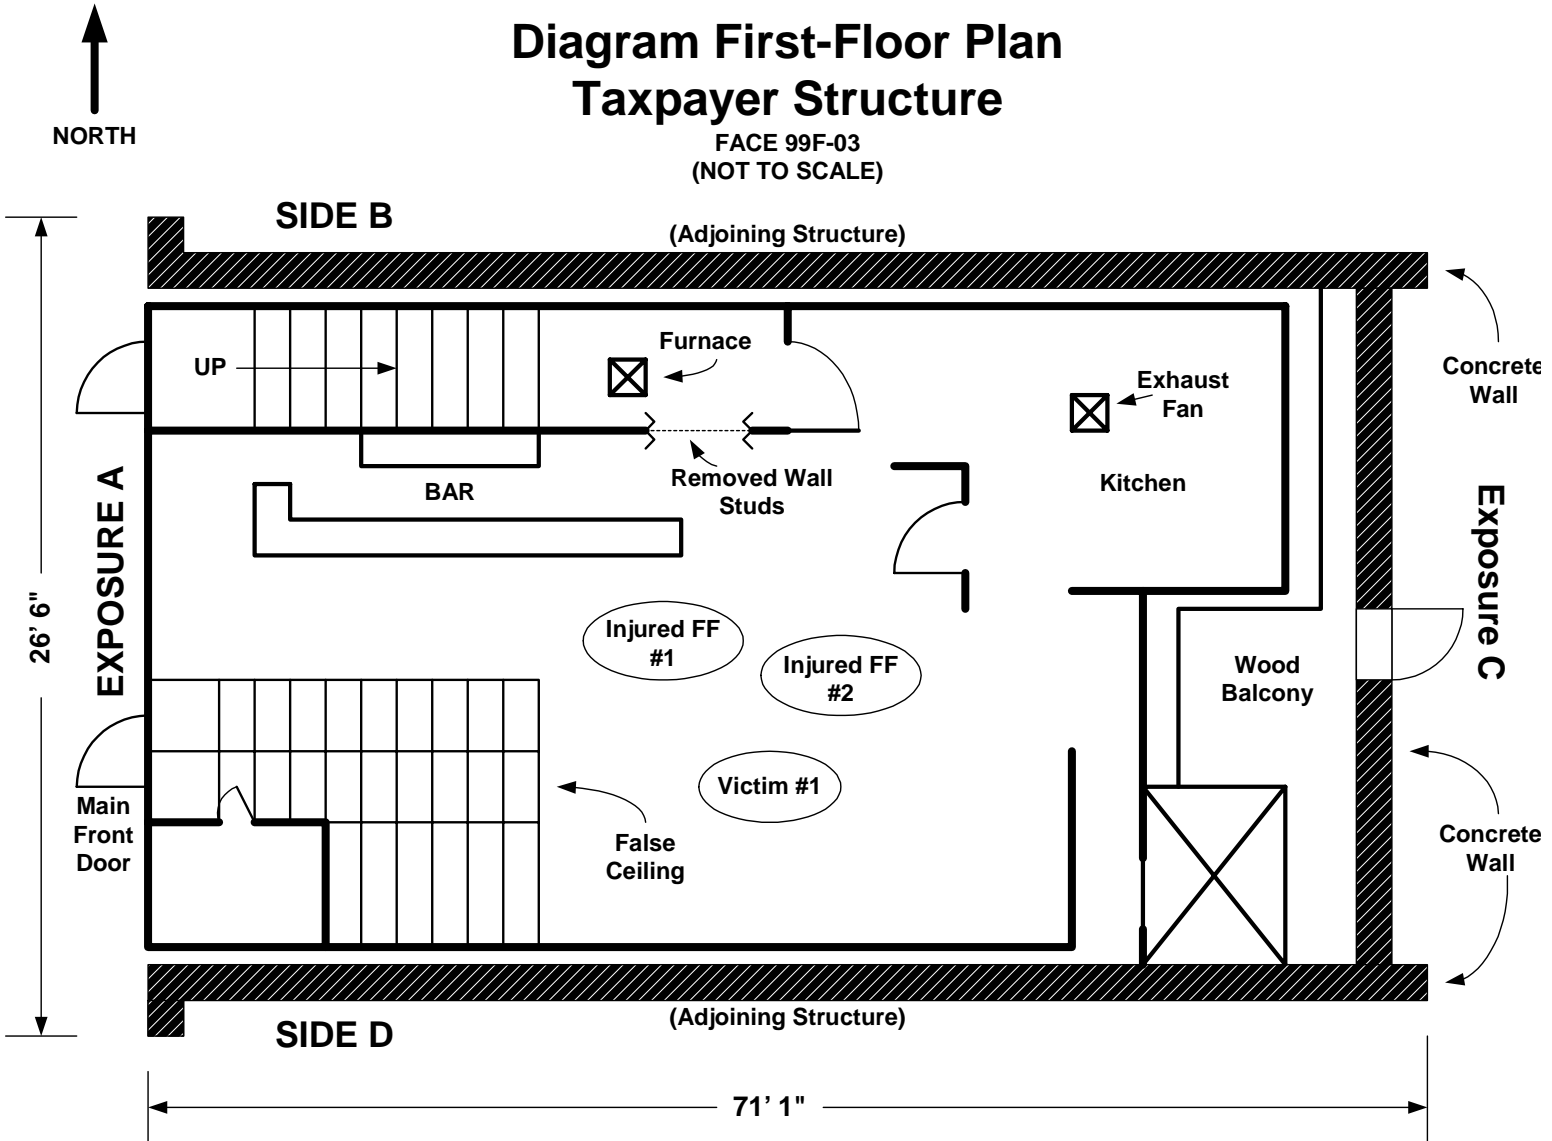
Diagram First-Floor Plan Taxpayer Structure

the exterior. *[NOTE: The furnace is believed to be the fire’s point of origin. When the fire fighters removed the furnace they ripped all connections apart; however, the gas company had shut off the gas prior to the furnace’s removal.]* The fire fighters reentered the structure and proceeded approximately 5-feet past the original position of the furnace where they remained applying water to the interior of the bar area (see Diagram) throughout the fire attack.

fire fighters approximately 15-feet inside the front door (see Diagram). After working his way through debris, he cut off the trapped fire fighter's SCBA, freeing her from the debris. The fire fighter then located the Lieutenant, who was approximately 5-feet away. As he moved the debris to reach him, the Lieutenant and fire fighters from the Heavy Rescue team retrieved airbags, hydraulic jacks, and cribbing needed to extricate the Lieutenant and the victim. They placed an airbag and cribbing under the debris to free the trapped Lieutenant. As they began to place a second airbag under the debris, they realized the regulator was not working, so they used the hydraulic jacks, which required additional time. Approximately 10 minutes after they reached the injured Lieutenant, they freed him and removed him to the exterior. Approximately 4 minutes later the victim was reached. The victim was found in a crouched position and heavy timbers from the second floor were applying constant pressure. The victim was unresponsive throughout the entire rescue. When they reached the victim, a pulse was not detected. Using the hydraulic jacks and cribbing, the Heavy Rescue team freed the victim and immediately started Cardiopulmonary Resuscitation. The victim was removed and transported to a local hospital where he was pronounced dead. The injured Lieutenant and fire fighter were also transported to a local hospital. They were treated for their injuries and released for further rehabilitation.
