Roof Collapse in Arson Church Fire Claims the Life of Volunteer Fire Fighter - Georgia

Fatality Assessment and Control Evaluation Investigative Report #99F-04

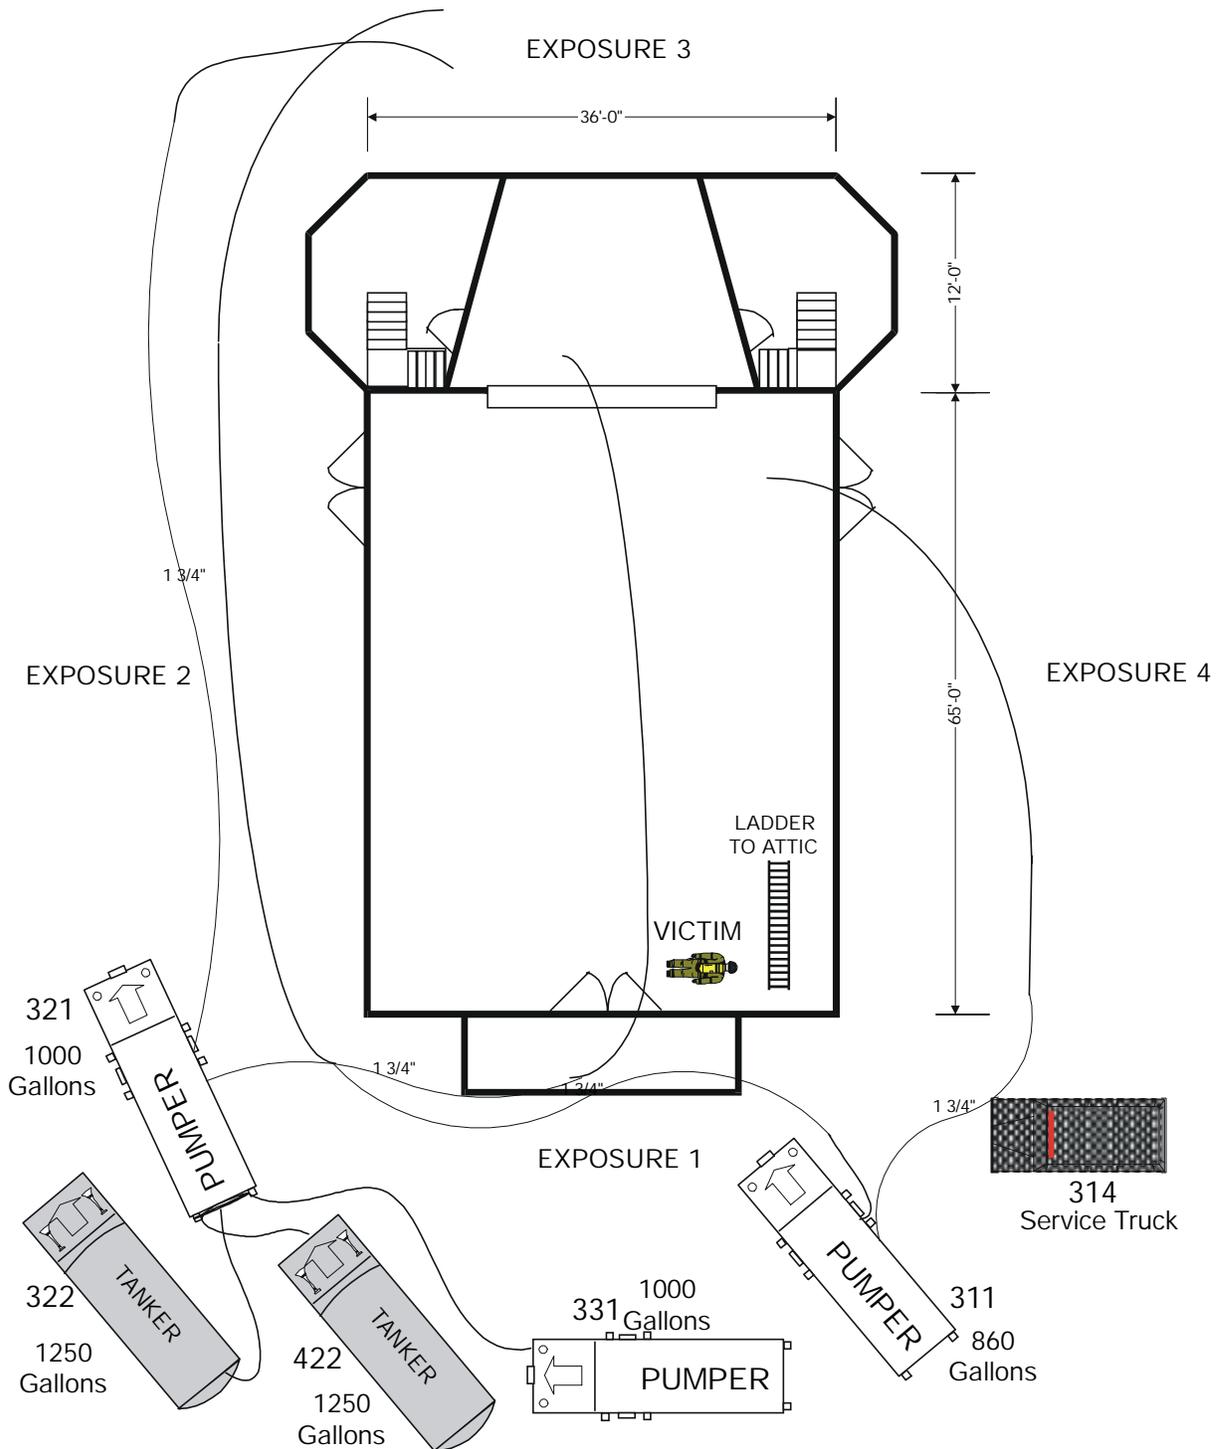
CHURCH DIAGRAM

After considering roof ventilation, the Chief ordered a crew of three fire fighters to take a ladder and pike pole into the front door and locate the access into the attic, which was reported to be to the right of the front door (see diagram). The ladder was placed between the first and second pews and leaned against the wall of the church. The crew was to check for fire extension in the attic area. Using a pike pole, a fire fighter attempted to pull down a ceiling tile from the drop ceiling (the church had a drop style ceiling 2 feet below a wood tongue-and-groove ceiling). As the fire fighter lifted one of the ceiling tiles, several ceiling tiles were sucked up into the attic and flames shot out of the hole. The fire fighters exited the sanctuary to notify the Chief. The Chief had gone to exposure 4 corner and observed an opposing hose stream coming over the roof area and that the fire was now venting through the roof at the rear of the church.

At approximately 2217 hours, the Captain along with a Lieutenant and two fire fighters entered the front of the church and proceeded to the access hole in the ceiling leading into the attic (see diagram). The Lieutenant climbed the ladder, which had been previously set by another crew to check conditions in the attic. The Captain (the victim) had re-entered the church and secured the ladder for the Lieutenant. The Lieutenant on the ladder observed no fire in the attic at this time and advised the Captain. Smoke conditions in the sanctuary consisted of only a light haze at this time. The Captain and one fire fighter exited the church and advised the Chief of conditions in the attic area. The Captain requested the Chief to step inside to size-up interior conditions. At the same time, the Deputy Chief, operating in the rear of the sanctuary went out of the door on exposure 2 to size-up conditions and noted flames spreading into the roof area. He re-entered and shouted for his crew to get out of the church.

The Chief had followed the Captain back inside the front door of the church at approximately 2220 hours when, without warning, the entire roof began collapsing into the interior of the church. The Lieutenant on the ladder reported seeing no fire and only a light haze in the attic, however, he noticed the drop ceiling moving toward him like a wave, and suddenly he was under a pile of burning debris, the entire roof was collapsing into the interior of the church. The Lieutenant was either blown from the ladder or was moving towards the door when this occurred, and the Captain (the victim) was trapped under heavy, burning roof timbers. The Chief stated he was approximately 10 feet inside the front door when without warning, the entire roof began coming down, blowing him towards the front door and sending a fire ball out the front door for approximately 100 feet. The Chief could hear the Lieutenant screaming for help, and grabbing the hose line, the Chief immediately applied water on him. With the help of another officer, he pulled the Lieutenant to safety. The pressure wave that vented through the side and front doors of the sanctuary could have been the result of a potential backdraft situation (ignition of hot gases in the attic) and/or the roof collapsing from the rear of the church to the front, thereby, pushing a large volume of air and flames toward the front of the church. The air and flames vented through the path of least resistance, the side and front doors.
