Fire Investigator Dies After Being Struck by a Chimney That Collapsed During an Origin and Cause Fire Investigation - New York

Fatality Assessment and Control Evaluation Investigative Report #99F-06

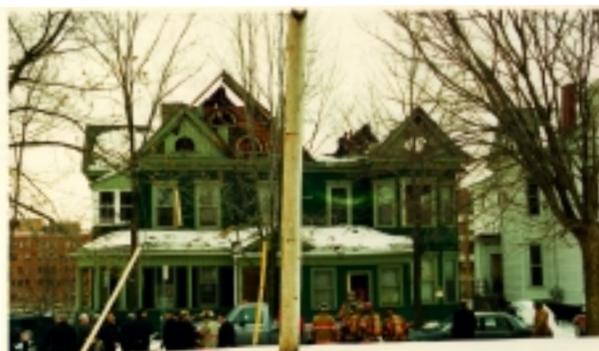
Figure 1. Fire Scene

On January 14, 1999, a fire at a residence more than 80 years old and containing three apartments

was reported to the city fire department (see Figure 1). The fire department responded and extinguished the fire within 1 hour by performing an exterior attack with deck guns. After salvage operations were completed the fire companies returned to their departments. It was determined that the investigation to determine the fire's origin and cause would be delayed until weather conditions improved from the sub-zero temperatures of the day of the fire. Five days after the fire, weather conditions had improved and an origin-and-cause investigation was scheduled for January 19, 1999. About 1030 hours on the day of the incident, a fire investigator from the department met with an insurance adjuster, a private fire investigator and an electrical consultant at the fire scene to conduct the investigation. All four men proceeded to the attic area where the investigation commenced. About 10 minutes into the investigation, the insurance adjuster left the area and proceeded to the floors below to continue his investigation. The three other men, including the victim, remained in the attic and sifted through debris for clues to the origin of the fire. About 2 ½ hours later, they had moved to an area near a brick chimney that was free-standing about 13 feet above the floor level of the attic. The section of the free-standing chimney above the roof line appeared to have been an add-on to the original chimney, as two different types of brick were present from below and above the roof line to the top of the chimney. The chimney had been constructed of single bricks and mortar stacked together, and the chimney contained no internal liner/flue (see Figure 2.). The dimensions of the section of chimney which collapsed were 98 inches high by 38 inches wide by 17 inches deep, and its estimated weight was between 2,500 - 3,000 lbs. The chimney had been free-standing for 5 days and had been subjected to direct fire exposure, freezing and thawing

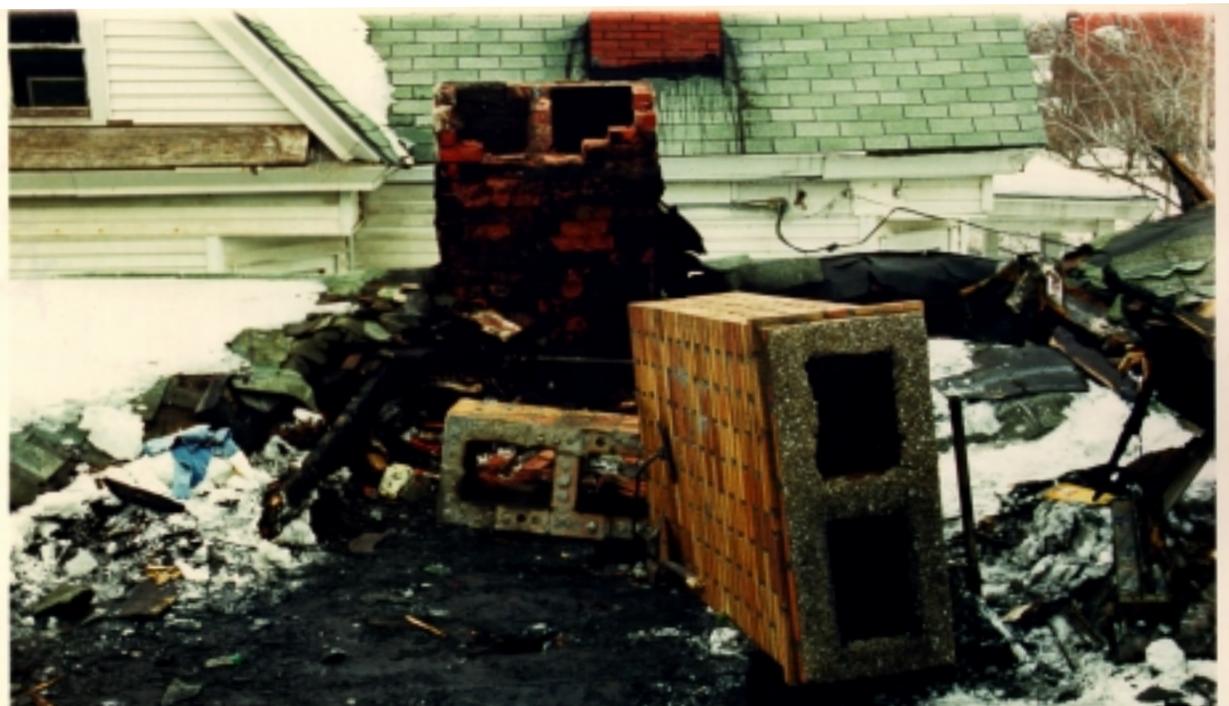
temperatures (-7° to 44° F), water loading from deck guns, and wind gusts to 56 m.p.h. *Note: About the time of the incident, wind was constant from the west and at a 90° angle to the chimney, between 33 - 36 m.p.h.*

After discussing the stability of the chimney the three men decided to continue work near it even though they had seen it swaying in the wind. Although working within 15 feet of one another, the three men were positioned at different locations in relation to the chimney. Two of the investigators were off to one side of the chimney, while the victim was located about 8 feet directly in line with the base of the chimney. The three men were sifting through and inspecting the debris when the chimney suddenly and silently collapsed and fell onto the victim. The sound of the chimney hitting the floor alerted the two other men, and after realizing what had occurred, they tried to lift the chimney off the victim, but it was too heavy. One of the men ran to a neighboring house and called 911. At this time another fire investigator arrived on the scene and was apprised of the situation. He used his fire radio to call for a rescue company. Hearing the call, two fire Chiefs arrived on the scene within a few minutes and the five men were able to lift the chimney off the victim. Emergency cardiopulmonary resuscitation was initiated and the victim was transported to the local hospital where he later died of his injuries.

Figure 2. Collapsed brick chimney

Recommendation #1: Fire department personnel should conduct an assessment of the stability and safety of the structure, e.g., roofs, ceilings, partitions, load-bearing walls, floors, and chimneys, before entering damaged, e.g.,

by fire or water, structures for the purpose of investigations.

Discussion: Due to the destructive powers of fire, most structures that have been involved in fires or explosions are structurally weakened. Analysis of the exterior of the structure should be done continuously while conducting exterior scene investigations. Similarly, before the interior examination is conducted, the structure should be determined safe to work in by conferring with the Incident Commander or requesting an inspection from building and safety. If necessary, the investigator should seek the help of qualified structural experts to assess the need for the removal of dangerously weakened construction or should make provisions for shoring up load-bearing walls, floors, ceilings, roofs, or as in this case, a chimney. In this case, had a thorough assessment been made of the structure, including the chimney, the origin-and-cause investigation could have been postponed until the area around the chimney had been roped off and a collapse zone established, or the chimney had been demolished or stabilized.^{1,2}
