Motor Vehicle Incident Claims the Life of Volunteer Fire Fighter- North Carolina

Fatality Assessment and Control Evaluation Investigative Report #99F-16

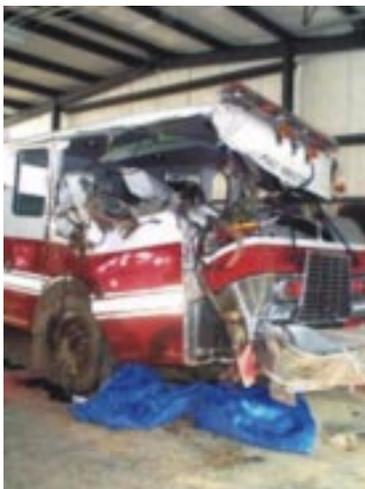
Engine involved in incident

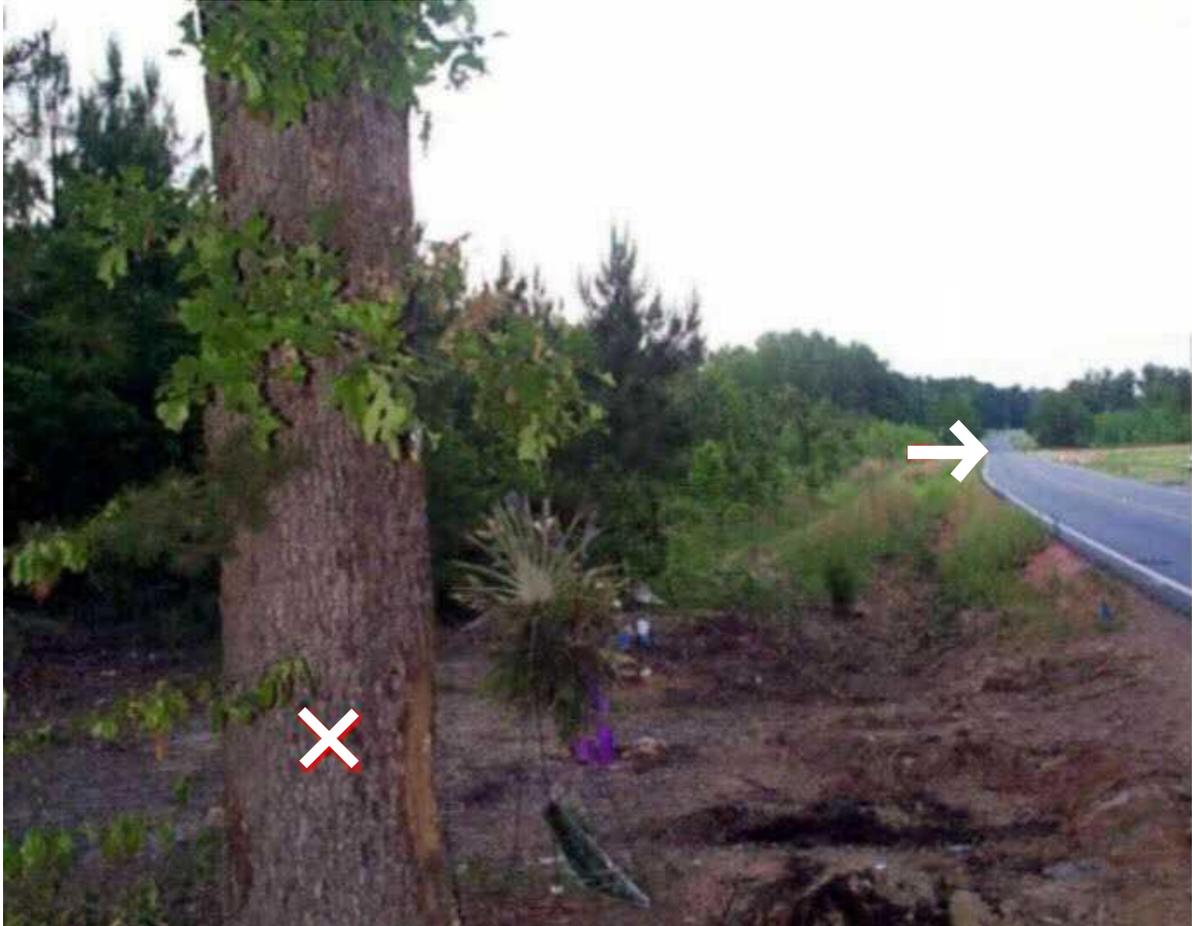
On May 2, 1999, at 1505 hours, a call came into Central Dispatch for a motor vehicle incident involving personal injury. Engine 252 with one fire fighter (the victim), Rescue 2 with one fire fighter, and the Assistant Chief, traveling by privately owned vehicle (POV), responded to the incident. The Assistant Chief arrived first on the scene and assessed the incident. Determining that the incident was minor and no one was injured, he canceled Engine 252 and the rescue truck. Returning to the station, the victim was driving Engine 252, heading southwest on a two-lane state highway. The pavement markings consist of a solid yellow line for the southwest direction, a dashed line for the northeast direction of travel and white edge lines. The shoulder of the southwest lane was narrow and dropped from a steep slope into a ditch. The road measures 19 ½ feet wide from shoulder to shoulder, with a hard shoulder measuring 1 foot, 10 inches on the southwest side (the direction of the victim's travel) and a hard shoulder measuring 5 feet, 6 inches on the northeast side. On the southwest side, the hard shoulder has a 4-inch drop to the soft shoulder. Although the lane was wide enough to accommodate the Engine, the victim steered the apparatus toward the shoulder to provide additional room for oncoming traffic. *Note: The Engine measured 8 feet wide, leaving 1 foot, 3/4-inches available in the victim's lane.* The road surface dipped, possibly causing the victim to oversteer the apparatus as he veered it to the right.

The Engine's right rear dual tires dropped off the hard shoulder onto the soft shoulder, and the victim tried unsuccessfully, to steer the Engine back onto the roadway. The Engine continued off the roadway, slid into the ditch and overturned onto the passengers' side. The Engine continued sliding on its side until the cab struck a large tree, killing the victim instantly. The Engine traveled 280 feet from the point where the rear tires dropped off the road until it struck the tree (see Figure 1). The driver of the rescue truck, who was approximately 100 yards behind Engine 252 when it went off the roadway, immediately stopped his vehicle and radioed for assistance. *Note: The ordinance speed is 45 mph; however, at the time of the incident, the road was under construction and the speed limit signs were removed. Therefore, in the absence of a speed limit sign, the ordinance speed was changed to 55 mph. The driver of the rescue truck stated he was traveling 45 mph at the time of the incident. Basing his estimate on distance traveled, tire impressions and the witness statement, the State Trooper, determined the Engine's speed as approximately 50 mph.* The rescue truck driver called for immediate assistance from the Assistant Chief, who was still on the scene at the first incident. He sent a fire fighter from the first incident to the incident involving the victim. At 1524 hours, Central Dispatch notified a State Trooper who was within a mile of the incident. The State Trooper arrived within seconds and was first on the scene, followed at approximately 1527 hours by the fire fighter from the first motor vehicle incident. The fire fighter began assisting the State Trooper in assessing the victim's condition. After the Assistant Chief was relieved from the first motor vehicle incident, he arrived on the scene at 1529 hours and established scene control. Within minutes of the Assistant Chief's arrival, an ambulance arrived, and Central Dispatch radioed the Assistant Chief to determine if a medical helicopter was needed. The fire fighter assisting the State Trooper climbed

Figure 1: Arrow indicates the dip in the highway where Engine 252's tires veered off of the road. The X indicates the tree with which Engine 252 collided.

Discussion: Fire departments should ensure driver/operators' of fire service vehicles are familiar with hazardous routes they travel (e.g., insufficient shoulder) and always maintain a safe speed. Additionally, drivers of large fire apparatus should use extreme caution when driving on narrow roadways.

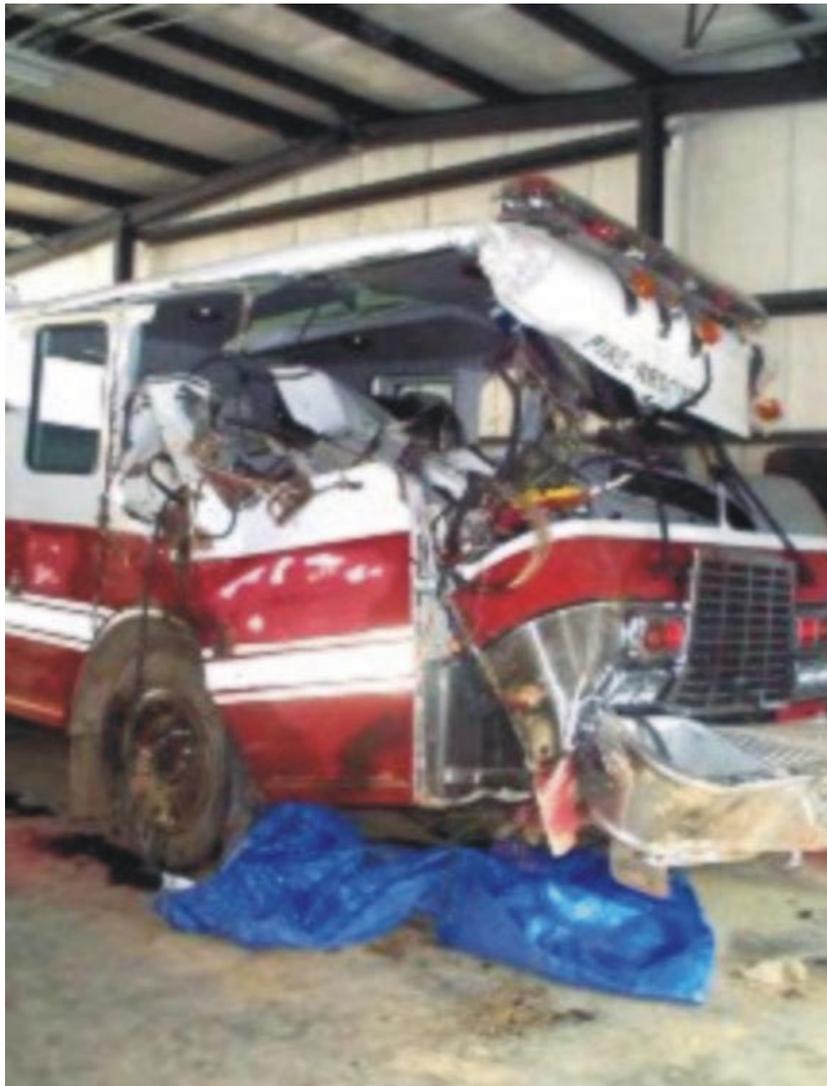
Figure 2: Engine involved in this incident.
