## Two Fire Fighters Die and Two Are Injured in Townhouse Fire—District of Columbia

## Fatality Assessment and Control Evaluation Investigative Report #99F-21

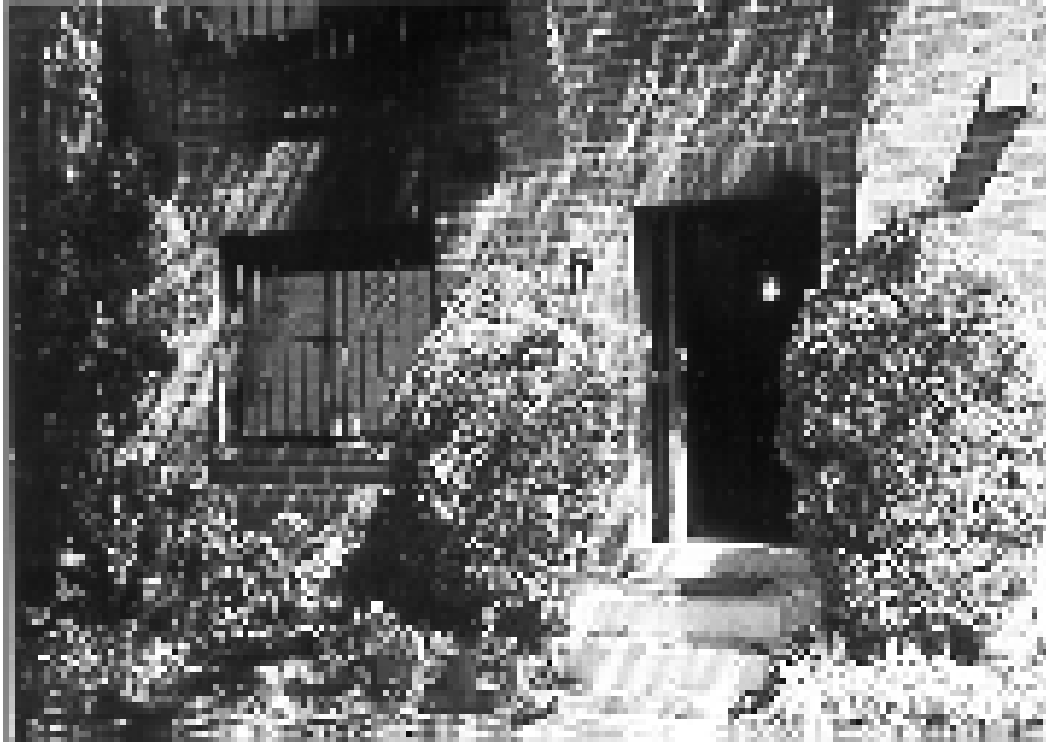
Photo 1: This photo depicts the front (side 1) entrance of the townhouse involved in the incident.

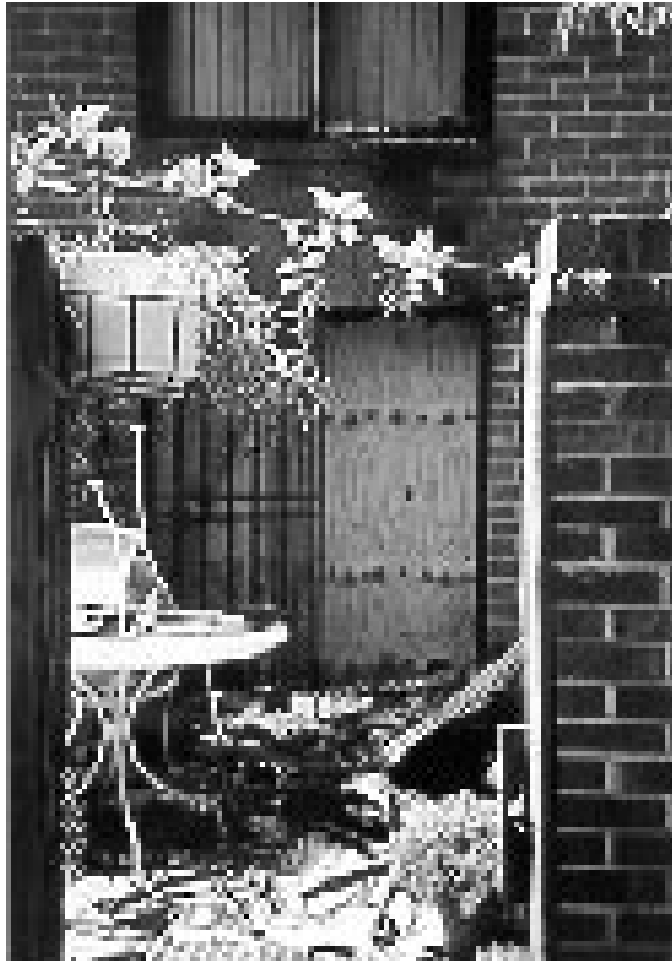
hammer, the officer and fire fighter from Truck 4 removed the iron security gate and broke open the glass door at 0026 hours (see Photo 2). Members of Truck 4 and Engine 17 stated that when the sliding-glass door was opened, air began to be sucked inside by the fire. They also saw small fires on the floor and stated that when the door was opened the fires grew larger. The Lieutenant from Engine 17 reported to the IC that they had fire on the first floor and requested permission to hit the fire. *[NOTE: Engine 17 was unaware that they were at the basement level due to the route they took to get to the rear. As they proceeded to the rear, they noticed the row houses they went between were only two stories, which caused confusion (see Diagram 1).]* The IC denied their request in fear of opposing hose lines. He then radioed the officer from Engine 26 to locate their position. He received no response from them. The IC knew that the crews from Engine 26 and Engine 10 had entered through the front door on the first floor.

Photo 2: This photo depicts the rear (side 3) sliding-glass door leading to the basement
