## One Fire Fighter Died and a Second Fire Fighter Was Severely Injured After Being Struck by a Motor Vehicle on an Interstate Highway-Oklahoma

## Fatality Assessment and Control Evaluation Investigative Report #99F-27

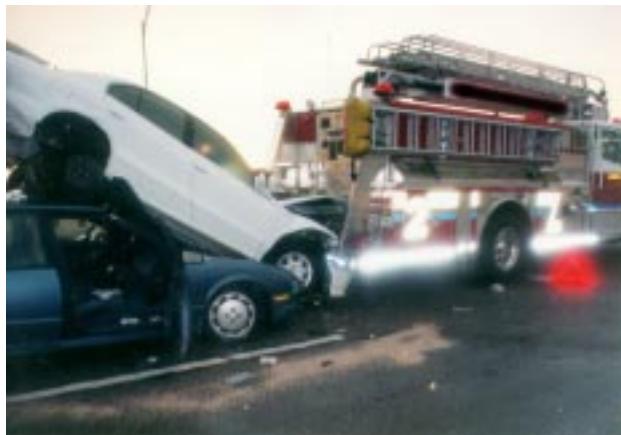
Incident scene

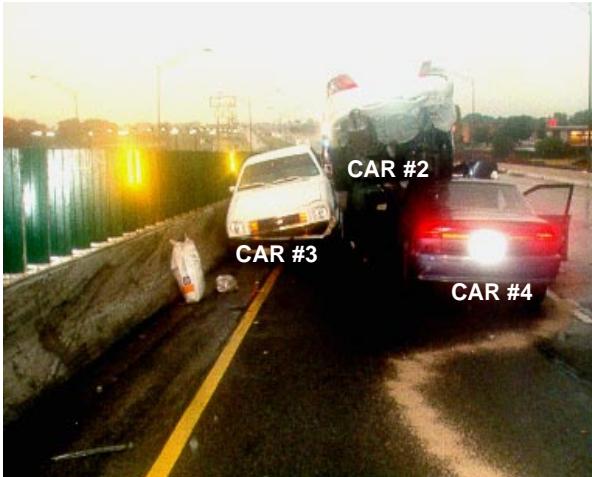
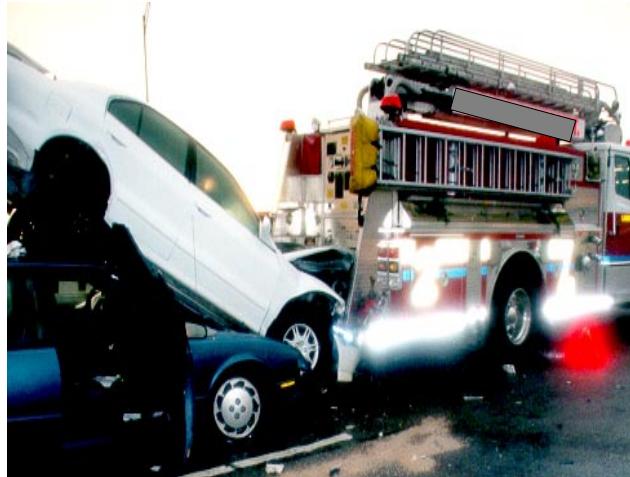
**Photo 1 - Incident Scene**

car #2, a fire fighter from Ladder 2, the victim from Squad 2, and the civilian driver of car #2 were struck by car #3 that had struck the median wall, wedging itself between the wall and the Ladder truck (See Diagram 1 and Photo 1).

View from back of scene

View of scene from side

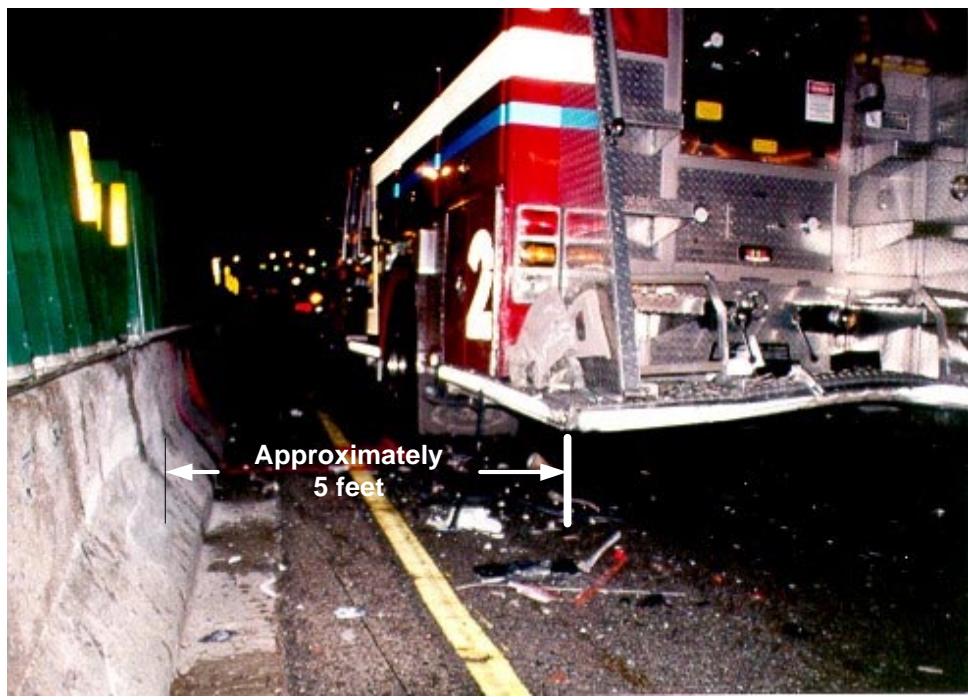
**Photo 2 - Ladder 2 after vehicles were removed.**

Note - Distance between median wall and Ladder 2 where car #3 was located is approximately 5 feet wide.

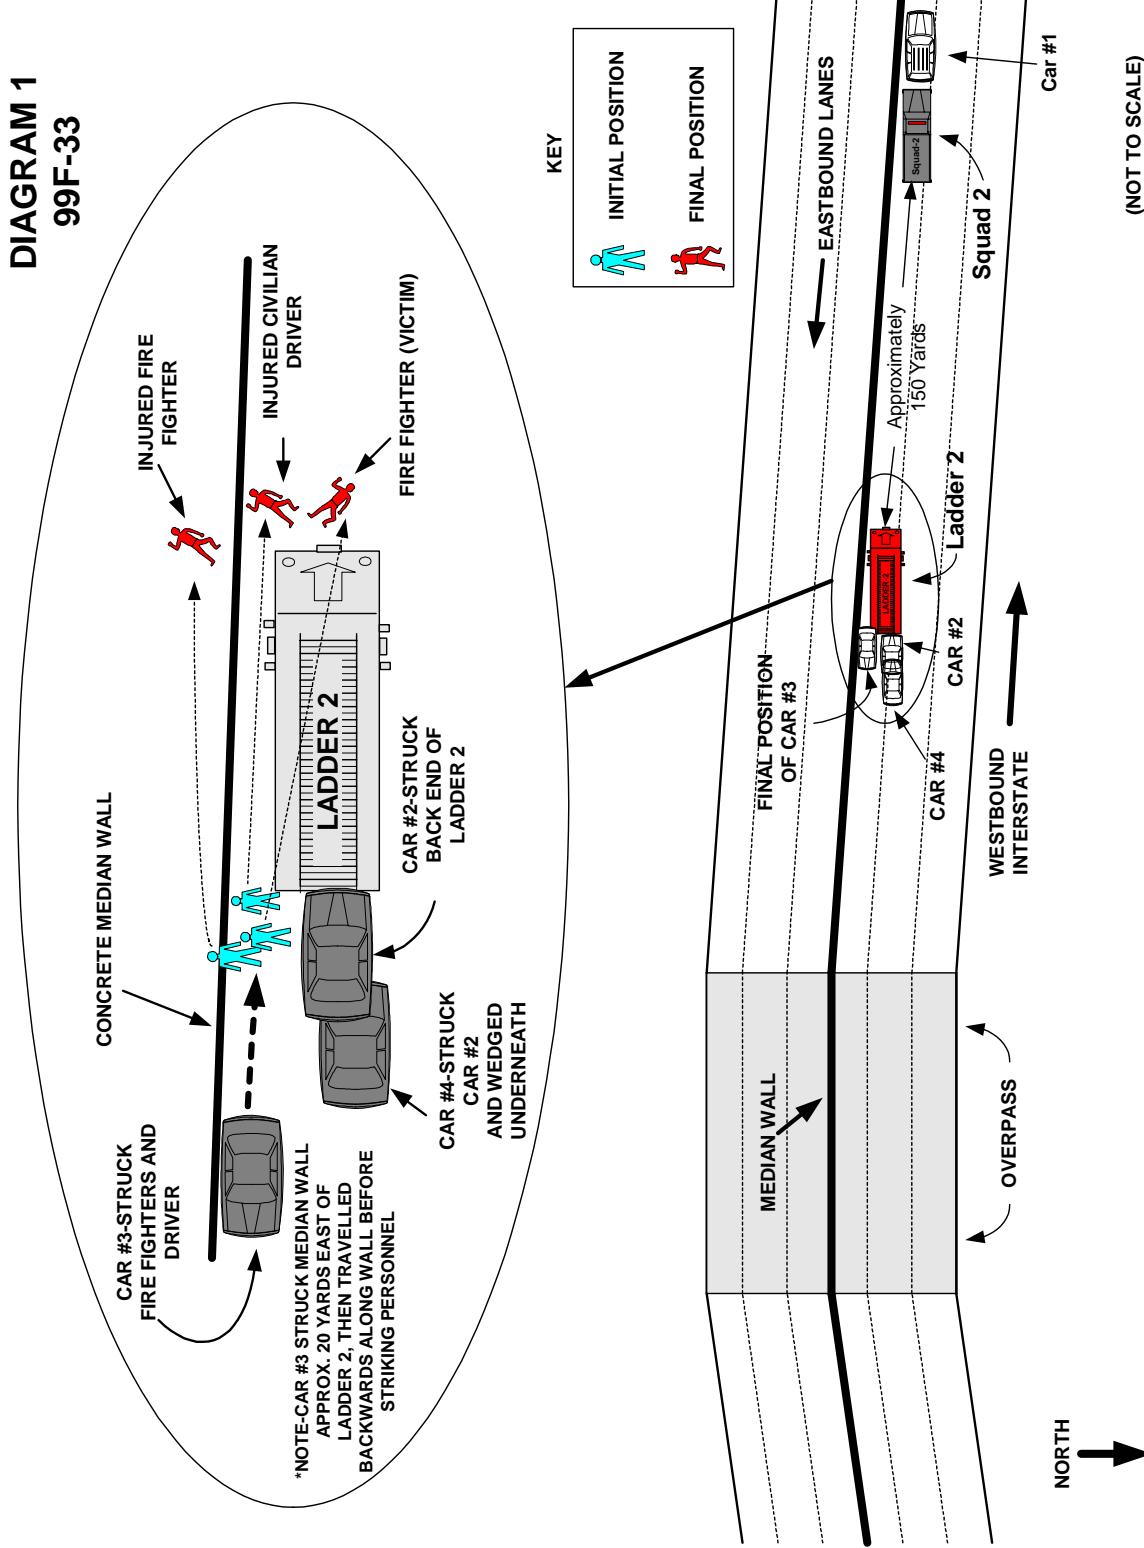
**DIAGRAM 1**  
**99F-33**

interstate ( See Diagram 1). The interstate highway on which this incident occurred was wet and slippery from an intermittent rainstorm. The units responding at 1920 hours included: Ladder 2 (Captain and two fire fighters), Squad 2 (two fire fighters), and one privately owned Emergency Medical Service (EMS) ambulance. Squad 2 was the first to arrive on scene at 1923 hours and reported a Signal 7 (no injuries). Squad 2 personnel then released the EMS from further response. At approximately the same time, Ladder 2 was stopping near the median wall (See Photo 2), approximately 150 yards directly behind Squad 2 to provide protection from oncoming traffic for both the occupant of the motor vehicle and Squad 2 personnel. The personnel of Ladder 2 remained in the truck, with the emergency lights turned on and operating, while the Captain called dispatch for an estimated time of arrival of the Highway Patrol. Dispatch replied that they would contact the Highway Patrol and relay the information back to him. At approximately 1926 hours, Ladder 2 was struck from behind by a motor vehicle (car #2). The personnel of Ladder 2 exited the vehicle to see if there were any injured motorists. As the fire fighters from Ladder 2 exited the vehicle, they noticed the civilian driver in the process of getting out of her car. They began to check her for injuries because she complained of a sore ankle. The Captain notified dispatch that the ladder truck had been struck from behind by a motor vehicle, and requested that EMS return to the scene and assist the injured driver of the car that rear ended Ladder 2. He then requested that the City Police also respond to the scene to provide traffic control (Note: The fire department was informed that Highway Patrol was not able to respond as quickly due to the high number of other auto incidents that had occurred at that time. Data was not available on the number of auto incidents that occurred on August 5, 1999 for this stretch of interstate). Seeing that Ladder 2 had been struck by a vehicle, one of the fire fighters (the victim) from Squad 2 ran up the

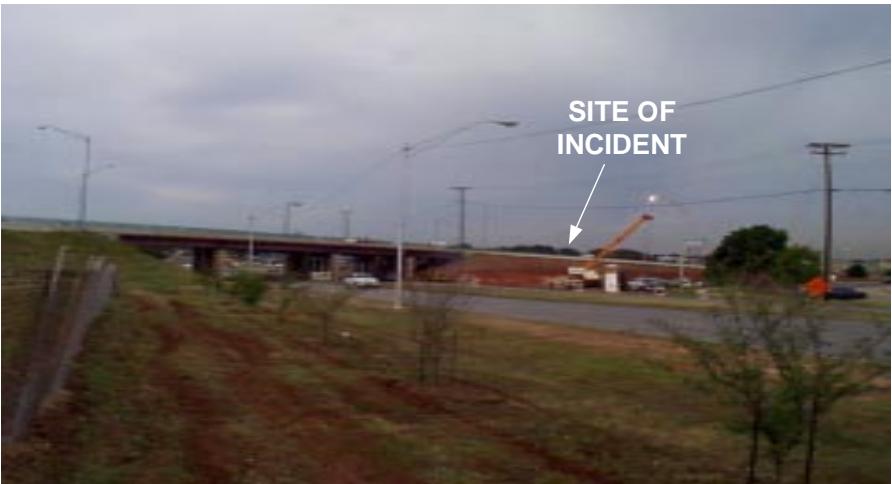
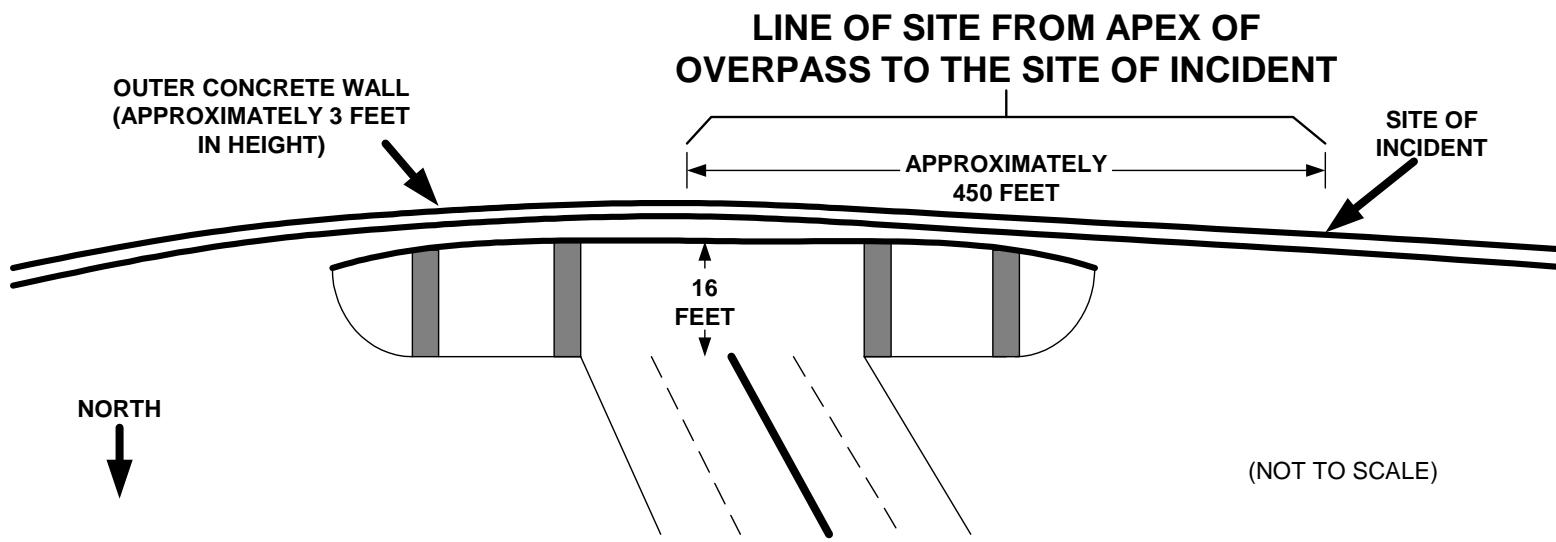
**DIAGRAM 2 - PROFILE OF HIGHWAY OVERPASS WHERE INCIDENT OCCURRED**

near car #1, noticed a car cresting the top of the overpass (note: the overpass has an elevation change which makes it similar to a hill with both sides having a slope), on the inside lane, and was rapidly approaching Ladder 2. He yelled out two warnings over the radio "Ladder 2 Captain, watch out behind you" as the car lost control. As the fire fighter from Ladder 2 and the victim from Squad 2 were attempting to move the injured driver from car #2 to a safer area between the wall and Ladder 2, the car (#3), which was out of control, spun backward. While traveling backward, the car impacted the median wall (approximately 20 yards east of Ladder 2), sliding between the wall and Ladder 2, missing the Captain and one of the fire fighters from Ladder 2, before striking the other two fire fighters and the injured driver from car #2. The two fire fighters and the injured driver were thrown approximately 47 feet from the point of impact, killing the fire fighter from Squad 2 and seriously injuring both the fire fighter from Ladder 2 and the driver from car #2. NIOSH investigators conclude that, to minimize the risk of similar occurrences, fire departments should:
