NIOSH
Fire Fighter Fatality Investigation
and Prevention Program

March 29, 2000

A Captain Dies and Two Fire Fighters Are Injured in a Motor-Vehicle Crash - Texas

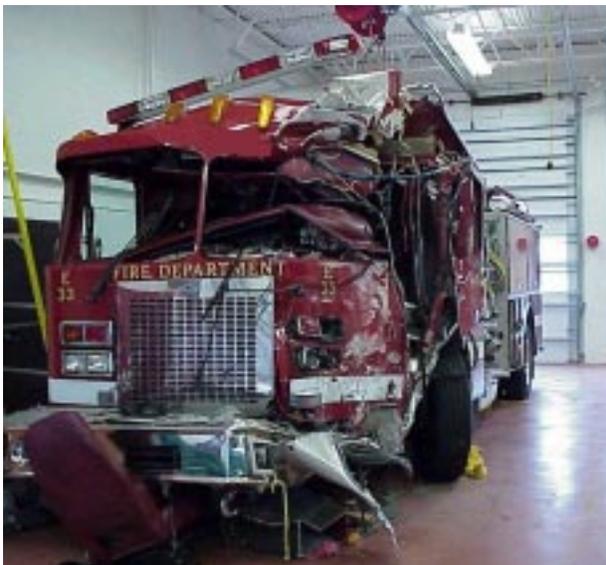
Engine Involved in This Incident

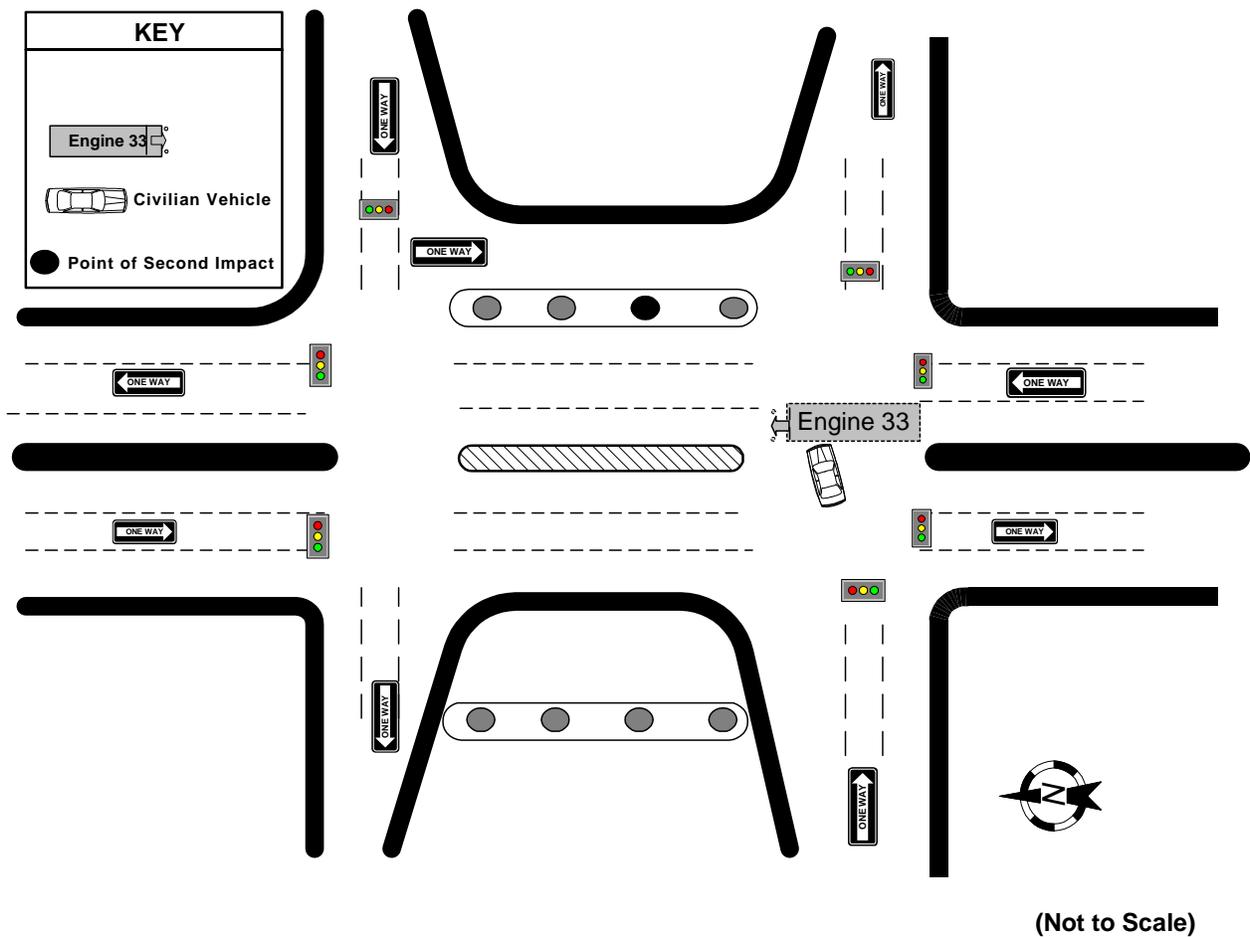
Diagram 1. Initial Impact of Engine 33 and Civilian Vehicle

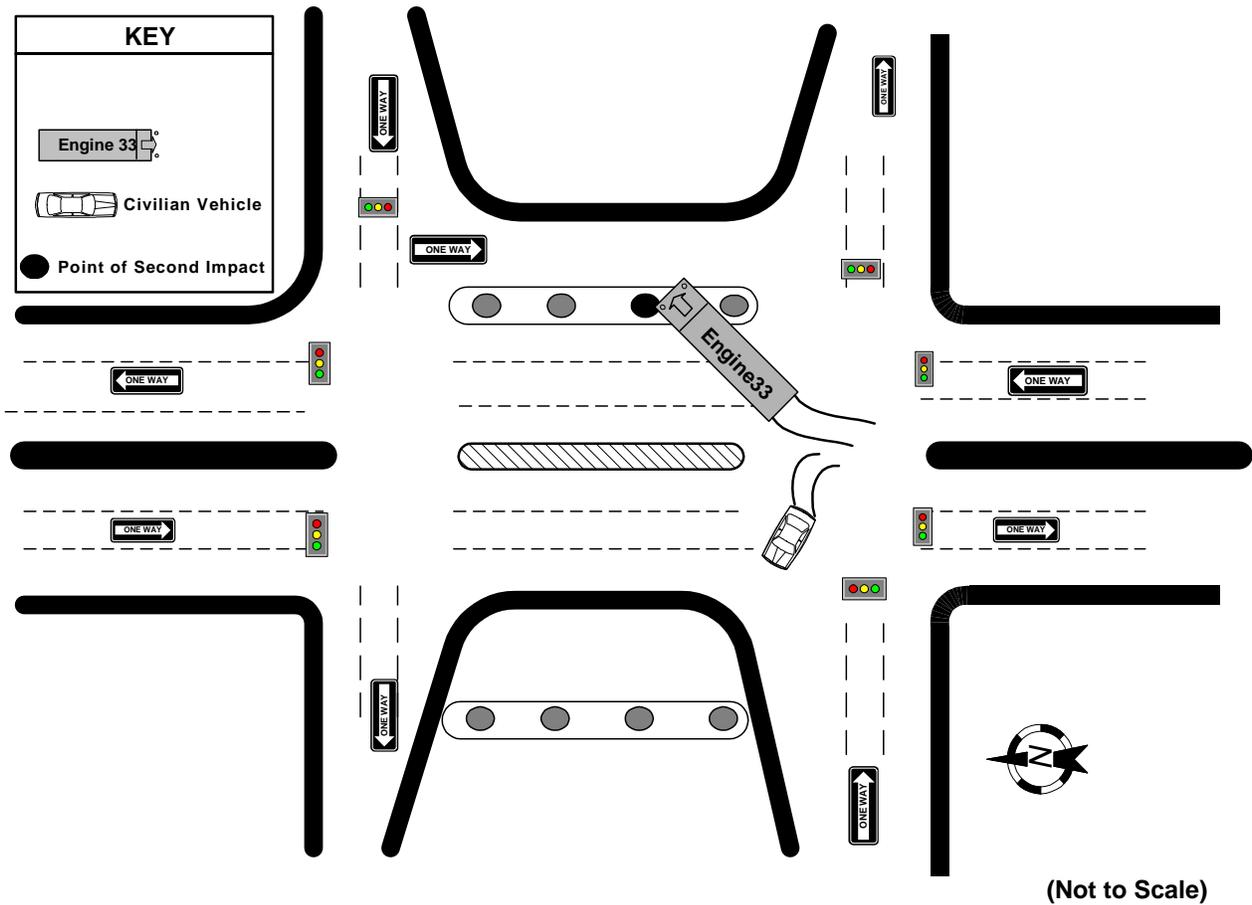
Diagram 2. Secondary Impact of Engine 33

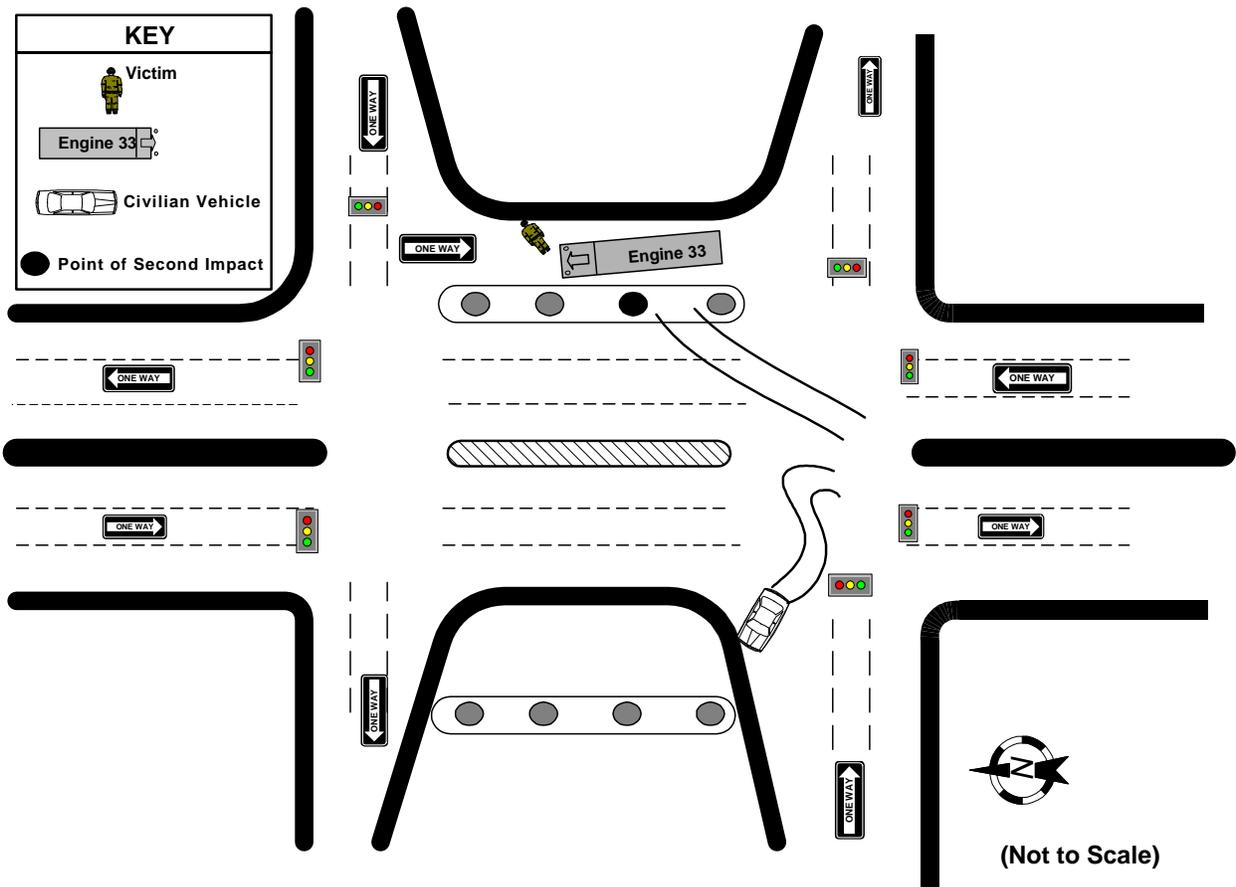
Diagram 3. Final Resting Position of Engine 33 and Civilian Vehicle

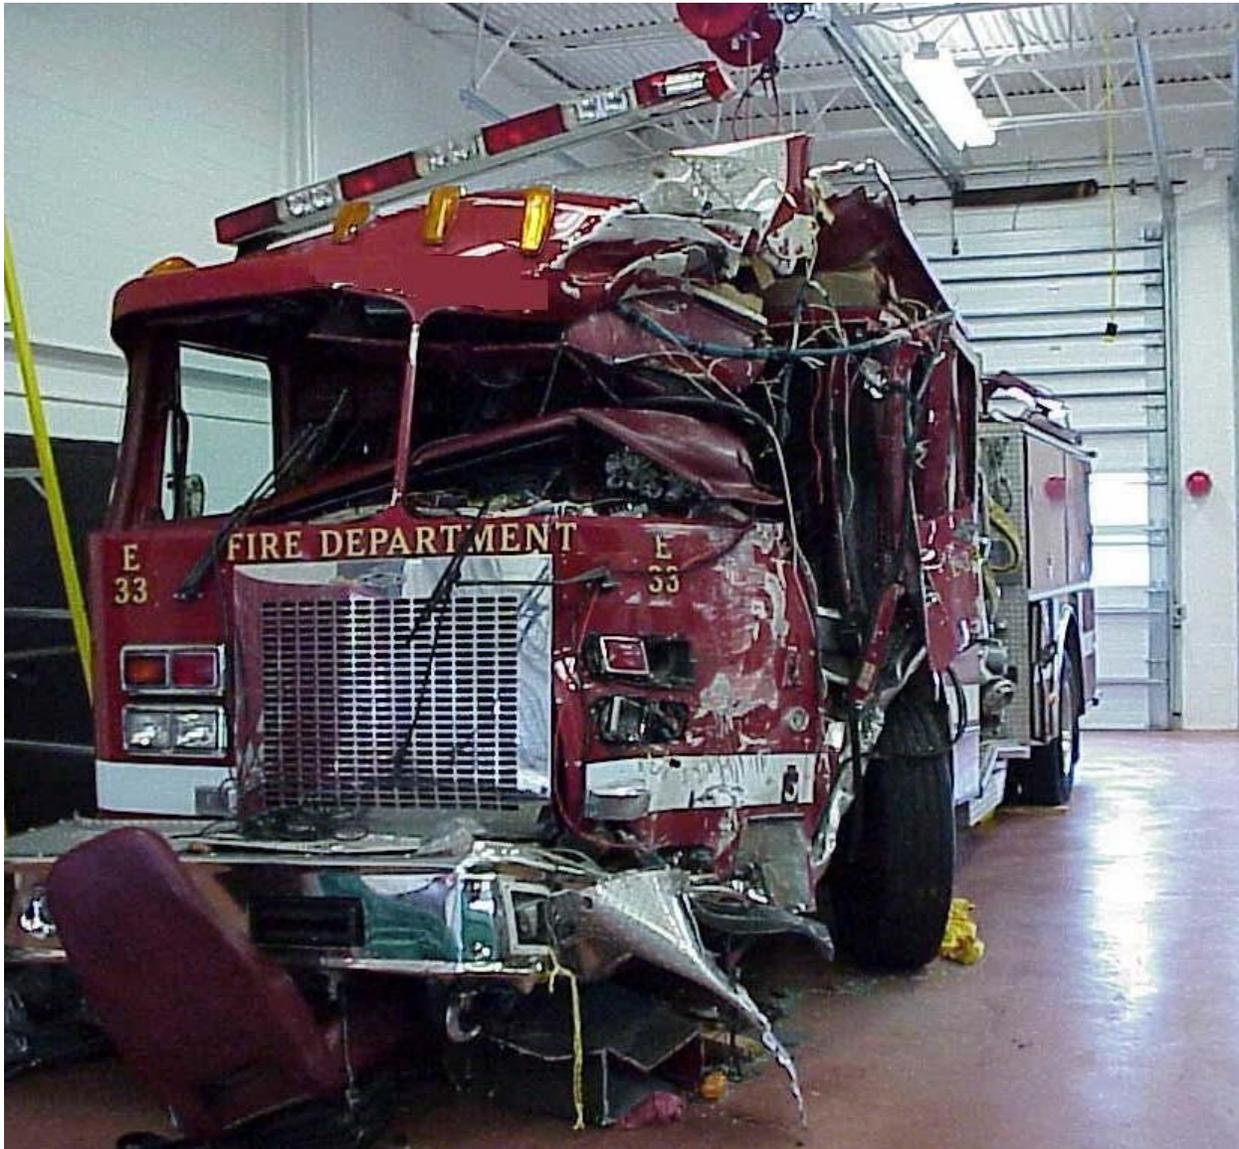
Photo. Engine Involved in This Incident
