**NIOSH**  
Fire Fighter Fatality Investigation  
and Prevention Program

March 7, 2000

## **Downed Power Line Claims the Life of One Volunteer Fire Fighter and Critically Injures Two Fellow Fire Fighters - Missouri**

## Fatality Assessment and Control Evaluation Investigative Report #99F-37

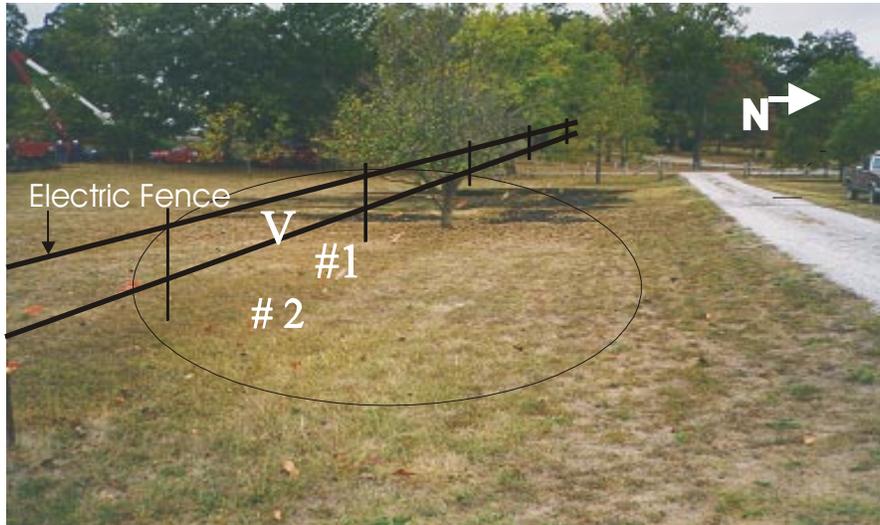
On October 4, 1999, at 0658 hours, a property owner notified Central Dispatch of a grass fire. The fire was started when one phase of a 3-phase, 7200-volt, overhead power line separated from the connection on a utility pole (Figure 2) and fell to the ground, igniting the surrounding grass area (Figure 1). When the power line fell, it crossed the road and a grassy field and came to rest on an electric fence, which it energized. At 0700 hours, Central Dispatch notified the fire department of a grass fire with a downed energized power line. At 0704 hours, the Chief was first to arrive on scene in his privately owned vehicle (POV) and parked approximately 20 feet from the end of the downed power line to alert arriving units of its location (Figure 3). The Chief conducted a scene size-up, and he reported a grass fire with a slow rate of spread and light fuel. He confirmed to the arriving units that a power line was down, and he indicated that the electric fence was energized due to the downed power line. (Note: This was an electric fence used to control live stock. However, the fence was not operable at this time.) He then radioed Central Dispatch and asked the power company to de-energize the line. Engine 1, which has a 1,000-gallon tank, arrived at 0706 hours with two fire fighters (the driver and Injured #1). The Chief directed the driver to pull the Engine into a driveway on the north flank of the fire (Figure 1). Truck 3 (brush/wildland truck with a 250-gallon tank), with a fire fighter/driver, arrived at 0707 hours and was directed by the Chief to a position on the south flank of the fire. Immediately after Truck 3's arrival, two fire fighters (the victim and Injured #2) arrived in their POVs, pulled into the driveway on the

***Figure 1. Secondary Fire Site: Location of Victim (V) and Two Injured Fire Fighters (#1 and #2) in Relation to Electric Fence***

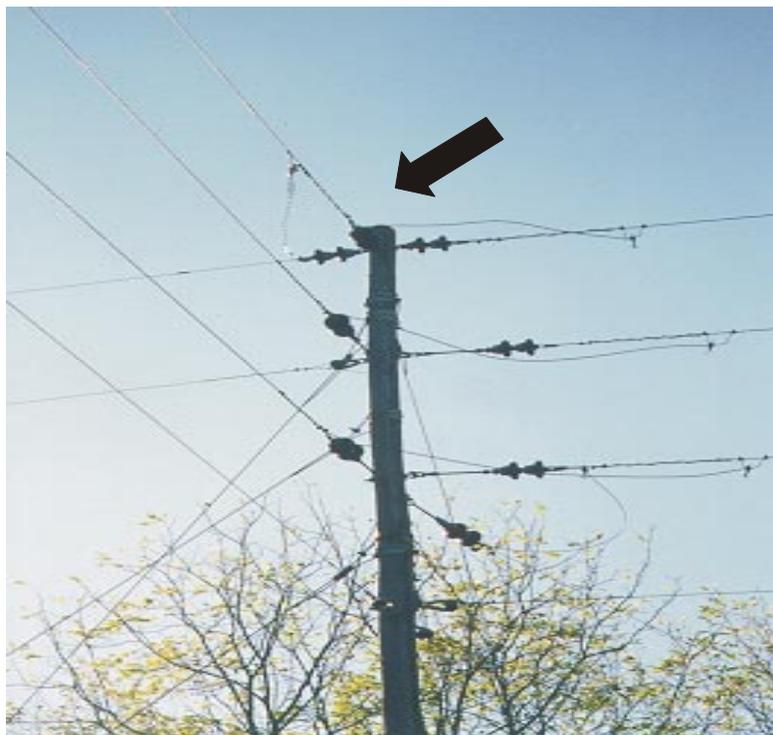
***Figure 2. Point of Separation Between the Power Line and Connector***

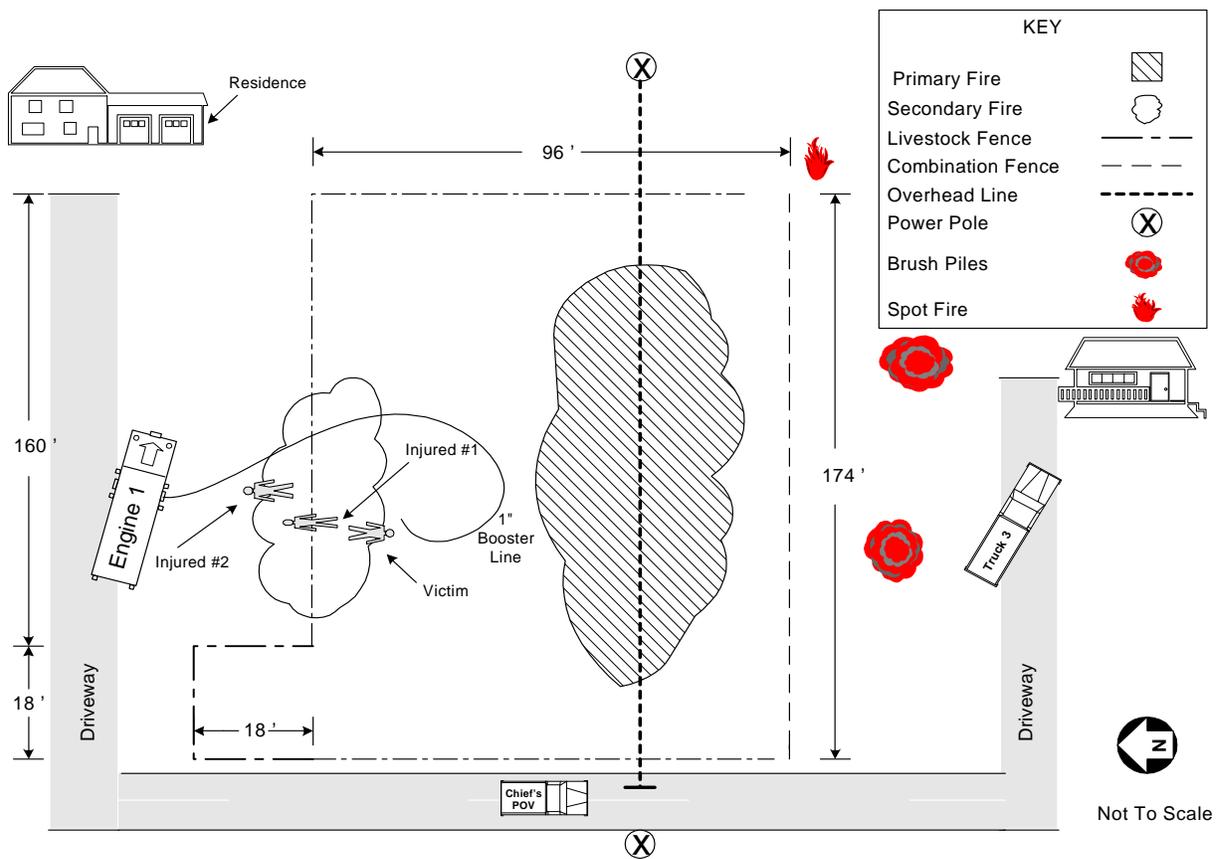
***Figure 3. Aerial View of Incident Site***

On October 4, 1999, a 20-year-old male volunteer fire fighter (the victim) was electrocuted and two other fire fighters were injured when they contacted an electric fence while fighting a grass fire. Central Dispatch notified the fire department at 0700 hours of a fire which was started when a downed power line ignited the surrounding grass. The Chief was the first to arrive on scene, and he confirmed that a power line was down. He also indicated to Central Dispatch and to the responding fire fighters that the electric fence bordering the area was energized by the downed power line. The Chief parked his truck on the road near the end of the downed line to warn arriving units of its location. Engine 1, with a driver and one fire fighter (Injured #1), was next to arrive and was positioned in a driveway on the north flank
